## Preliminary Ecological Appraisal and Roost Assessment

Home Farm, Shaw Hill, Shaw, Wiltshire, SN12 8EW

‘Demolition of buildings, creation of hardstanding and modified grassland’

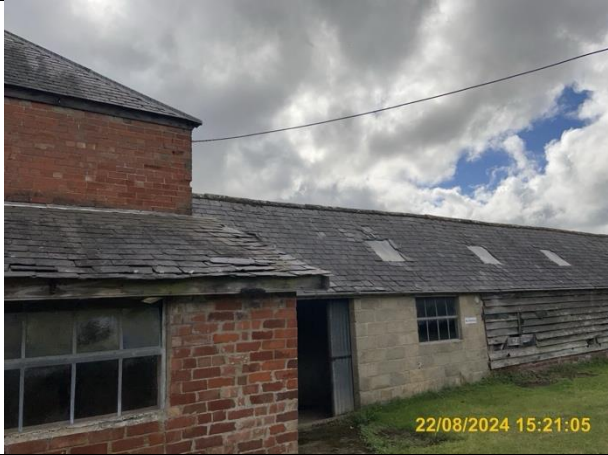
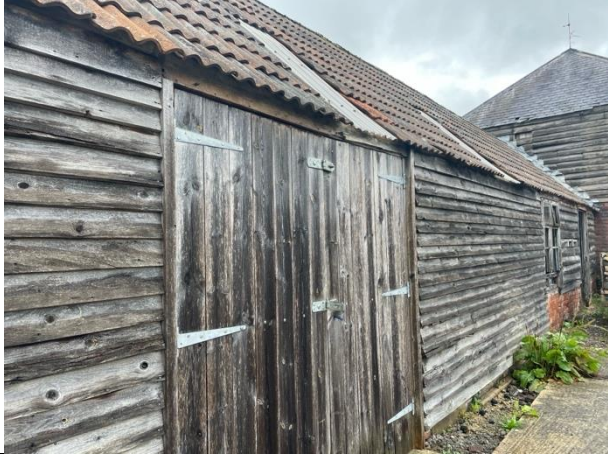
| these crevices. Moreover, any external evidence would be quickly weathered away. The building has <b>high roosting habitat value</b> . | | | |
|---|---|---|---|
| Walls B1a | Timber cladding, breeze blocks | <p><b>Condition/description</b></p> <p>Timber cladding on the southern, northern and western elevations as well as breeze blocks on the northern elevation. The cladding is in poor condition - aged and lifted on all elevations.</p> <p><b>Suitability/access/evidence of bats</b></p> <p>Raised external cladding provides crevices under which bats could roost or gain access into the interior.</p> | |

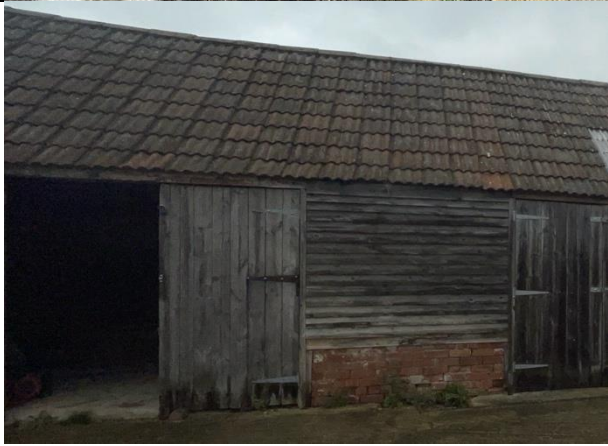
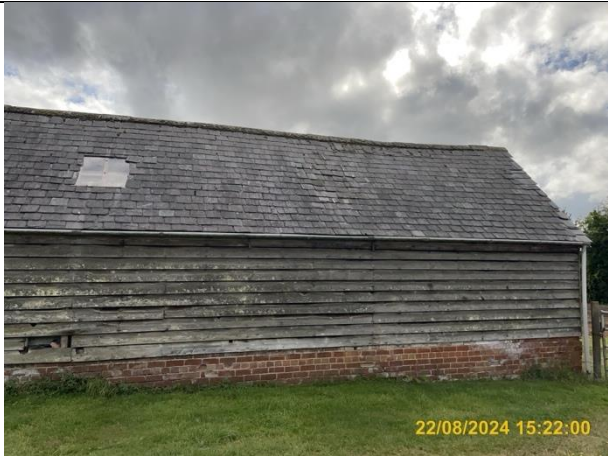
| Roof B1a | Clay interlocking tiles, slate tiles. | <p><b>Condition/description</b><br/>The roof is pitched and gable ended on the western elevation. It is clad in clay interlocking tiles on the southern elevation and slate tiles on the northern elevation. The gable end has timber cladding in poor condition and numerous interlocking tiles and slate tiles are dislodged or missing on all elevations.</p> <p><b>Suitability/access</b><br/>Crevice dwelling bats could roost in-between lining and tiles on the northern elevation and in crevices created under dislodged tiles. Both crevice and void-dwelling bats could access into the interior through crevices created by missing and raised tiles.</p> | |

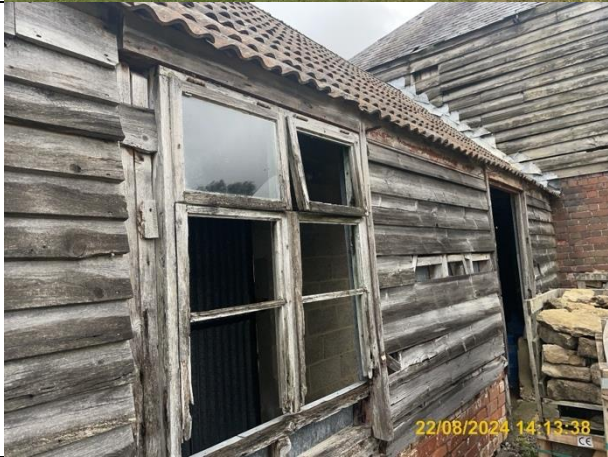
| Eaves B1a | Closed | <p><b>Condition/description</b><br/>Gaps between tiles and eaves.</p> <p><b>Suitability/access</b><br/>These gaps can provide crevices in which bats could roost or gain access into internal void.</p> | | <p>22/08/2024 14:13:38</p> |

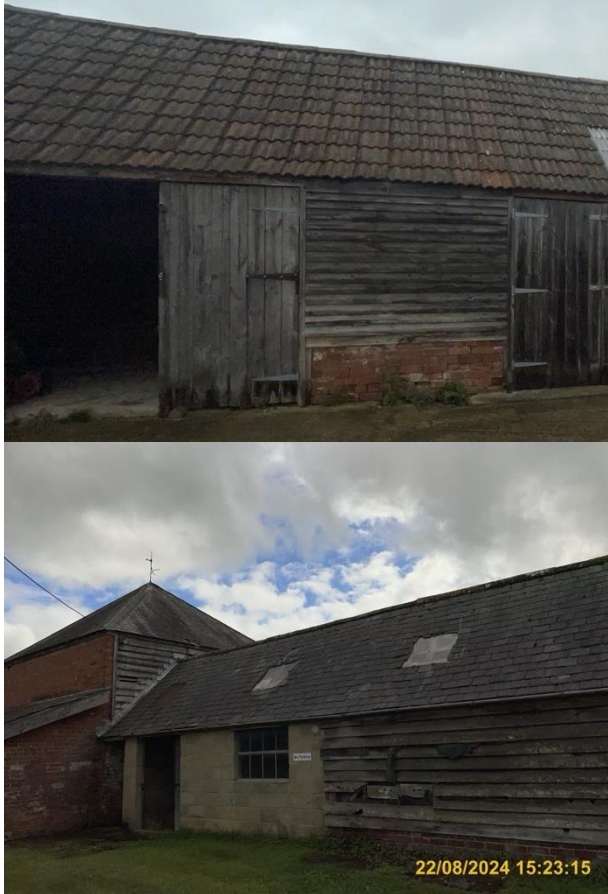
| Window/doors frames and lintels B1a | Timber | <p><b>Condition/description</b></p> <p>Timber doors with small gaps along the frame, broken window with metal sheet behind on the southern elevation and opening without barrier on the northern and southern elevation, and well-sealed window on the northern elevation.</p> <p><b>Suitability/access</b></p> <p>Small gaps between door frame and doors provide access into internal void. Metal sheet behind the broken window on the southern elevation limits access into internal void, but the unrestricted openings on the southern and northern elevation provide access into the interior.</p> | <p>22/08/2024 15:23:15</p> |

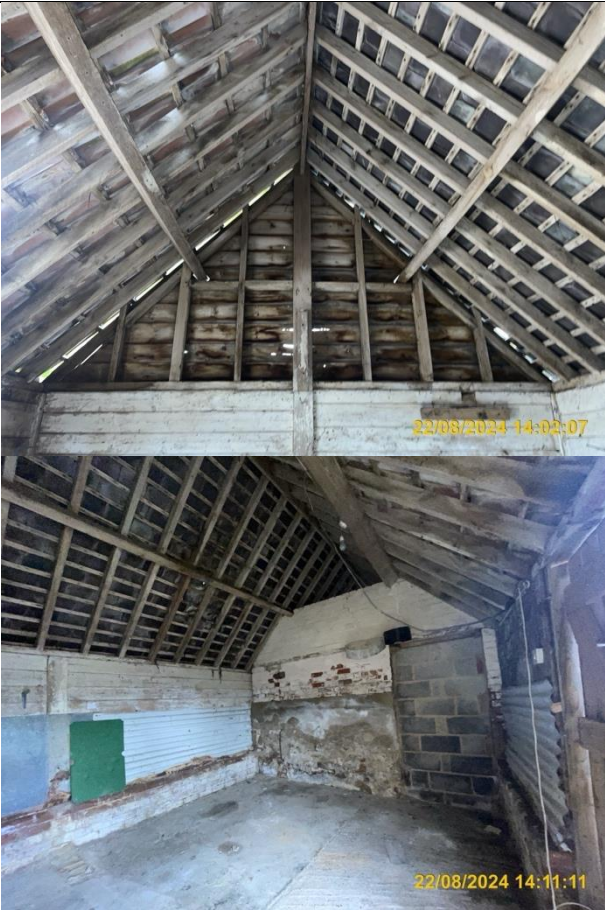
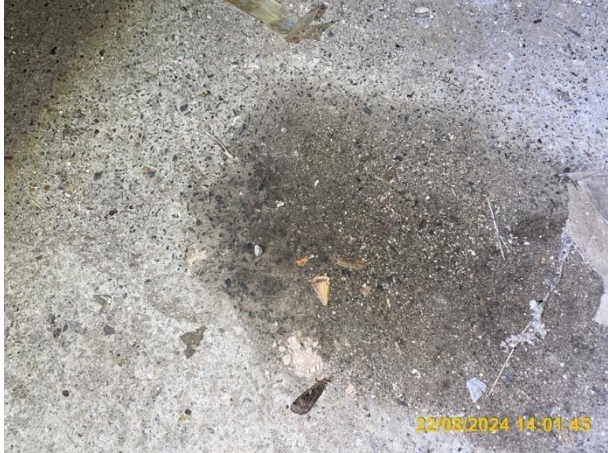
| Internal voids B1a | Timber rafters and ridge beam. Open floor to ridge. Mortise and tenon joints. Internal stone wall with large opening | <p><b>Condition/description</b></p> <p>Internal space measures approx. 10 m long, 4 m wide, floor to ridge height approx. 5 m. The internal timbers appear to be original and in good condition. Humidity of the interior was 80.7%, with mycelium present on walls. Internal stone wall separates area with unrestricted opening and creates darker interior with only small amount of natural light spill from gaps in door frame and eaves. There is slate lining under</p> | |

| | <p>bellow the ridge beam.</p> | <p>the slate tiles on the northern elevation, and no lining on the southern elevation.</p> <p><b>Suitability/access/evidence of bats</b></p> <p>Low number of bat droppings (~10) and discarded moths and butterfly wings (~5) were found on the floor of the building. Samples of bat droppings were collected for DNA analysis. Some droppings were of bigger size, which is indicative of large bat species. Discarded insect parts indicate bat-feeding activity inside the building. Moreover, high humidity inside the building and low number of droppings would be indicative of a non-maternity roost. The unrestricted openings into the building, gaps in dislodged tiles and gaps in door frame and eaves provide access into the void. The void is suitable for roof-void dwelling bats, which require gaps from as small as the width of our thumb to access the roost and need timber joists or beams on which to roost.</p> | |

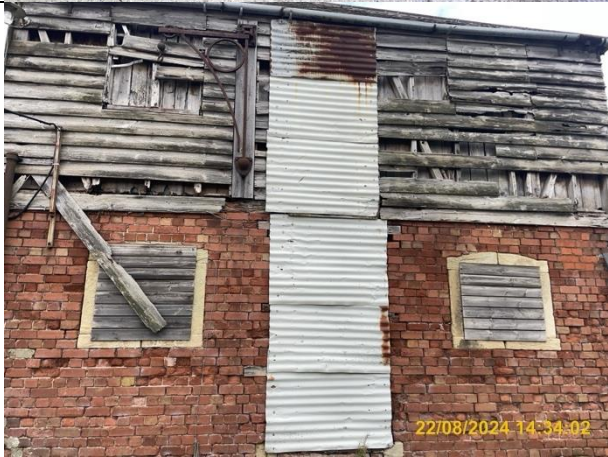
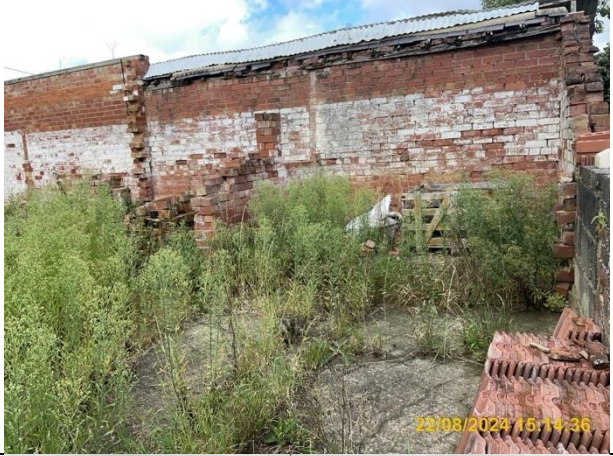
| Walls B1b | Brickwork, timber cladding, metal sheets | <p><b>Condition/description</b><br/>Brickwork with gaps on northern and southern elevation and aged, raised timber cladding on southern and eastern elevation. Wall on the southern elevation has six metal sheets running vertically, and it is assumed the sheets were used to cover an open area which was utilised by animals to access the interior of the second storey and subsequently the loft void. This is supported by the presence of two dead birds in the loft void, which most likely got trapped in the loft void after the opening got boarded up. A brick wall on the south-eastern elevation has numerous gaps in brickwork and lifted timber cladding.</p> <p><b>Suitability/access</b><br/>These gaps in brickwork and raised cladding create crevices in which bats can roost or use as an access point into the internal void.</p> | |

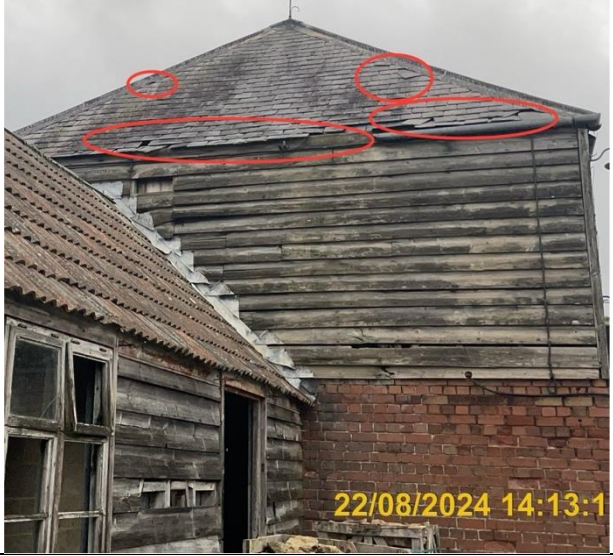
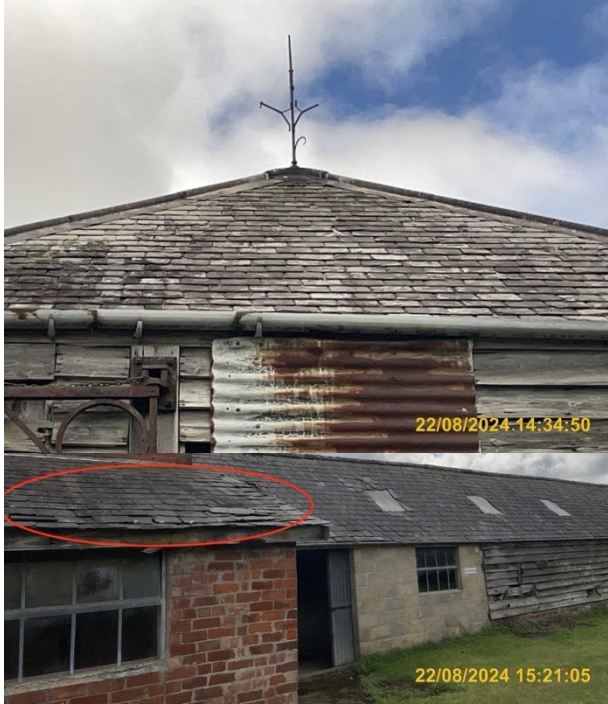
| Roof B1b | Clad in slate tiles and metal roofing sheets | <p><b>Condition/description</b></p> <p>The main roof of B1b is hipped and clad in slate tiles, and two adjacent lean-on roofs on the northern elevation have metal roofing sheet and slate tiles clad. Both the main roof and lean-on roof clad in slate tiles have broken, dislodged or missing tiles, revealing gaps, and there is exposed lead flashing on all elevations of the main roof.</p> <p><b>Suitability/access</b></p> <p>The numerous gaps in roofs clad in slate tiles create crevices in which bats could roost or gain access into the interior void and loft void.</p> | <p>A photograph showing a wooden building with a damaged roof. The roof is clad in slate tiles, and there are several gaps and missing tiles visible. Red circles are drawn around the damaged areas. A yellow timestamp '22/08/2024 14:13:1' is visible in the bottom right corner.</p> |

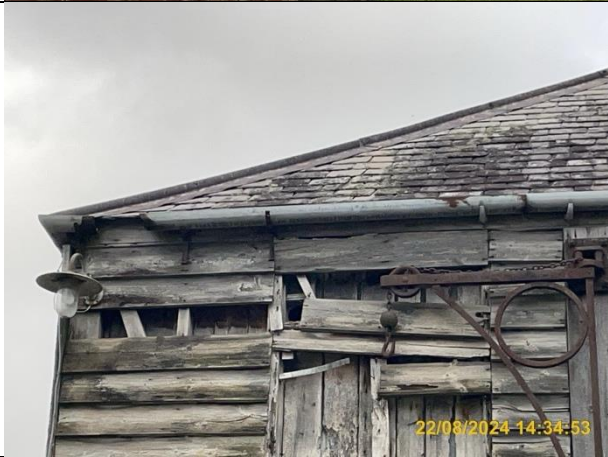
| Eaves B1b | Closed | <p><b>Condition/description</b><br/>Eaves are in poor condition with gaps between tiles and eaves on all elevations.</p> <p><b>Suitability/access</b><br/>These gaps can provide crevices through which bats could gain access into internal void and loft void.</p> | |

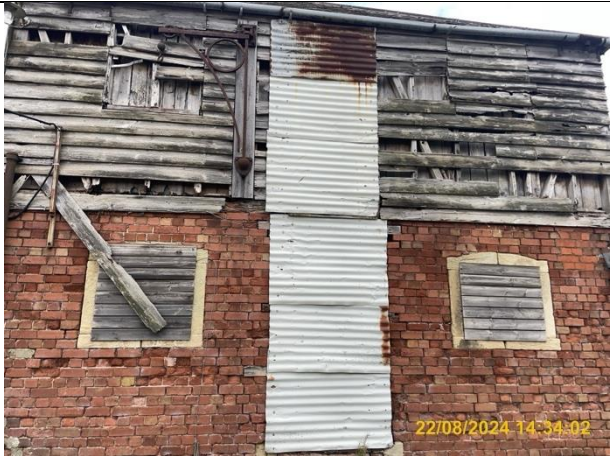
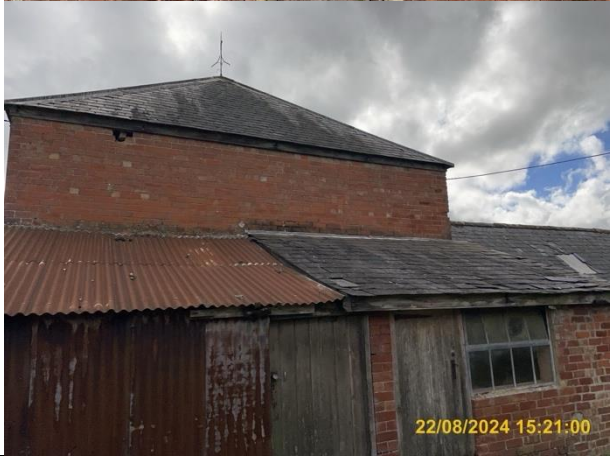
| Windows/door frames and lintels B1b | Stone and timber window frame, timber door frame | <p><b>Condition/description</b></p> <p>Windows on the southern elevation are boarded up, with gaps in stone and timber frames, creating natural light spill visible from the interior. Doors on the northern elevation seem to be tight fitting.</p> <p><b>Suitability/access</b></p> <p>Gaps in window frames allow access into the interior void and subsequently the loft void.</p> | |

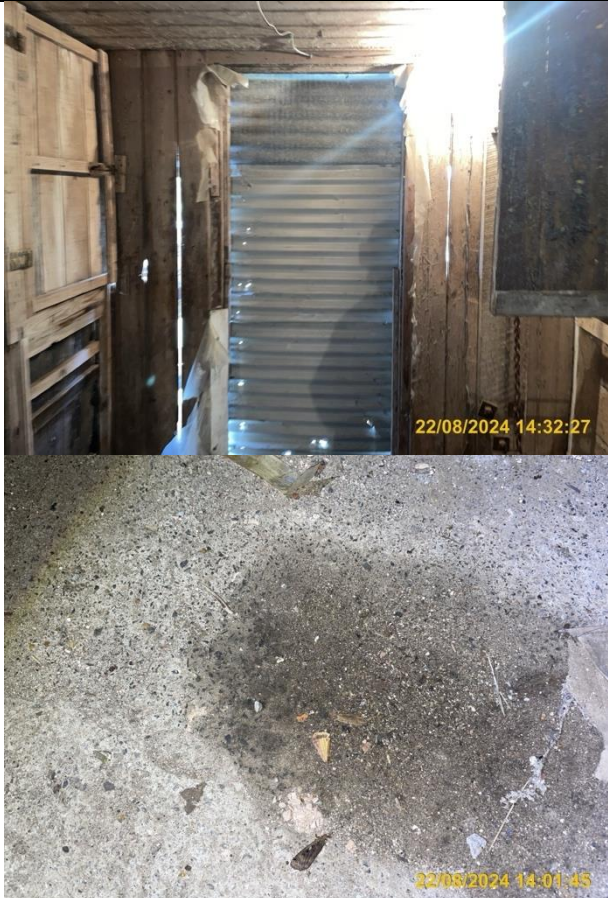
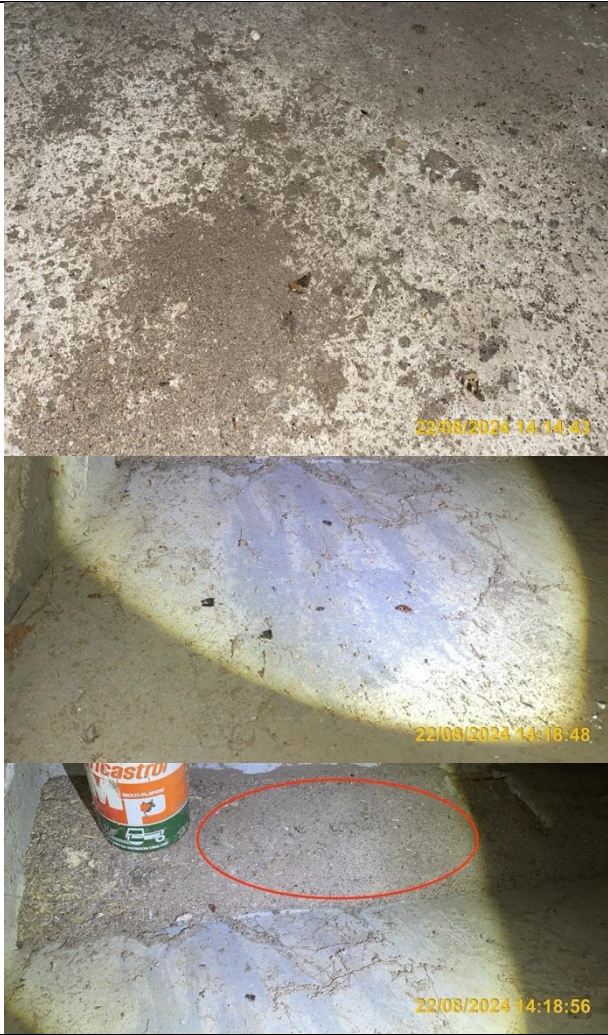
| <p>Internal voids<br/>B1b</p> | <p>Timber rafters and ridge beam. Open floor to ridge. Mortise and tenon joints.</p> | <p><b>Condition/description</b></p> <p>First storey can be accessed through opening into the corridor between B1a and B1b. The interior was dark with low levels of natural light spill through gaps in window frames and brickwork. Second storey is accessed by a ladder and contains two dark enclosed spaces, running along eastern elevation and western elevation of the building. Both spaces don't have a barrier in their opening, allowing full access. The second storey has some natural light spill through the gaps between timber cladding and metal sheets which were used to board up windows and door.</p> <p><b>Suitability/access/evidence of bats</b></p> <p>First storey had a low number (&lt;5) of discarded moths and butterfly wings. A large number of bat droppings (~50) with mixture of colours and discarded moths and butterfly wings (~20) were seen within both two dark enclosed spaces on the second storey. Samples were collected for DNA analysis. There is a mixture of colours which shows different ages of droppings, with darkest droppings indicating more recent activity. Size and shape of droppings indicate a large bat, such as serotine or horseshoe.</p> | |

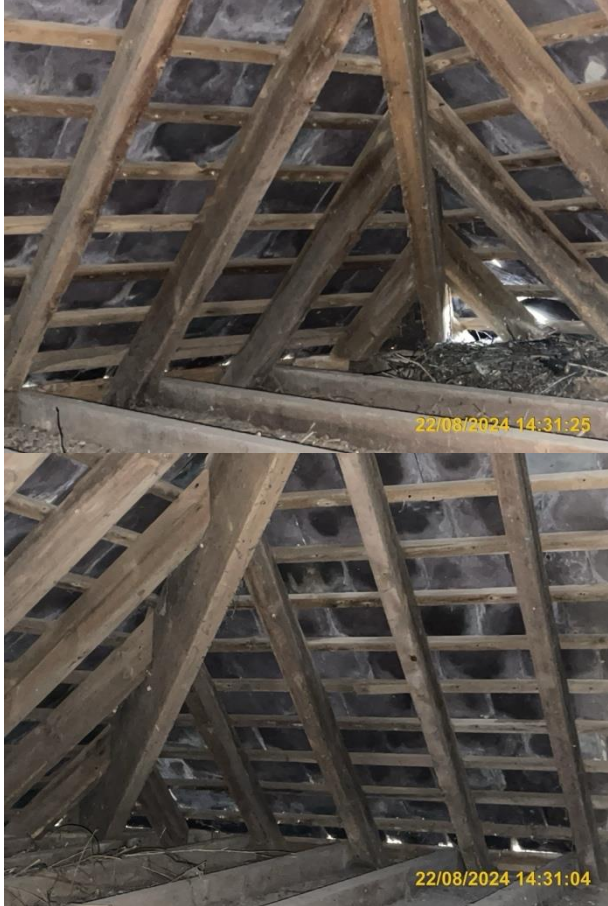
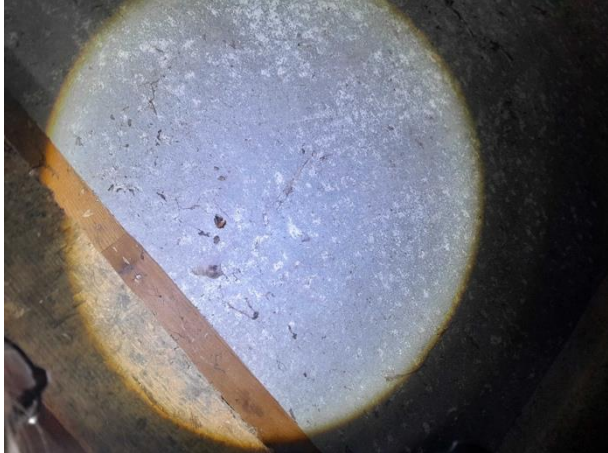
The loft void of Building B1b had unstable loft joists, and therefore couldn't be fully accessed and surveyed.

| Loft void B1b | Timber rafters and ridge beam. Open floor to ridge. | <p><b>Condition/description</b></p> <p>Loft void is on the third storey of the building, it has timber rafters and ridge beam in good condition, and it is 2 m high and 4 m wide in diameter. The loft roof is not lined, with exposed slate tiles. 2 dead birds, presumably pigeons, 4 pigeon nests and rodent droppings were seen. The loft void couldn't be fully accessed and surveyed due to safety reasons as the loft joists were unstable.</p> <p><b>Suitability/access/evidence of bats</b></p> <p>Bats can access the loft void through crevices in slate tiles, eaves and opening leading to the second storey. ~10 bat droppings and discarded moth and butterfly wings were found, however due to safety reasons it was not possible to inspect the whole area of loft void and therefore more evidence of bats might have been missed. Samples were collected for DNA analysis. The loft is suitable for roof-void dwelling bats, which require gaps from as small as the width of our thumb to access the roost and need timber joists or beams on which to roost.</p> | |

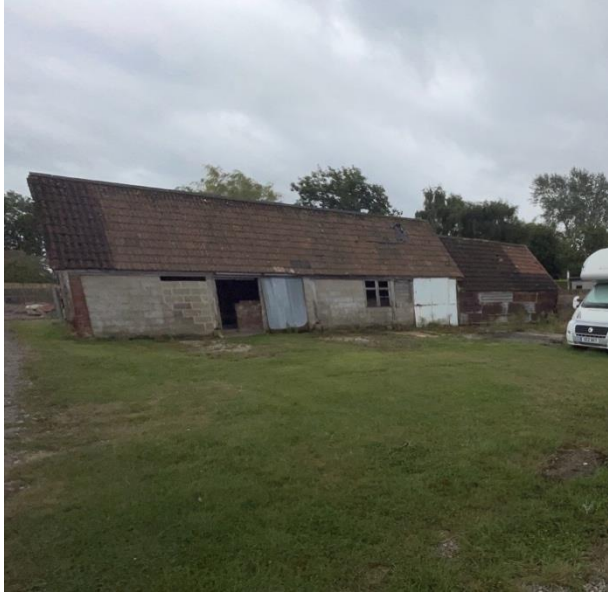
| | | | | | |
|---|--|--|--|---|--|
| <p><i>Summary</i></p> <p>B2 is a one-storey farm building in poor condition, with two sections (B2a, B2b) connected internally by an unrestricted opening. The roof is clay tiled and walls consist of timber clad, brickwork and breeze block. All structures contain suitable bat roosting and access features for crevice and void-dwelling bats. These include crevices and gaps under/in timber boards, eaves, roof tiles, brickwork and barge board. Moreover, there are areas of unrestricted access in form of open area of B2b which leads to the exterior. There are two internal voids. Within the internal void of B2a evidence (bat droppings and discarded insect wings) of bats using the interior was found. No evidence was found on external walls, however, this couldn't be used to indicate a likely absence of crevice dwelling bats. This is because bats such as pipistrelles can be found roosting behind hanging tiles, soffit and barge or eaves boarding, between roofing felt and roof tiles or in cavity walls, and all internal evidence is trapped within these crevices. Moreover, any external evidence would be quickly weathered away. The building has <b>high roosting habitat value</b>.</p> | | | | | |

| <i>Recommendations</i> | <p><b>Roosting habitat [B1+B2]</b><br/>Three bat emergence/re-entry surveys are required on B1 and B2 during the active bat season (May – September) to confirm presence/likely-absence of bats roosting in or on the building.<br/>These survey visits should be completed during the optimal survey period mid-May to August inclusive. The survey visits should be at least three weeks apart. Sub-optimal: early May and September. Would require greater justification of timing e.g., weather conditions, known local bat activity.<br/>Six surveyors are required to provide full coverage of the building's elevations to look for emerging/re-entering bats. An infrared camera should also be employed as part of the survey to see where any specific roost locations are located.<br/>Lighting mitigation may be required based on the outcome of the night bat surveys. An EPSL application to Natural England will be required. The EPSL application requires that all surveys have been undertaken within the most recent active bat season and planning permission must have been granted and all relevant wildlife-related conditions have been discharged prior to submission.</p> <p><b>Foraging and commuting habitat</b><br/>No activity surveys are required, however foraging and commuting behaviour will be observed and recorded during the night time of bat emergence surveys.</p> <p><b>Artificial lighting</b><br/>A low impact lighting strategy will be adopted for the site during post-development which outlines the areas of the site that will be retained as dark corridors. Parameters can be found on the Bat Conservation Trust website: <a href="https://www.bats.org.uk/our-work/buildings-planning-and-development/lighting-">https://www.bats.org.uk/our-work/buildings-planning-and-development/lighting-</a></p> <p><b>Designated sites for bats</b></p> |

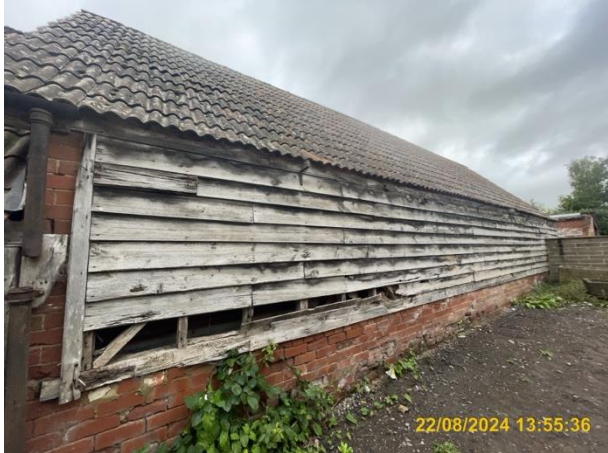
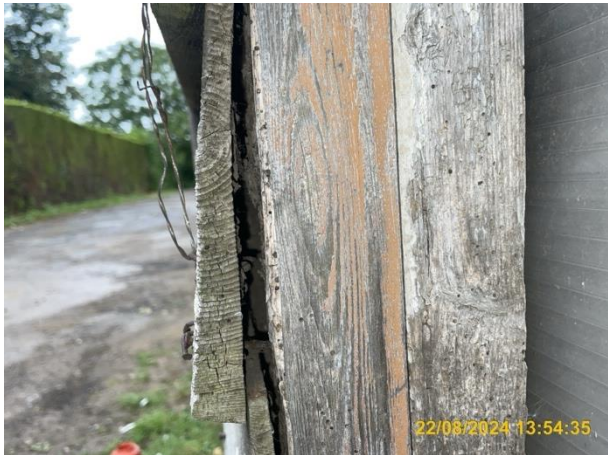
| Feature | Materials | Condition/description/suitability | Photograph(s) |
|---|---|---|---|
| Walls B2a | Timber clad, breeze blocks, brick columns. | <p><b>Condition/description</b></p> <p>Aged, lifted and broken timber cladding on the northern, and eastern elevation, creating crevices. Breeze blocks with missing blocks on the western elevation, brick columns with gaps on the northern elevation.</p> <p><b>Suitability/access</b></p> <p>Crevices formed under lifted cladding and in brick columns provide roosting habitat for bats and access into the internal void. The interior can also be accessed through a large gap in area of missing breeze blocks.</p> | |

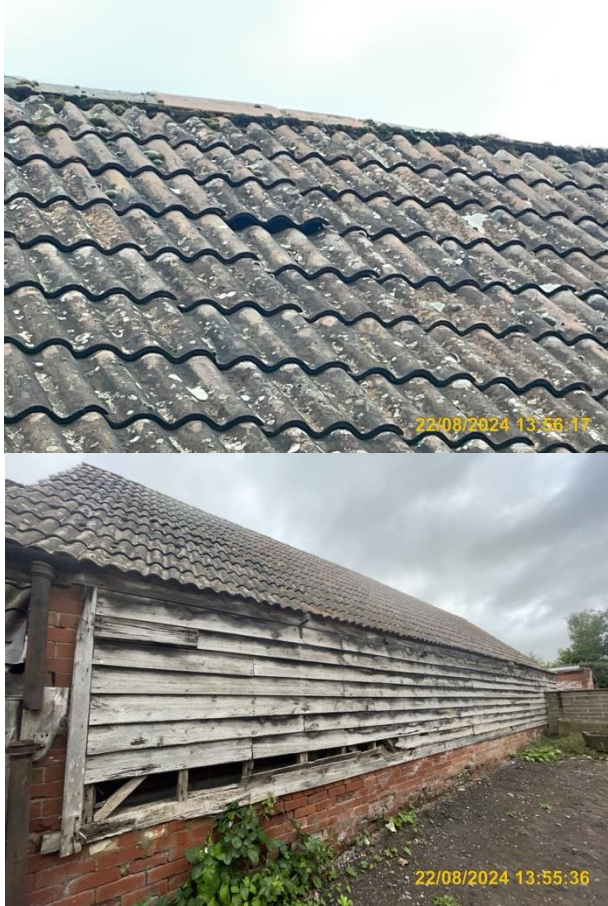
| Roof B2a | Clay interlocking tiles | <p><b>Condition/description</b></p> <p>The roof is pitched, clad in clay interlocking tiles and gable ended on the northern elevation. The tiles are raised and dislodged on all elevations. The gable end has timber cladding in poor condition, with raised and broken timber boards.</p> <p><b>Suitability/access</b></p> <p>Crevices formed under raised and dislodged clay tiles provide roosting habitat for bats and access into the internal void.</p> | |

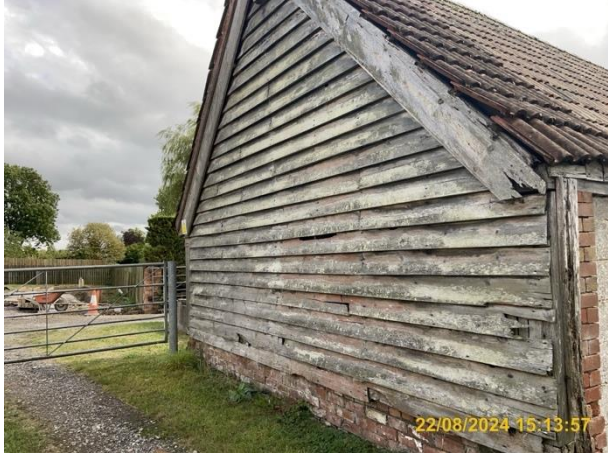
| Barge boards/fascia boards B2a | Timber | <p><b>Condition/description</b></p> <p>Barge board on the gable end is aged and broken with gaps between the board, cladding and tiles.</p> <p><b>Suitability/access</b></p> <p>These gaps provide roosting habitat for bats and access into the internal void.</p> | |

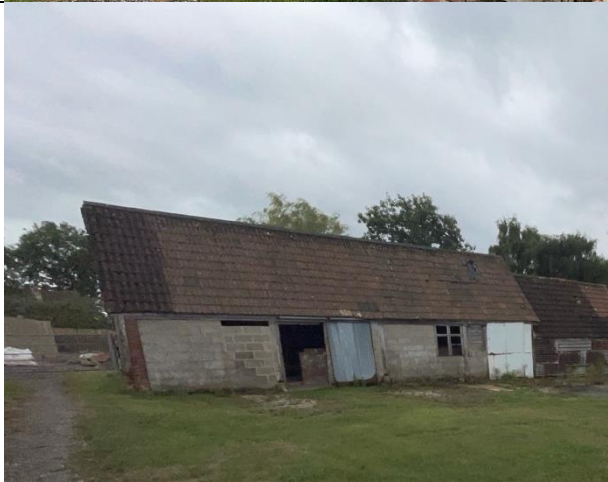
| Window/doors frames and lintels B2a | Timber | <p><b>Condition/description</b></p> <p>Timber frames on the northern elevation are in poor condition – aged and rotten, creating crevices.</p> <p><b>Suitability/access</b></p> <p>Crevices formed within timber frames provide roosting habitat for crevice-dwelling bats.</p> | |

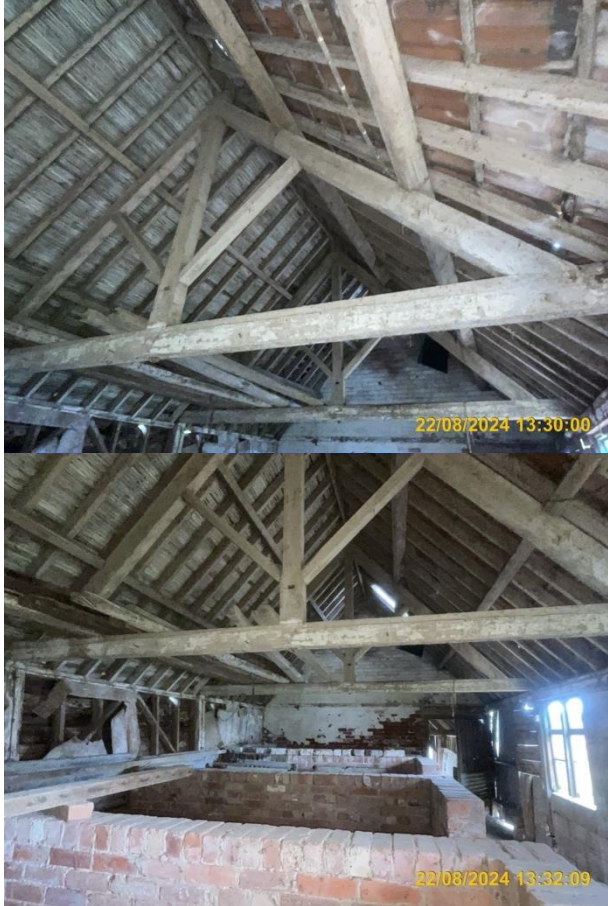
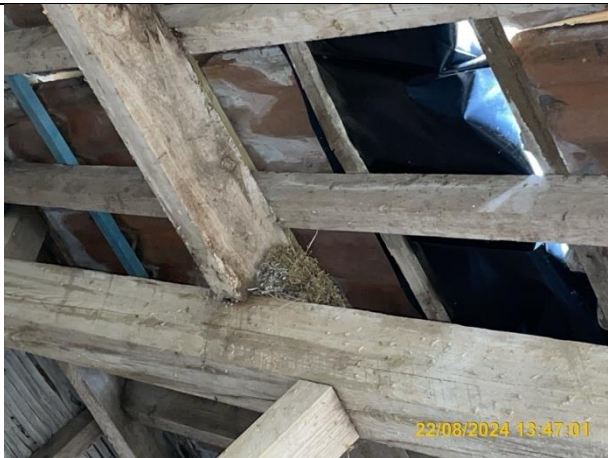
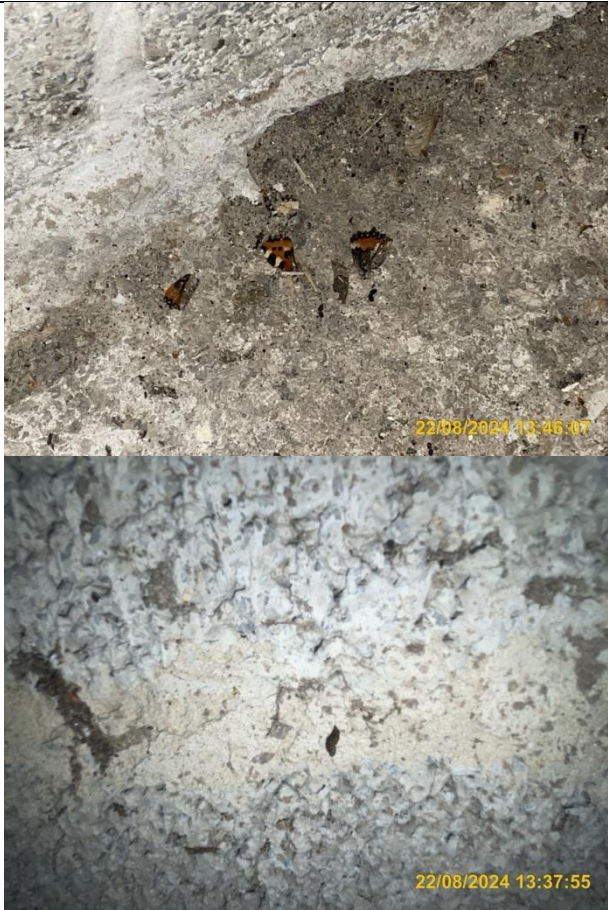
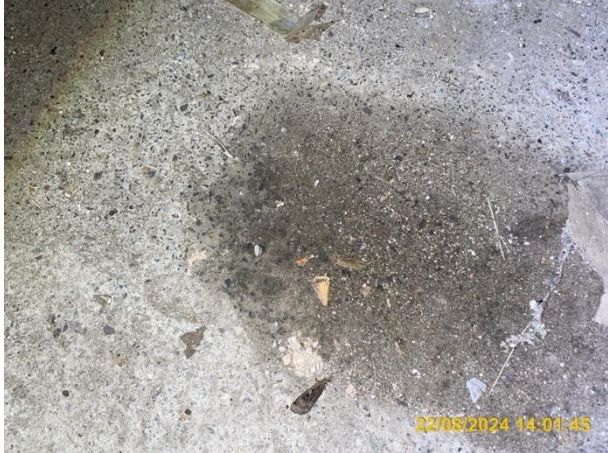
| Internal voids<br>B2a | Timber rafters and ridge beam. Open floor to ridge. Mortise and tenon joints. | <p><b>Condition/description</b></p> <p>Internal space measures approx. 11.5 m long, 4.5 m wide, floor to ridge height approx. 5 m. The internal timbers appear to be original with traditional mortise and tenon joints. There is timber lining under clay tiles and some areas with plastic and metal sheets on eastern elevation and no lining on western elevation. Gaps in timber cladding, metal and plastic sheets and roof tiles are present, especially on the northern and western elevation. The void has a large amount of natural light entering the space through gaps in timber cladding, clay tiles, missing breeze blocks, window and opening into B2b. There were four old bird nests on the intersection of timber beams.</p> <p><b>Suitability/access/evidence of bats</b></p> <p>Between 20 - 59 bat droppings and ~20 moth and butterfly wings were found on the floor. Samples were collected for DNA analysis. Size and shape of droppings indicate a large bat species. There is a mixture of colours which shows different ages of droppings, with darkest droppings indicating more recent activity. This, along with the volume found eliminates a one-off exploratory visit. High level of natural light internally is indicative of this space not being used as a day or maternity roost, and therefore the void is most likely used as a feeding roost.</p> | |

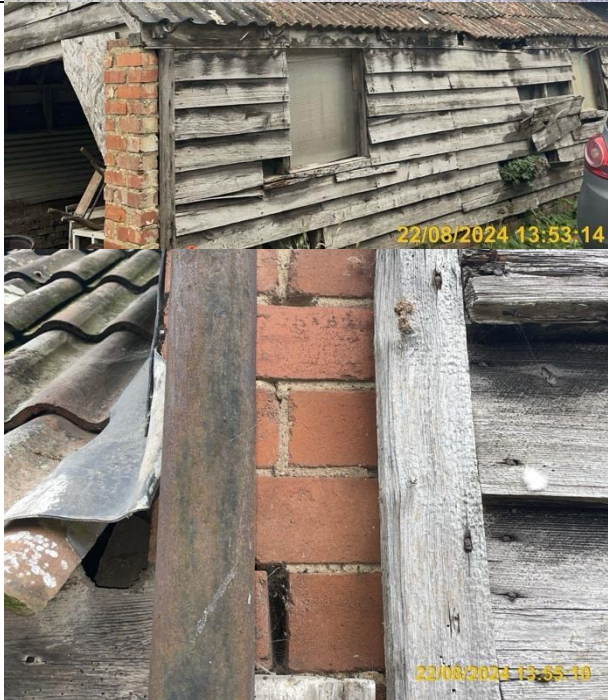
| Walls B2b | Timber clad, brick columns, metal sheets. | <p><b>Condition/description</b><br/>Aged, lifted and broken timber cladding on the southern, and eastern elevation, creating crevices. Metal sheets on the western elevation, brick columns with gaps on the southern elevation. There is no wall on the southern elevation, creating open area into the exterior.</p> <p><b>Suitability/access</b><br/>Crevices formed under lifted cladding and in brick columns provide roosting habitat for bats and access into the internal void. The interior can also be accessed through the open area on the southern elevation.</p> | |

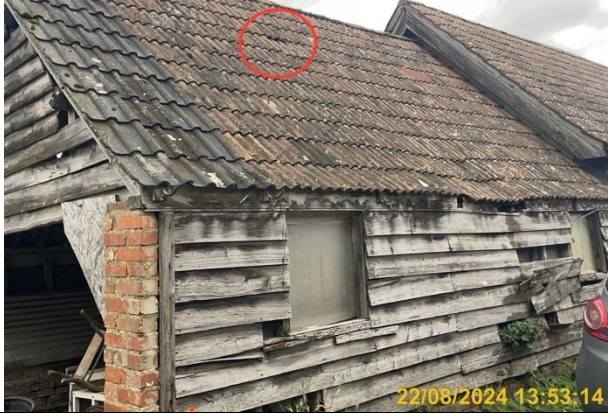
| Roof B2b | Clay interlocking tiles | <p><b>Condition/description</b><br/>The roof is pitched and clad in clay interlocking tiles. The tiles are raised on all elevations.</p> <p><b>Suitability/access</b><br/>Crevices formed under raised clay tiles provide roosting habitat for bats and access into the internal void.</p> | |

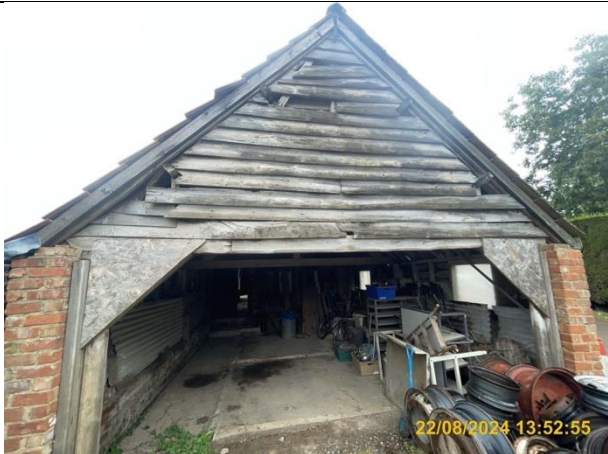
| Windows/door frames and lintels B2b | | <p><b>Condition/description</b><br/>Timber frames on the western elevation are in poor condition – aged and rotten, creating crevices.</p> <p><b>Suitability/access/evidence of bats</b><br/>Crevices formed within timber frames provide roosting habitat for crevice-dwelling bats.</p> | |

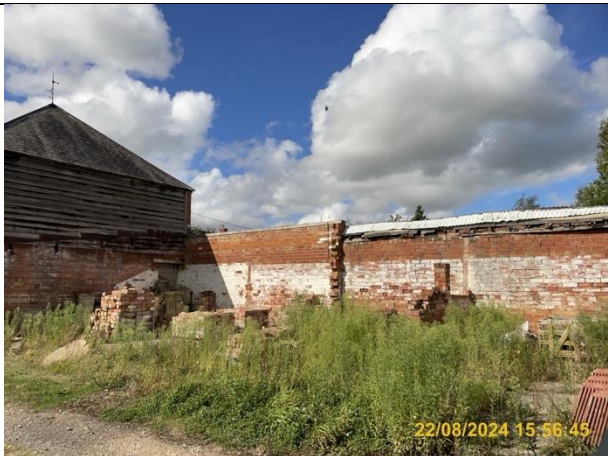
| | <p>Figure 3: Ruderal vegetation adjacent to eastern and southern elevation of B1b</p> |

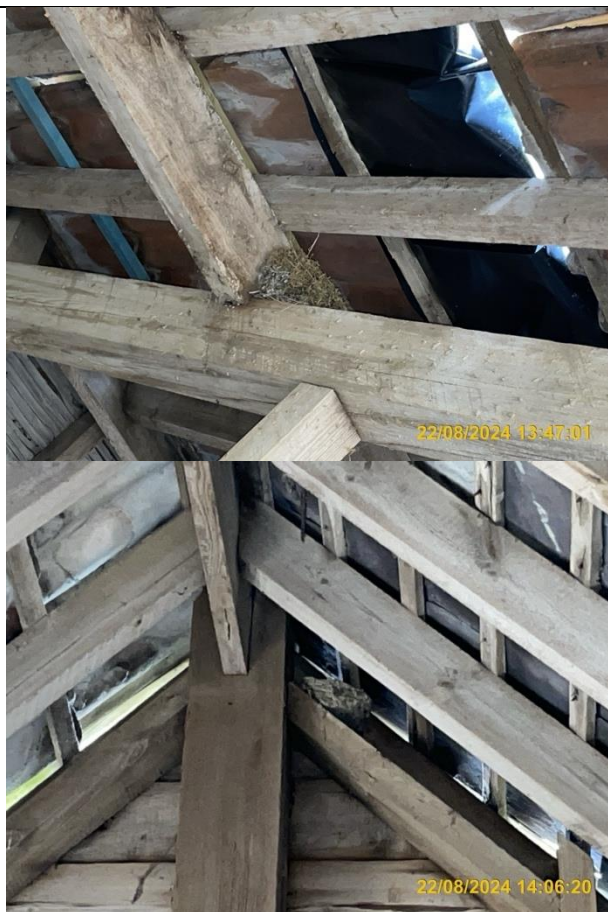
| <i>Summary of Survey Findings</i> | <p><b>Buildings</b><br/>Five old bird nests were identified in the buildings' interior (Figure 10), four in B2 and one in B1, all on the intersections of timber beams. Four nests were open-cup type nests of mud composition, which is suggestive of them being swallow nests. One nest was of bigger size than the other three and was made of sticks and twigs, which is suggestive of pigeon nest.</p> <p><b>Trees and vegetation</b><br/>No bird nests were identified within the vegetation of the native hedgerows with trees and ornamental hedgerow, however these habitats offer nesting opportunities and nest-building resources for birds.</p> <p><b>Barn owls</b><br/>The site provides suitable nesting sites for barn owls in the form of farm buildings, however, no evidence of nesting barn owls was recorded on-site.</p> <p><b>Overwintering birds</b><br/>Due to the small size of the site and the extent and type of the habitats recorded, the site not considered suitable to support a significant assemblage of protected and/or notable birds.</p> |

Figure 10: Old bird nests in the interior of B1 and B2

| <i>Recommendations</i> | <p><b>Buildings/trees</b><br/>Any building removal should be undertaken outside the period 1st March to 31st August. If this timeframe cannot be avoided, a close inspection of the buildings should be undertaken immediately, by a qualified ecologist, prior to the commencement of work. All active nests will need to be retained until the young have fledged.</p> |
