## **Planning Support Statement**

**George Hotel, 19 High Street,  
Amesbury, Wiltshire**

Reference: 24905

**Opening-Up Works Support Statement**

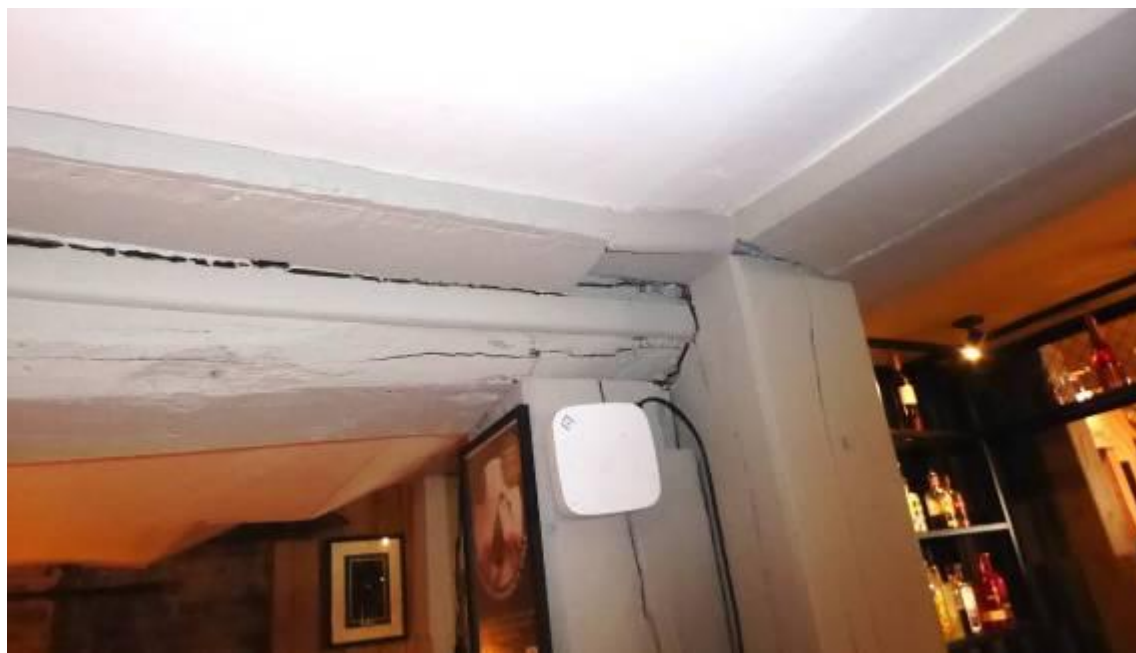
Fig 3.1.1: Bar beam

- 3.1.1 In the main bar, towards the west side, there is a beam within the ceiling that extends from the back of one of the main frame posts in the back wall of the original part of the building. From there it pitches on to a modern post that has been bolted on to another modern post where the back wall of one of the 20<sup>th</sup> C rear additions has been removed. This latter support could date to the third or fourth quarter of the 20<sup>th</sup> C when the area beyond, now the dining room has been formed.

- 3.1.4 The primary concern is over excessive deflection that is occurring to the beam of the bar, which is also associated with cracking in this. There is now a gap between the sides of the beam where this is bowing down below the ceiling surface. Adjacent to this there is further displacement occurring with the ceiling and so suggesting there is further movement happening in the floor and structure to the area under the linen cupboard floor.

- 3.1.5 From the limited inspection afforded by lifting floor boards in the linen cupboard and bedroom 107 it is believed that the first floor level side wall to the rear extension, which is of loading bearing stud construction face with plasterboard with a skim coat of plaster. This has a secondary stud wall facing on the bedroom side, which was possibly applied to even it up for decorative reasons.

- 3.1.6 It would seem that the original wall, where it spans over the bar below is based on a large timber wall plate or beam over that seen in the beam that is visible in bar below. The upper plate has evidence of suffering from heart rot so this is likely to be in a state of failure and in turn applying increased load to the beam below and which is resulting in the deflection seen in the bar.

- 5.1.1 It is proposed to remove a section of the roof side wall within the linen room where this closes off the eaves to the ca slide roof over this section of the building to allow the full structure of the wall to be exposed. This will remove the plaster board facing to the wall as well as some of the studwork to allow access within the lower roof space. Following completion of any subsequently completed repair work this is to be restored in a like for like manner to that dismantled.

- 5.1.2 The chipboard floor over the linen room is to be taken up to allow access to the base of the wall along this side. On completion this will be replaced with the boarding that has been lifted.

- 5.1.3 Within the bar area temporary structural propping will be introduced on either side of the bar beam to support the floors above and the base of the wall between the two rooms. Then a section of ceiling beside the beam is to be removed to allow a full inspection of the floor and beam arrangement as well as the lower part of the first floor dividing wall. This ceiling is of plasterboard with a skim plaster finish. In the time between the opening-up and the start of any subsequent repair work the ceiling will be replaced with a temporary finish of decorated plasterboard.

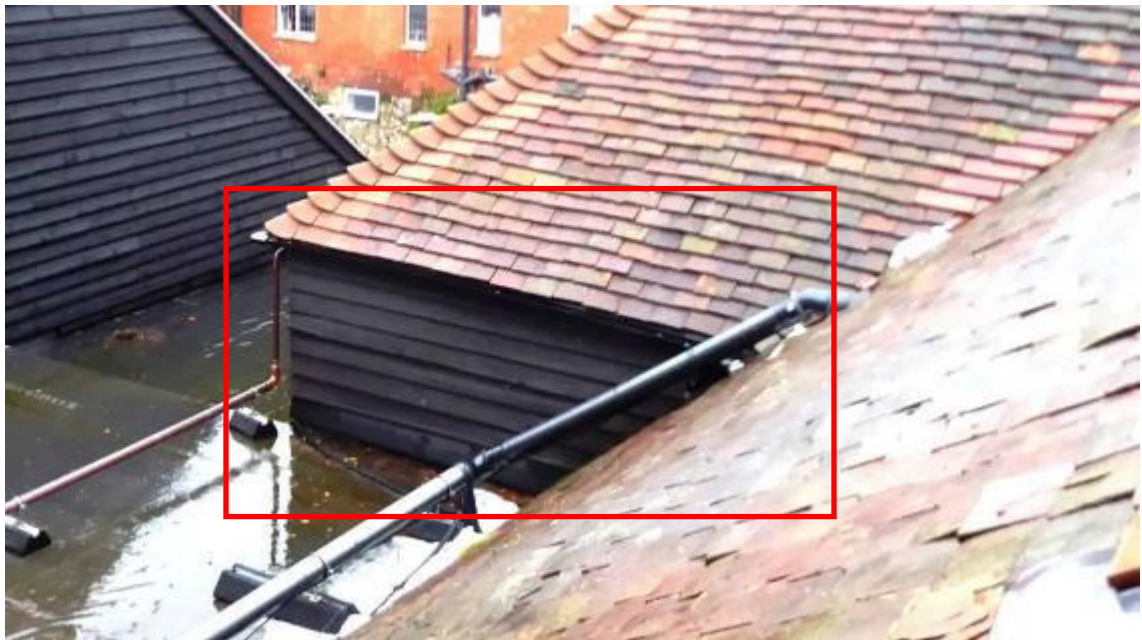
Fig 3.1.7: Wall and roof sections supported on wall above bar beam

- 3.1.7 Loading on to this wall comes from a section of the rear cat slide roof to the main part of the hotel as well as the roof over the rear extension section that is over room 207. It is to better understand the amount and type of loading that the

upper wall and therefore the bar beam is carrying that further opening-up of the internal fabric is requested. That will allow a comprehensive design to be prepared to ensure it is appropriate for this historic structure.

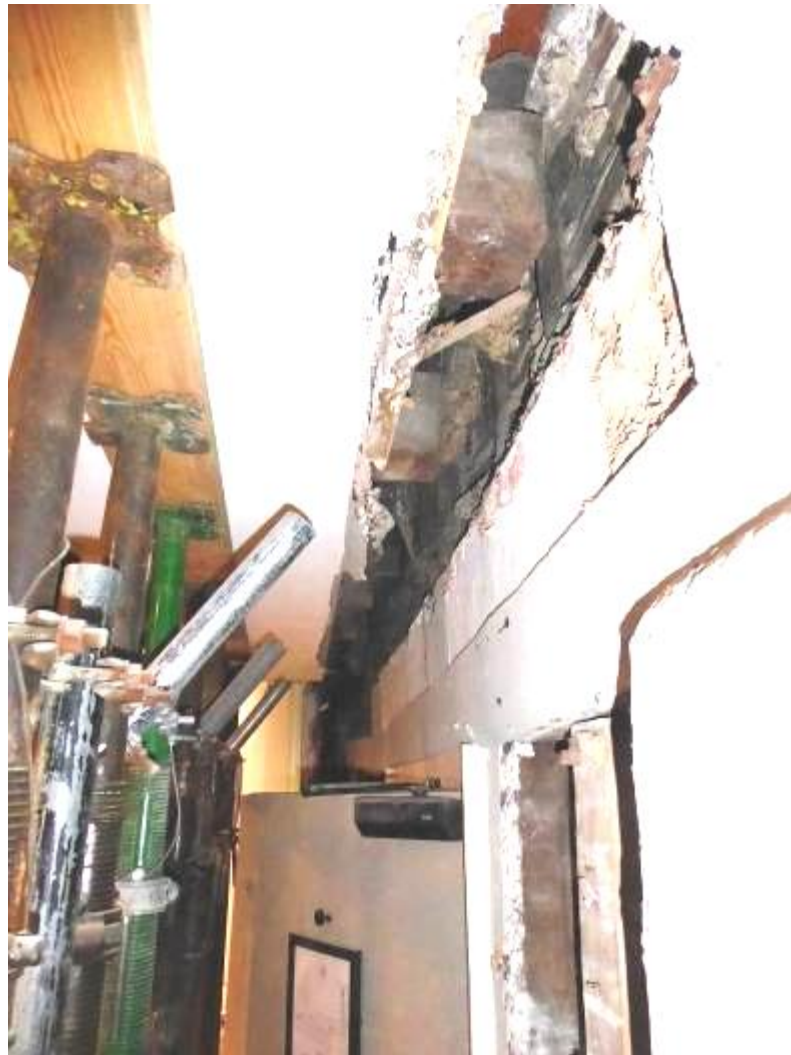
Fig 3.2.2: Position of failed bear plate

- 3.2.2 The defect first came to light following the sudden failure and collapse of timber bearer plate that carried the ends of the attic (second) floor joists from a possible late 18<sup>th</sup> or early 19<sup>th</sup> C rear extension as suggested by the external brickwork used within this part. This plate was secured to the posts of the timber framing to the 17<sup>th</sup> C raised back wall of the original building by timber pegs and a narrow bearing ledge.

- 5.2.1 Additional structural propping is to be inserted between the ground floor and the underside of the roof framing at high level to support the roof to the rear extensions and the eaves at the back of the original building. This is to be to specialist engineer design.
- 5.2.2 Around the rear post it is proposed to remove the late 20<sup>th</sup> C casings and wall lining to properly expose this post from ground floor to high wall plat level. This primarily involves plasterboard, plywood and other lightweight modern materials. Sections of modern plaster board ceilings will be removed at ground and first floor levels.

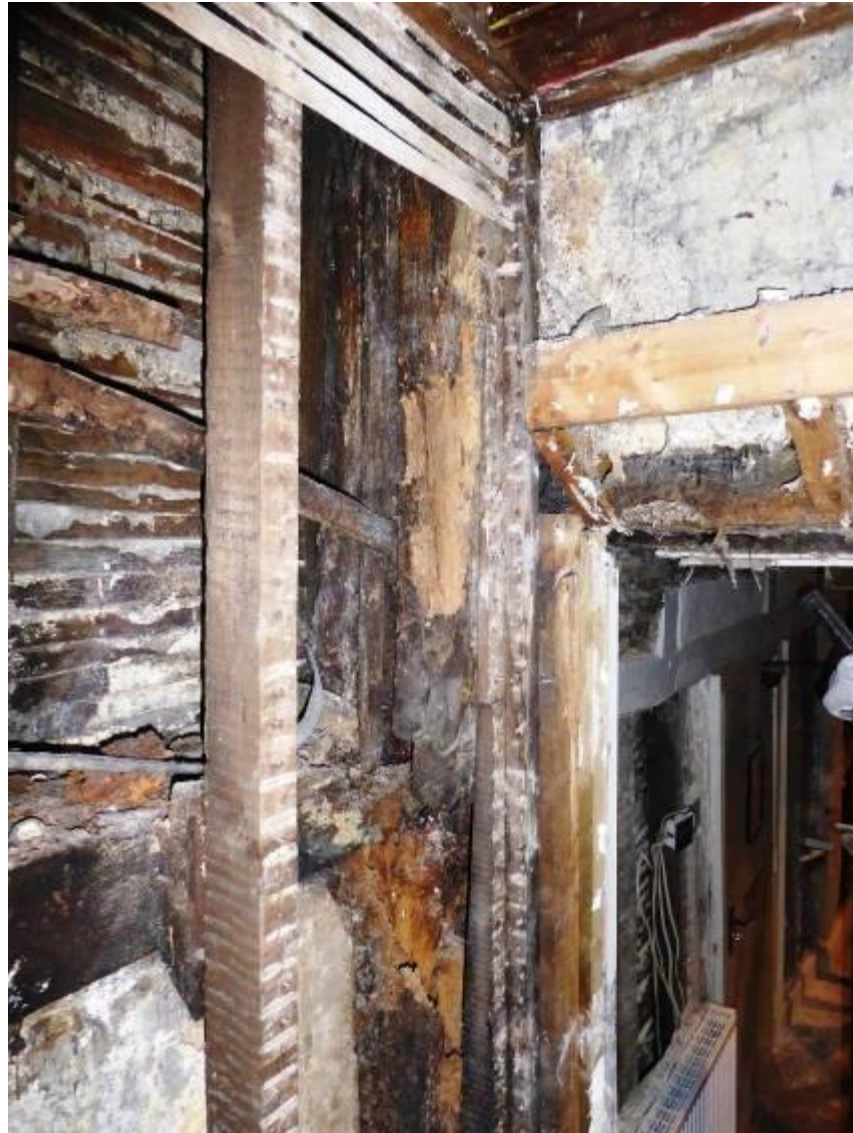
Fig 3.2.3: Decayed main timber post

- 3.2.3 Following the collapse of the plate emergency propping was installed up through this part of the building from the ground floor to support the whole of the upper structure of this section of rear wing some limited opening up was undertaken to try and identify the cause of the failure of the member. In doing that it was found that there is very extensive wet related decay to the main post from approximately first floor level to second floor head plate, as well as the side rails that run in to it.

- 3.2.4 In this location it can be seen where the main frame and rear wall of the original building has been raised to create the second floor. From this limited investigation it would seem that the lower part of the post dates to the 16<sup>th</sup> C building of the inn and that the upper section was added after a significant fire in the early 17<sup>th</sup> C. This post has also become a major support member to the rear extension roofs where the junction of two of thee as well as the main building roof pitches on to the head as well as taking secondary support.

- 3.2.5 The decay seems to have come about through very long term or even historic water entry from defective valley gutters and roof coverings. This has resulted in very severe wet related decay to the post, head plate, the connecting side rails and infill panels of various ages. It can be seen where there has also been outward movement in the lower post where this has the added floor framing fixed over the top, possibly as a result of the increased loading from the adjacent roofs.

- 5.2.3 Historic wattle and daub panels within the timber framing at first floor level will be retained within the framing wherever possible in an appropriate manner for each situation.
- 5.2.4 At roof level localised stripping of the coverings may be found to be necessary to determine the extent of any decay to the head plate to the timber framing and the bottom of rafter feet where they pitch on to that part of the top of the wall timber framing.
