# DAVID PARTRIDGE LTD

**REPORT ON :**      **REDUNDANT BARN,  
100 ACRES FARM,  
SOPWORTH,  
WILTSHIRE  
OX15 6HW**

**JOB NUMBER**      **25 / 73**  
**CLIENT**            **Mr Andrew Sells**  
**DATE**                **22<sup>nd</sup> April, 2025**

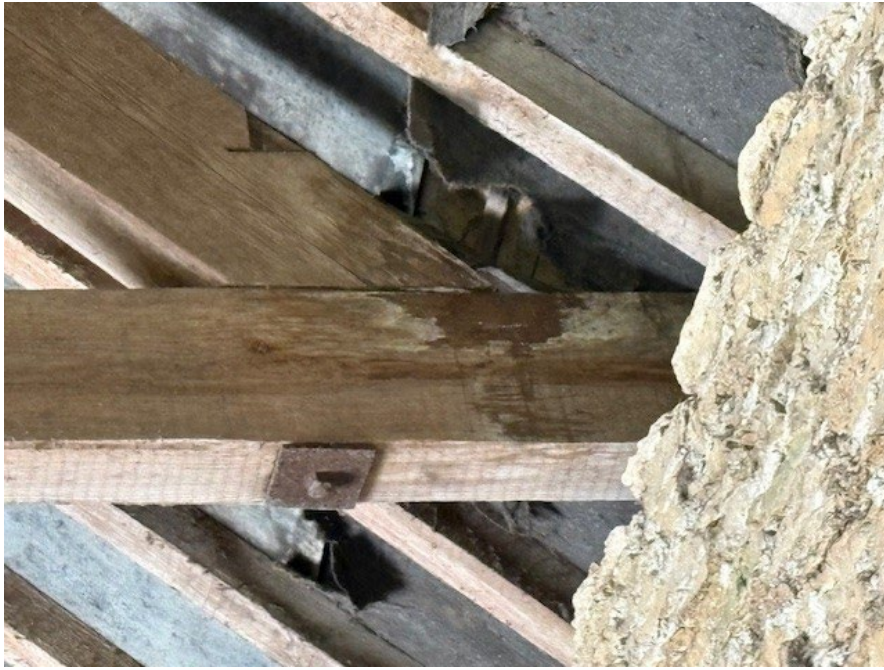
- All timbers of the rafters, purlins and trusses are generally free from damage caused by damp ingress, rot and splitting. Very minor water ingress has stained some timber surfaces, particularly at eaves level [ Plate 06 ] but no apparent loss of structural cross sectional area can be seen in any timber.
- Notably, all timber joints of the trusses remain tight with no distortion or splitting. [ Plates 07 and 08 ]. The trusses remain vertical with no sway towards either gable end which can be a common defect in this type of building.

**PLATE 06 -- NOMINAL DAMP PENETRATION**

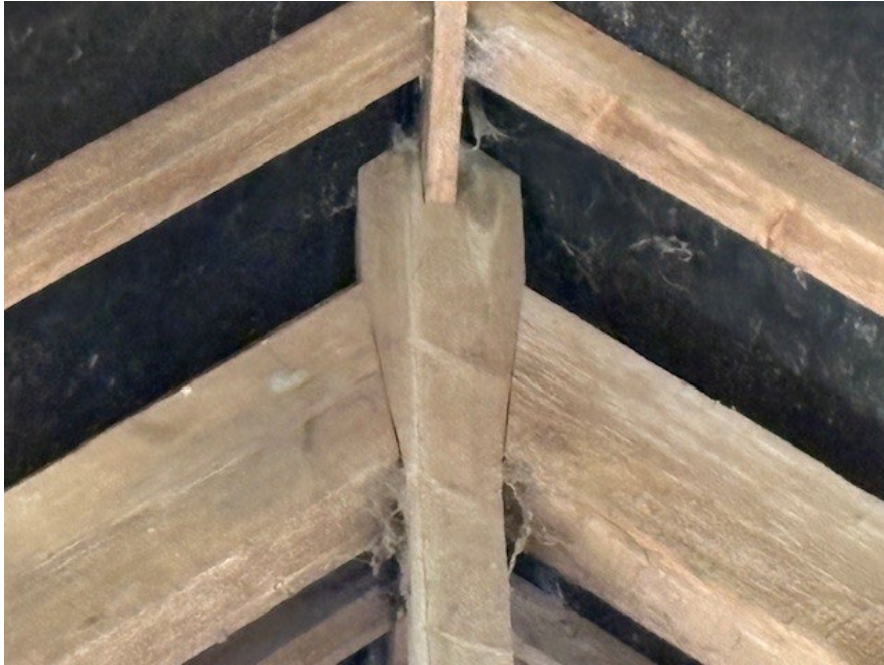
**PLATE 07 -- TIGHT TRUSS JOINT AND RIDGE**

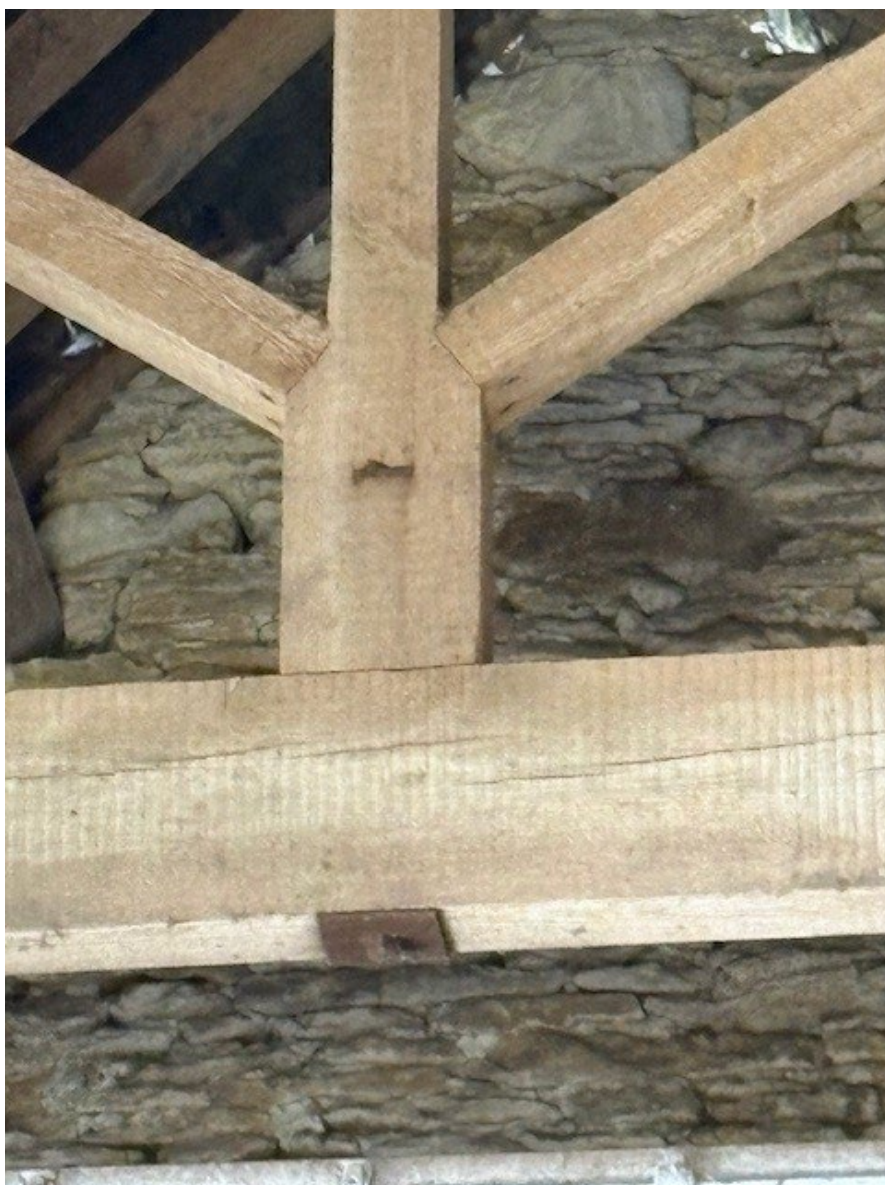
**PLATE 08 -- TIGHT TRUSS JOINT AND BOTTOM TIE**

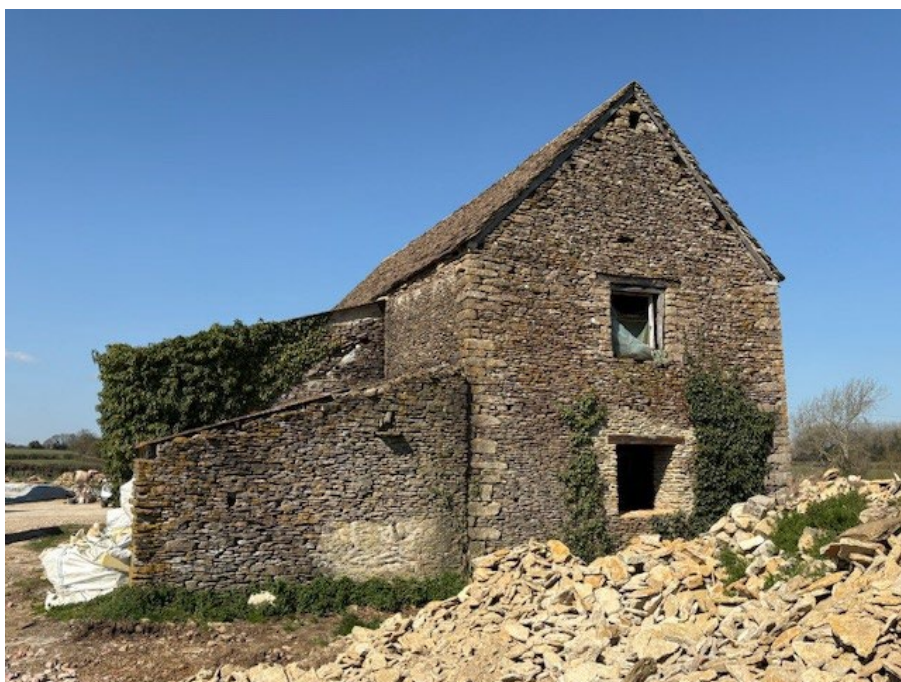
The roof rafter ends and masonry in the gable ends are supported over the wall openings with timber lintels which have sufficient end bearings and are well set on the masonry. [ Plates 09 ].

**PLATE 09 -- TIMBER LINTELS OVER OPENINGS**

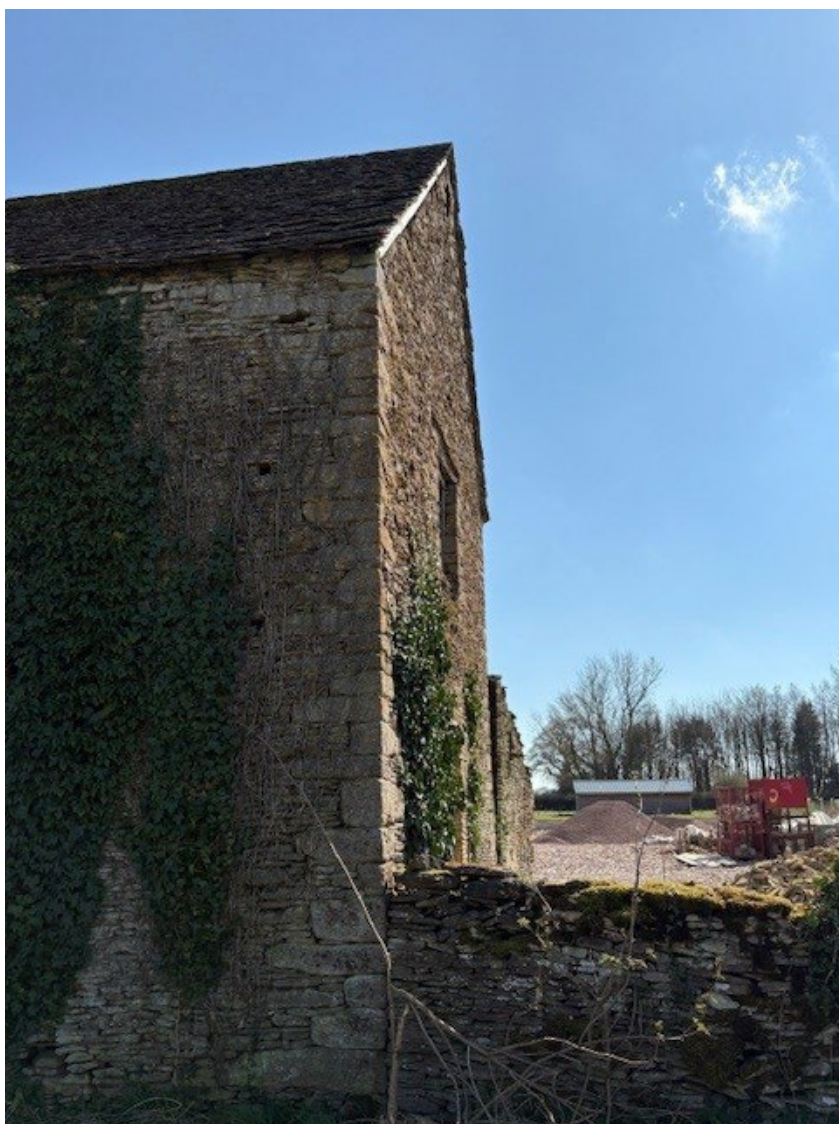
- The two gable end and southern walls are generally vertical over their entire elevations with no relevant or significant distortion. Except that the top of the eastern gable leans out slightly [ Plate 10 ].
- The northern wall leans out along the majority of its length [ Plate 11 ] and vertical cracks have opened internally at the wall's abutment with the gable ends. [ Plates 12 and 13 ].
- The masonry under each truss bearing is in excellent condition and not distorted.
- The timber beam carrying the wall over the large opening in the northern wall is quite badly deflected. [ Plate 14 ].

**PLATE 10 -- OUTWARDS LEAN IN TOP OF EASTERN WALL**

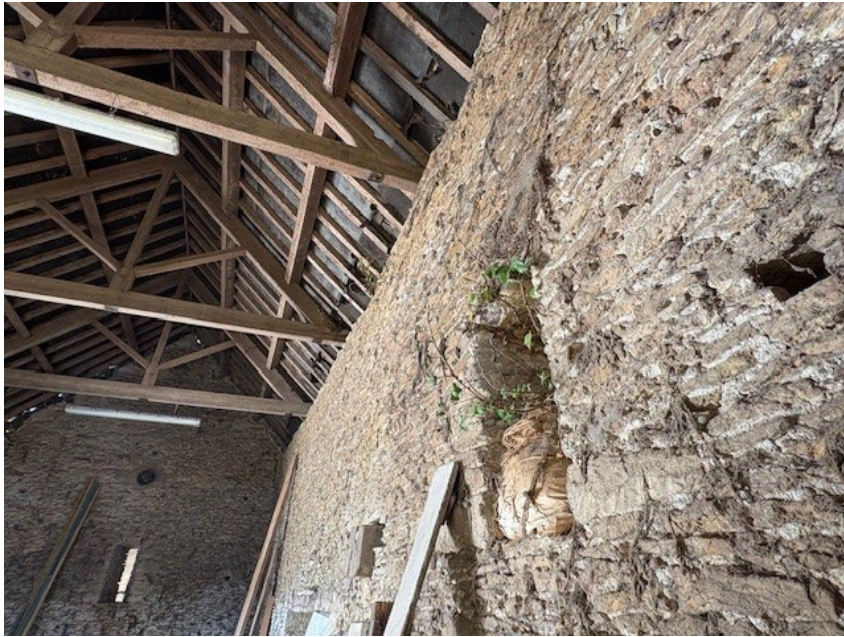
The height to thickness ratio of the external walls is well within the maximum ratio allowed by the British Standard Code of Practice for Loadbearing Masonry [ BS5628 ]. The outwards lean in the northern wall has been caused by nominal slippage of the timber rafters down the slope because the rafters are not robustly fixed to the purlins. In addition, the walls of Part 'Y' are offering significant lateral support to the southern wall of 'X' meaning that any tendency for lateral sway will be wholly manifest in its northern wall.

**PLATE 11 -- OUTWARDS LEAN OF NORTHERN WALL**

The introduction of a new first floor will allow the discreet installation of metal tie across the narrow width of the building to arrest any chance of future lateral movement quite apart from the stiffening effect an intermediate floor will provide by itself.

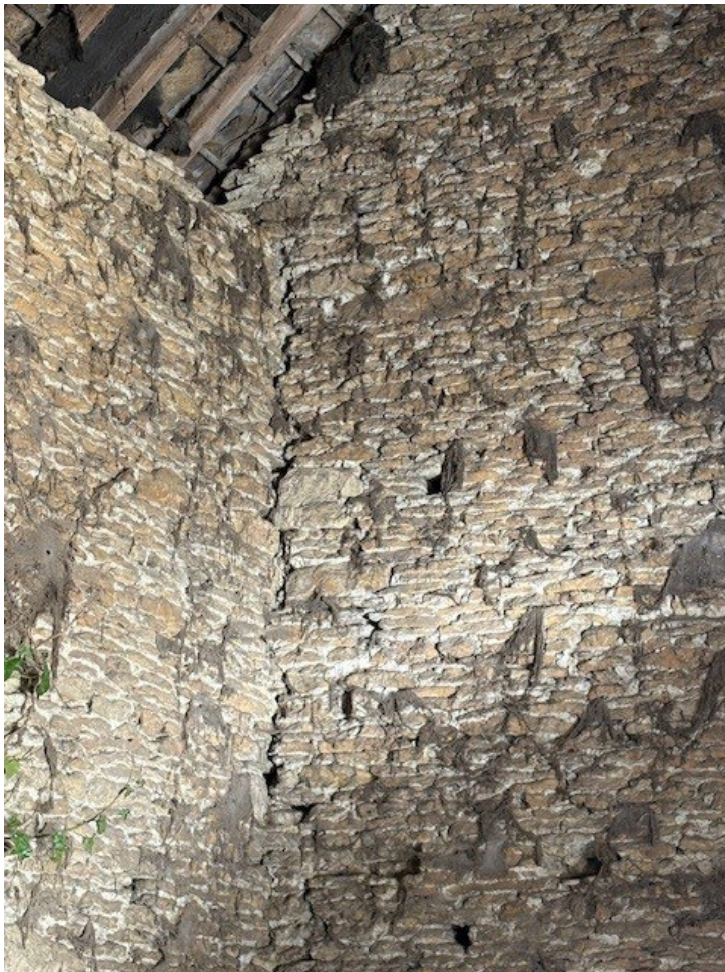
**PLATE 12 -- CRACK IN CORNER**

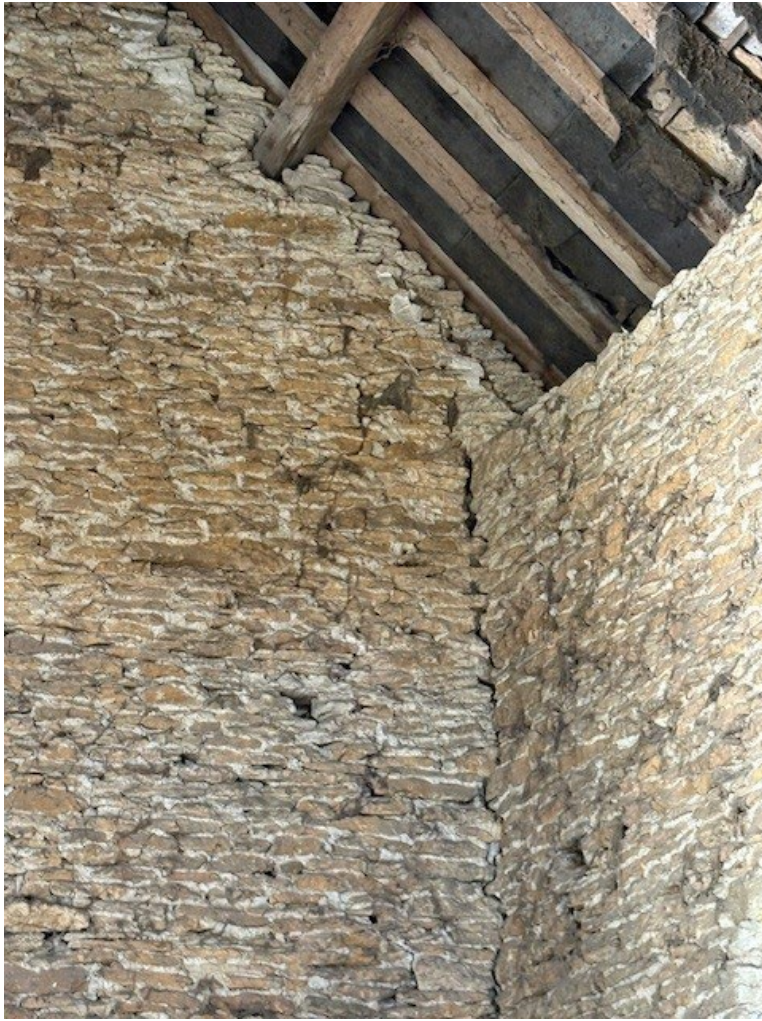
**PLATE 13 -- CRACK IN CORNER**

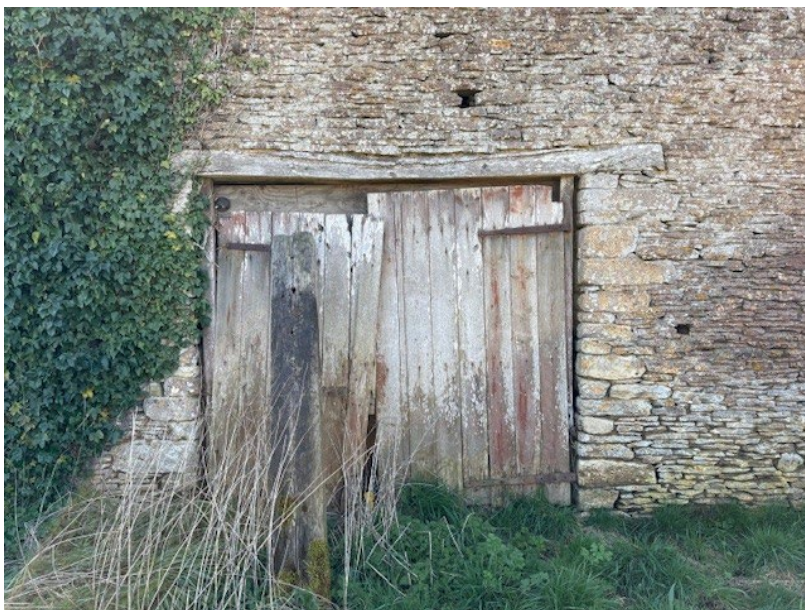
**PLATE 14 -- BADLEY DEFLECTED TIMBER LINTEL**

The timber lintels over the opening in the northern wall are too badly deflected to be retained and should be replaced 'like for like'.

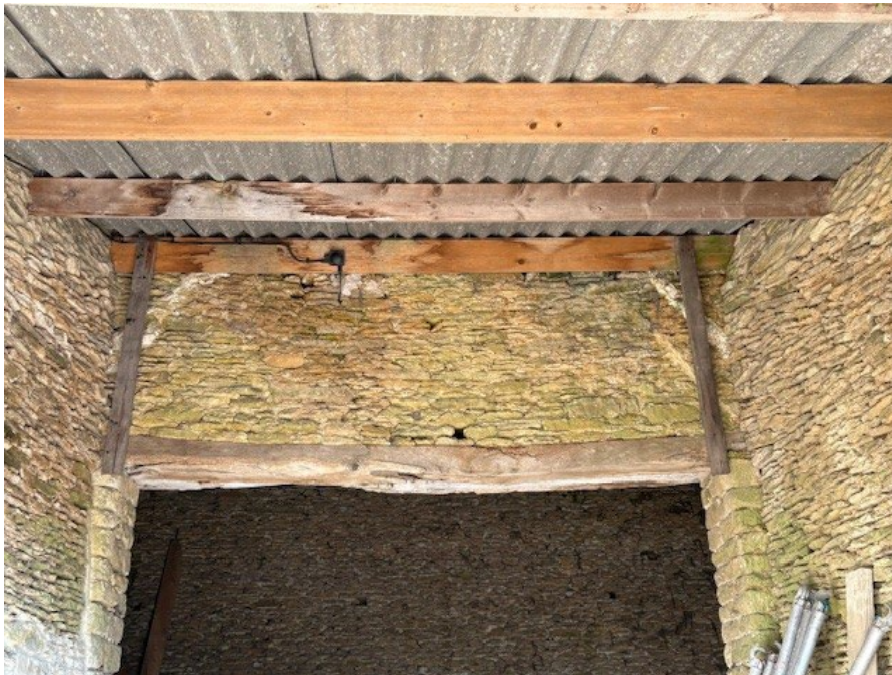
The structural form of the corrugated sheet clad mono-pitched roof is series of timber purlins spanning on to the two side walls. [ Plate 16 ].

- The purlins are straight with no vertical deflection.
- Minor damp penetration exists but there is no loss of timber cross sectional area.

PLATE 16 -- ROOF PURLINS

The roof purlins display no significant distortion and can be retained.

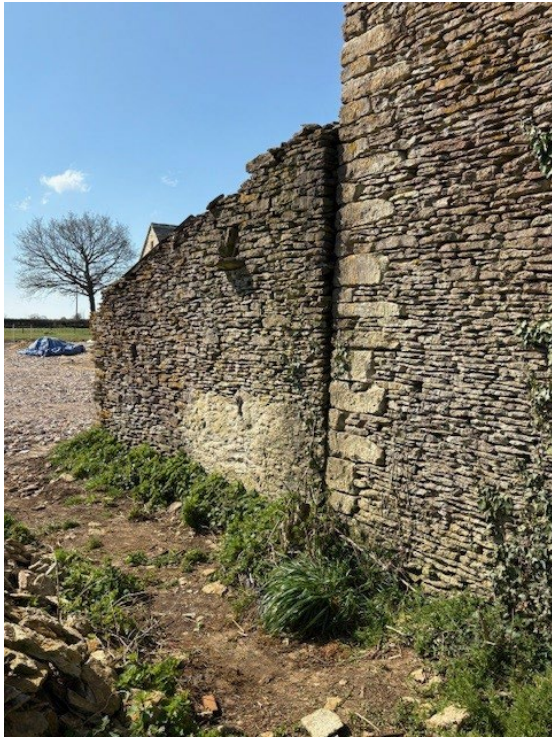
The walls are essentially 'wing' walls to form an extension against the south wall of the original building. They are not bonded to the south wall. [ Plate 17 ].

- The top of all walls lean outwards. [ Plates 17 and 18 ].
- The top of the main eastern wall is collapsed between eaves level and the roof of the associated lower part. [ Plate 19 ].

Whilst the relative thickness of the walls to their height is well within the Code of Practice limit, the fact that they are not bonded into and are therefore not restrained by Part 'X' has caused them to deflect laterally, almost to the point where ideally they should be re-build. The absence of bonding is probably exasperated by the walls having no foundations.

**PLATE 17 -- UNBONDED WING WALL**

Whilst the roof of Part Y might be capable of retention, the three 'wing' walls display sufficient lateral deflection and stone collapse to warrant their re-construction.

Part Y should not be retained.

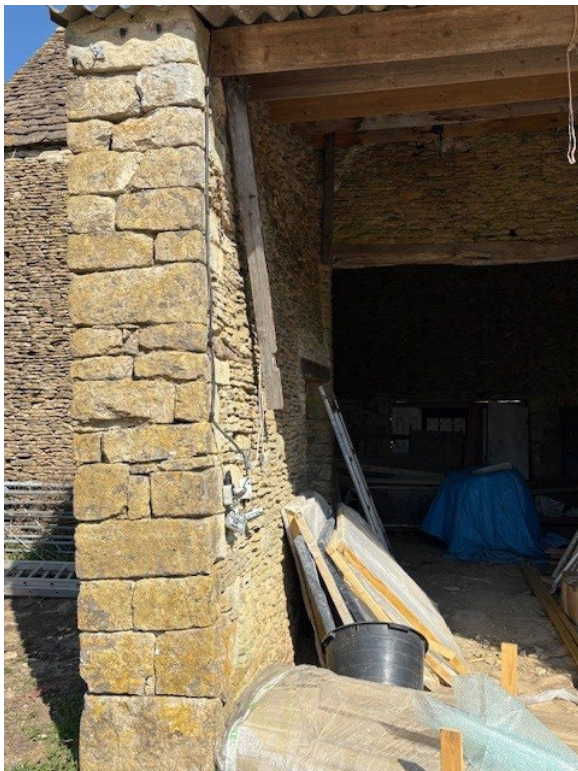
**PLATE 18 -- BADLY LEANING WING WALL**

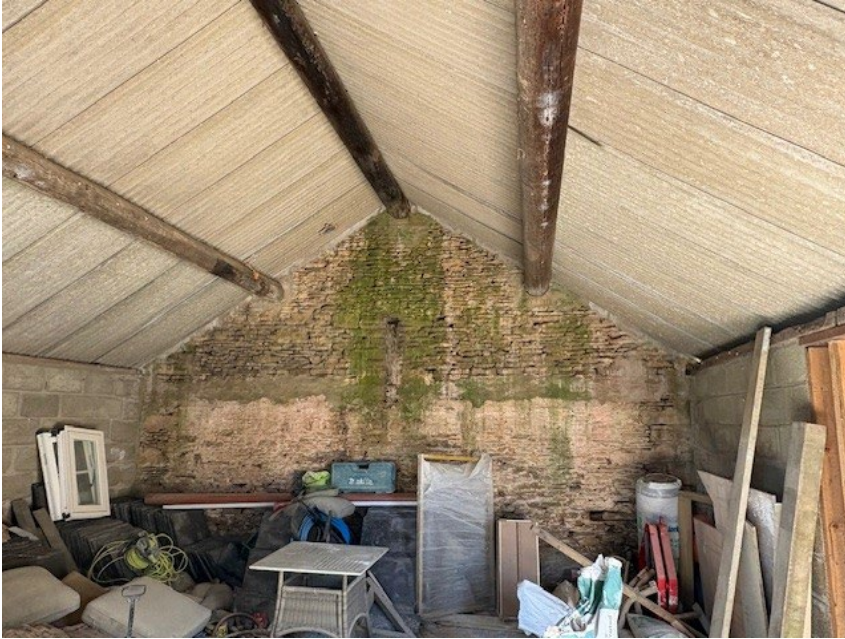
The structural form is very simple, comprising a duo-pitched corrugated sheet covering supported on timber purlins spanning the full length of the building. [ Plate 20 ].

- The purlins show no obvious, serious deflection or distortion.

PLATE 20 -- ROOF PURLINS

The roof purlins display no significant distortion and can be retained.

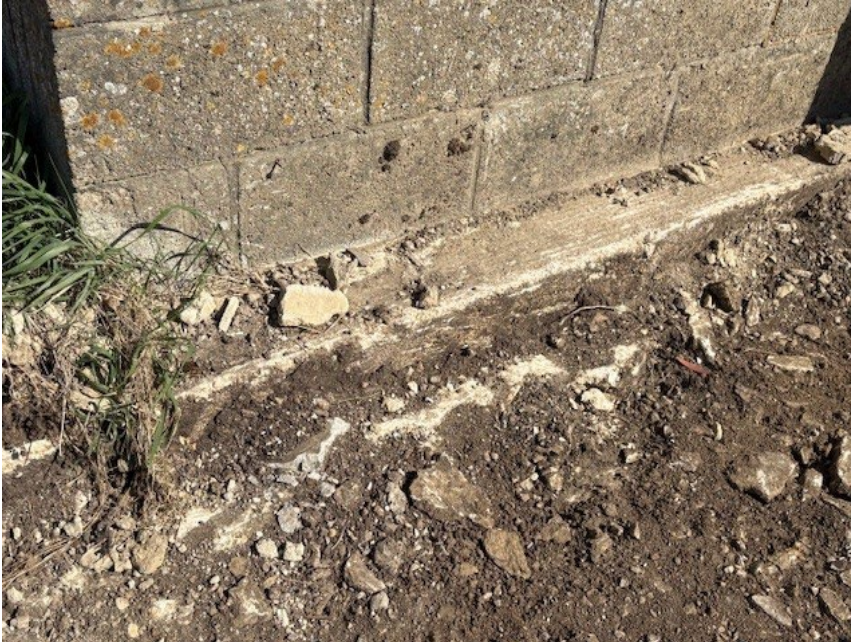
The walls comprise 215mm thick dense concrete blockwork supported on a concrete raft foundation taken into the natural brash subsoil. [ Plate 21 ].

- No distortion or cracking exists in the walls.

The relative thickness of the walls to their height complies with the Code limits which together with the existence of a robust concrete foundation explains the absence of superstructure movement.

PLATE 21 -- WALL AND FOUNDATION
