# **Historic Building Condition Survey**

**Old Vicarage, Homington Road,  
Coombe Bissett, Wiltshire.**

Reference: 24929

**January 2025**

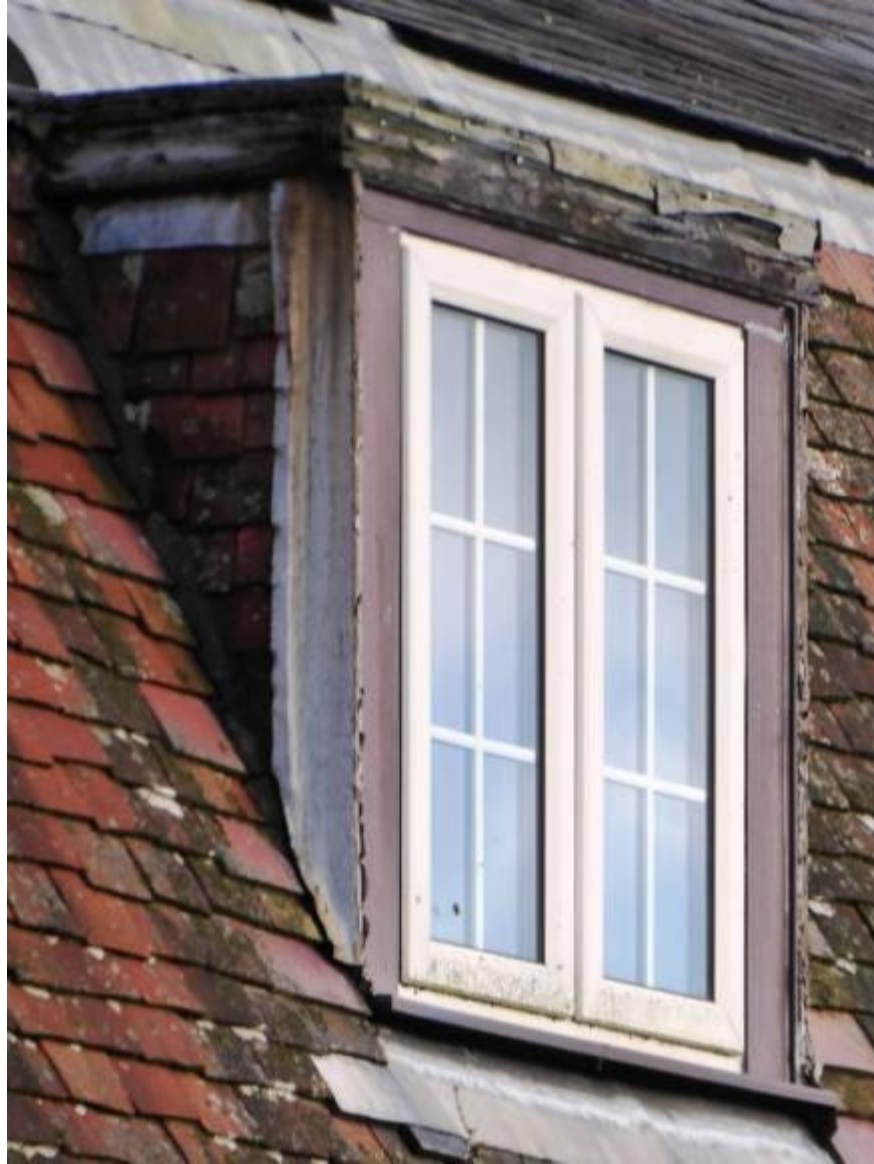
deteriorating condition with the tops needing complete remaking as well as to the cheeks and flashings.

Fig 3.1.4: Mansard south side dormer

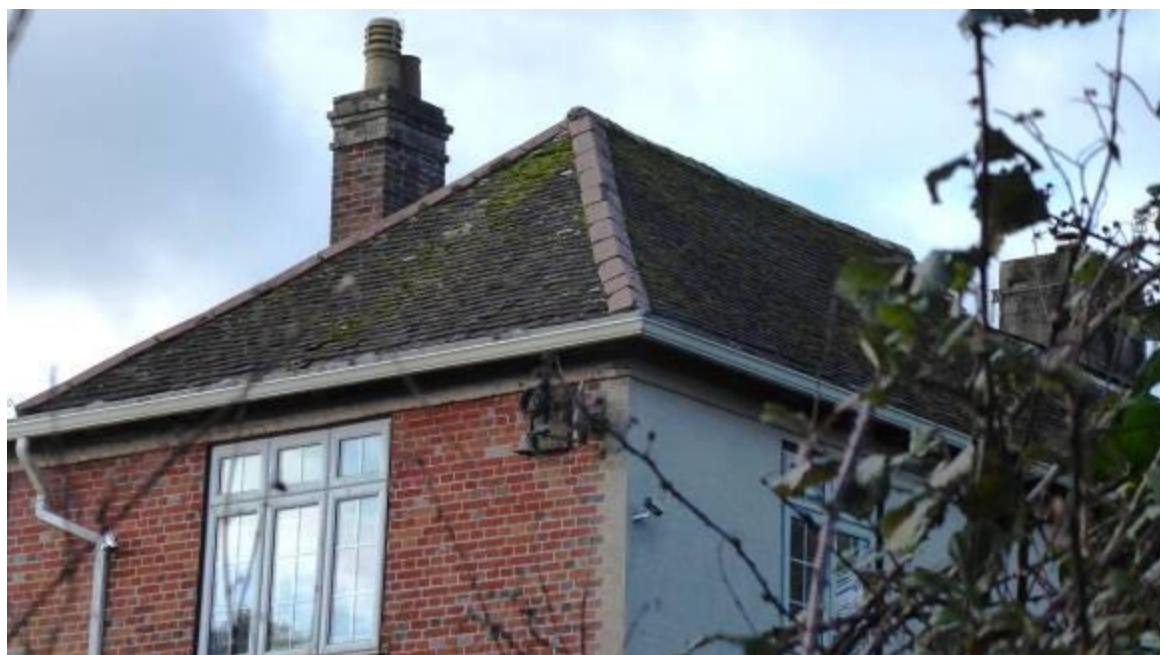
- 3.1.5 The roof to the two storey east section of the main house is a hip ended structure covered with clay plain tiles over the slopes with angled ridge tiles to the tops of the hips and hog back style ridge tiles to the main ridge. The coverings appear to be in fair condition, but all ridge and hip tiles need re bedding and re pointing, where these are severely eroded and slipping. There is displacement of the bottom edge tiling all along the north and east sides to this.

Fig 3.1.6: East two storey roof

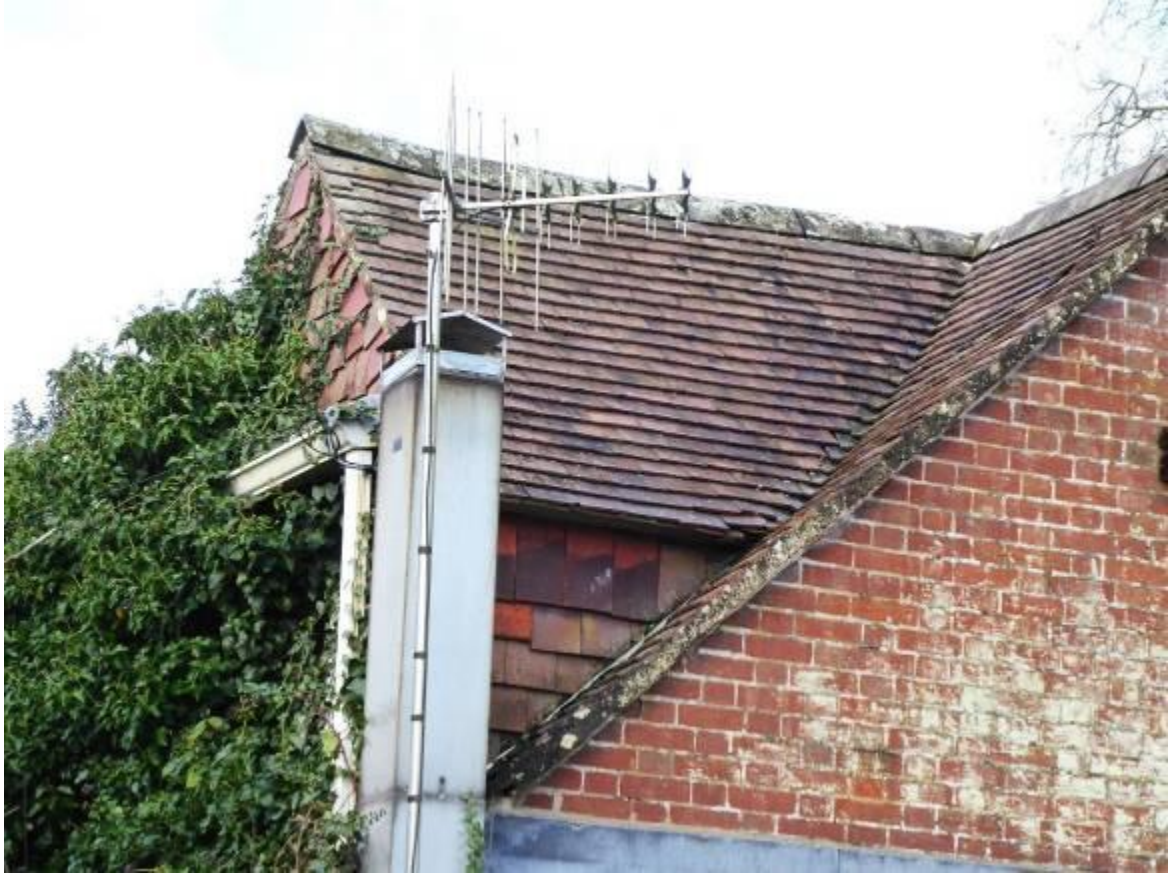
Fig 3.1.9: Service block roof

- 3.1.10 All of the service block roof is covered with modern machine made clay tiles running up to ridges capped with concrete ridge tiles mortared in to position where these are very eroded and the valleys are formed with valley tiles. There are spalled, broken and slipped tiles across all the faces of this roof, although much of the south roof slope could not be inspected due to severe overgrowth of ivy and other vegetation. A strip and re-tile of the whole of this roof will be required.

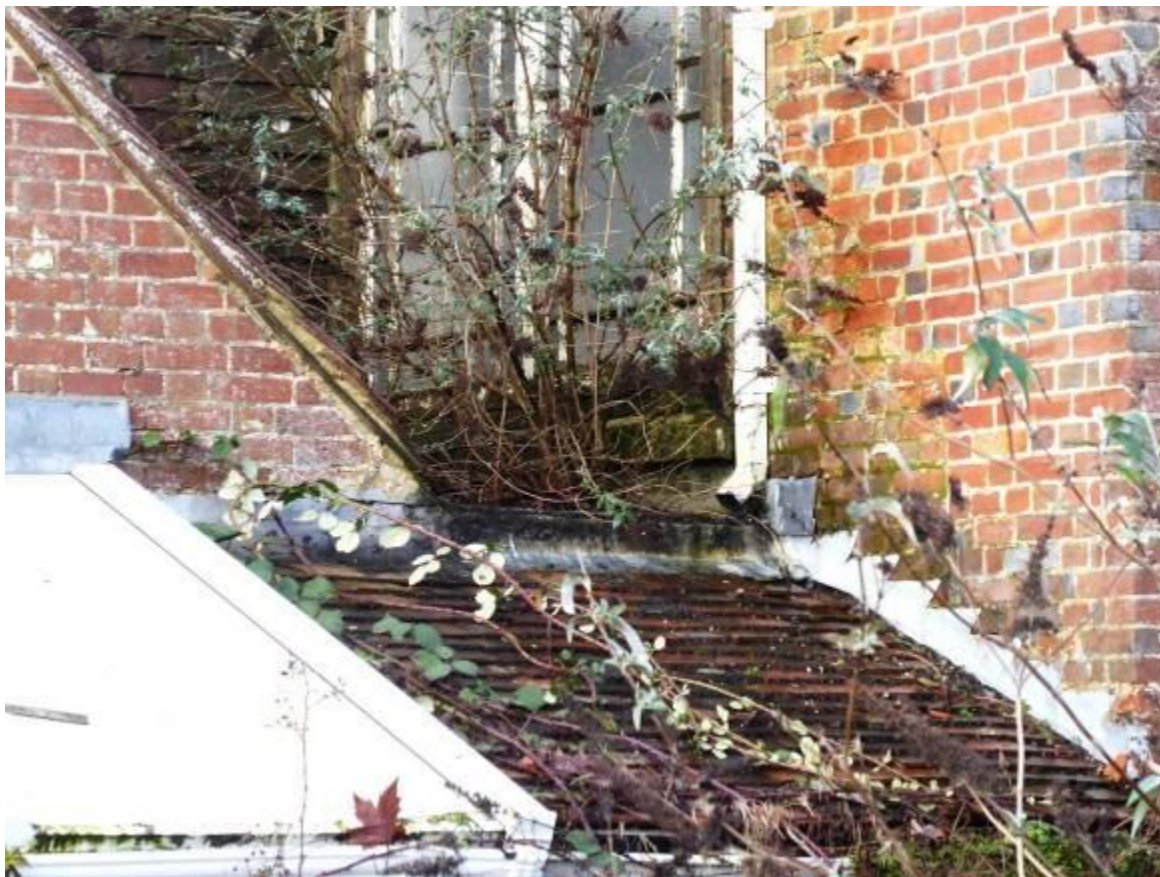
Fig 3.1.13: Failed roof

- 3.1.13 On the east side of the link corridor there is an area of lead or zinc sheet covered flat roof in a very poor condition. This is much disrupted with at least one buddleia plant growing out of the roof deck and there is much water entry through this in to the area and roof space below.

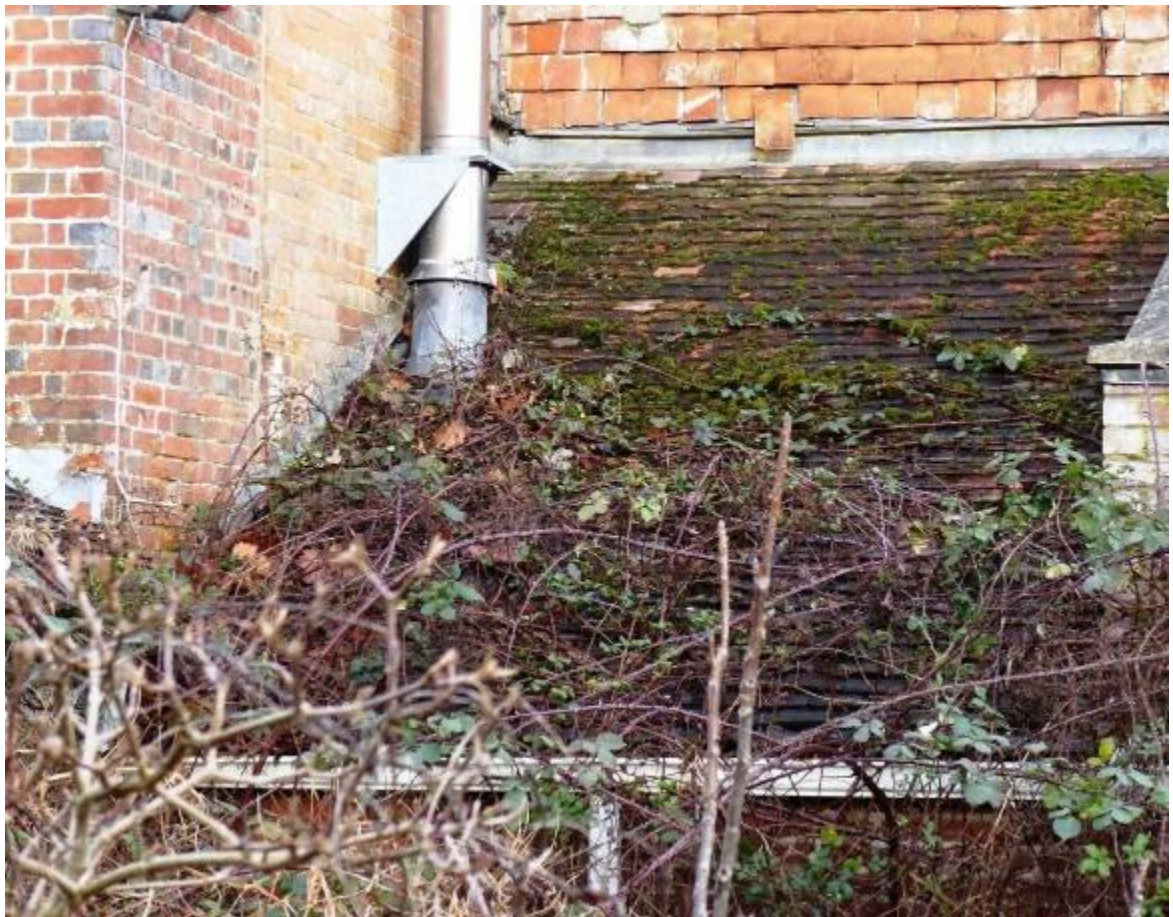
- 3.1.16 In the south side junction between the three storey section and two storey part of the main house is a mono pitch roof over the cloakroom and lobby. This is covered with clay plain tiles, mostly of a machine made type, which is in a very poor condition and is much disrupted by plant growth with localised collapse in this adjacent to the boiler flue that runs up the east wall of the three storey section. This section of roof is will require complete reconstruction, including the underlying structure.

Fig 3.1.16: Cloakroom and lobby roof

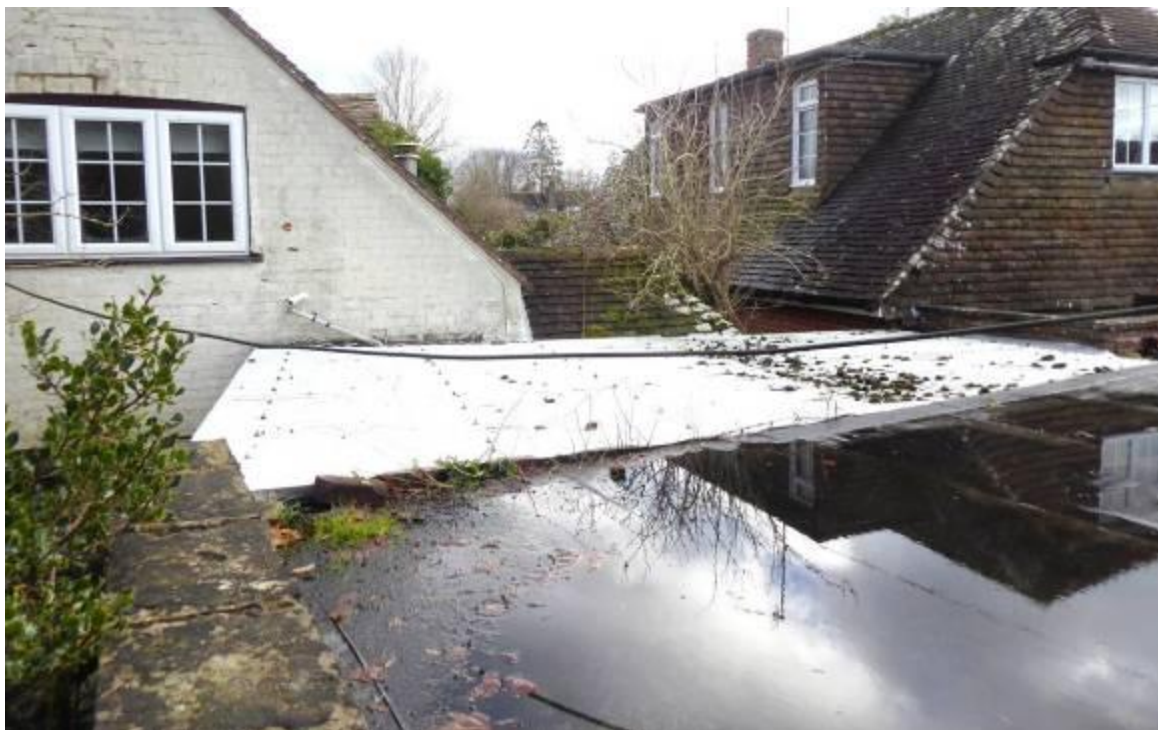
Fig 3.2.1: Garage and car port roof

- 3.2.4 The surface of the garage roof has sagged towards the east end, particularly on the north side, as well as there being general undulation in the surface, suggesting that there is failure in the structure below. No attempt was made to access this surface due to its apparently unsafe nature. This is likely to require restructuring as well as recovering entirely as the felt appears to be largely life expired.

- 3.2.5 The car port roof is covered with single skin translucent corrugated plastic sheeting with much moss being held on the surface. This drains to an outlet against the parapet wall to the adjacent property on the south boundary. The overall appearance of this material would suggest it to be life expired and becoming brittle, so will need replacement with 5 years.

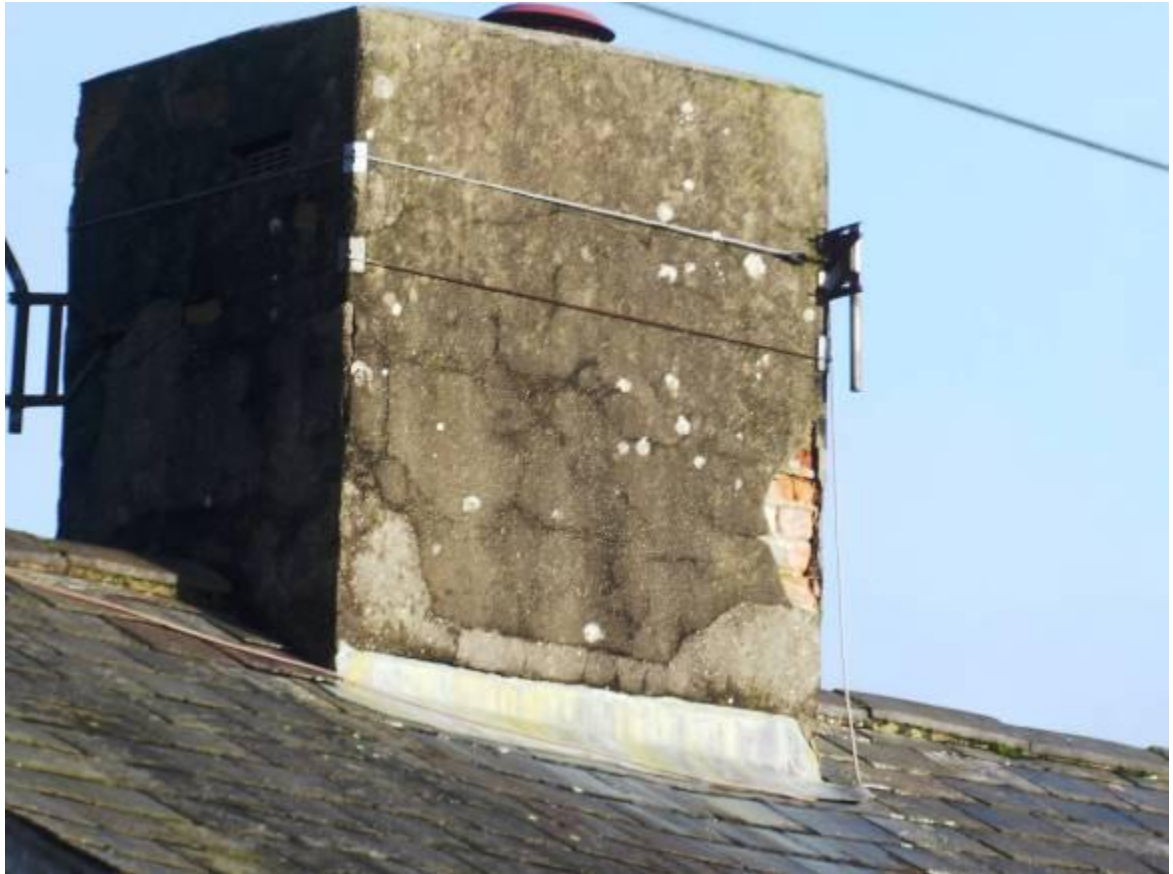
Fig 3.3.1: Main chimney

- 3.3.1 Projecting up through the west end of the ridge of the west three storey section, there is a large, somewhat monolithic looking, chimneystack of brickwork that has been fully rendered and has lead flashings to the surrounding roof. This is deteriorating with loss of render to the surface and will need to be stripped and re-rendered in lime mortar of an appropriate mix, colour and surface texture.
- 3.3.2 There is a two flue brick stack with shoulders to the lower section that projects up through the east side of the roof to the two storey east part of the main house, which is surmounted by two clay pots. This rises from a projecting chimneybreast on the south wall of the house with shoulders, where it reduces, above eaves level

that are render covered. It is flashed in the roof coverings with mortar fillets on the sides and a lead back gutter, with much moss and other plant growth around this junction that will require re-making. At lower level the shoulders of the chimneystack, just above the roof to the conservatory, are finished with flat laid bricks in a fair condition.

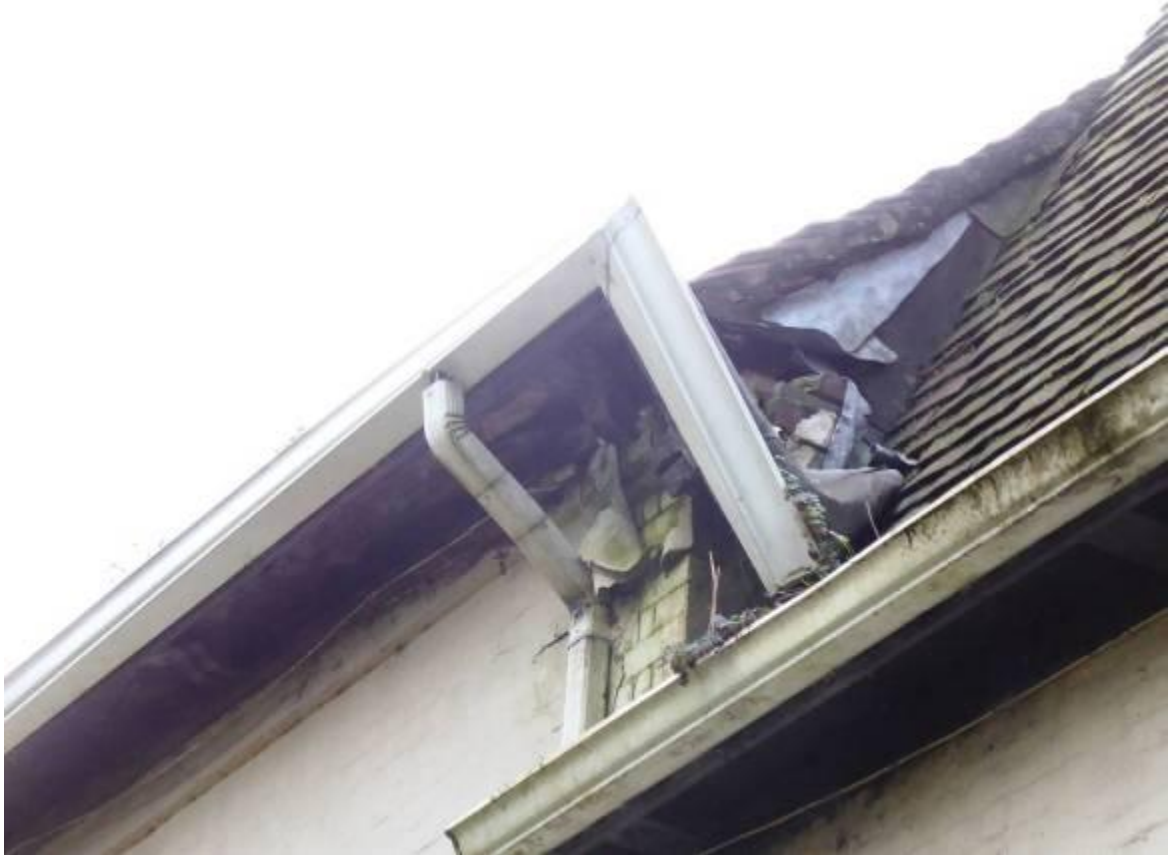
Fig 3.4.4: Collapsed gable wall head and eaves

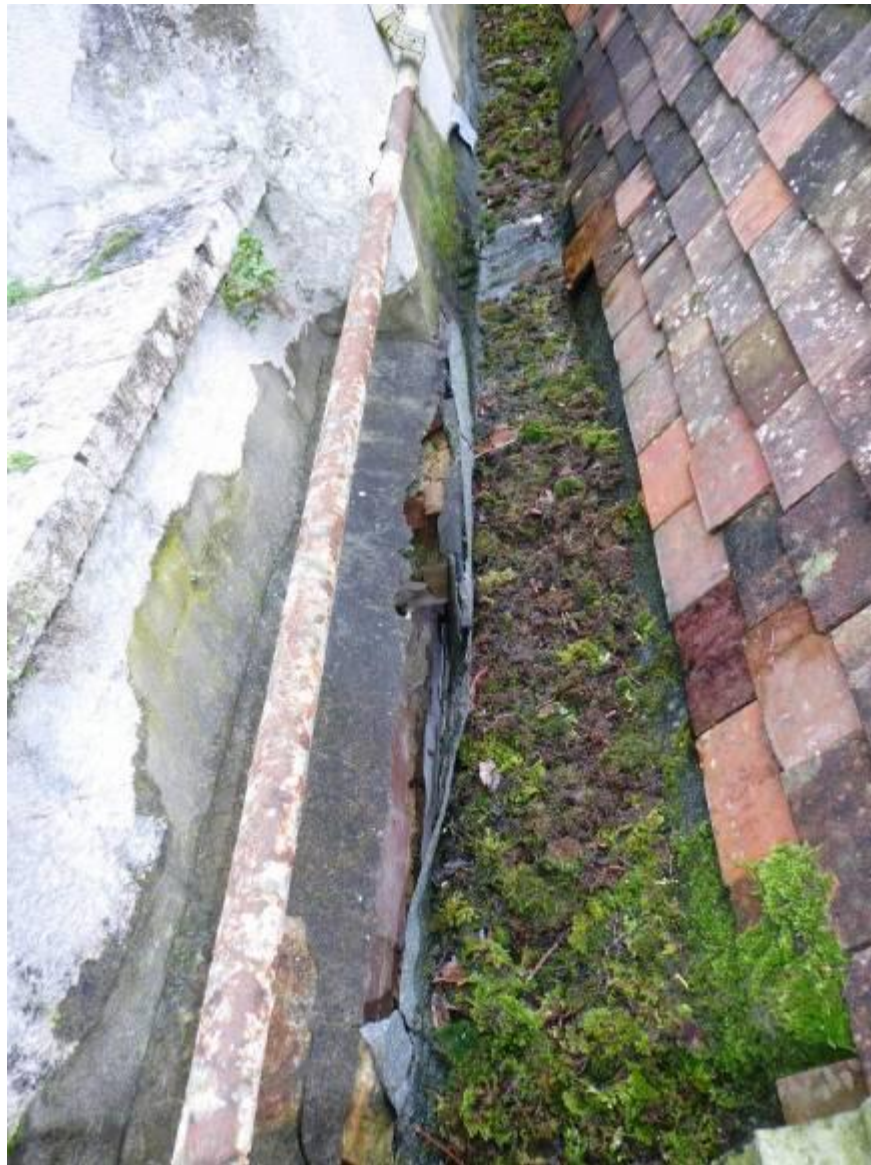
Fig 3.4.8: Failed valley gutter to north side of service block

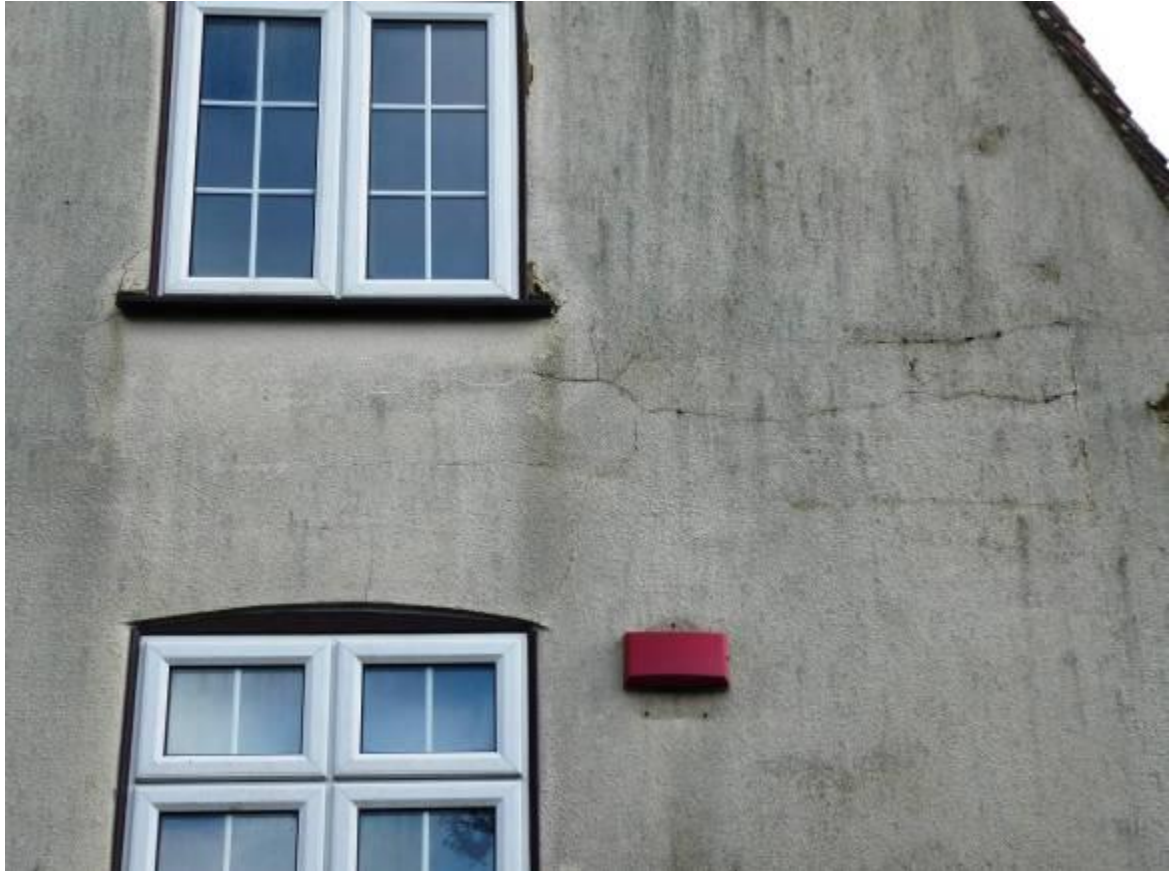
head of that to the verge of the roof. On the south side of this wall there is horizontal cracking running from just below the second floor window towards the south roof verge before it dies out.

Fig 3.5.2: Cracking and movement in west wall

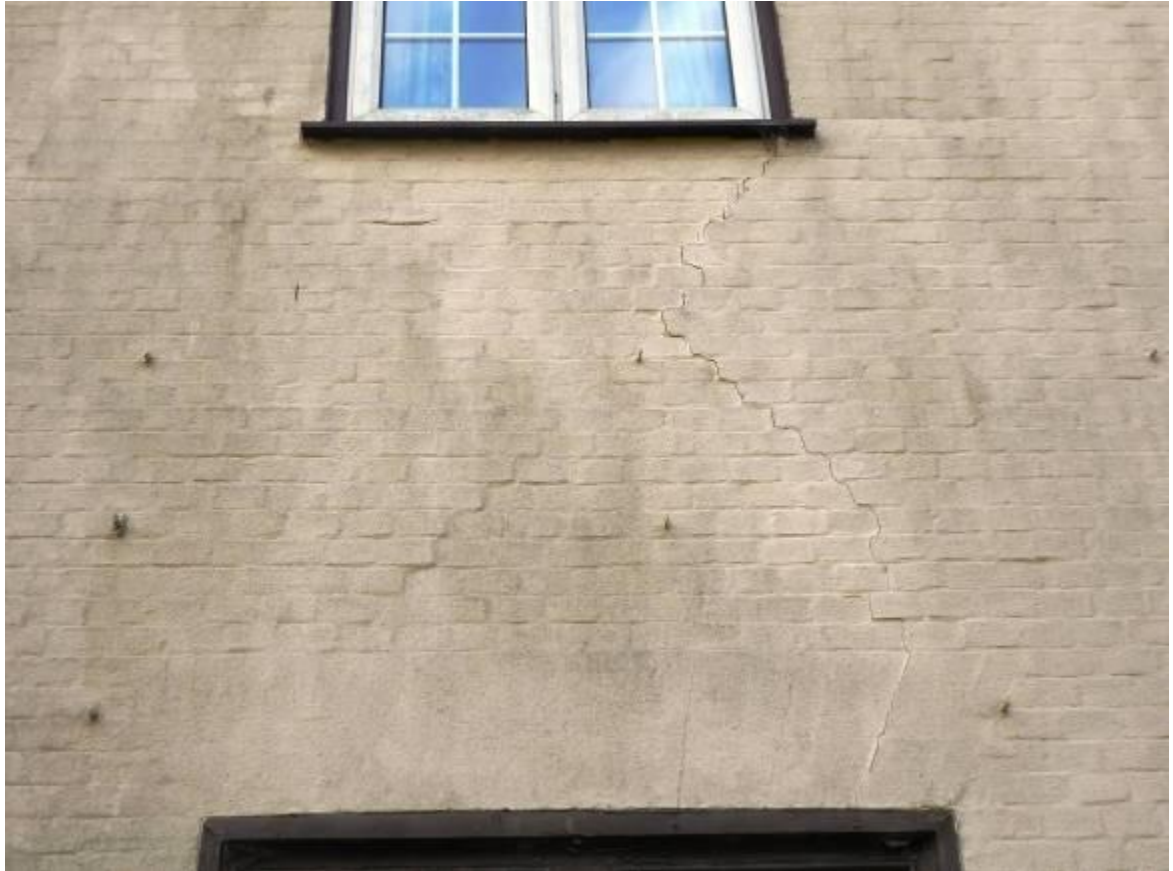
Fig 3.5.9: Cracking in north wall of east two storey part

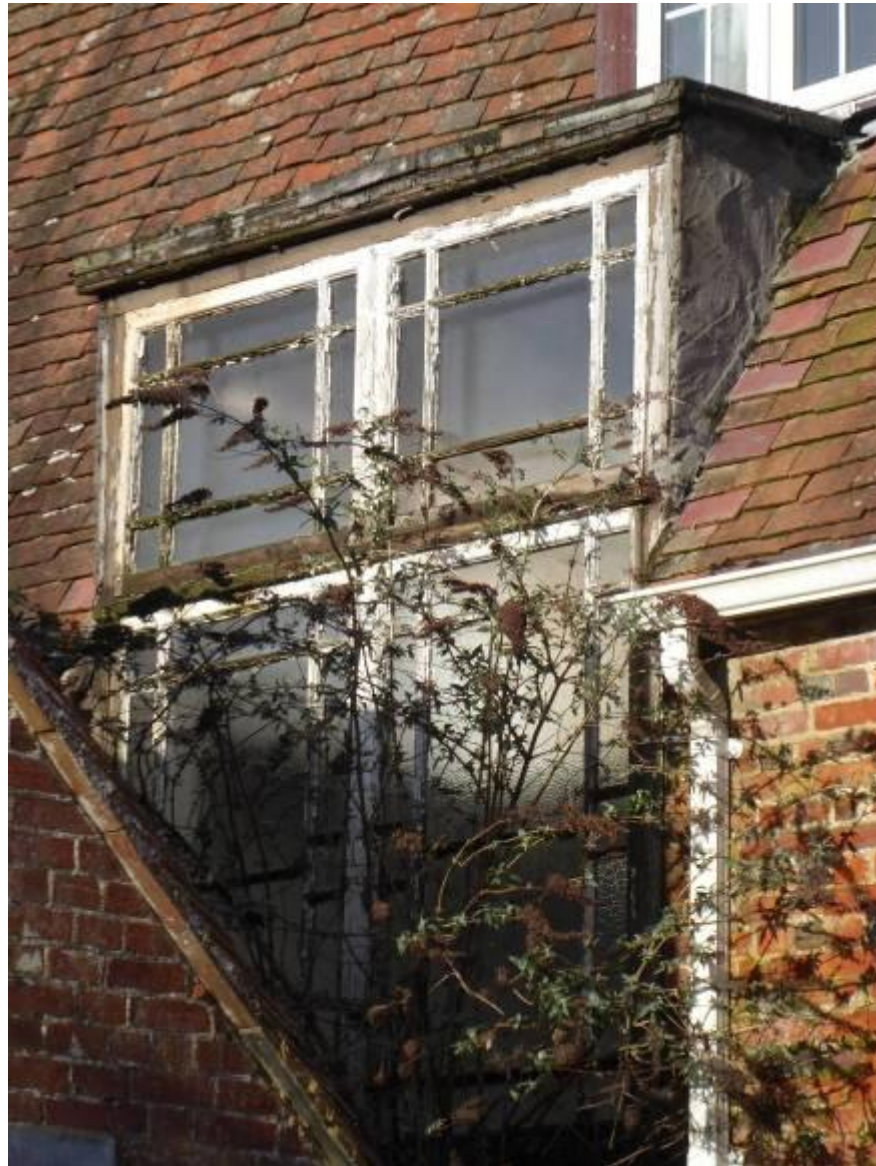
- 3.6.10 There is a staircase window in the south side of the three storey block that is largely a single glazed fixed light unit with a dormer type top where it projects in to the lower part of the mansard. This is all in poor condition with much wet related decay to sills, intermediate frames and the glazing framing and the whole of this unit will need complete replacement.

Fig 3.6.10: Staircase window

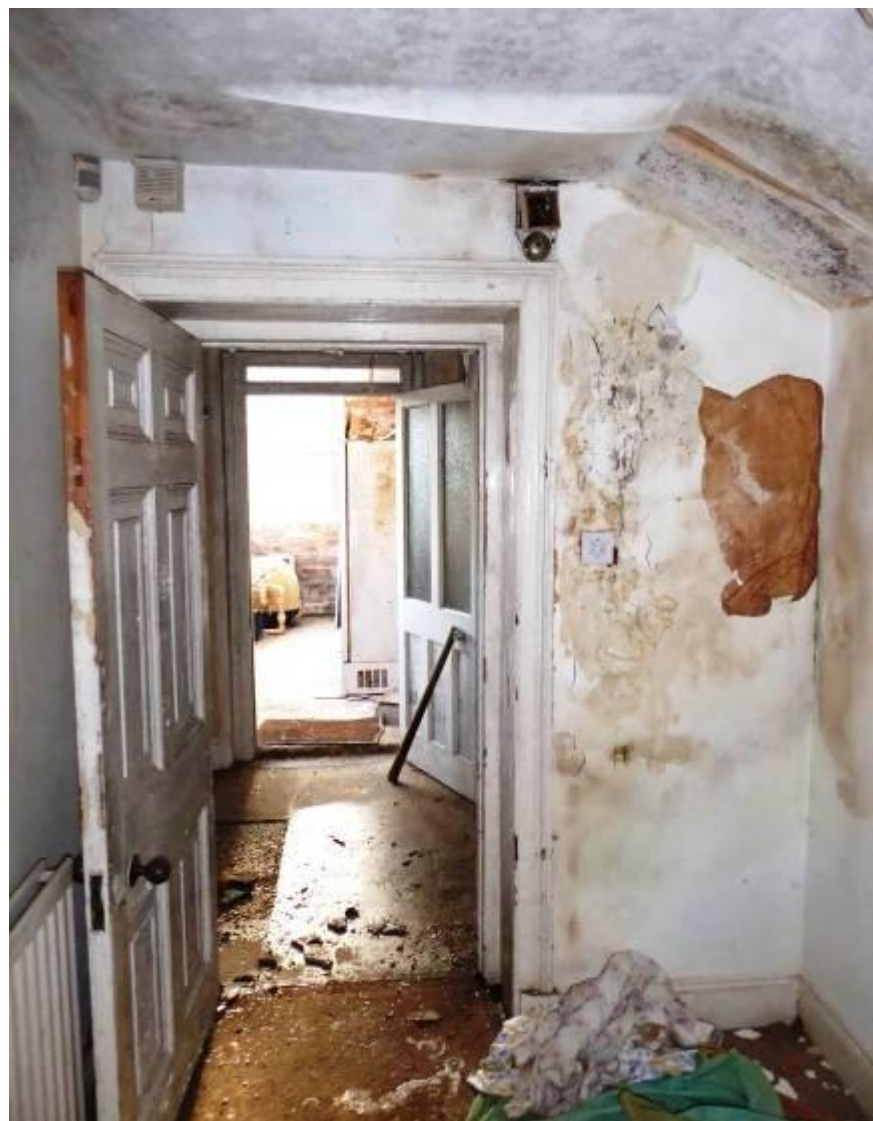
- 4.1.4 There are extensive signs of damp and condensation staining to the walls throughout this area. Much of this is due to condensation as well as penetrating damp due to defective gutters and the like.
- 4.1.5 The ceiling is a flat soffit of plasterboard on the underside of what would appear to be fairly modern floor joists on either side of a dropped beam that spans across the room in an approximately central position at the base of the staircase. There is a great deal of dampness and condensation seen within this from roof leaks and other problems from above.

Fig 4.1.6: Severe damp entry and dry root to rear of entrance hall

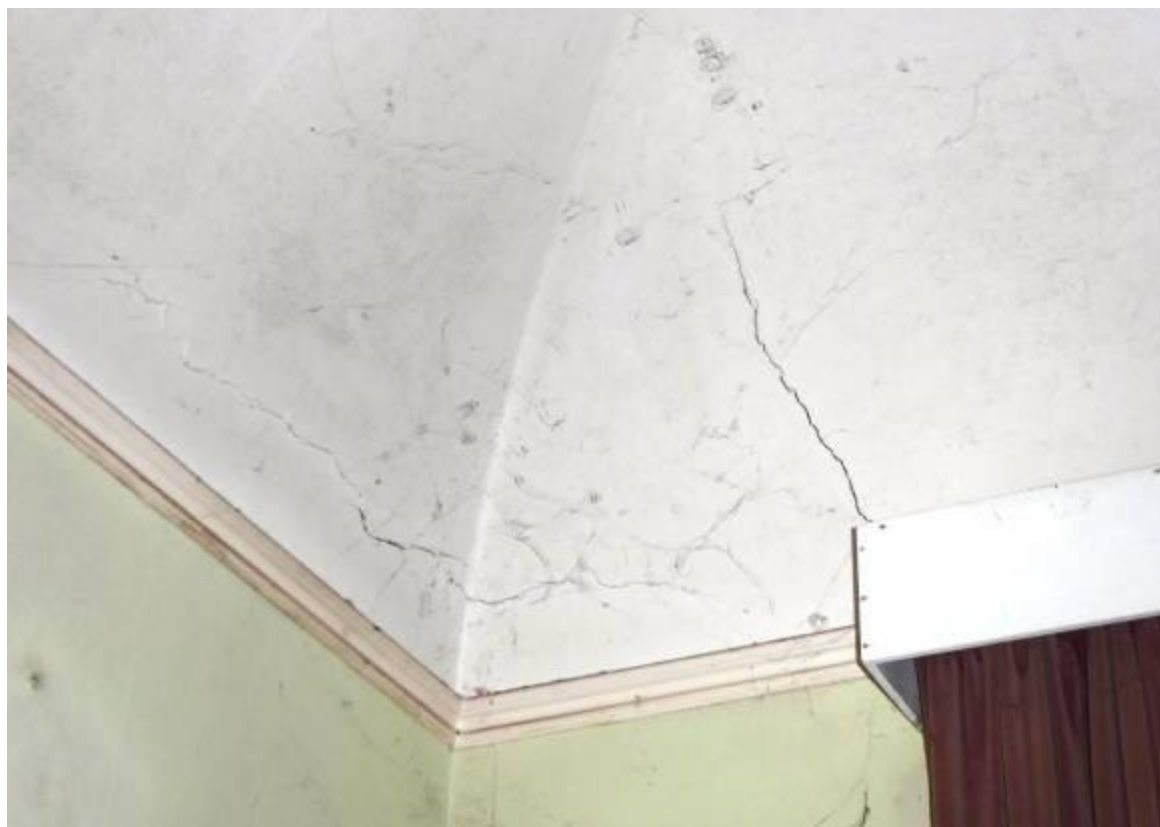
Fig 4.3.6: High level cracking and movement

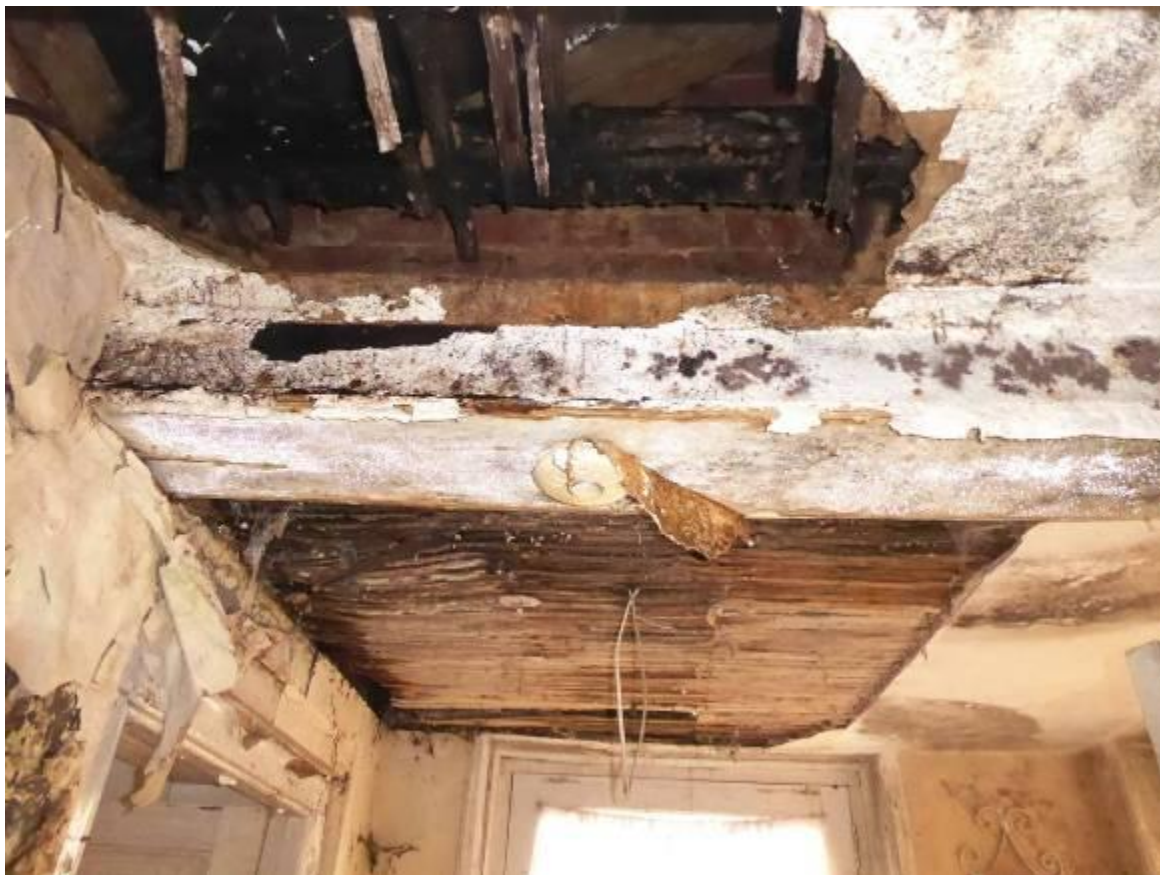
- 4.8.5 The ceiling over the west end lobby is a flat soffit that, as already described, has completely failed, is inadequately supported and should be considered as an unsafe area and screened off.

Fig 4.8.8: Collapsed ceiling and failed service block roof junction to main house

as valley gutter to be completely reformed and line with lead in accordance with LSTA recommendations. Following that the ceilings can be remade.

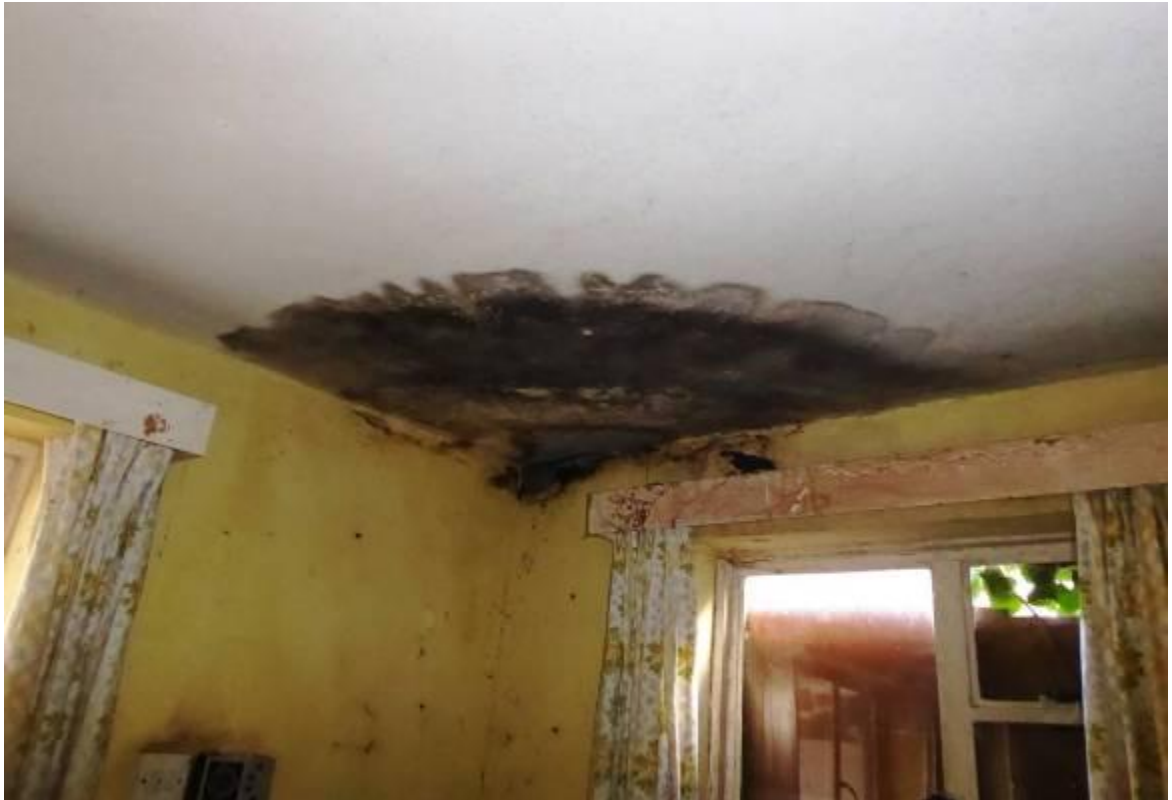
Fig 4.11.3: dry rot to ceiling and walls

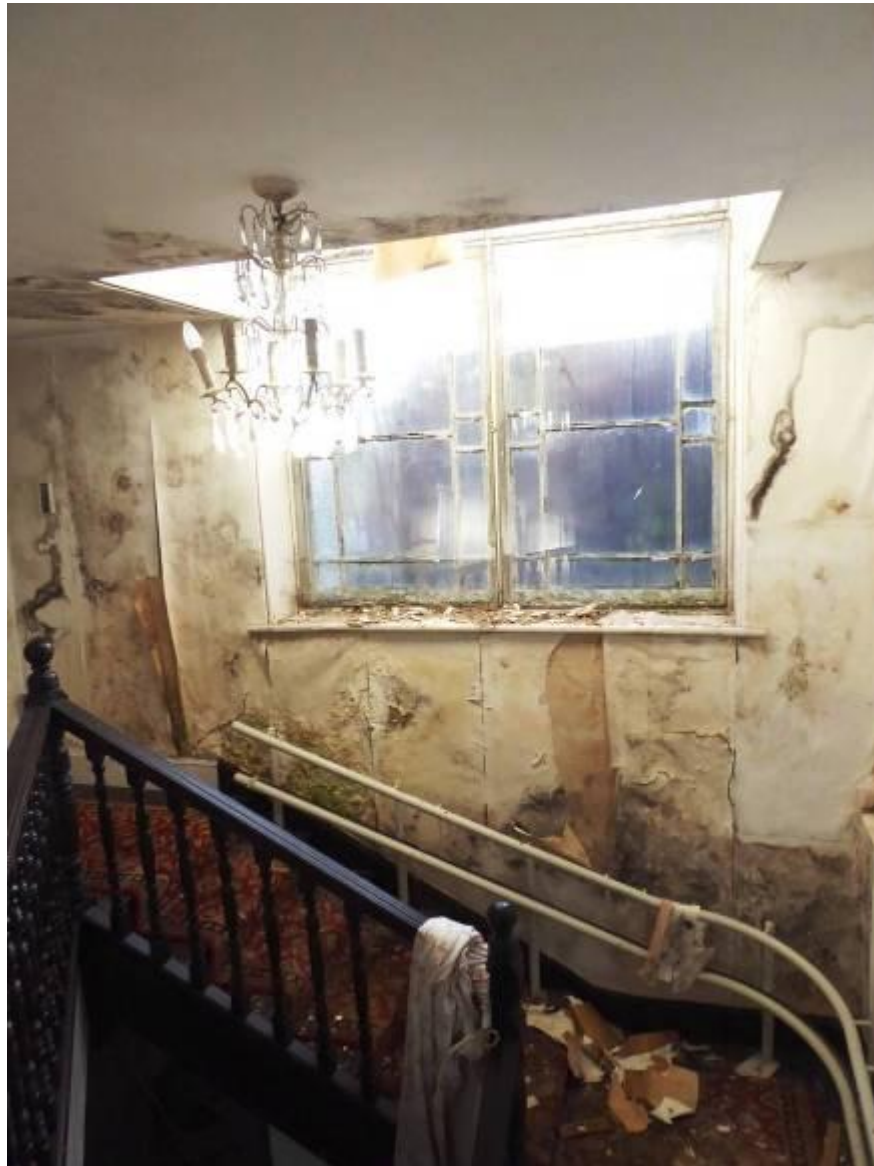
- 4.14.4 The walls up through the stairwell, are of solid construction on the ground floor and hollow construction at first floor level internally, but the external walls are all of solid construction. There is much water ingress to the external wall where there is severe water leakage from the external valley gutter and failed flat roof to the side of the service block. This has caused complete failure of the internal decorations as well as the on-set of dry rot and damage to the staircase structure. Localised rebuilding is likely to be required to this wall as well as the roof as noted as part of the external inspection.

Fig 4.14.4: Severe damp damage to wall and ceiling over stairs

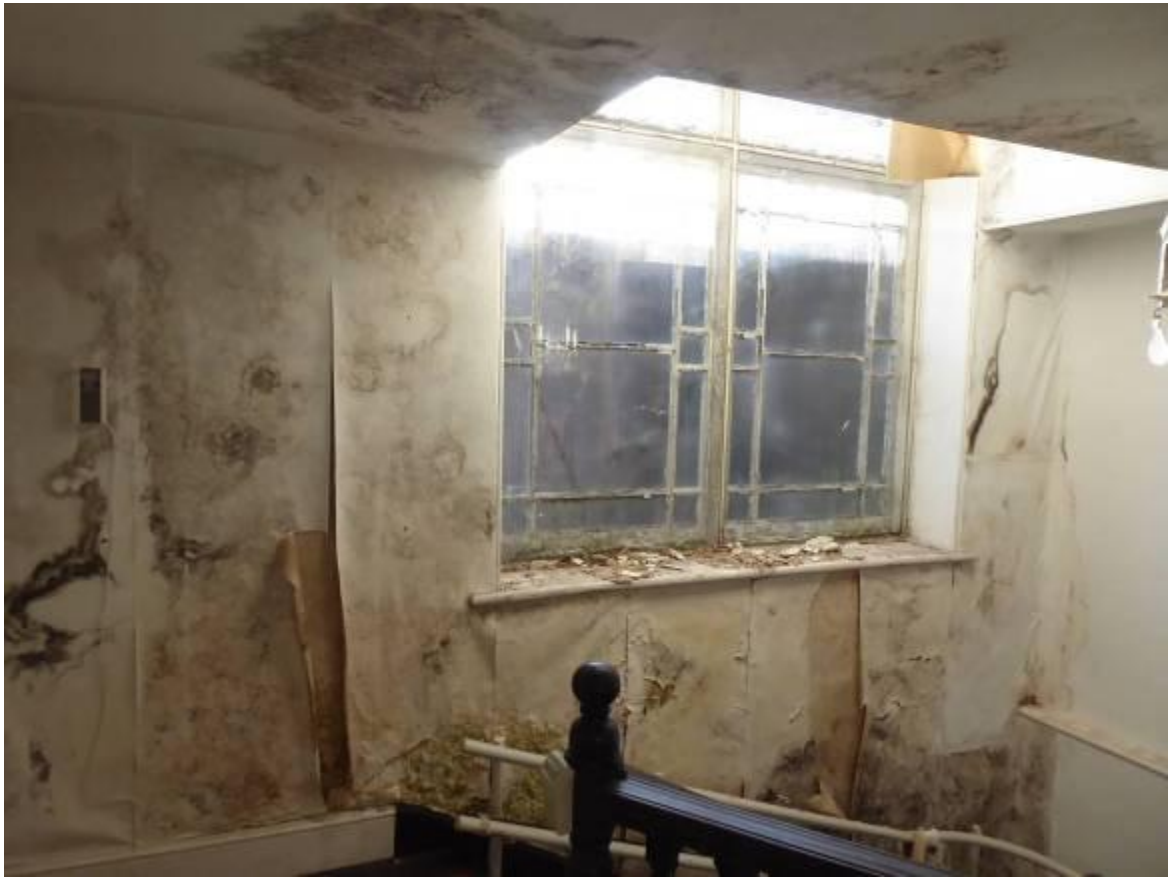
- 4.15.3 The walls are of solid construction to the exterior and hollow to the interior. The south wall, where this is a continuation of that to the staircase is very badly affected by water ingress with resultant failure to the decorations and the adjoining floor structure. Elsewhere there is much condensation staining on the surfaces, mostly due to a lack of heating and ventilation as well as water ingress from the exterior.

Fig 4.14.3: First floor landing south wall

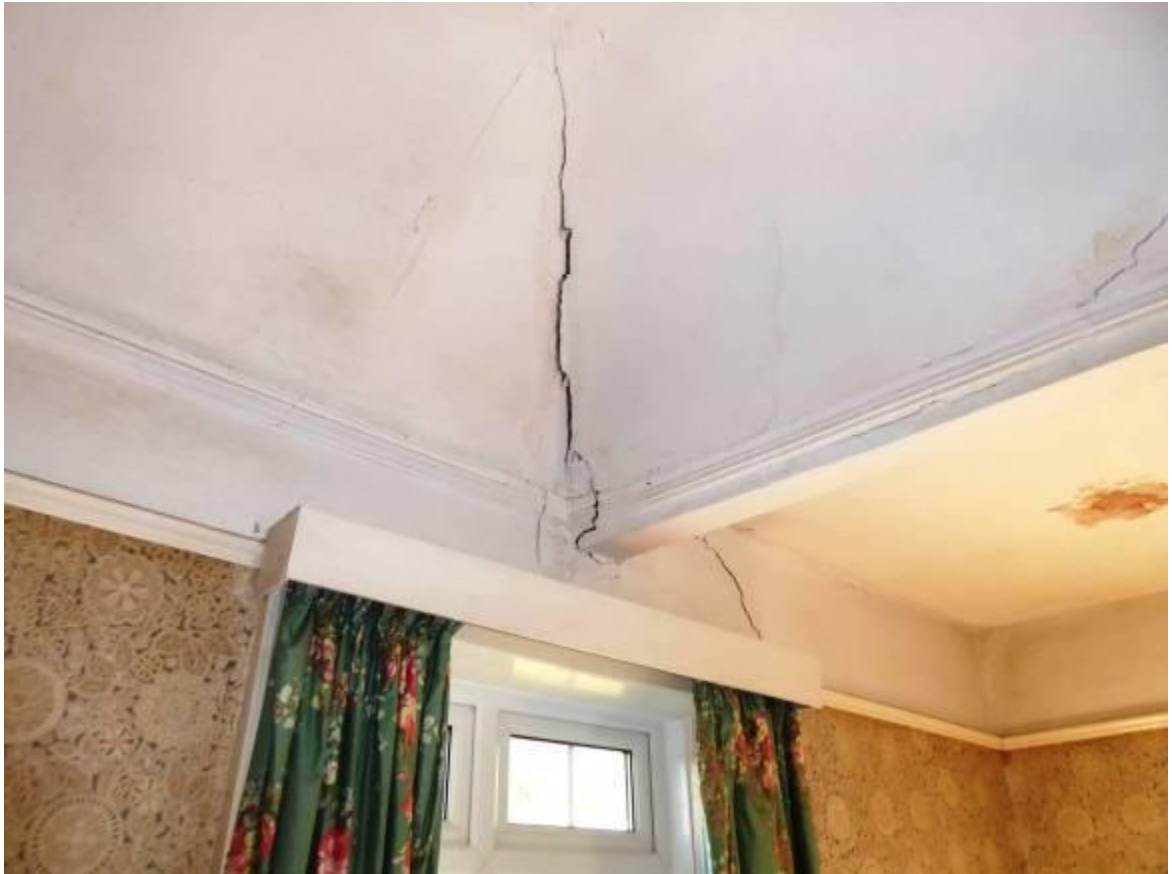
- 4.21.6 Severe structural cracking and movement was noted to the wall head and the junction with the coving and ceiling in both the northwest and southwest corners. This relates to movement in the corresponding area of the room seen below due to roof and wall movement.

Fig 4.21.7: Severe cracking to beam end and walls

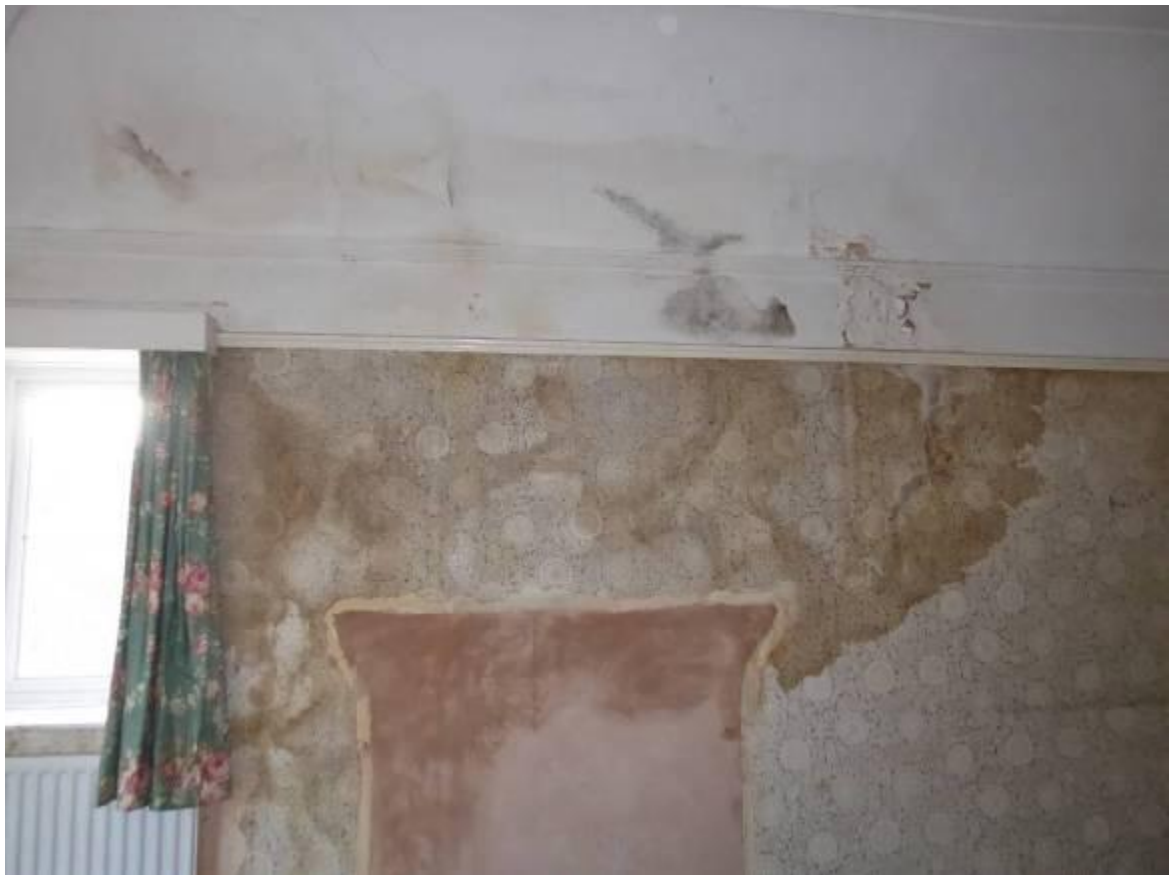
- 4.21.9 The ceiling is in two sections on either side of the dropped beam, where on the west side this has is a large coved section running up from a high level picture rail to a flat central soffit. Then on the east side of the beam there is a dropped flat soffit, with no perimeter coving.
- 4.21.10 Over the west part of the room there is much movement on the wall to coving joints and also bowing in the ceiling with a drop in the surface. This includes cracking to the centre of the ceiling where this is also deflection downwards and to some extent outwards. Much signs of loss of lamination to the plasterboard and lathing above that.
- 4.21.11 The ceiling to the east end of the room has cracking and movement in the centre as well as to the perimeter and to the side of the beam, where this is also showing further signs of displacement.

Fig 4.21.12: Damp entry to ceiling and walls
