**Arboricultural Assessment of a tree growing  
on former Westbury Hospital site, Westbury.**

***On behalf of:***  
**Backhouse Housing Limited**

***Prepared by:***  
**Chris Wright M.Arbor.A**  
**Arboricultural Consultant**  
**May 2025**

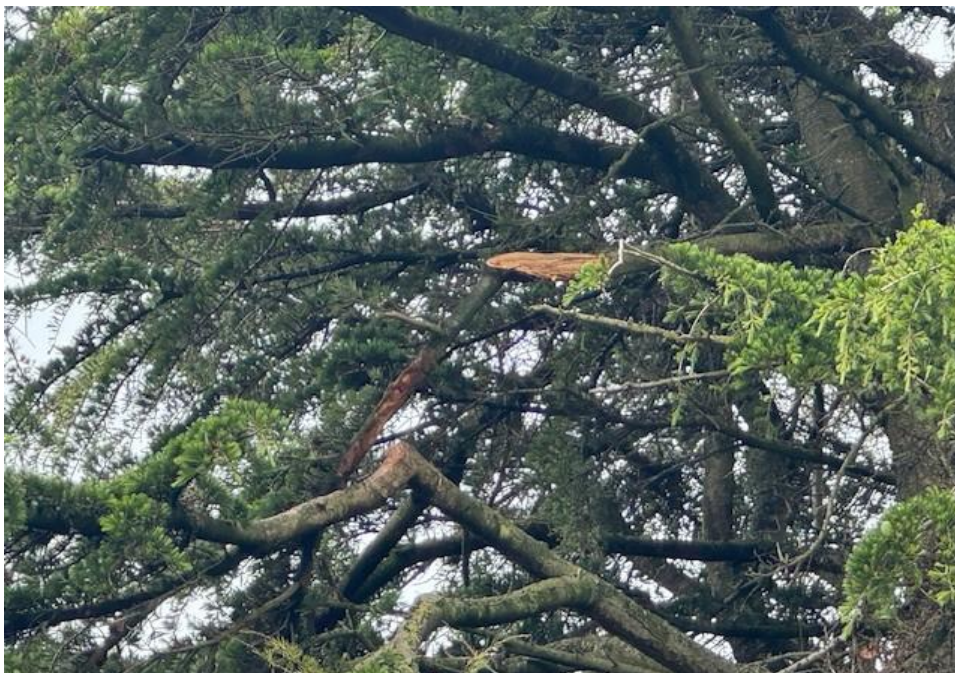
Photo 1

- 4.1 At the time of our inspection there were no significant defects noted within the stem or canopy of the tree. Minor dieback was evident within the canopy and on the tips of a few branches, as would be expected with a mature tree, probably a result of canopy shading rather than dieback. The canopy was a good colour with healthy extension growth of the tips of the branches. Overall, the tree appeared to be in a good structural and physiological condition.
- 4.2 There were evident the tree has suffered some wind damage during the winter months with a number of snapped branches hung up in the canopy and spurs where the branches have failed. ( photo 1, 2 & 3)

- 4.3 It is considered that these wounds and damage bark could potentially offer entry points for pathogens which could impact on the health of the tree. Remedial works should be undertaken to tidy the snapped branches. There are also a several snapped branches hung up in the canopy which could potentially pose a health and safety risk to people using the open space area.

It is recommended that a crown clean is undertaken to remove any hung-up branches and cut back snapped branches to a suitable growth point, in accordance with BS3998:2010
