**George Hotel – Room 111 defective post – 11.09.25**

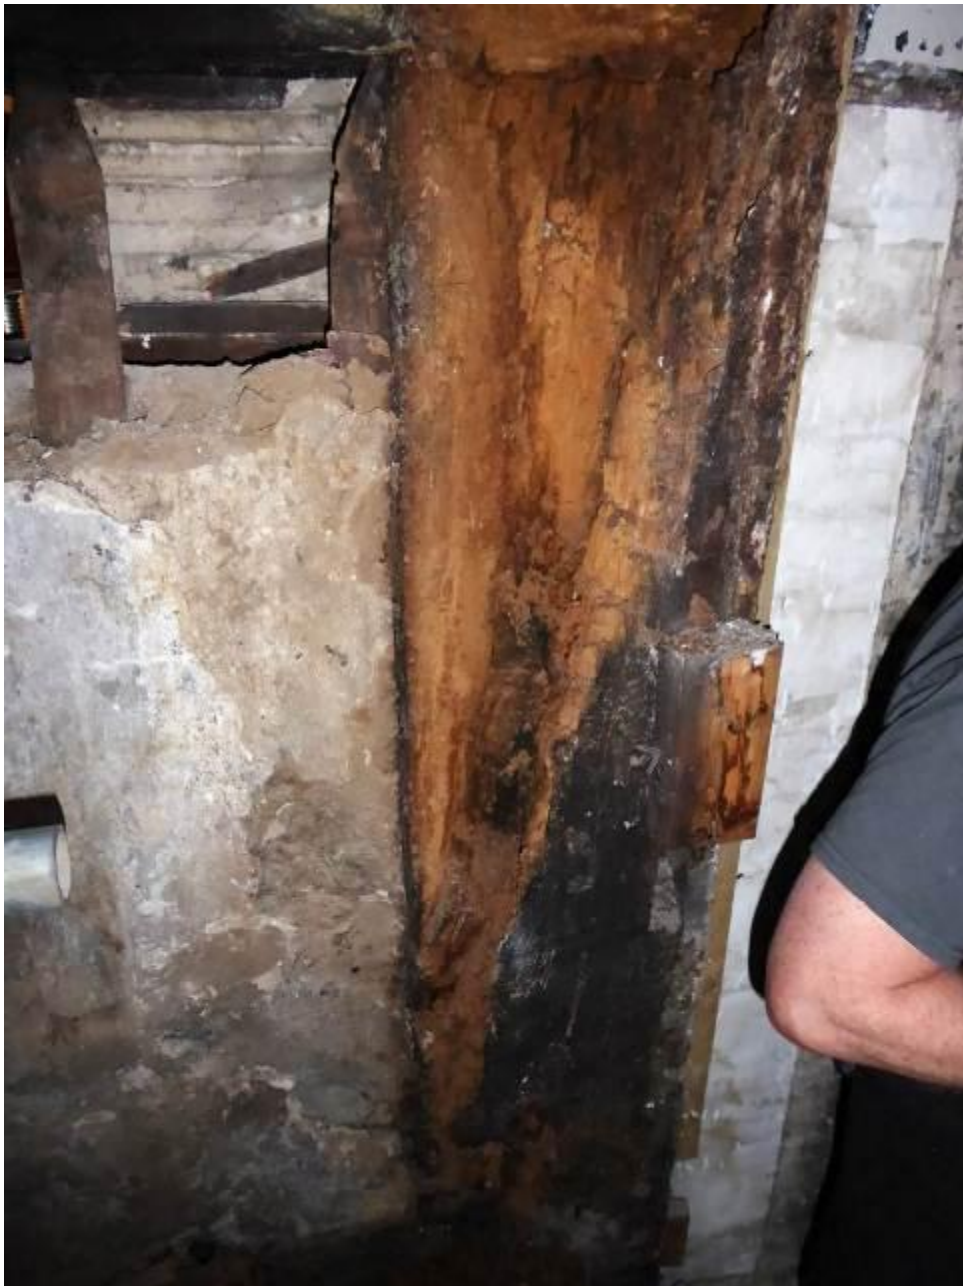
Top of lower post

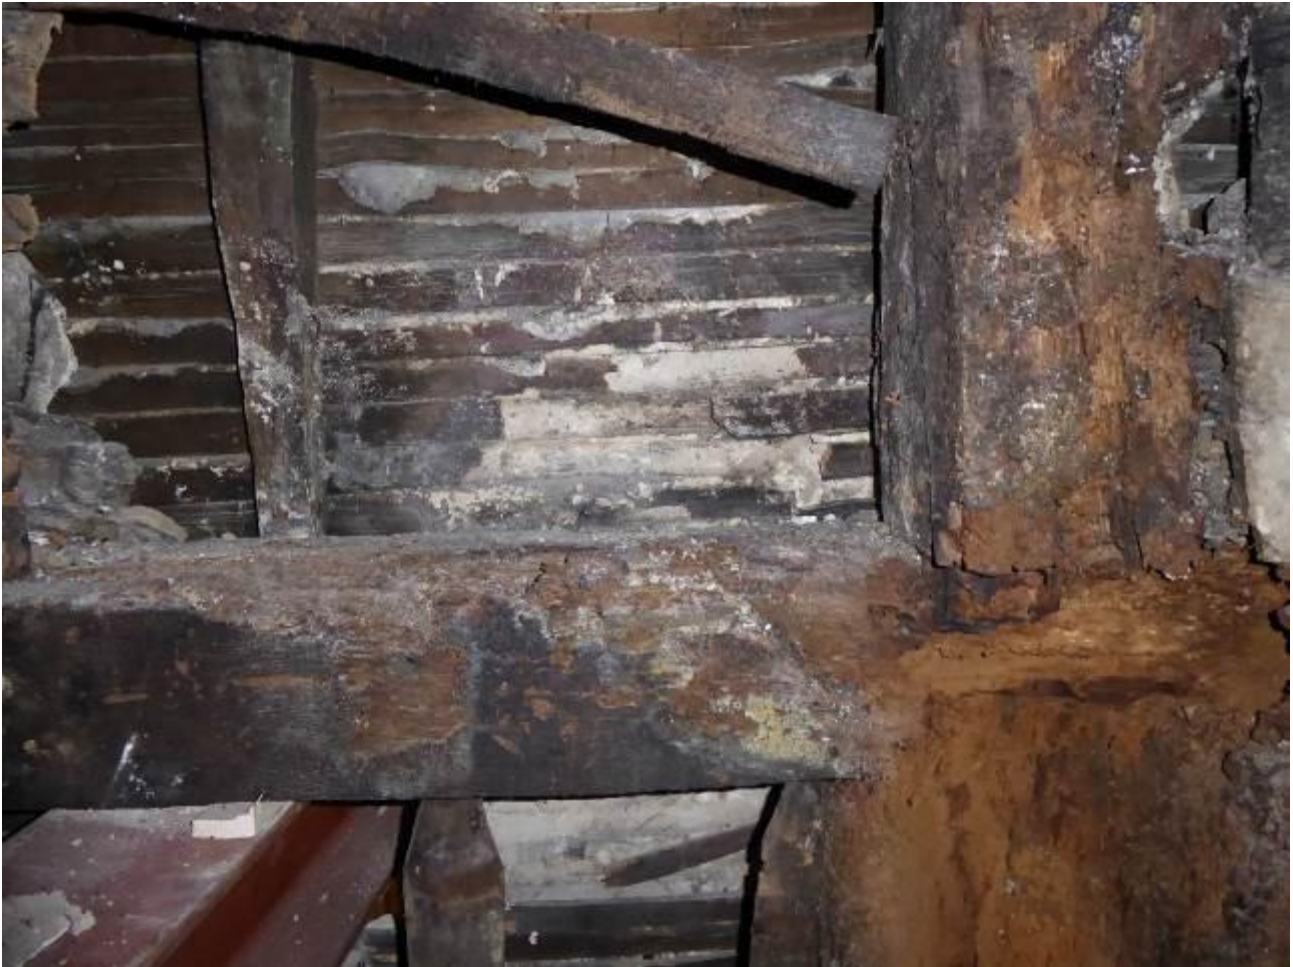
Lower and upper post junction with cross rail

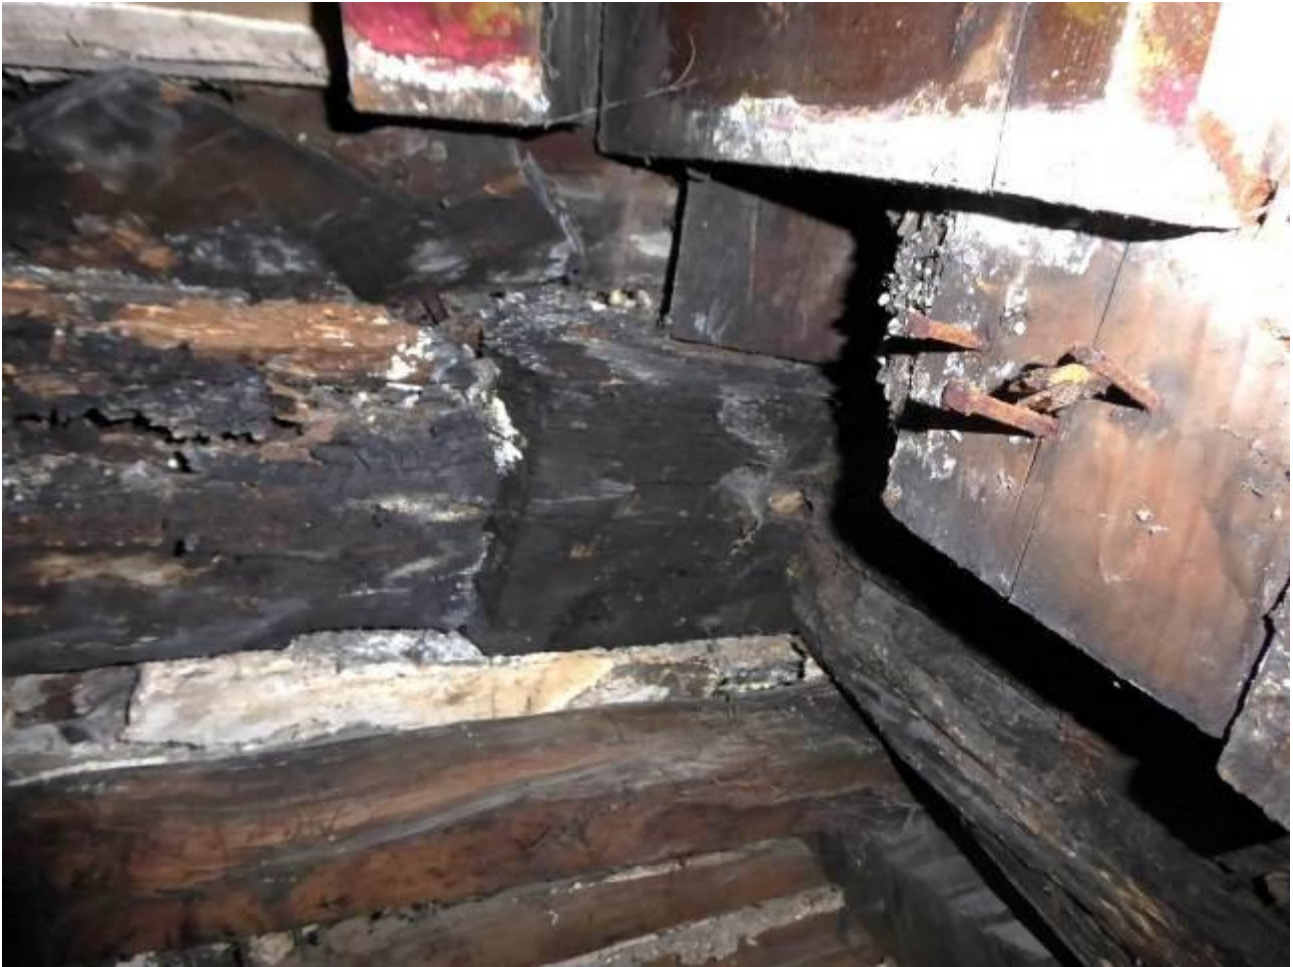
Head plate to left of top post

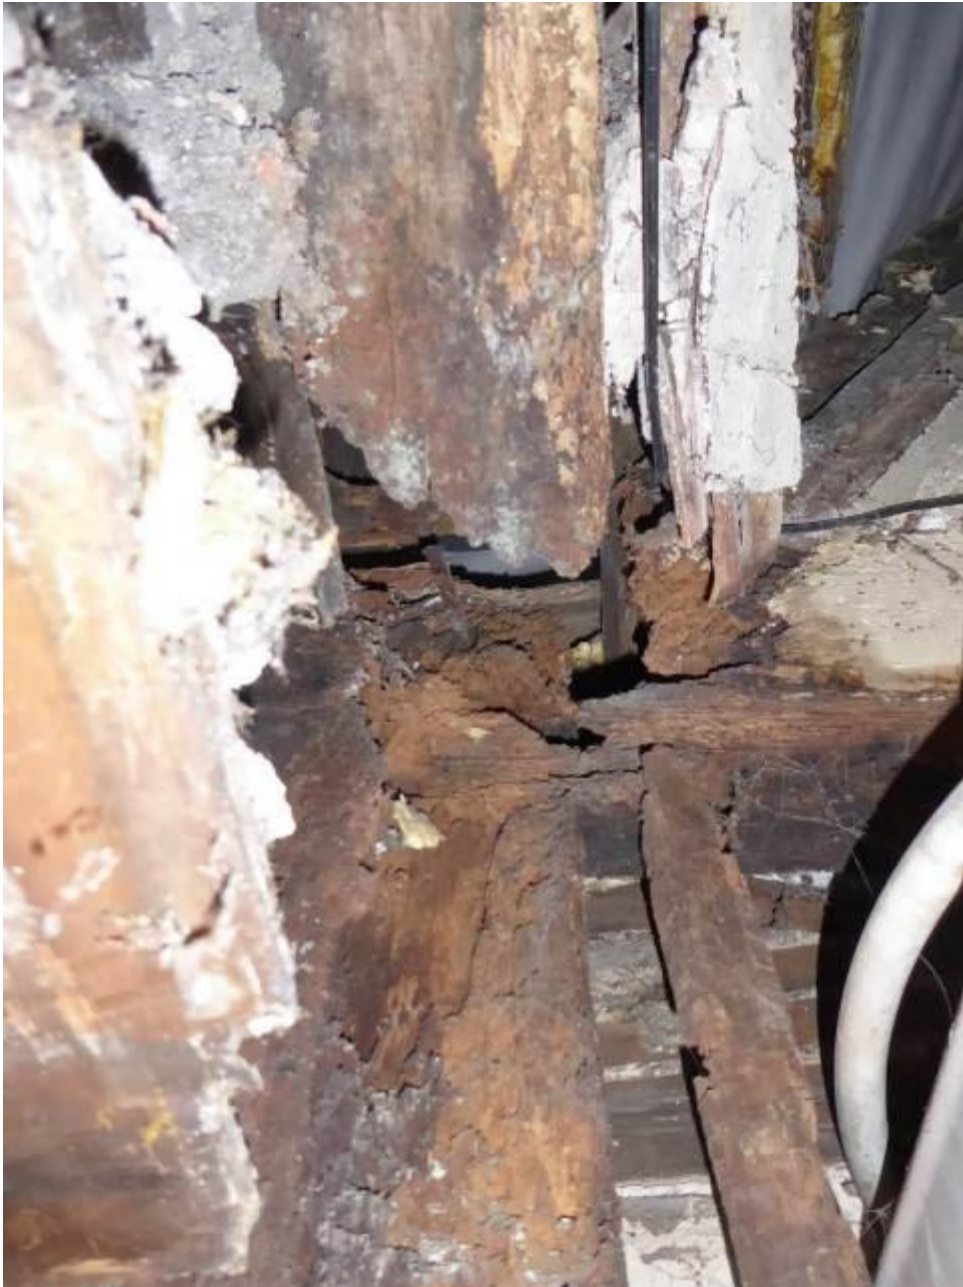
Head plate to right of top post

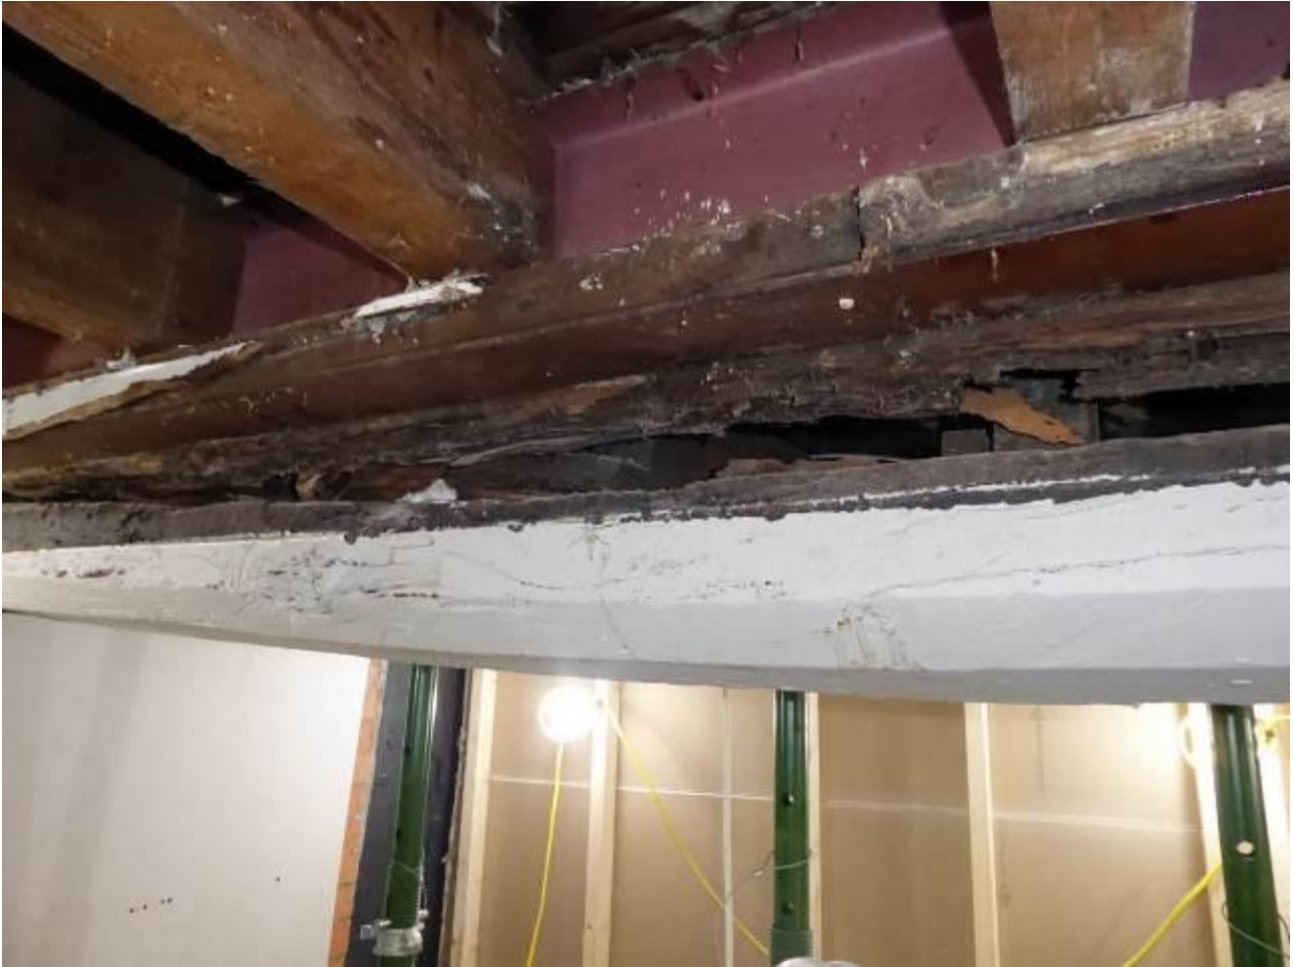
Beam over bar area

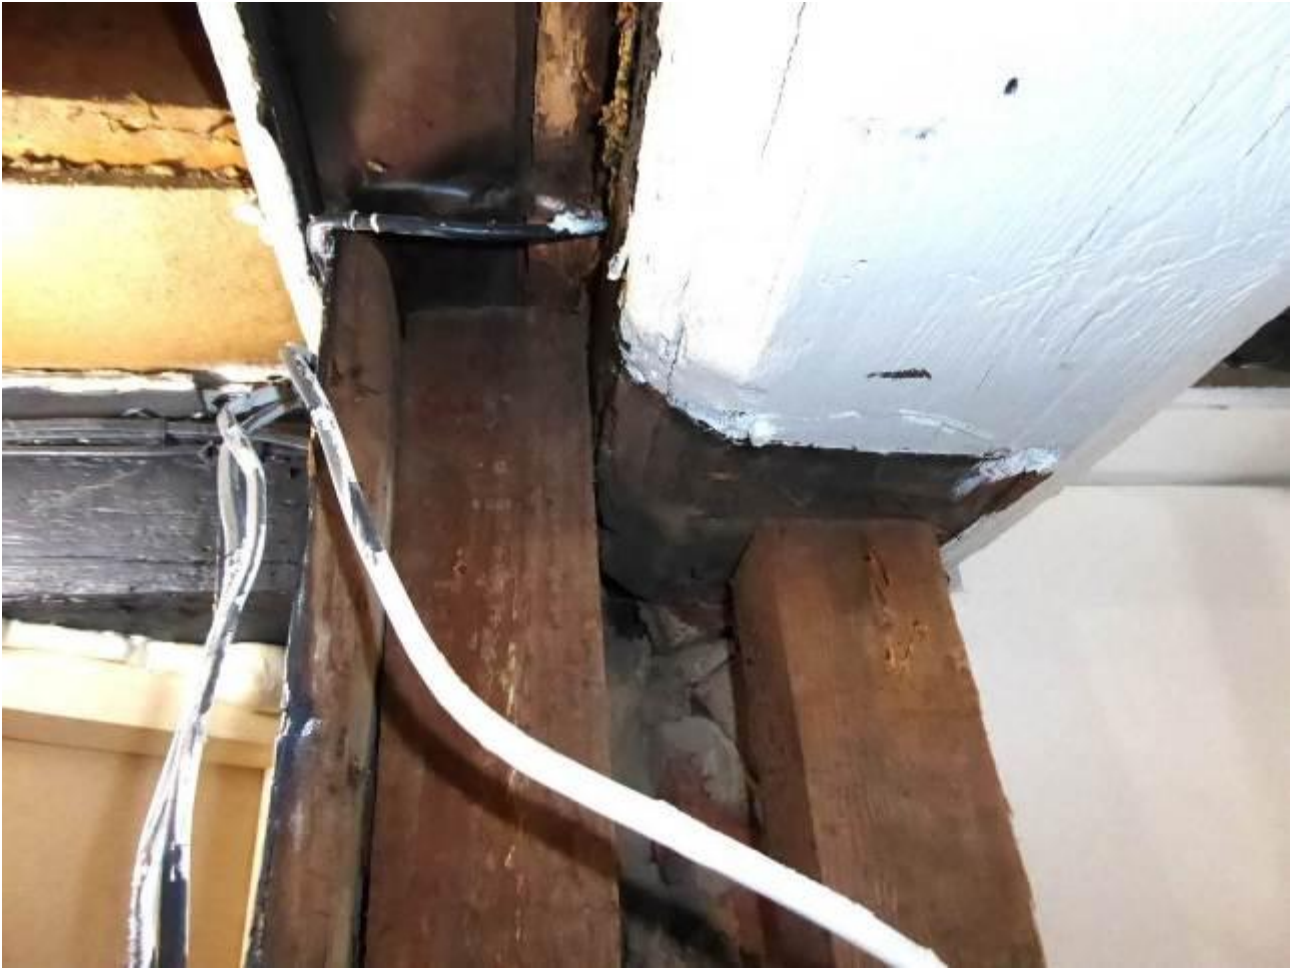
Modern end support post butted against brick pier

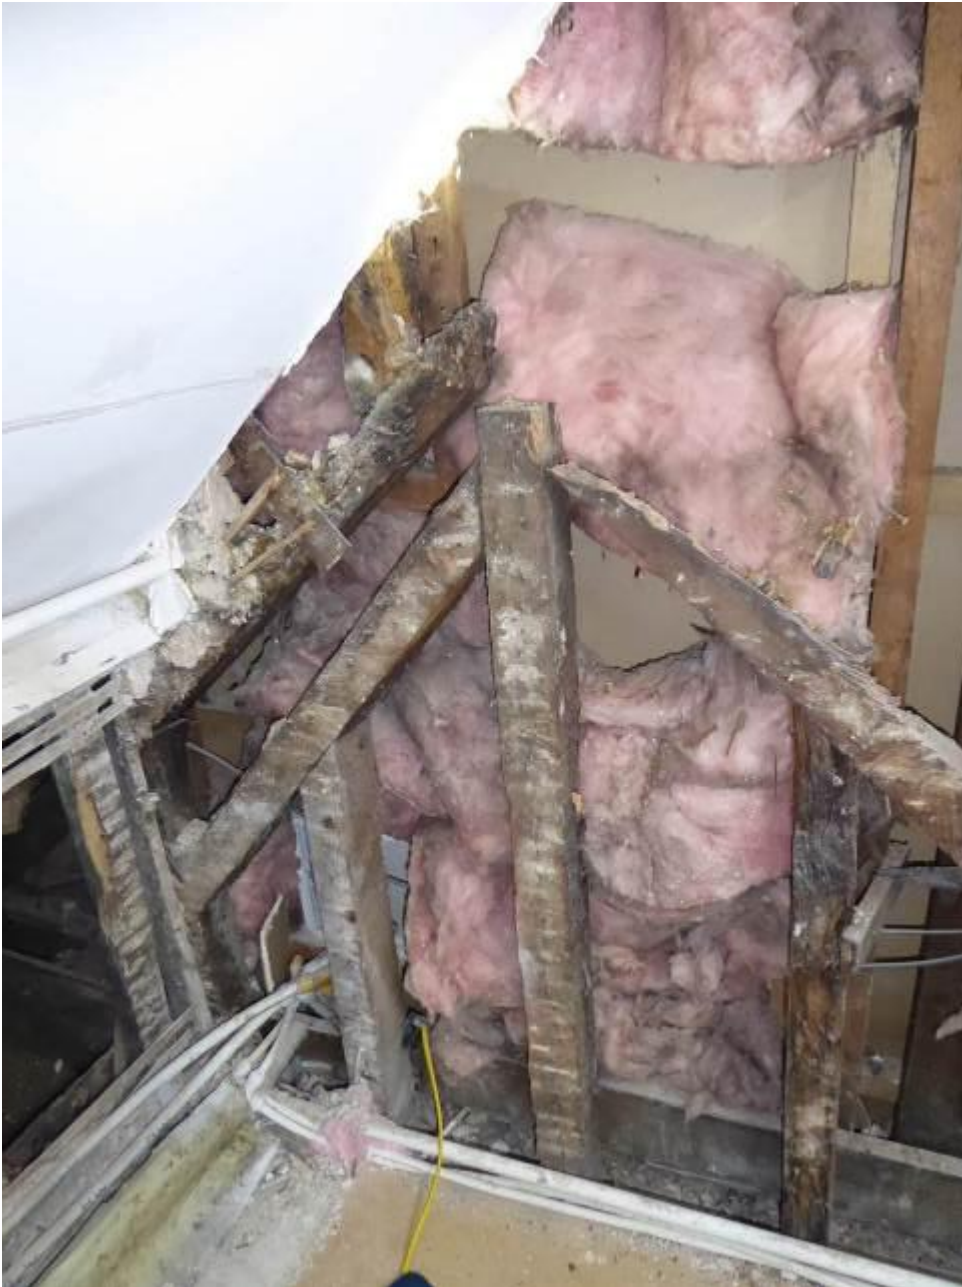
Failed roof support framing above bar beam
