| Client: Mr O & Mrs E Collins.<br>Bewley Cottage, Bowden Hill,<br>Lacock, SN15 2PW | | Drawing: Existing North & South<br>Elevations | | DOLMAN<br>ARCHITECTURAL DESIGNERS<br>COST CONSULTANTS | | BUILDING SURVEYORS<br>CDM PRINCIPAL DESIGNERS | |
| Project: Fire Damage Repairs to<br>Cottage | Drawn: JAG | Date: 26/08/2025 | Scale: 1:50<br>@ A1 | Rev. A | Sussex House<br>Bath Road<br>Devizes<br>Wiltshire SN10 2AF | Tel: 01380 729456<br>Web: www.dolmansurveyors.co.uk<br>Email: info@dolmansurveyors.co.uk | |
| Drawing number: 4430-03 | | | | | | | |

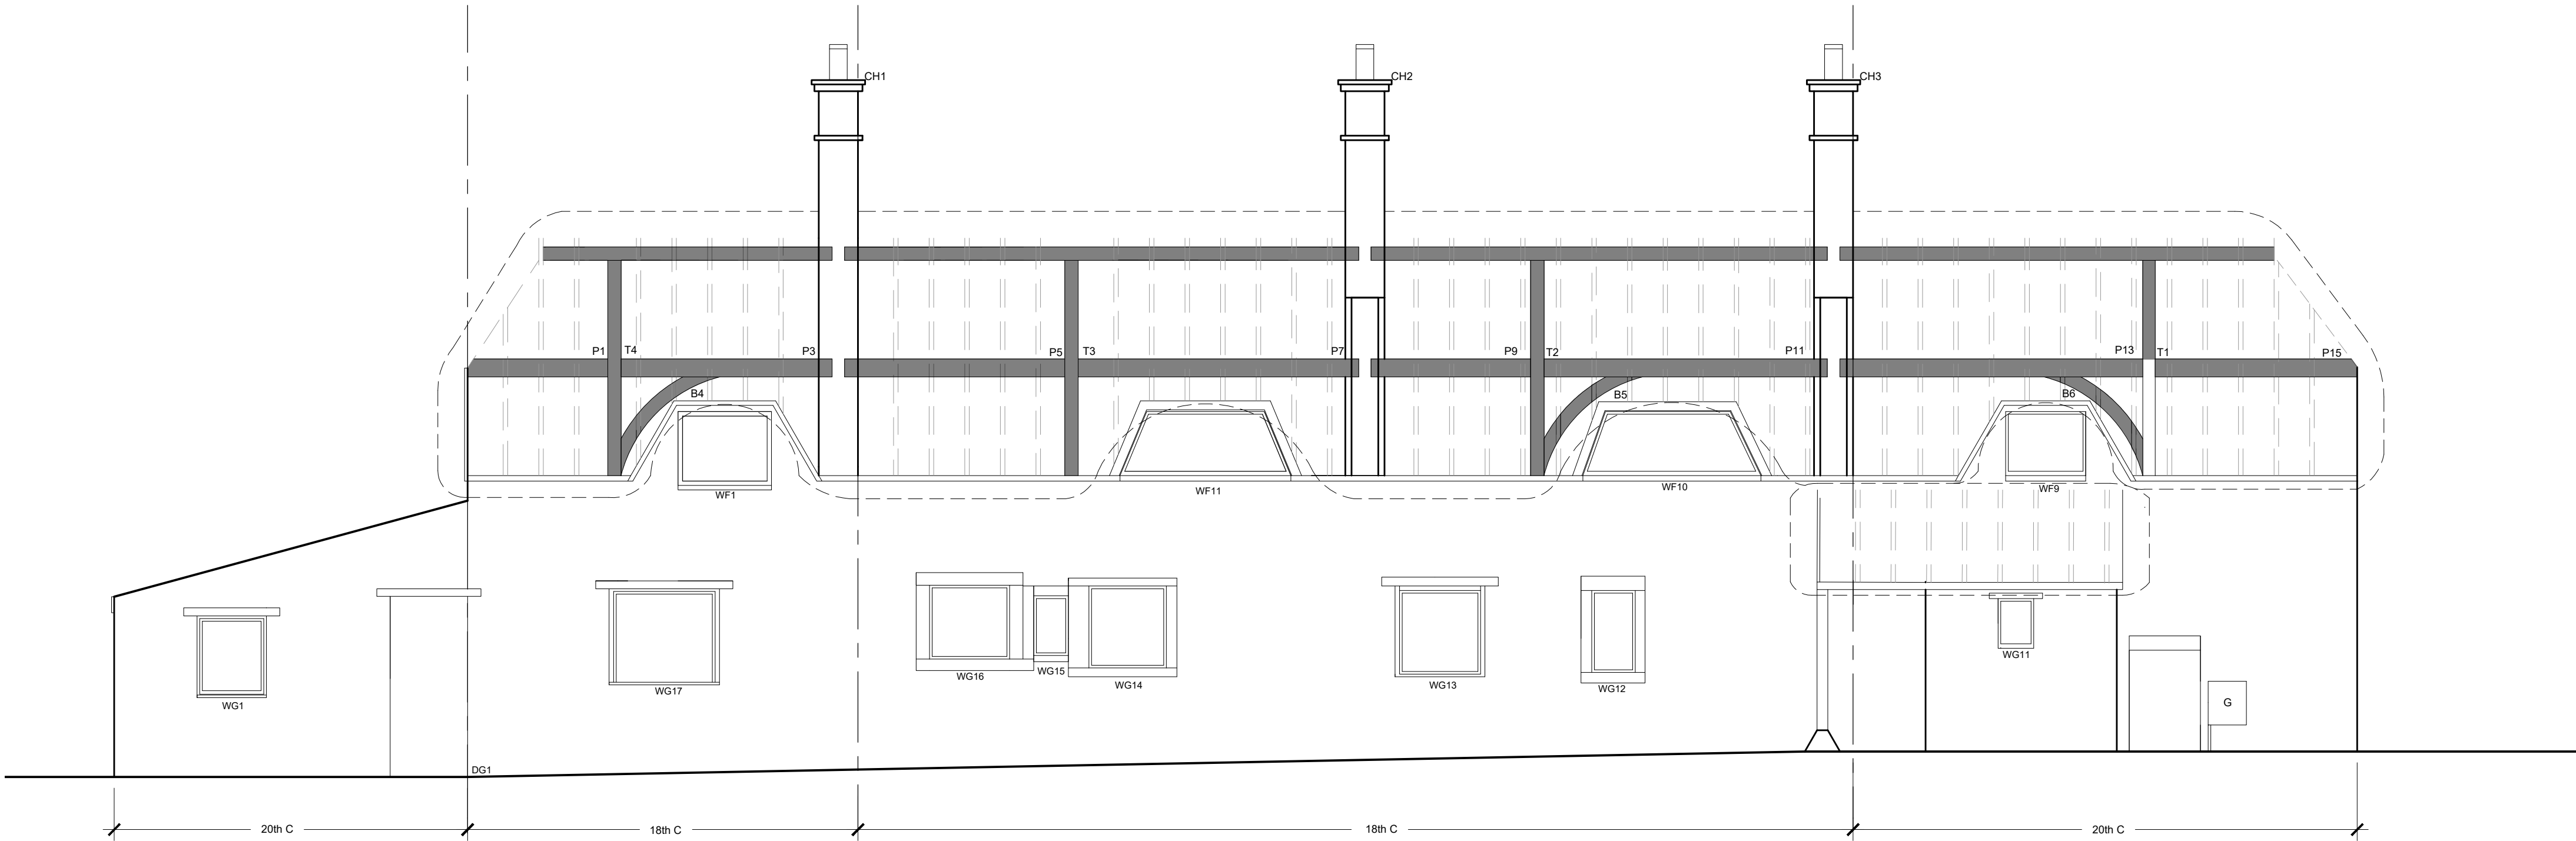
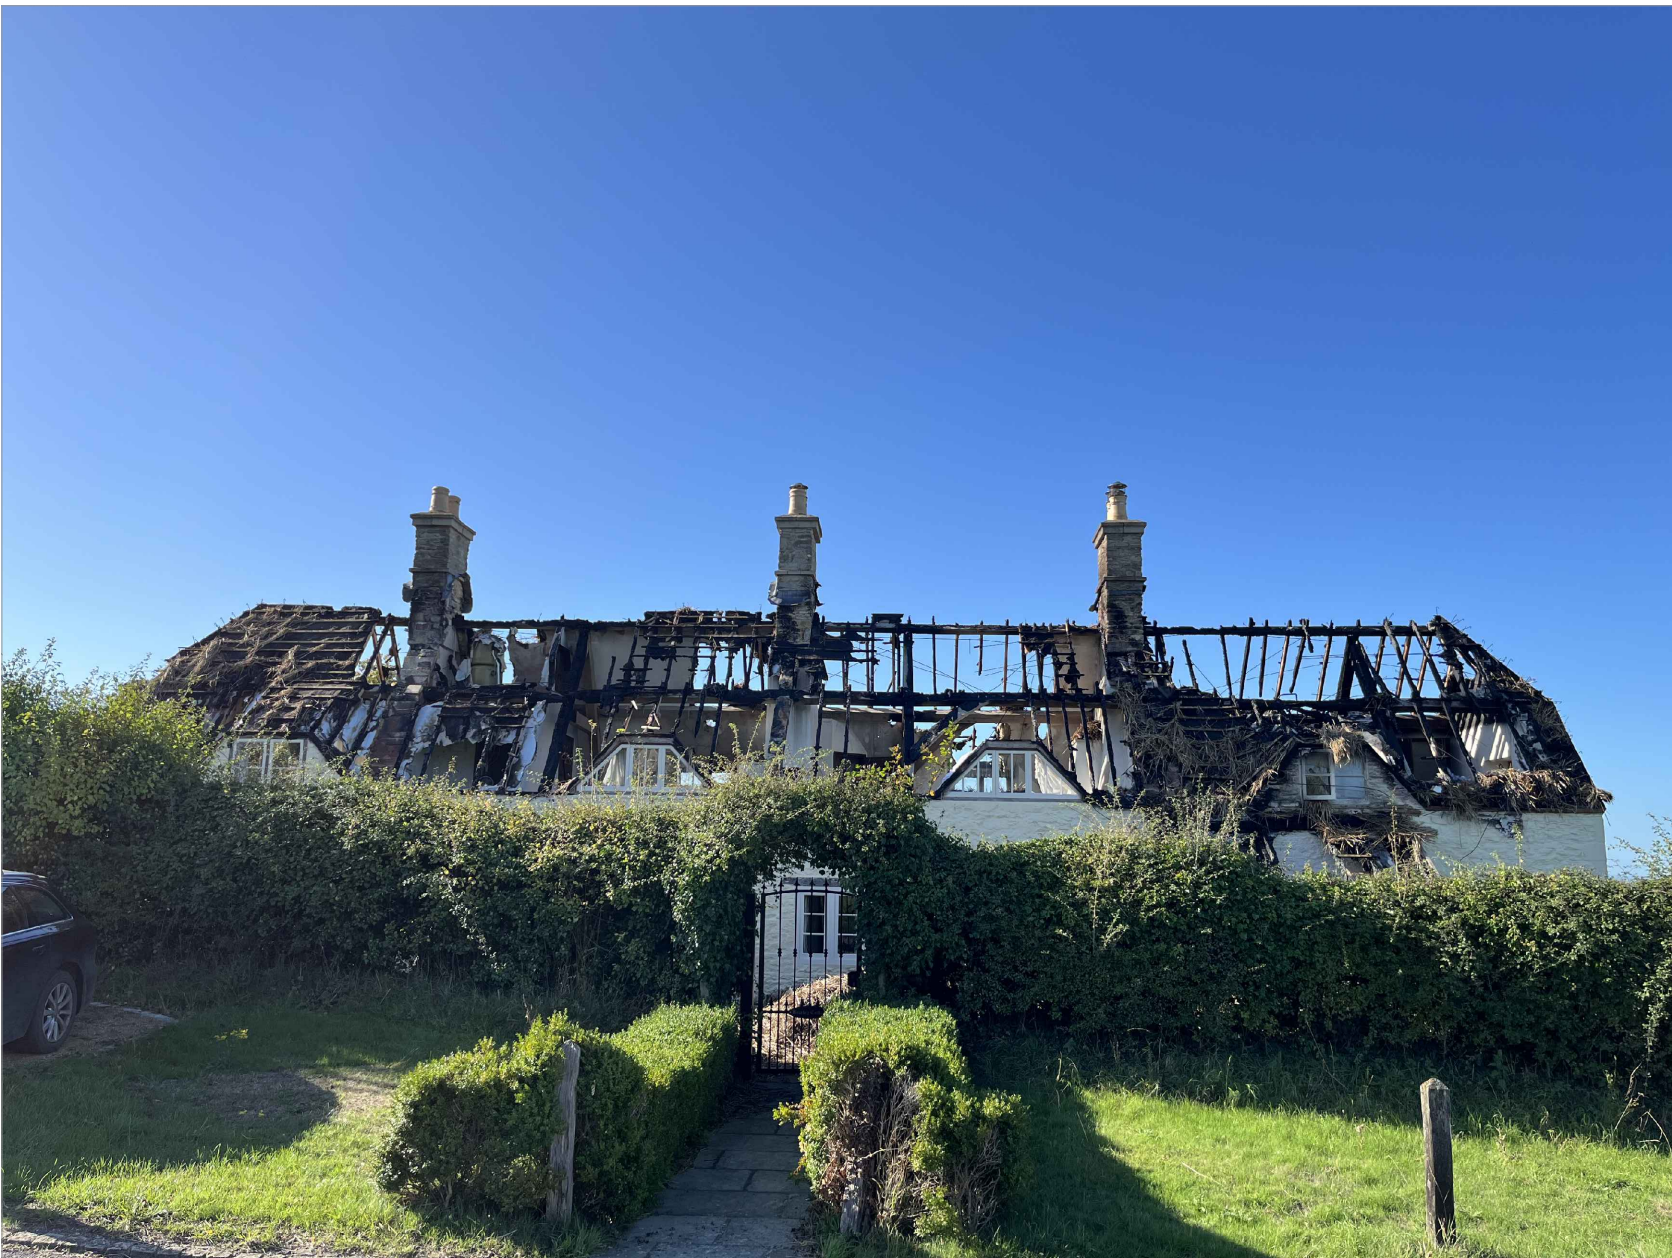
Existing North Elevation  
Scale 1:50

**Note - Post Fire Condition**

- Thatch - combed wheat reed 100% loss
- Concrete tile to lean to - salvagable
- Rafters - softwood - 100% loss
- Green oak roof structure - raised collar trusses 90% loss:

- T1 south 50% salvagable
  - T3 south salvagable
  - T1 north 50% salvagable
- Chimneys - localised pointing & lead flashing reinstatement required. All other respects structurally sound

- Stone walls - localised wall plate level pointing to be expected. All other respects structurally sound
- Windows (frames painted timber) - WF9 100% loss

- Glass panes - WF1,3,4,5,6 & 9 have broken panes - renewal required (single except WF4 & WF6 which are double glazed)
- WG 12 & 16 have broken panes - renewal required (single glazed)

- Purlins - 100% loss
- Ridges - 100% loss
- Curved braces - 90% loss - B2 salvagable
- Verge & eaves thatch cutting boards and arris - cedar - 60% loss
- Wall plates - softwood - 100% loss

- Truss wall plates - 50% loss
