# Arboricultural Consultancy for Prestige

| Insured | Mr Burkhard Kuesel | Address | 82 Victoria Road, Trowbridge, BA14 7LA | | |
| ES Ref | SA-255942 | Consultant | Keith Burgess | Contact No. | 0330 380 1036 |
| Report Date | 01/09/2025 | | | | |

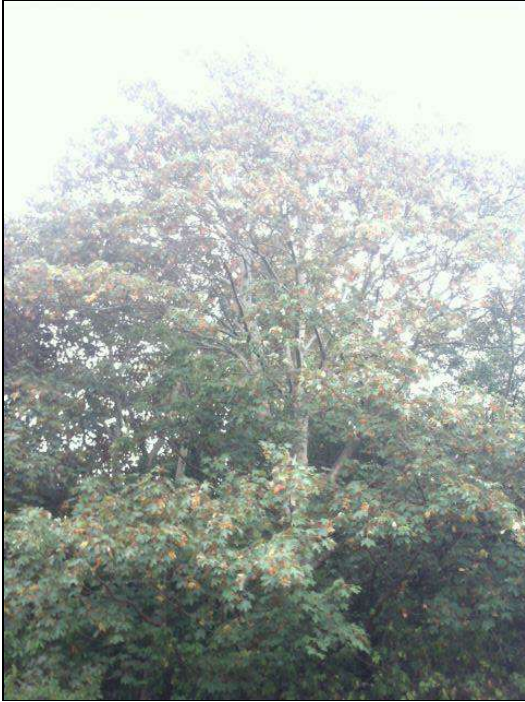
T1 - Maple (Sycamore)

With due regards to species profile, size and proximity, T1 (Sycamore) and C1 (Wisteria) are considered the dominant features proximate to the focal area(s) of movement and accordingly, where vegetation is confirmed as being causal, we have identified them as the primary cause of the current subsidence damage.

The size and proximity of the above vegetation is consistent with the advised location(s) of damage and it is our opinion, on balance of probability, that roots from the above vegetation will be in proximity to the footings of the insured property.

Consequently, we have advocated the complete removal of T1 and C1 as it will offer the most certain arboricultural solution likely to restore long-term stability.

| Tree No. | Species | Age Cat | Approx. Height (m) | Distance to Building (m) * | Ownership | Action | Requirement |
|---|---|---|---|---|---|---|---|
| T1 | Sycamore | 2 | 16 | 8.9 | C - Insured | Remove | Remove close to ground level; do not treat stump(s) due to translocation risk. Where such a risk exists, we advise that any emergent regrowth is removed annually. |

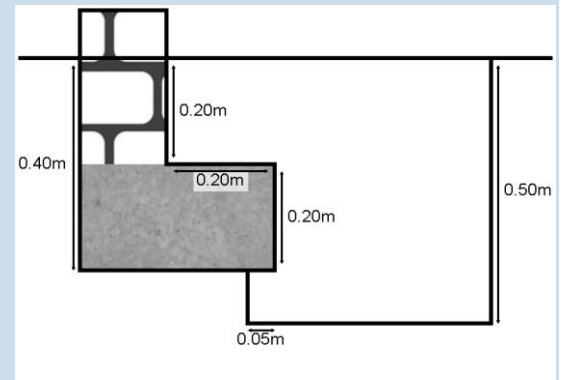
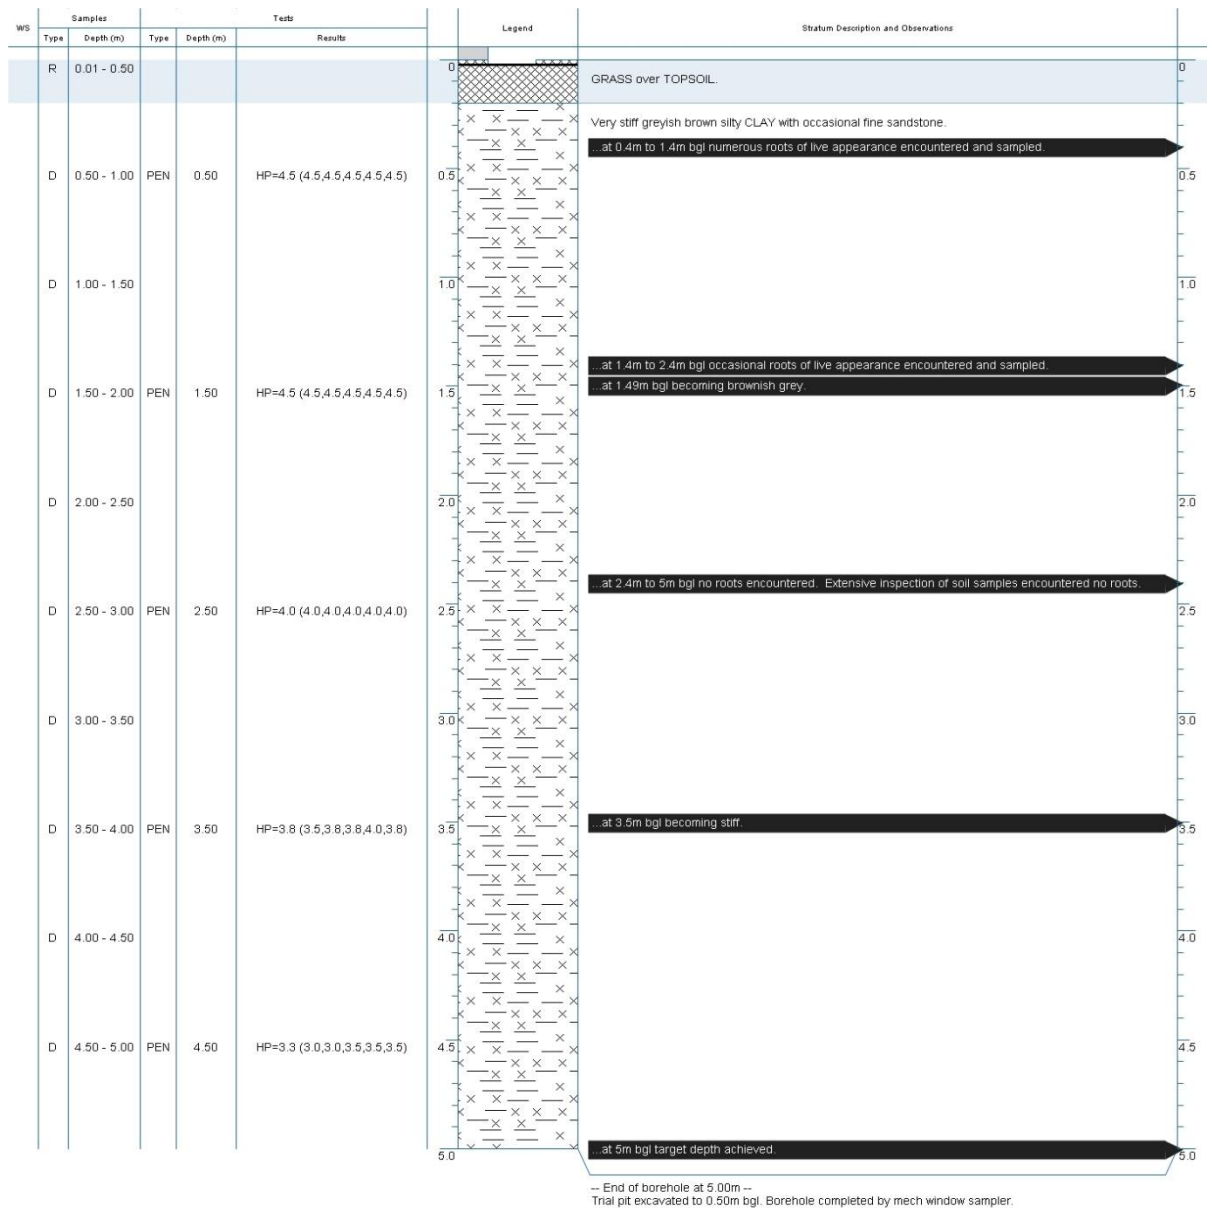
## TP/BH1 Foundation Detail and Borehole Log

House foundation comprised of stone wall to 200mm bgl, bearing on concrete to an estimated depth of 400mm bgl, with a total projection of 200mm from the elevation. Underside of foundation (USF) was estimated by pushing a probe, approximately 115mm back from the face of the foundation, at an angle with no apparent contact with the face of the foundation beyond the estimated depth.

At 0.4m to 1.4m bgl numerous roots of live appearance encountered and sampled in TP/BH1.

At 1.4m to 2.4m bgl occasional roots of live appearance encountered and sampled in TP/BH1.

At 2.4m to 5m bgl no roots encountered. Extensive inspection of soil samples encountered no roots in TP/BH1.
