## **Old Sarum Airfield**

### **Hanger 3 structural survey report**

Project no. 1455

Document no. 1455-INT-ZZ-ZZ-RP-S-0001

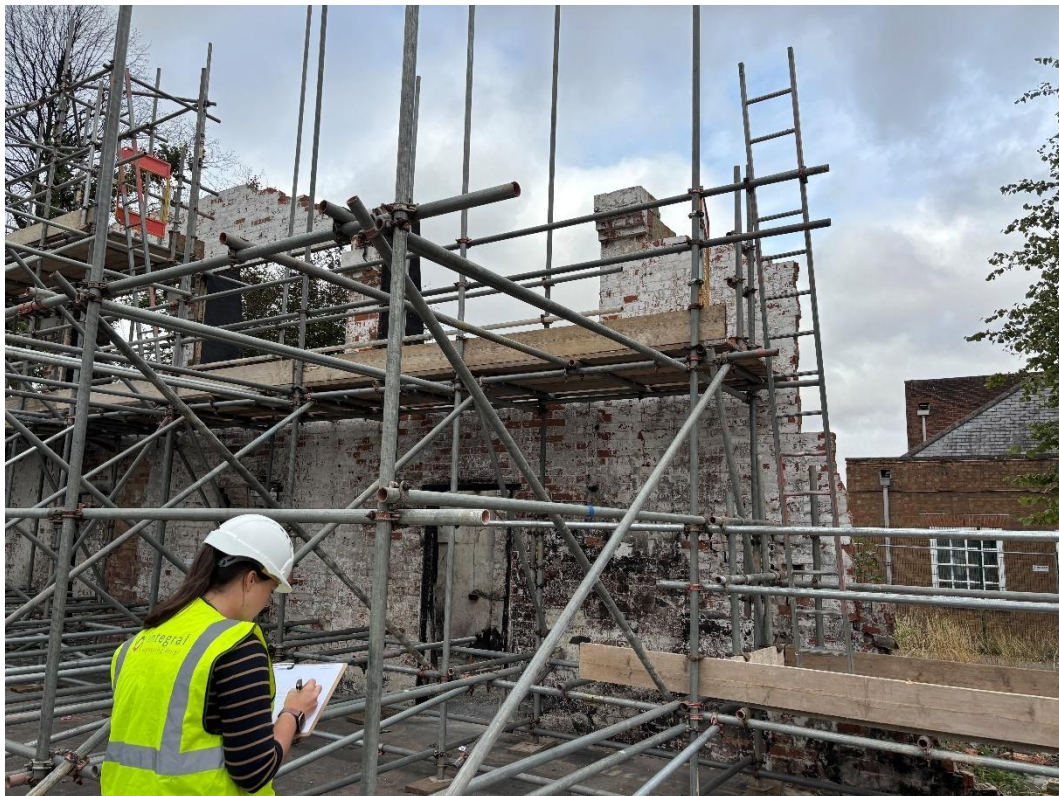
The door support masonry piers at the northern end have collapsed. Masonry from these piers is currently stored on site. Almost the entire wall height between GL01 and GL02 has collapsed along with the masonry panel above the high level window between GL02 and GL03. At lower level between GL02 and GL03 there is some diagonal cracking to the masonry, likely to have been caused as the door support piers and end section of the wall collapsed. The tops of the buttresses on GL02 and GL03 have collapsed above the high window head level. The top of the remaining section of buttress on GL03 is twisted on plan.

Figure 5 Wall collapse between GL01 and GL03

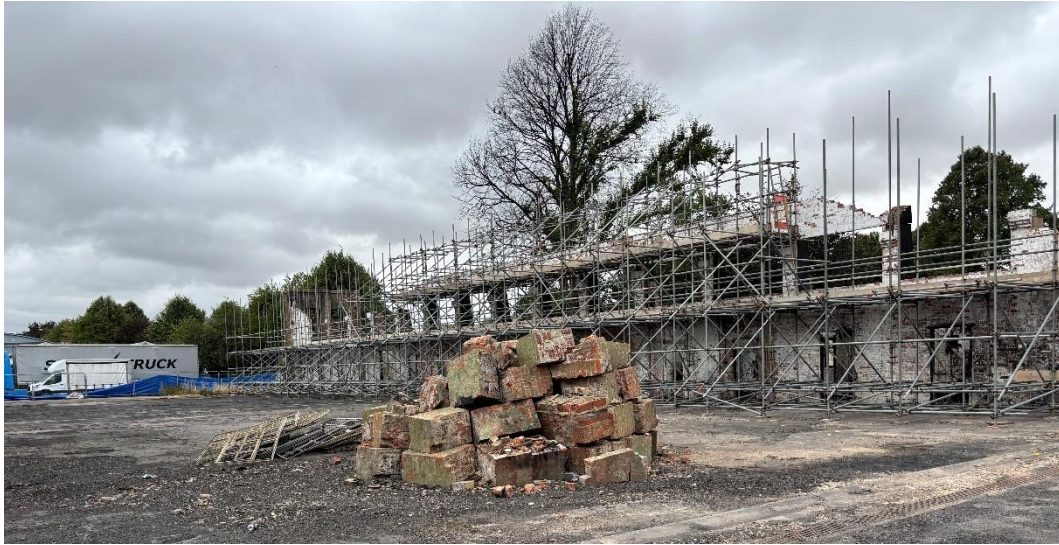
Figure 6 Masonry stored on site from collapsed door support piers

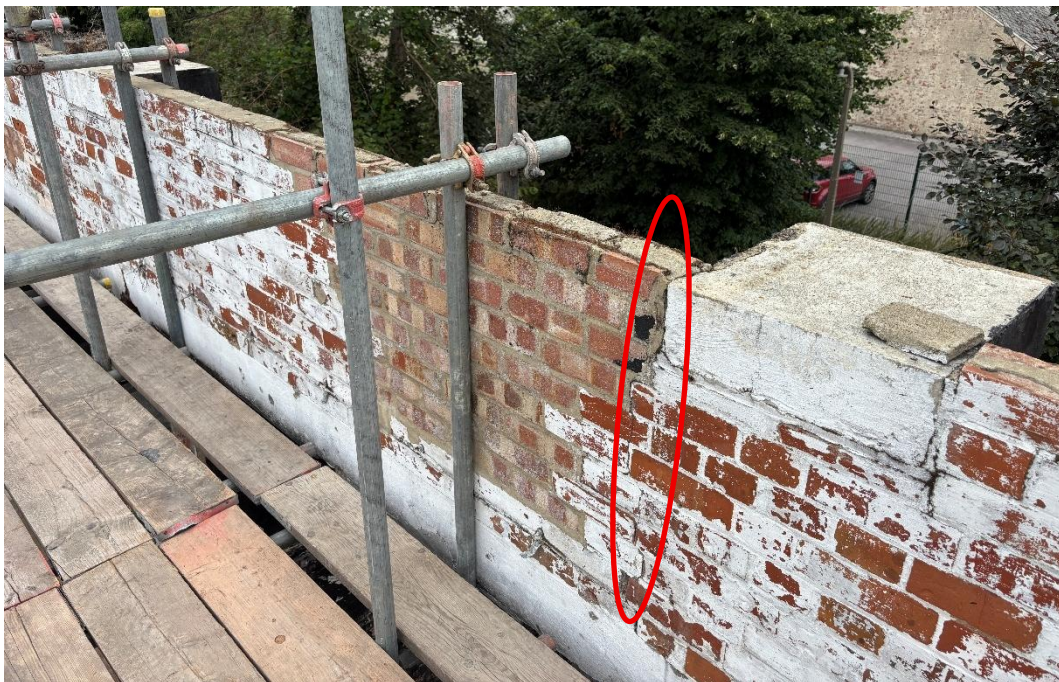
Between GL05 and GL07 there are several areas of brickwork above the windows that have been repaired in the past with modern brick. On the southern side of GL06 there is a vertical crack between the brick panel above the window and the brick buttress. There are similar cracks to the southern side of GL09, GL10 and GL11. At the GL11 crack the concrete lintel over the window is also cracked in this location.

Figure 7 Example of past brick repair and vertical crack between buttress and wall panel

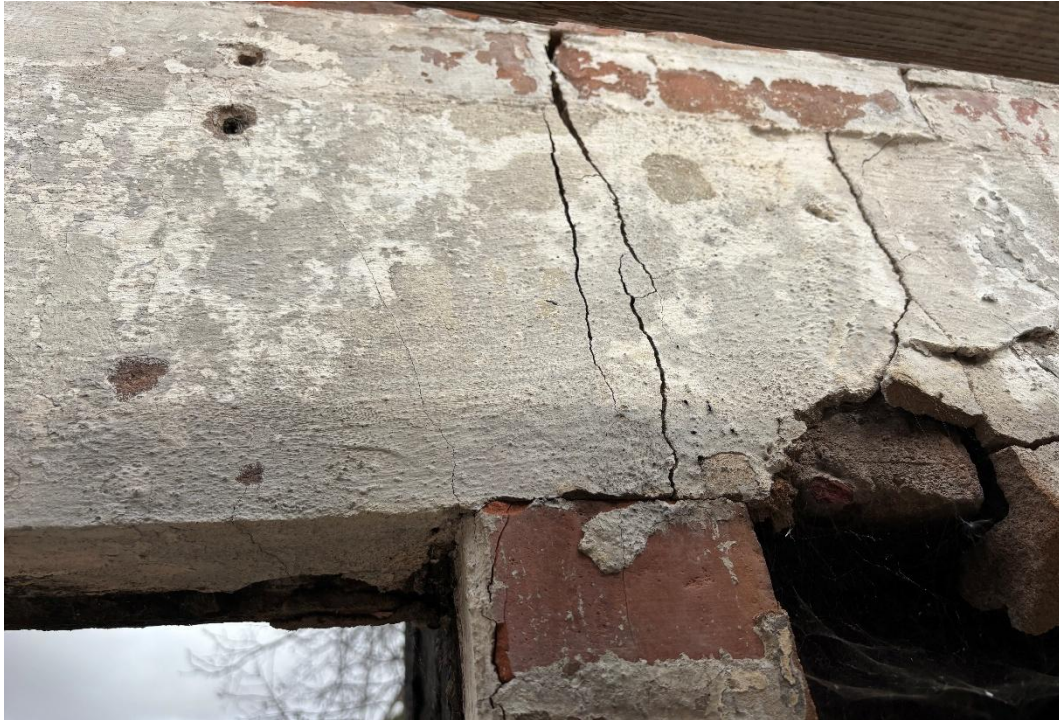
Figure 8 Lintel crack GL11

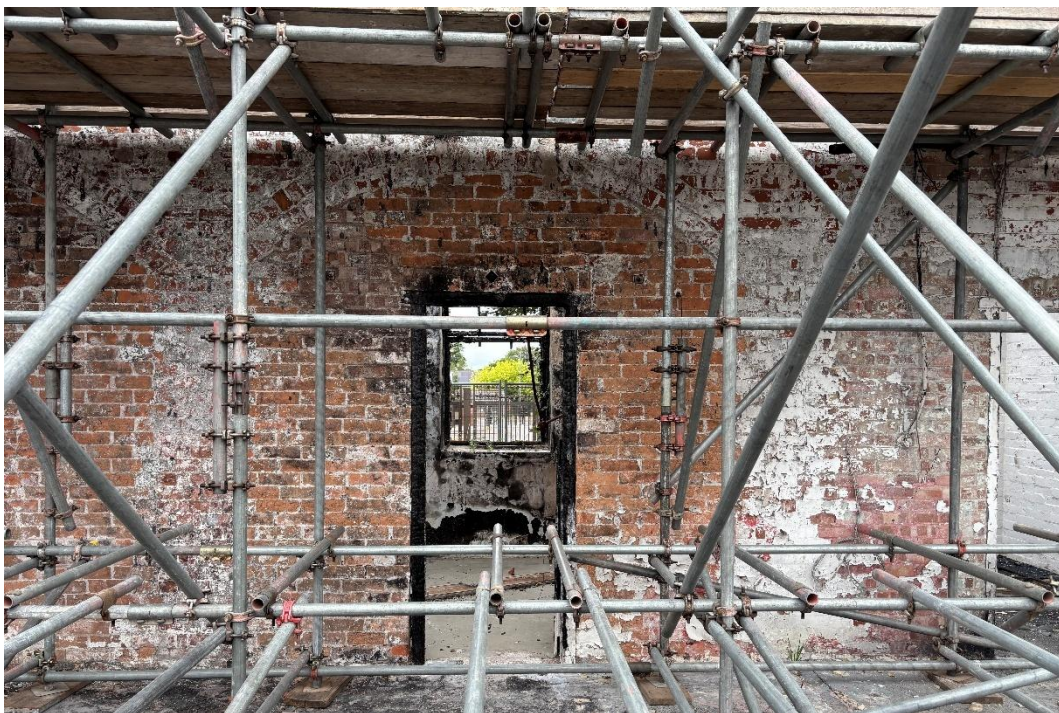
Between GL06 and GL12 there are masonry arches in the wall at low level between the buttresses. These arches have been infilled with brick masonry and small single leaf doorways built into the infill. It is assumed that these were the original access points to the single storey rooms running along the outside of the main elevation. Between GL02 and GL06, and GL12 and GL17 conventional doorways allow access to the side rooms. These appear to have been added at a later date and are not part of the original construction.

Figure 9 Infilled arch with doorway inserted

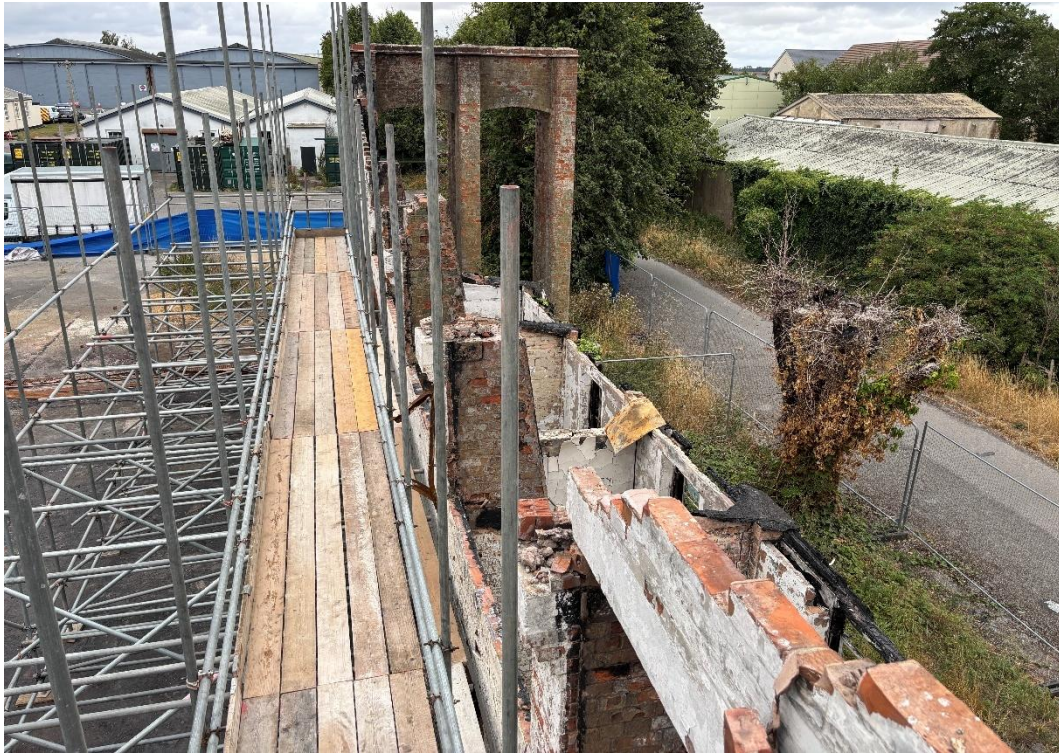
From the midpoint between GL11 and GL12 until GL17 the top section of masonry above the high level windows has collapsed. In addition the buttresses above window head level on GL12, GL13, GL15, GL16 have collapsed. The buttress on GL14 has not collapsed but is crack through its entire section three brick courses above window cill level. The buttress at GL13 is cracked at the level of the window cill. The buttress on GL15 is cracked 4 courses and 10 course above window cill level.

Figure 10 Masonry collapse between GL11 and GL17

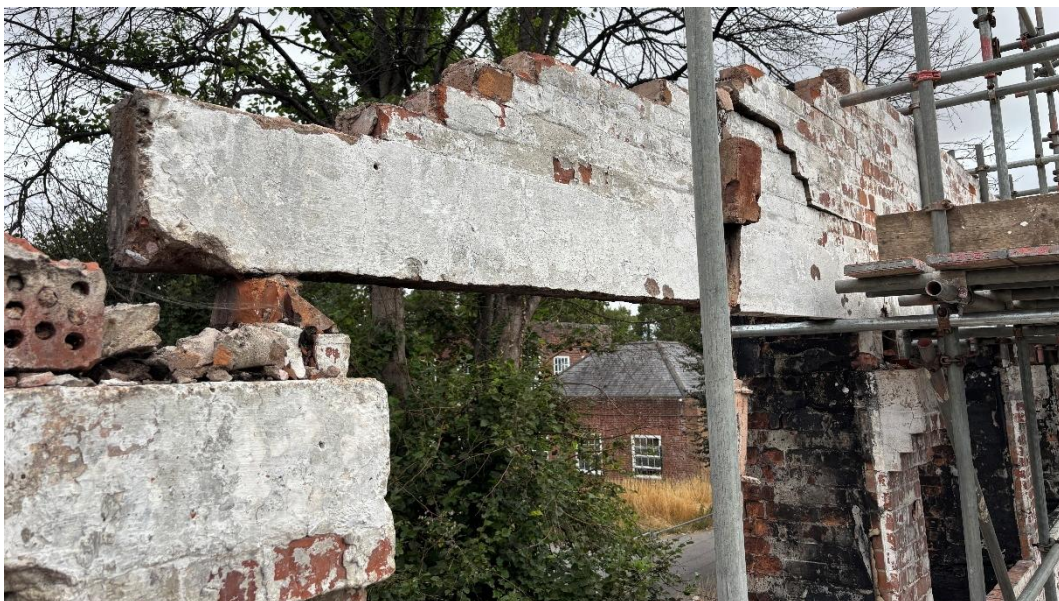
The concrete lintel above the window between GL11 and GL12 has dropped by one brick at the bearing on GL12. This is likely to have occurred as the wall above it collapsed and it is just by chance that the lintel ended up resting on its bearing location, but a brick lower.

Figure 11 Lintel between GL11 and GL12

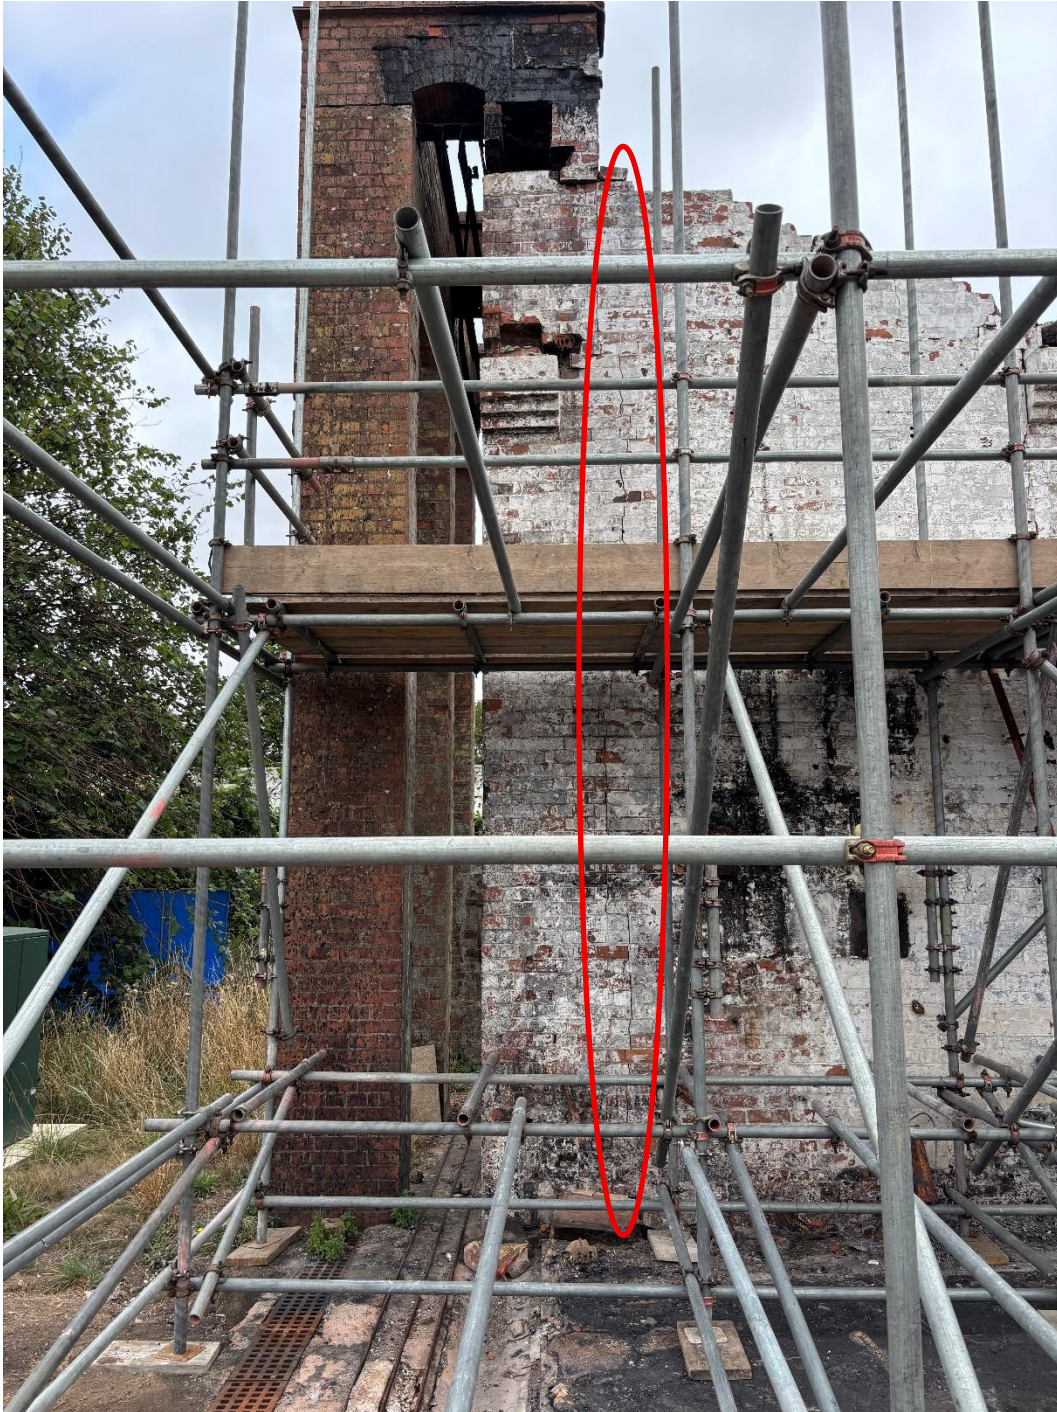
There is a vertical crack running the full height of the wall between pier number 3 in Figure 12 and the main wall of the elevation to the north of the pier. Pier number 3 has rotated on plan clockwise such that the north western corner has moved to the east by 25mm. this has caused the crack observed. There are a number of cracks to the masonry arches linking the six piers at high level. There are also a number of vertical and diagonal cracks to the western elevation between GL17 and GL14. It is likely that all these cracks are a result of the doors collapsing which has pulled on the top support rails which were fixed to the door support piers.

Figure 13 Crack between wall panel and door support piers on GL17

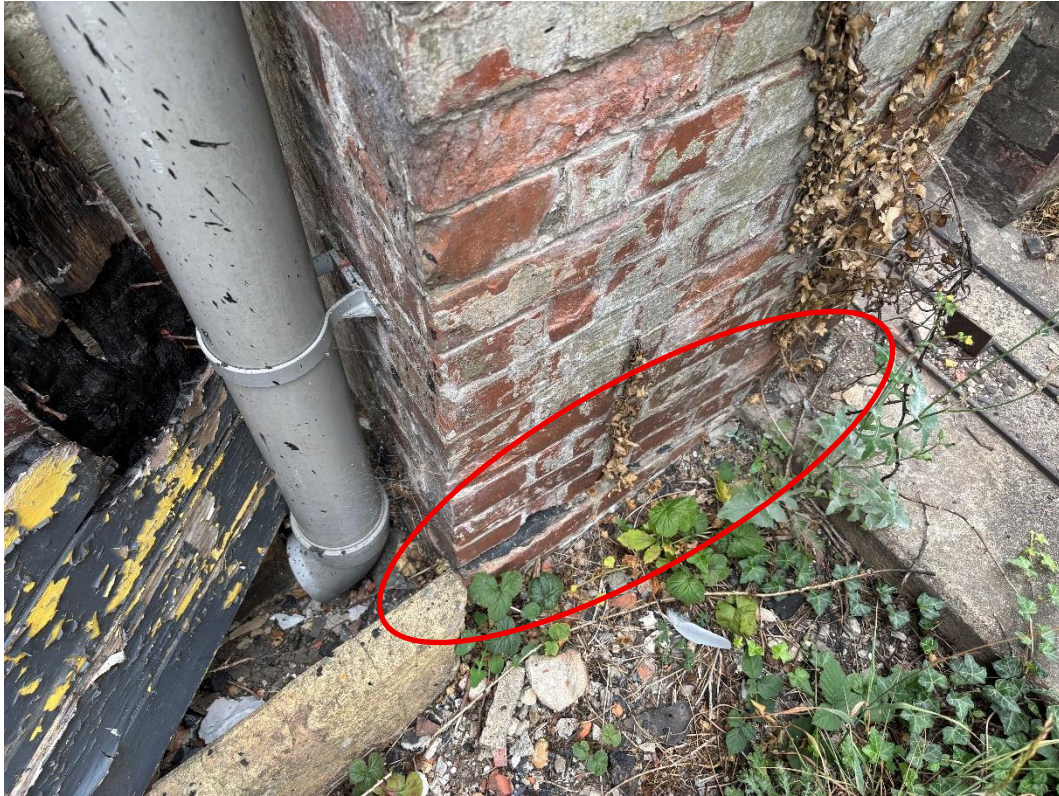
Figure 14 Rotation of pier 3

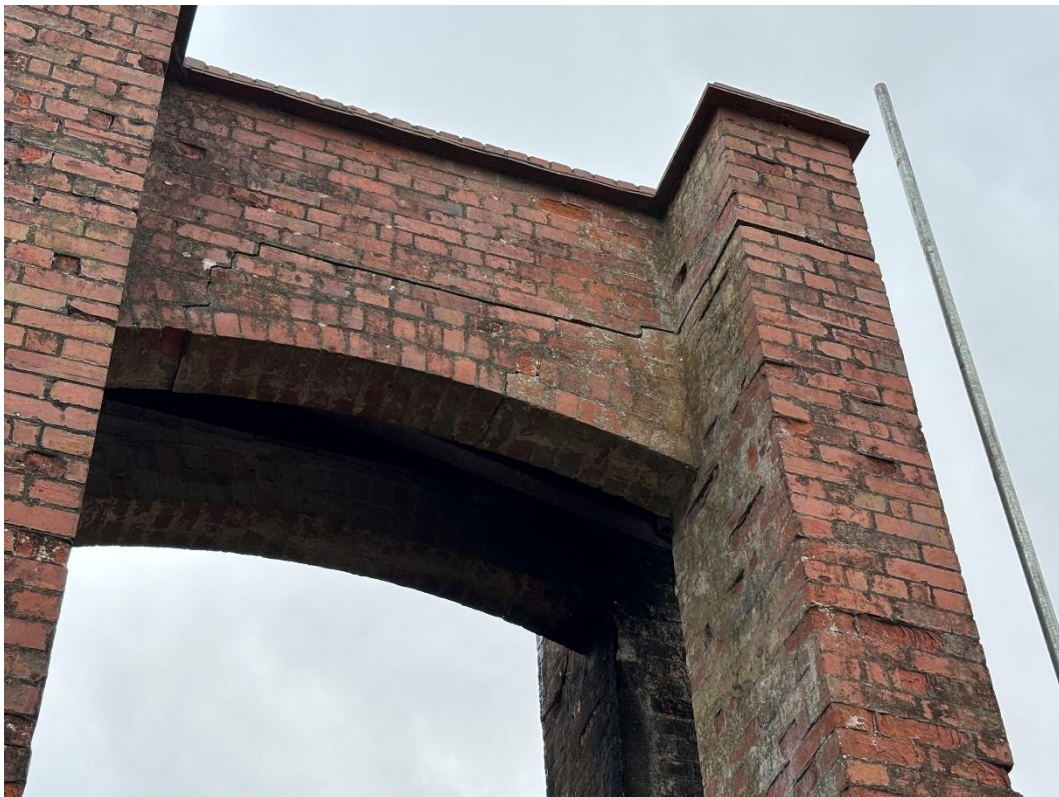
Figure 15 Cracking to the top of door support piers and connecting arches

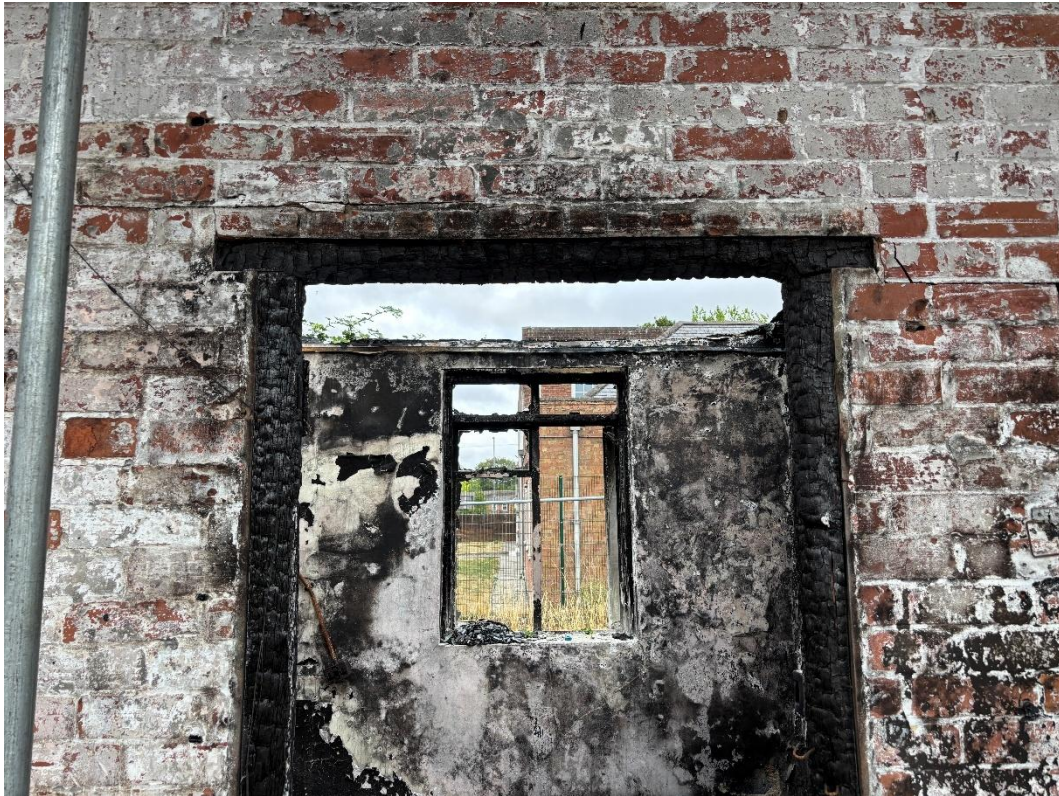
Unless specifically mentioned above concrete lintels appear to be in reasonable condition. All timber lintels over the doorways into the side rooms have been burnt by the fire and will require replacement.

Figure 16 Example of fire damaged timber lintel

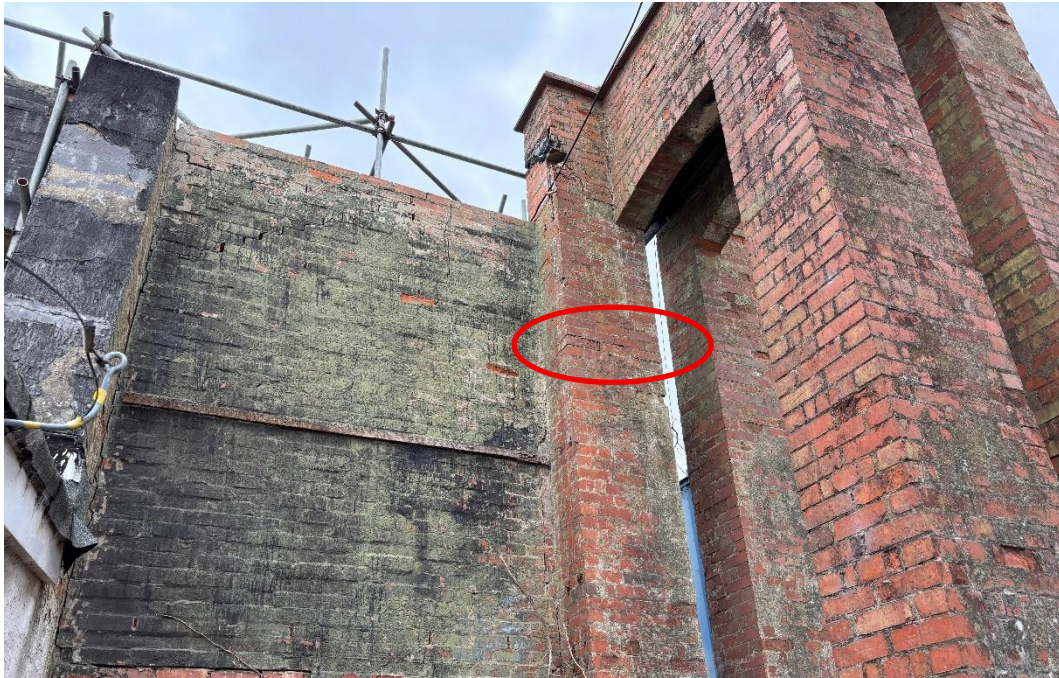
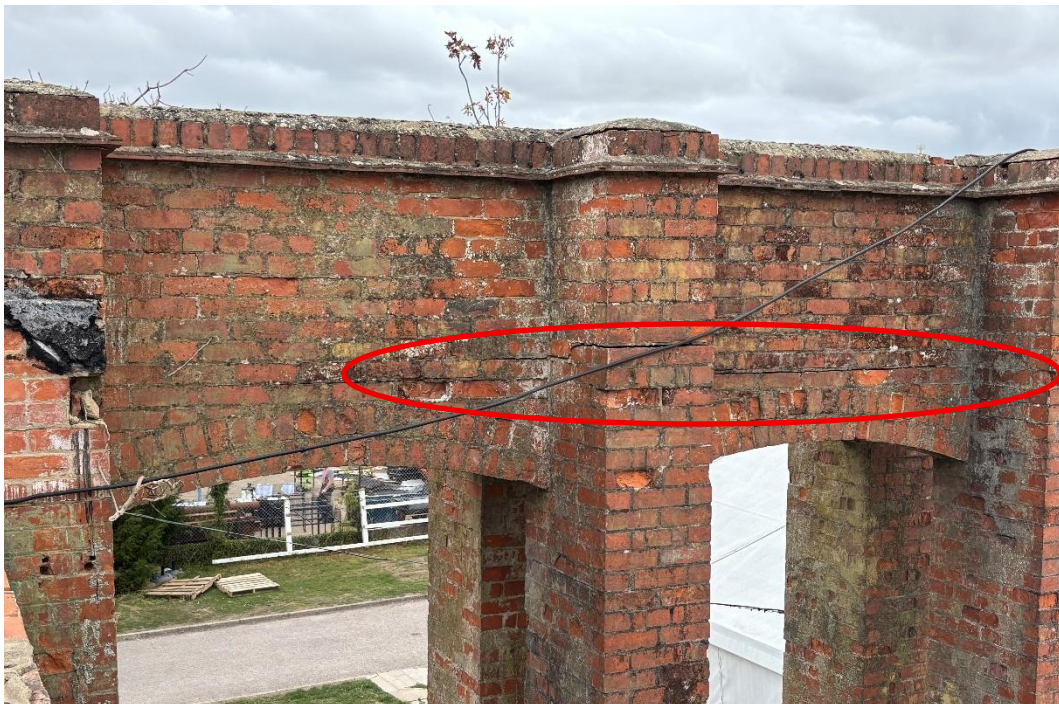
The door support piers at the northern end are standing and appear generally to be in reasonable condition. There are some minor cracks to the arches between piers and at approximately three quarters of the way up the north western pier. The collapse of the sliding doors in January 2024 appears to have caused little damage to these piers.

Figure 19 Cracking to northern door support piers

Figure 20 Cracking to northern door support piers

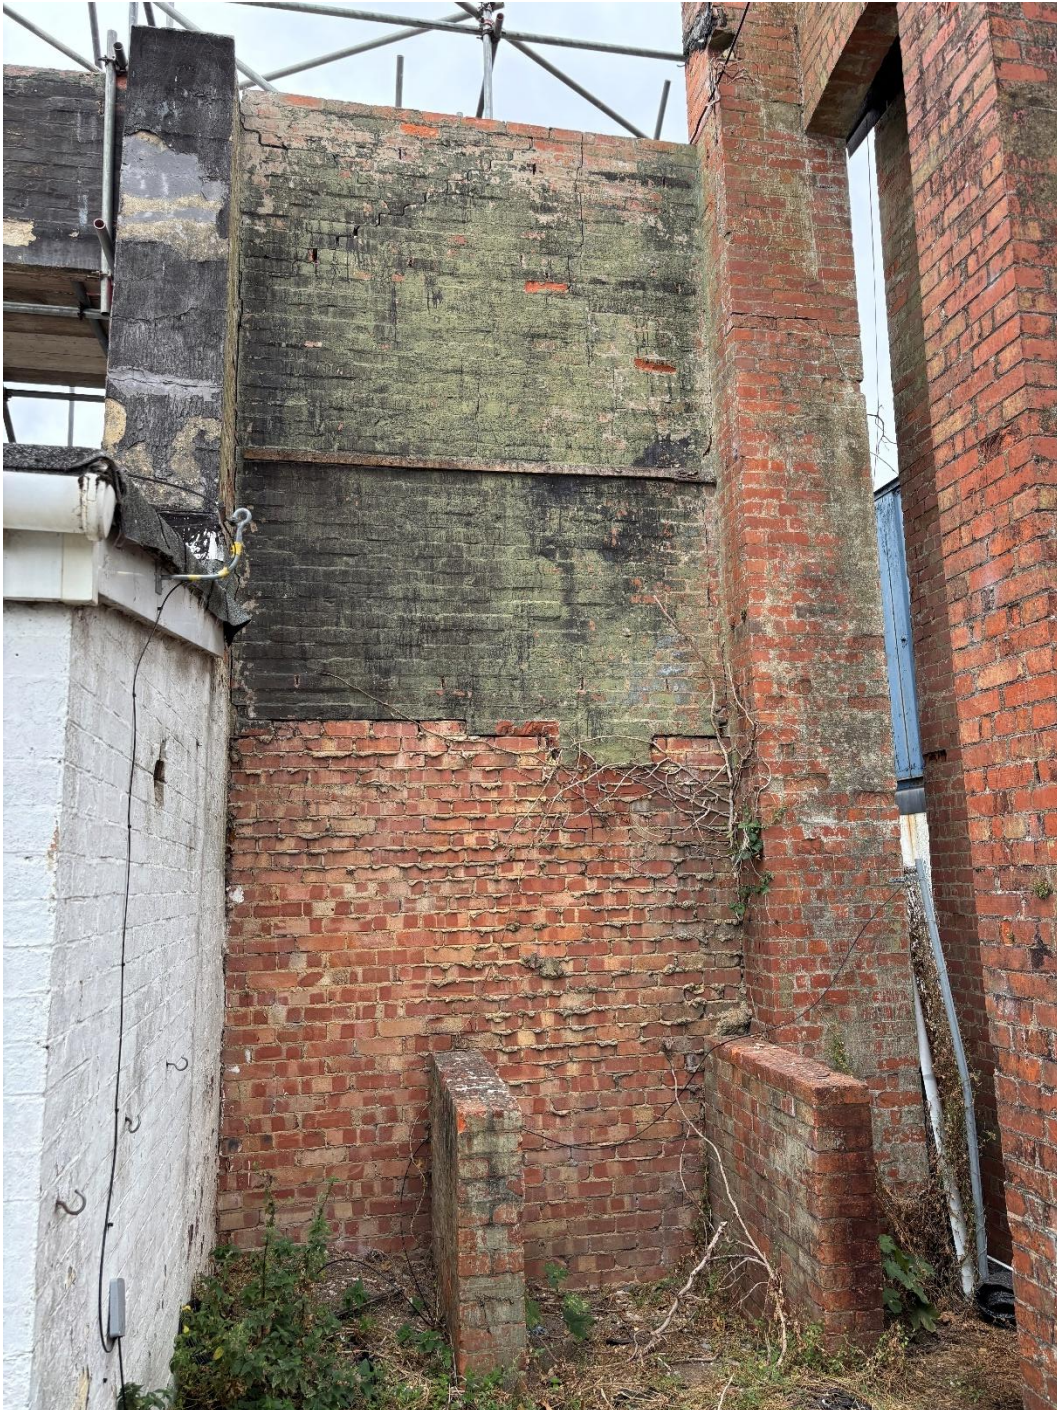
Between GL01 and GL 02 there is evidence of past repairs. The lower half of the wall panel appears to have been rebuilt in the past. Whilst the rebuilt brickwork appears to be in good condition there is vertical cracking between the rebuilt section and the piers of GL01 and GL02 where the new brick is not well bonded to the original. At high level there are some minor diagonal cracks. There is a historic vertical crack between the high level wall panel and the pier on GL02 which has been repaired with mortar in the past but is now opening up again.

Figure 21 Wall panel between GL01 and GL02 with rebuild section at lower level viewed from south east (outside hanger)

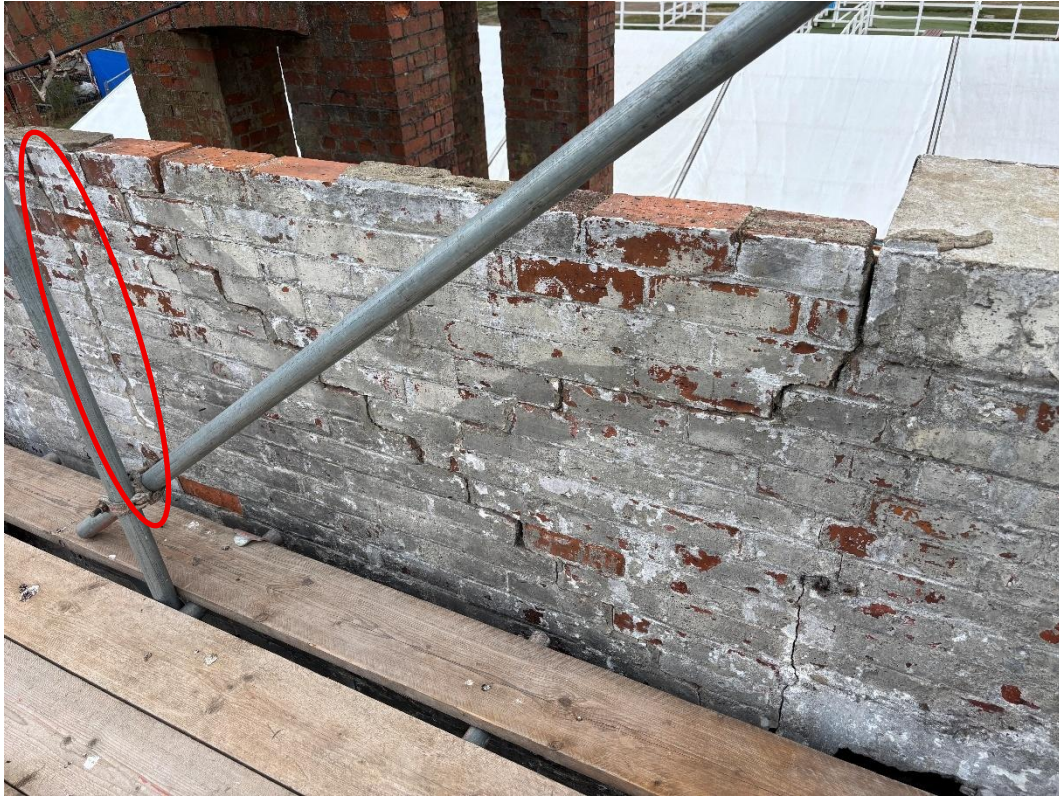
Figure 22 High level cracking between GL01 and GL02 including historic repaired cracks

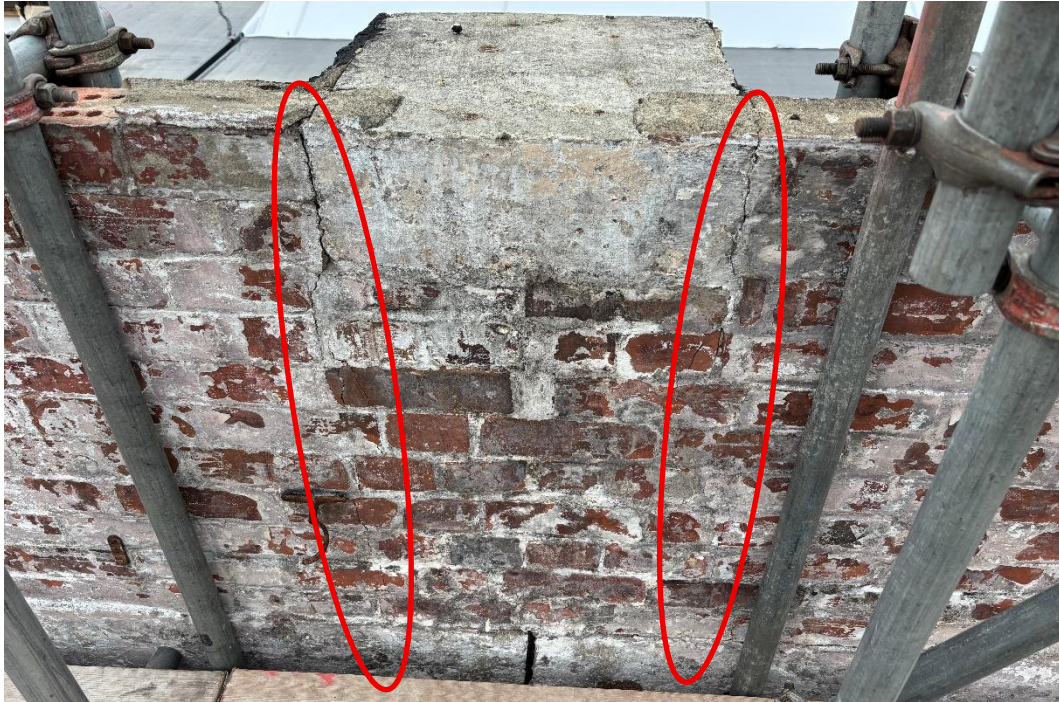
On GL07 to GL15 there are vertical cracks between the high level masonry panels above the windows and the buttresses there are likely to have been caused by thermal expansion and contraction of the very long elevation over decades. The elevation at this level would have been in direct sunlight for much of the day as it is above the side room roof level and the minimal overhang from the main roof would have given little or no shading to this wall.

Figure 23 Example of cracking between high level masonry panels and buttresses

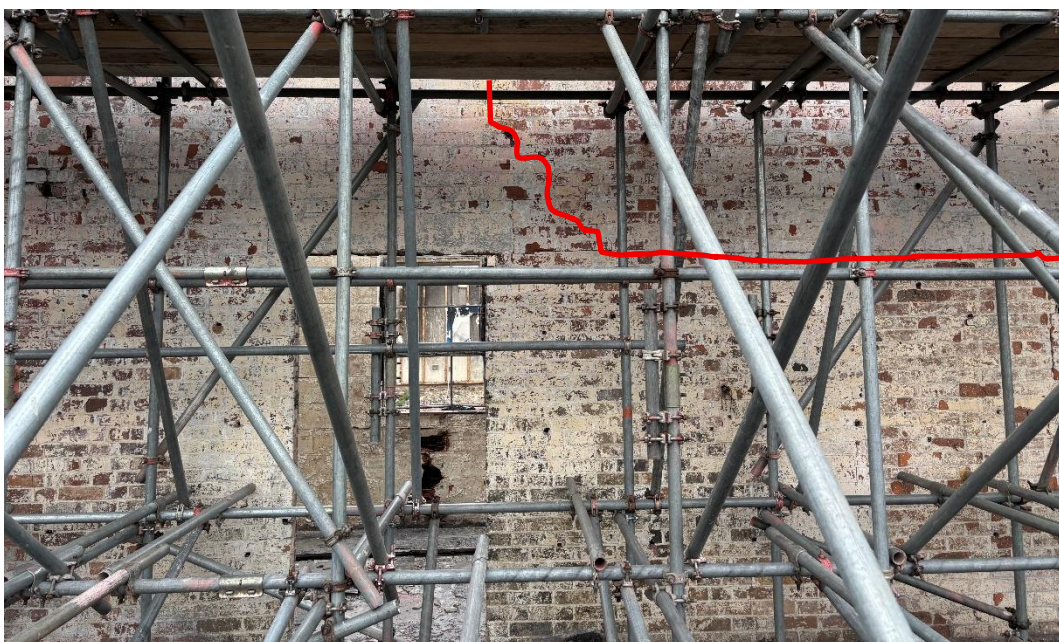
Between GL08 and GL09 there is a diagonal crack above the door lintel which extends horizontally across at door lintel height to the door between GL09 and GL10. The door between GL09 and GL10 has been infilled with masonry in the past. The crack then extends diagonally from the blocked doorway towards the ground at GL10. The doorway between GL10 and GL11 has been infilled with masonry in the past

Figure 24 Cracking between GL08 and GL10

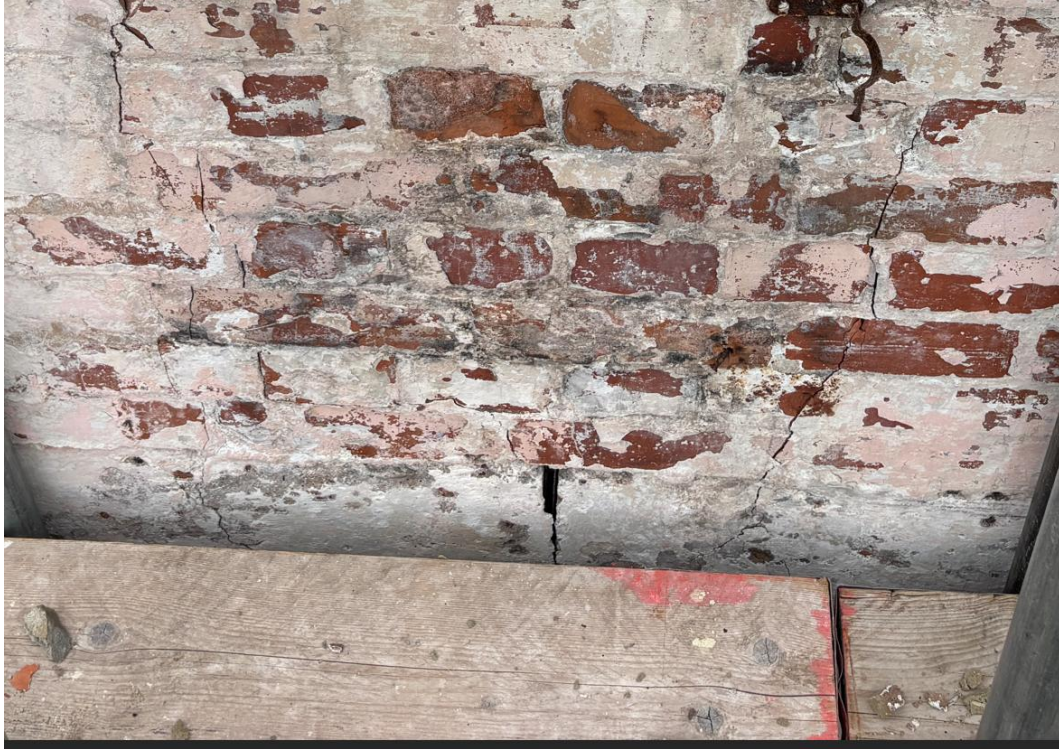
At the high level windows the concrete lintels that bear onto the buttress at GL11 have cracks at their bearings. The window lintel between GL12 and GL13 has significant cracks and concrete spalling to the underside with the reinforcement visible.

Figure 25 Cracking to lintel bearings GL11

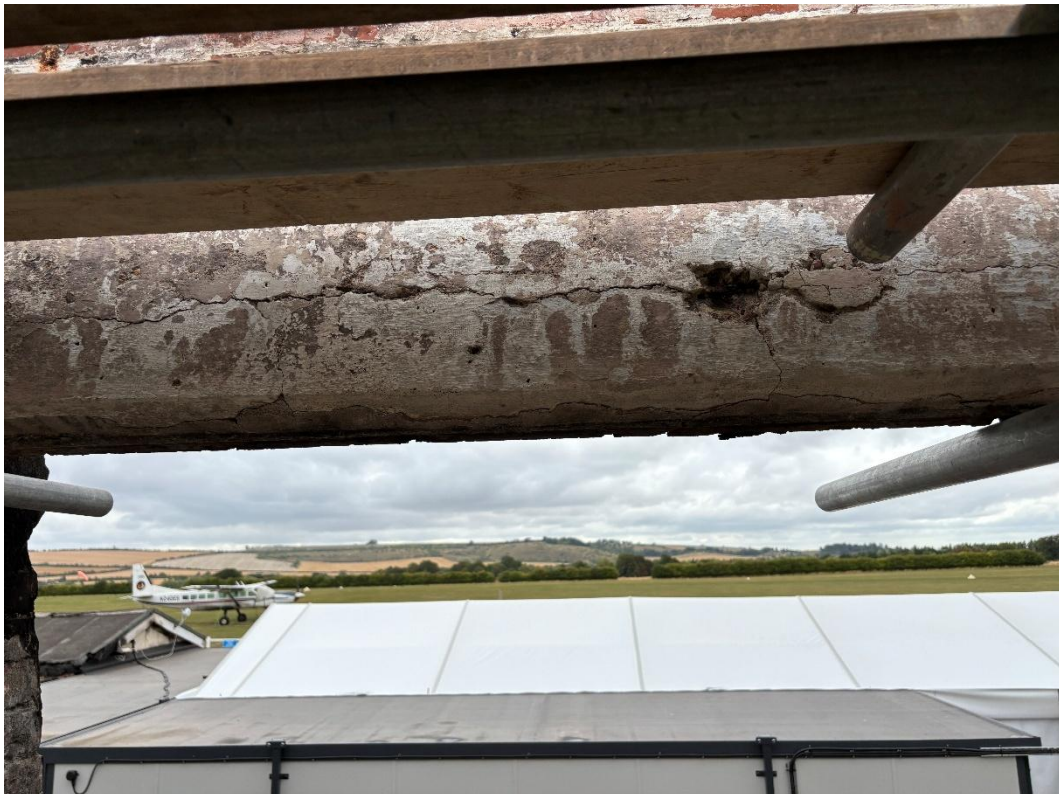
Figure 26 Lintel between GL12 and GL13

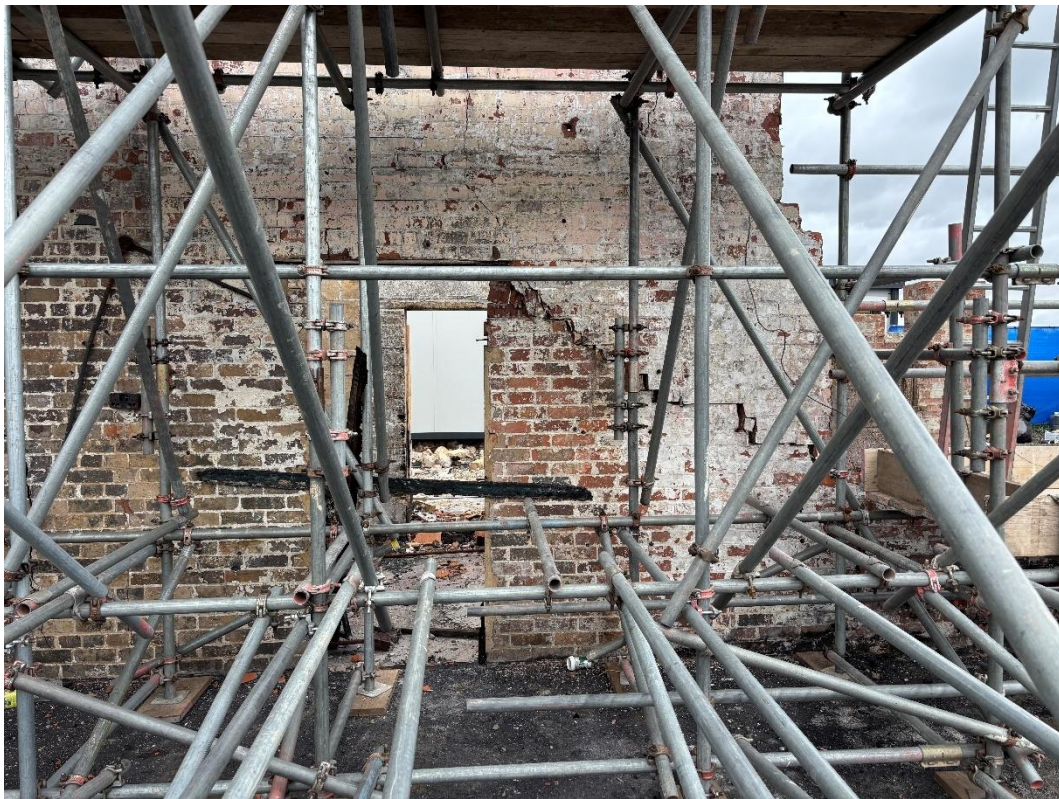
Between GL12 and GL16 there are a series of diagonal and horizontal cracks to all masonry panels between the doors. In some instances these cracks extend above the door lintel height. The buttress on GL14 has a horizontal crack at approximately 1.5m above floor level. Above this height the buttress has been moved on plan towards GL15 by 20mm. The buttress on GL16 has cracked in a similar manner and moved towards GL17 by 36mm. The buttress on GL 15 doesn't appear to have moved or cracked. However given the extent of movement on GL14, GL16 and to the wall panels between GL12 and GL16 this seems unexpected. It is likely the buttress on GL15 has moved to some extent, but it was not possible to determine how during the visual survey.

All of the movement and cracking at this end of the elevation is likely to be associated with the collapse of the sliding door support piers. The piers collapsed during the fire when the sliding doors fell out of the building pulling the door tracks away from the building and consequently the masonry piers as well. As these fell away from the building it appears they also pulled with them the masonry wall between GL16 and GL17 and caused the cracking and movement in the masonry to GL12. The masonry from the collapsed door support piers is currently on site.

Figure 27 Cracking to southern end of wall (GL15 – GL17). Collapsed section of wall to right hand side of image

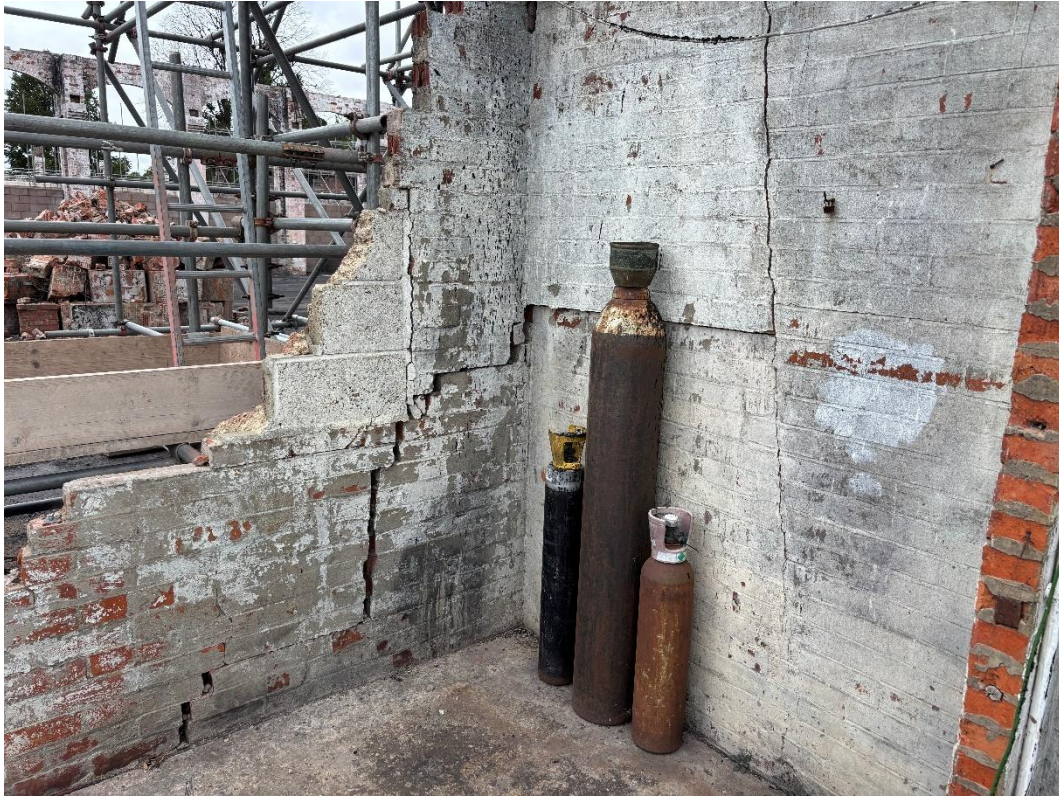
Figure 28 Cracking to buttress on GL16

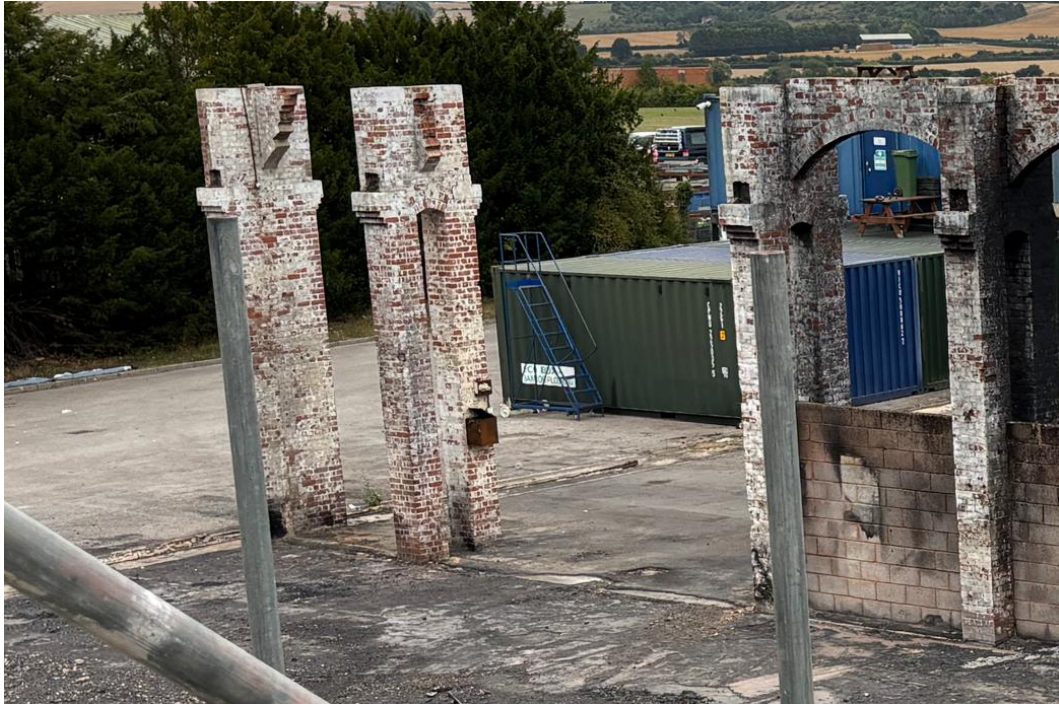
The masonry piers on GL01 and GL03 have collapsed. The arches spanning between GL01 and GL02, GL02 and GL03, GL03 and GL04 have collapsed. The masonry piers on GL02 and GL04 have cracking to the tops.

Figure 32 Collapsed pier and arches GL01 to GL04

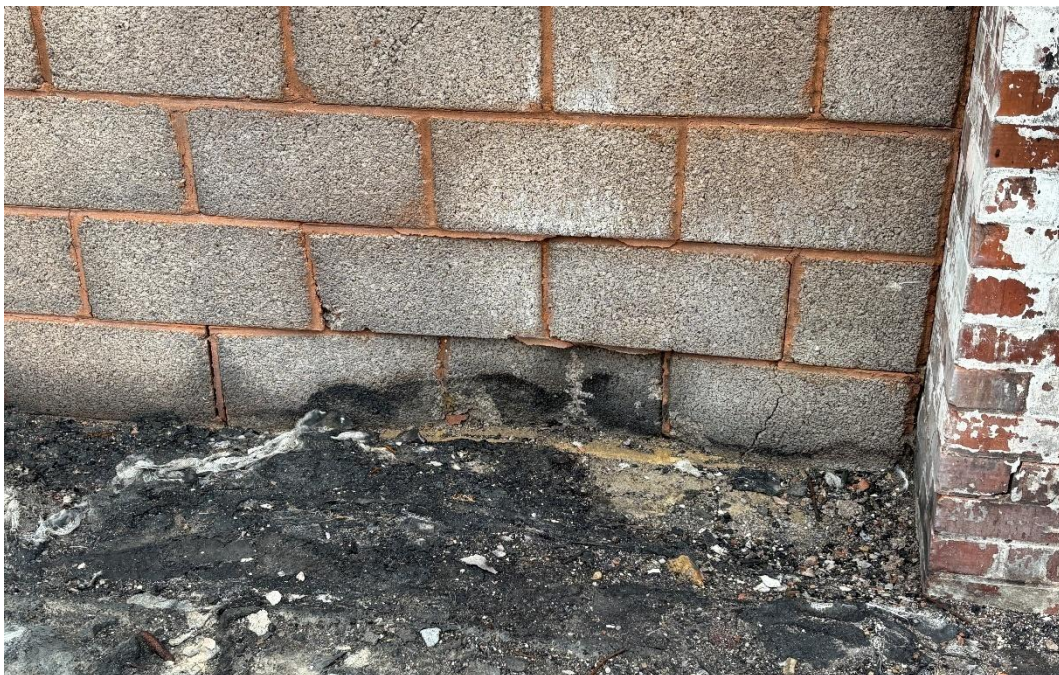
The blockwork panel between GL05 and GL06 is damaged at its base and potentially unstable. It appears to have received an impact at its base. The scarring from the impact looks very recent and it could have been caused by a strike from the excavator being used by the clearance contractor following the fire. There is a horizontal crack to the base of the western pier on GL06 and the pier appears to have rotated slightly. The exposed mortar surface in the crack is not weathered and suggests the cracking and movement have occurred recently. It is not clear if this has happened as a result of the fire or from an impact on the adjacent blockwork panel, however the latter appears more likely as there is no blackening or fire damage to the crack surfaces.

Figure 33 Damage to blockwork panel GL05 to GL06

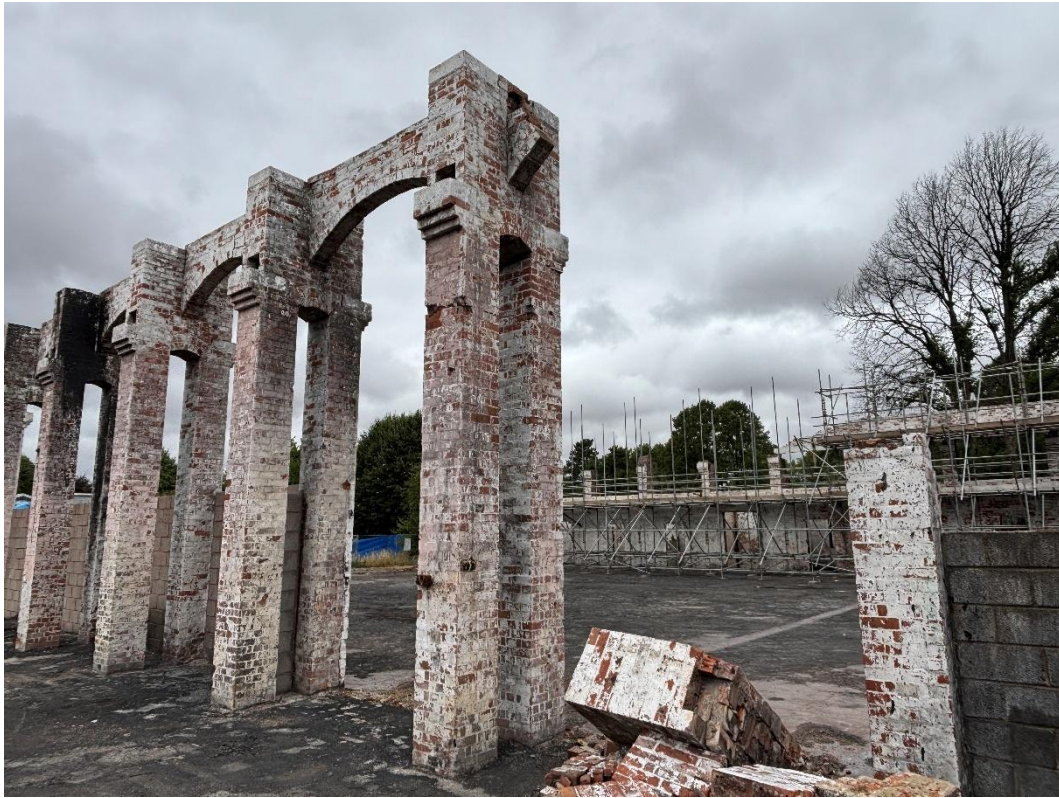
The masonry piers on GL09 have collapsed to approximately 2.3m above floor level. As a result the arches between GL08 and GL09, and GL09 and GL10 have collapsed.

Figure 34 Collapsed pier GL09
