## **Old Sarum Airfield**

### **Hanger 3 structural survey report**

Project no. 1455

Document no. 1455-INT-ZZ-ZZ-RP-S-0001

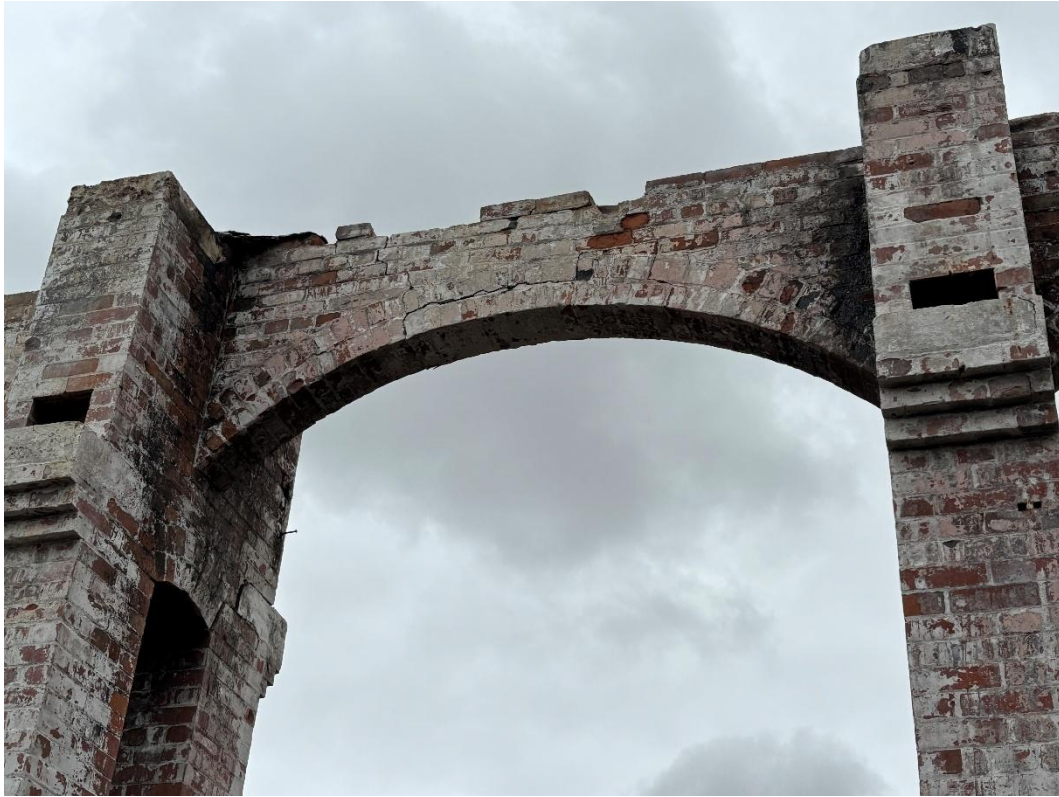
The arches between GL12 and GL16 have smaller cracks which can likely be repaired insitu. The arch between GL16 and GL17 has collapsed.

Figure 35 Cracking the arch between GL15 and GL16

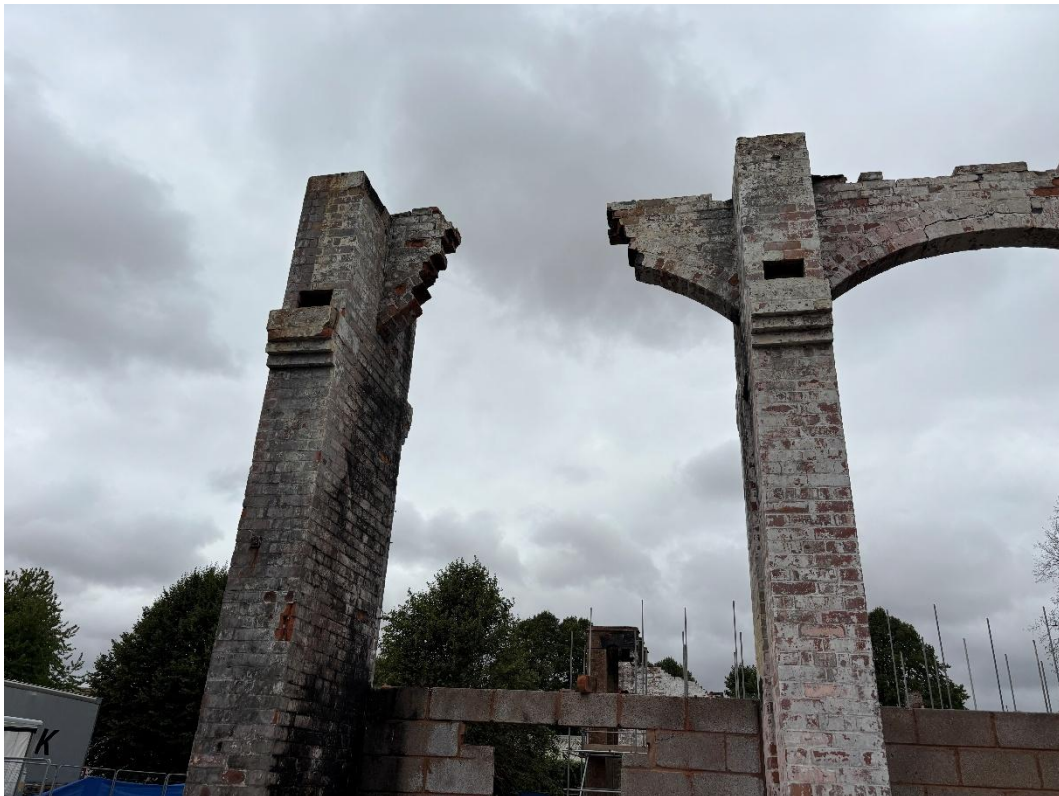
Figure 36 Collapsed arch GL16 to GL17

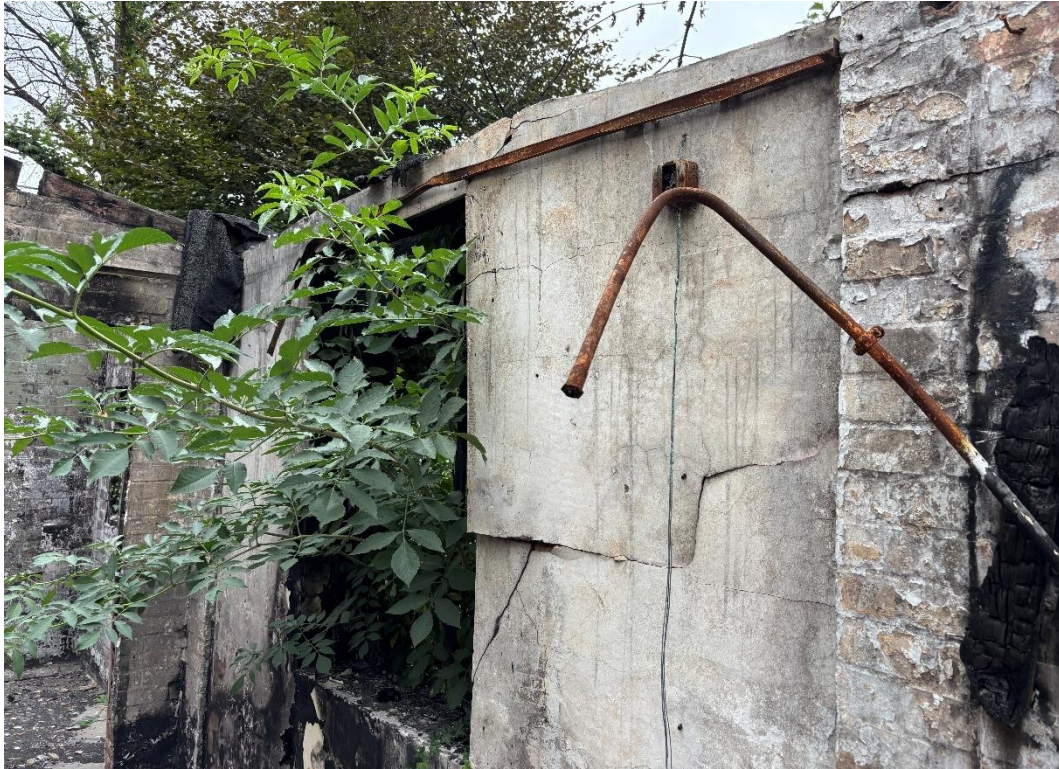
The single storey side rooms do not appear to be constructed to the same high quality as the main hanger building. There have been a number of alterations over the history of the building. The external walls appear to have originally been single skin brickwork, approximately 100mm thick. In many of the rooms a skin of concrete blockwork has been added internally to the external wall. The blockwork and original brickwork are not tied together. Consequently in many locations the two leaves are separating, in some areas very severely.

Figure 38 Example of inner blockwork and brick skin separating

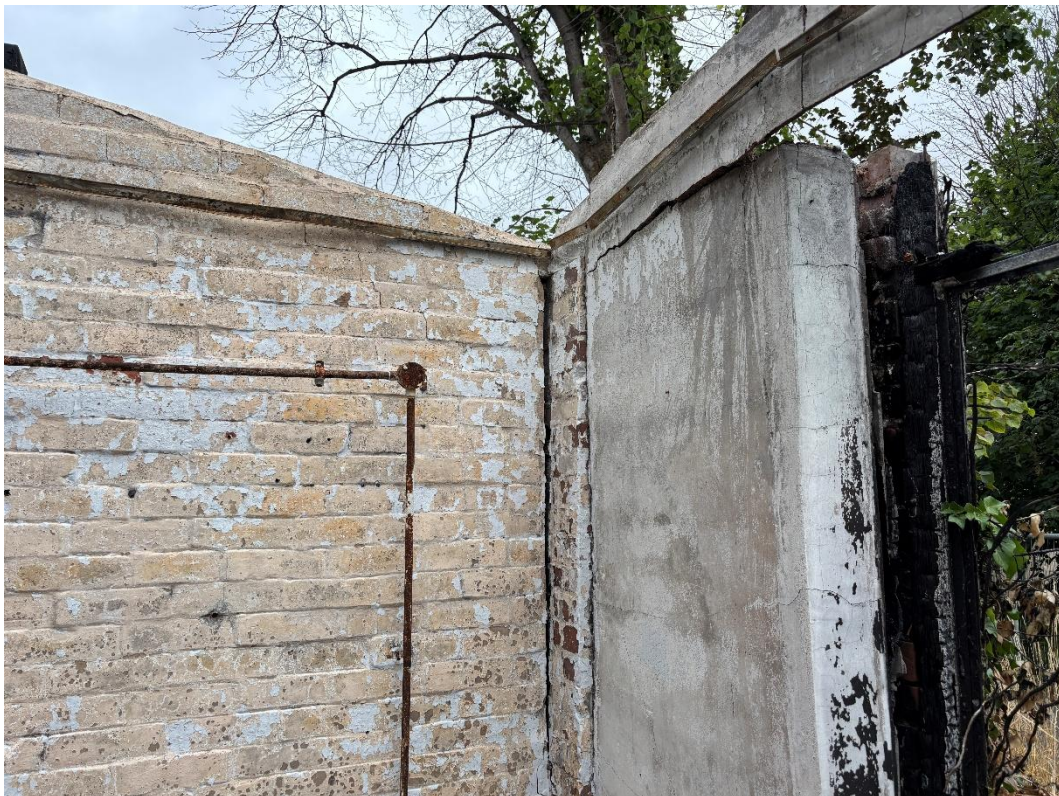
It appears that many of the dividing cross walls were also later additions. They are not tied to the main hanger buttresses or to the single storey external walls, consequently they offer no lateral restraint to the external elevation of the single storey area. There is cracking between the majority of the cross walls and the external wall. Similar cracks exist at the buttresses.

Figure 39 Dividing wall separating from external wall

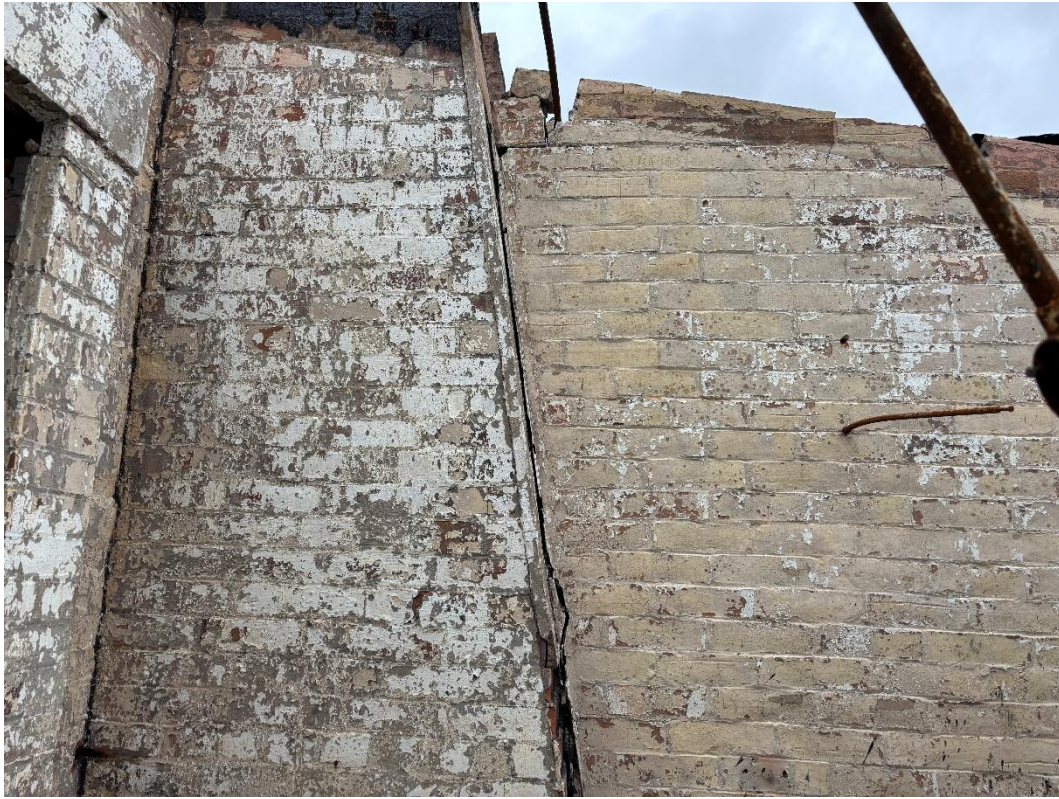
Figure 40 Dividing wall separating from buttress

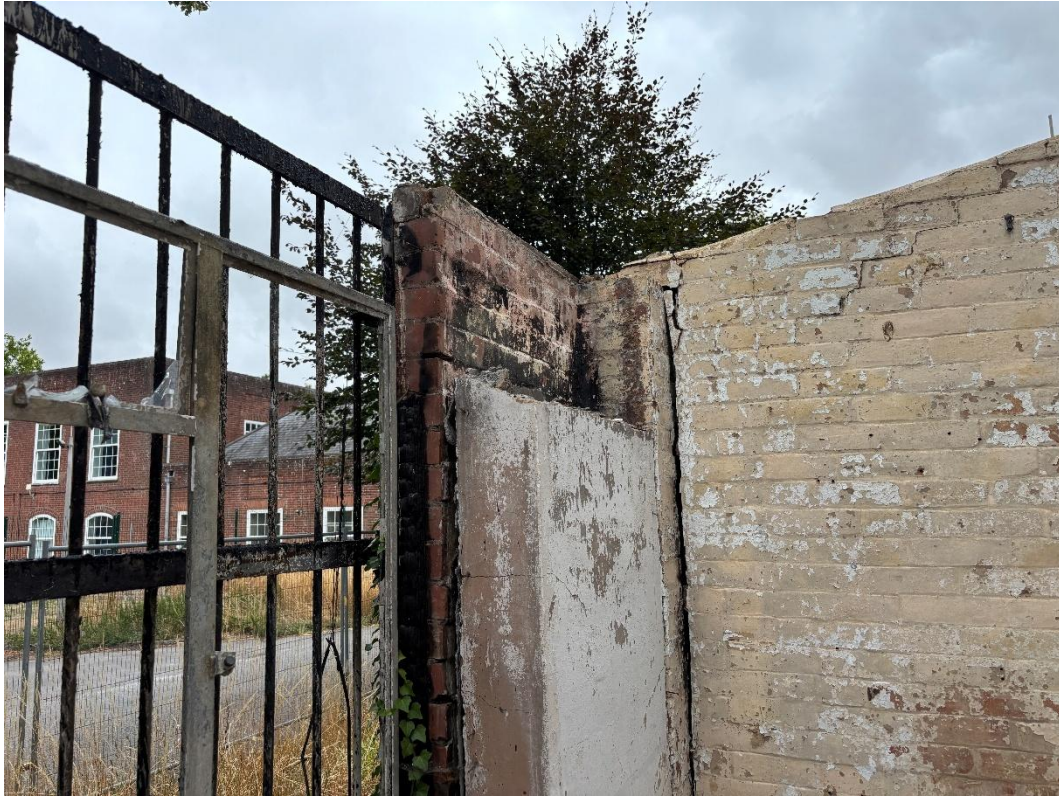
Along the central section of the single storey rooms between GL06 and GL13 the external wall is leaning out away from the main hanger. At the worst location the lean is approximately 20mm over the full height of the wall. Provided the wall had sufficient restraint this may be deemed structurally acceptable. This is based on the assumption that the structural element of the wall is the original brickwork only and the inner leaf has no structural function.

Figure 41 Cracking between dividing wall and external wall showing external wall leaning to left

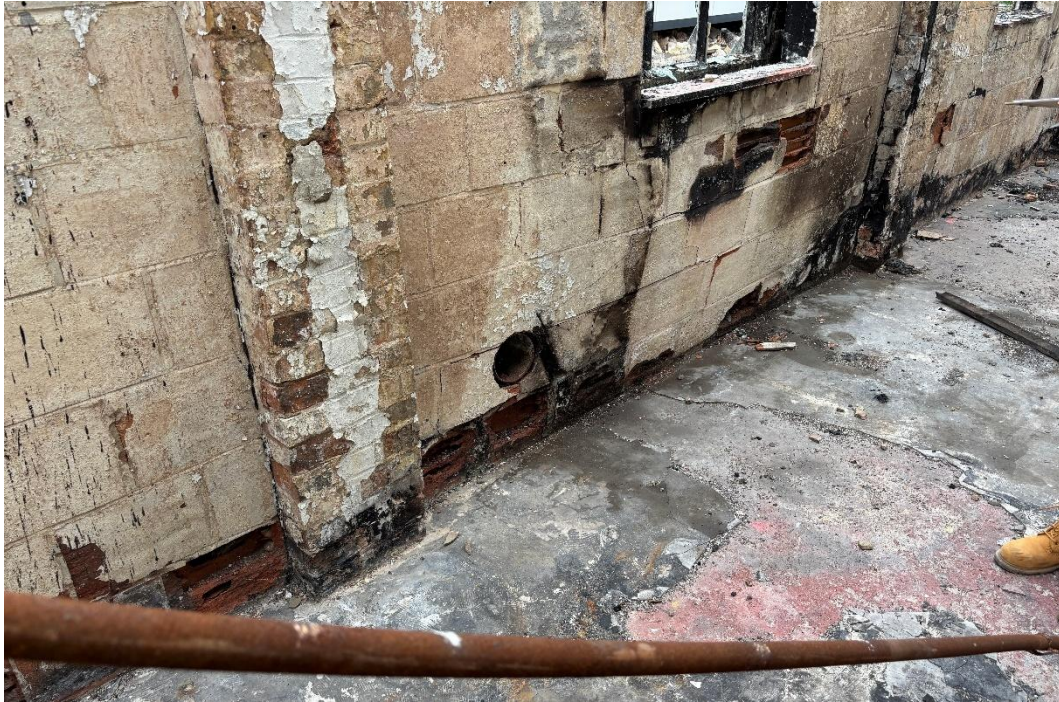
The single storey side rooms do not appear to be constructed to the same high quality as the main hanger building. There have been a number of alterations over the history of the building. The external walls appear to have originally been single skin brickwork, approximately 100mm thick. In many of the rooms a skin of 50mm thick extruded hollow light weight clay blocks has been added internally to the external wall. The clay blocks and original brickwork are not tied together, consequently in many locations the two leaves are separating, in some areas very severely.

Figure 43 Example of inner clay block separating from brick outer leaf

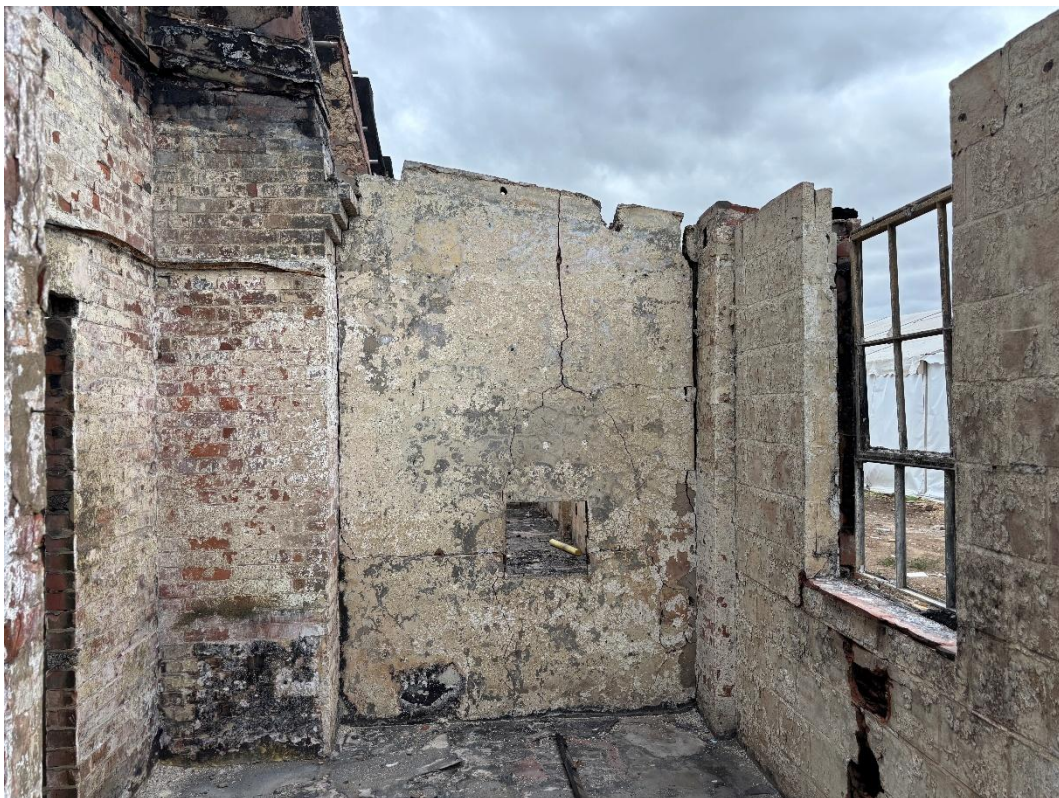
Many of the same structural issues are present in the single storey rooms on this side of the hanger as on the north western side. There are fewer internal cross walls and the ones present have more widespread cracking across the walls in addition to not being tied into the main hanger walls or the external walls.

Figure 44 Cracking to masonry cross wall

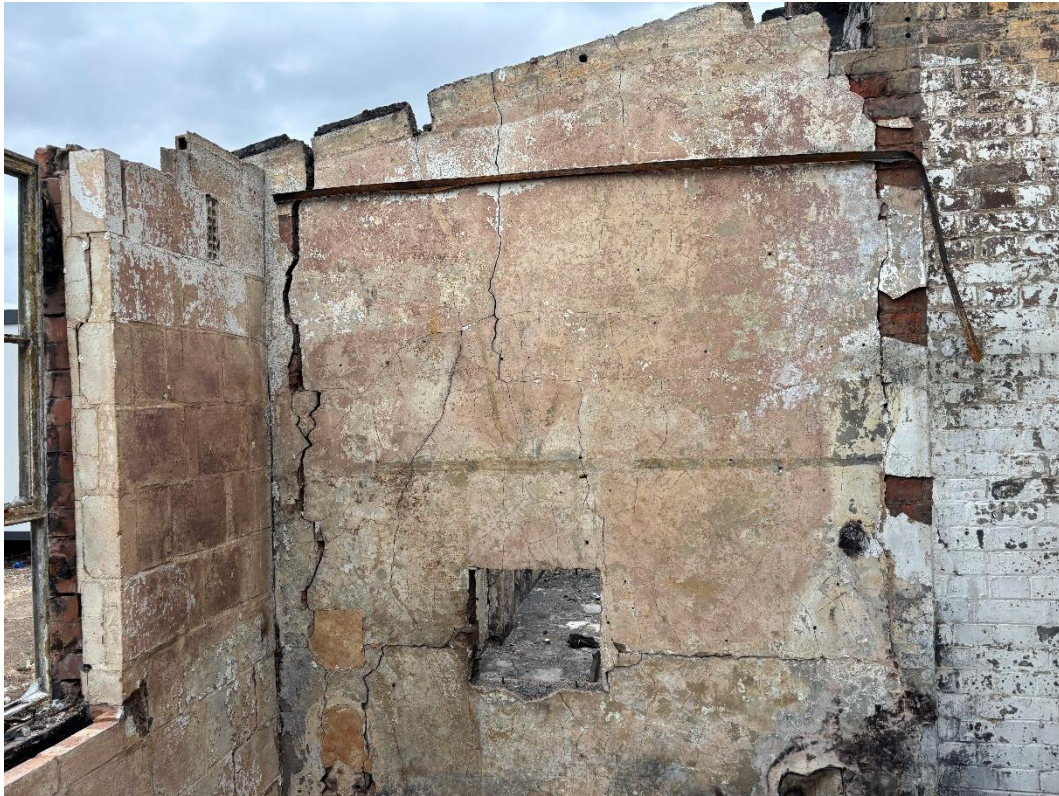
The external walls are leaning away from the main hanger building. the walls lean out by approximately 41mm over the 2.5m wall height. This puts the centre of gravity outside the middle third of the wall thickness at its base. When the centre of gravity is outside the middle third the wall is potentially unstable under its own self weight. With the roof now missing following the fire there is no top restraint to this wall and, with limited return walls, it should be considered unstable and access around the wall restricted. This is based on the assumption that the structural element of the wall is the original brickwork only and the inner leaf has no structural function.

Figure 45 Cracking between cross wall and external wall showing external wall leaning to left

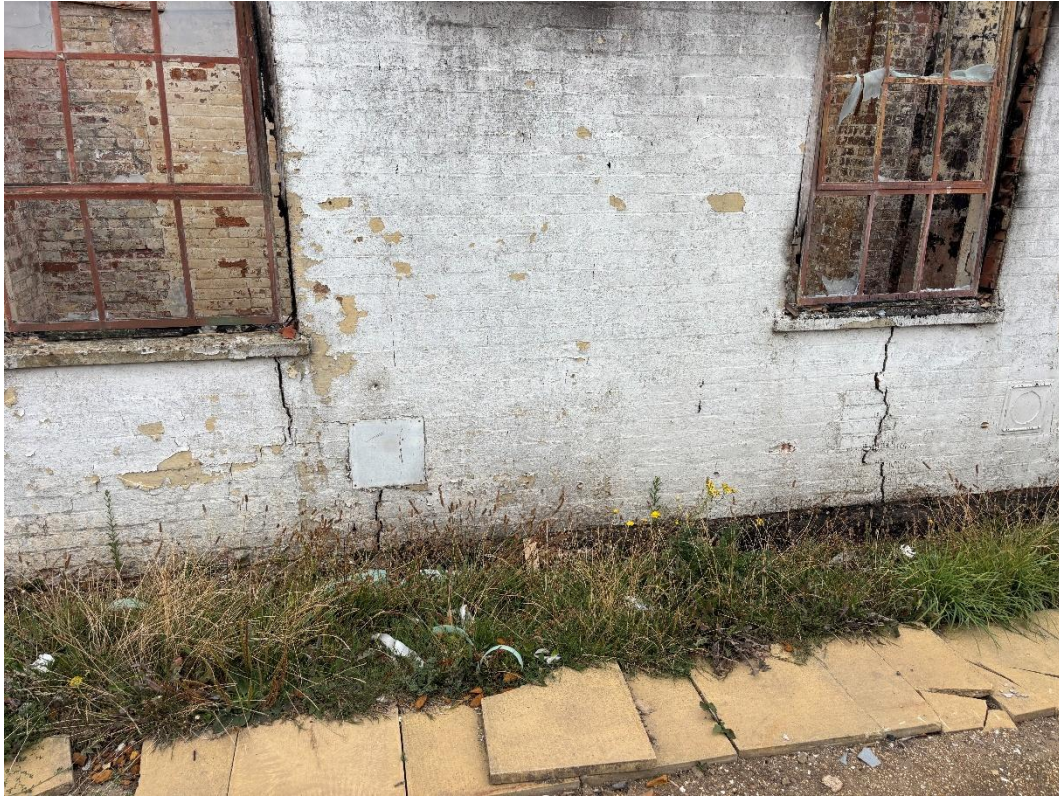
There is cracking along the external face of the full elevation. This is typically around the window and door openings and is typical of cracking caused by thermal movement. The elevation faces south east and therefore will absorb a significant amount of heat from the sun which is likely to have caused large thermal movements over the lifetime of the building.

Figure 46 Example of cracking the external wall
