Design and Condition Report  
Old Sarum Airfield  
**Repairs to Hangar 3,**  
9765 / A05a  
September 2025

## 1.0 Introduction

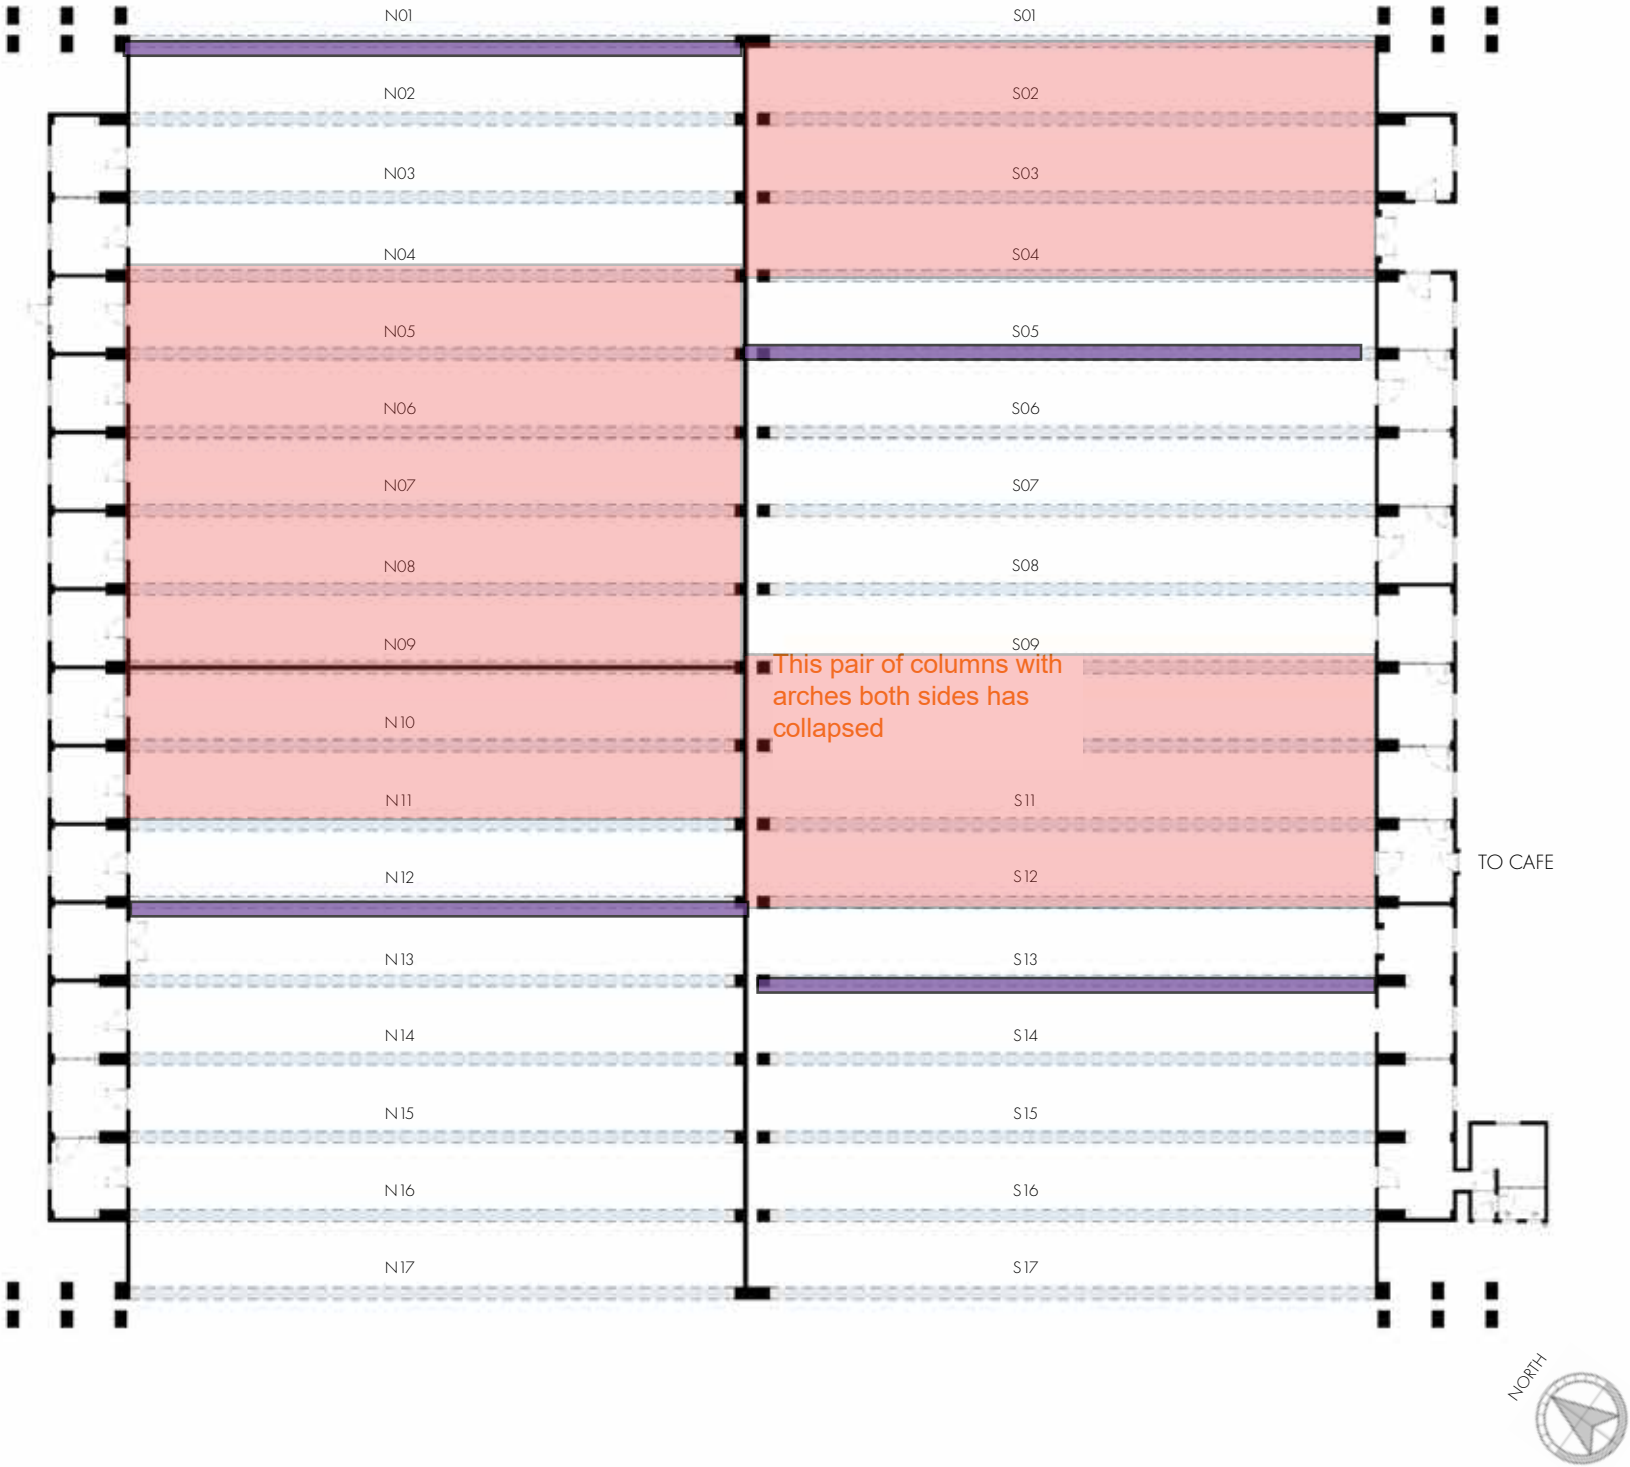
Location of Existing Trusses- Truss Location Plan 2017 Report

Indicates truss identified as potentially repairable by Tim Ratcliffe in April, 2023.
-

Remaining trusses in poor condition unlikely for viable repair.

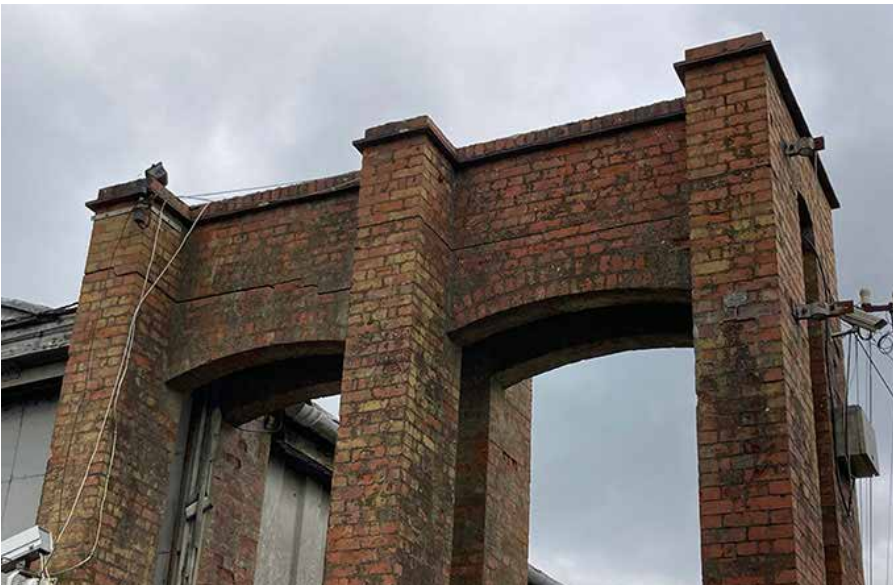
Top of gantry tower showing horizontal cracking

7.3c Carry out localised brick repairs to all four corner gantry towers.

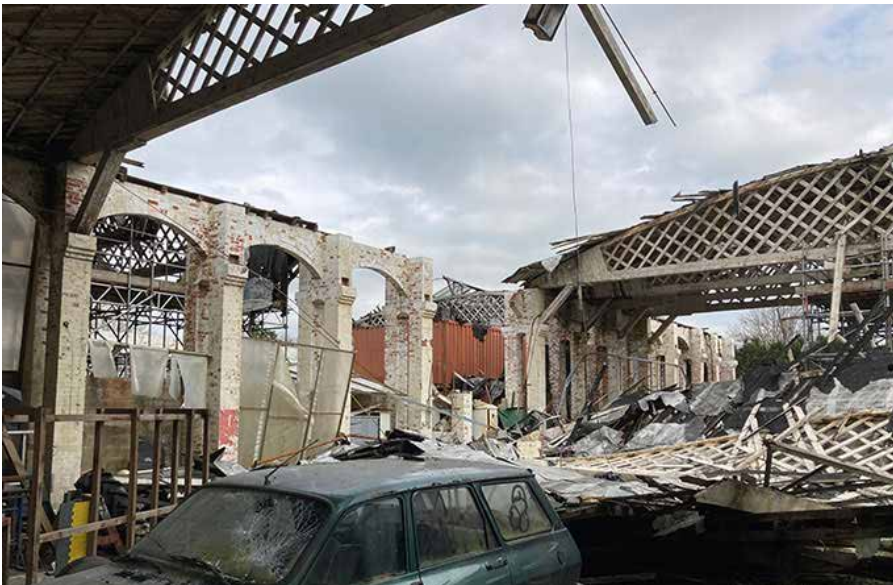
Area of collapsed roof

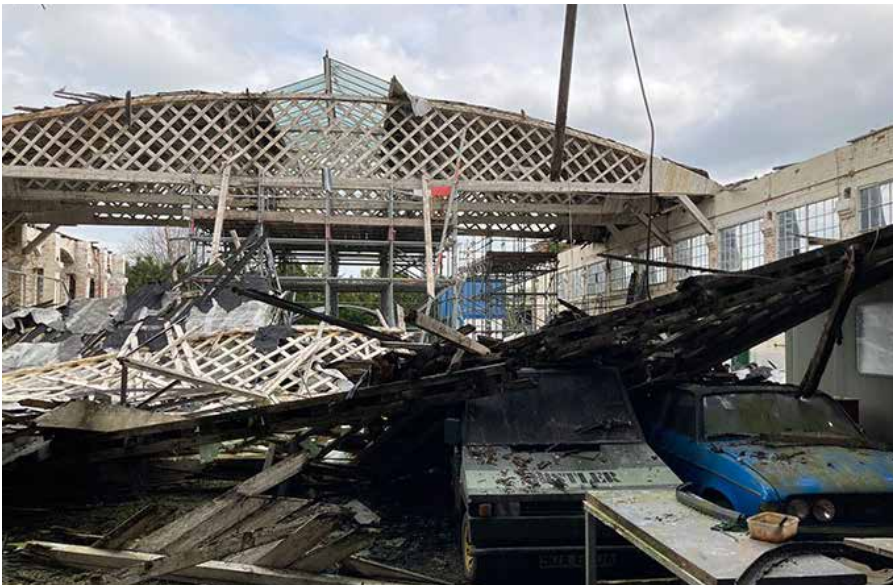
Area of collapsed roof

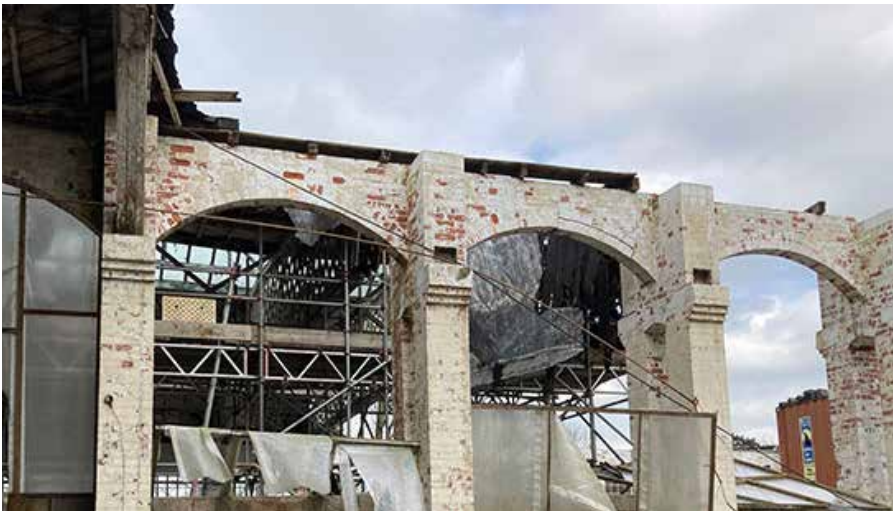
Central brick arcading in need of brick repairs

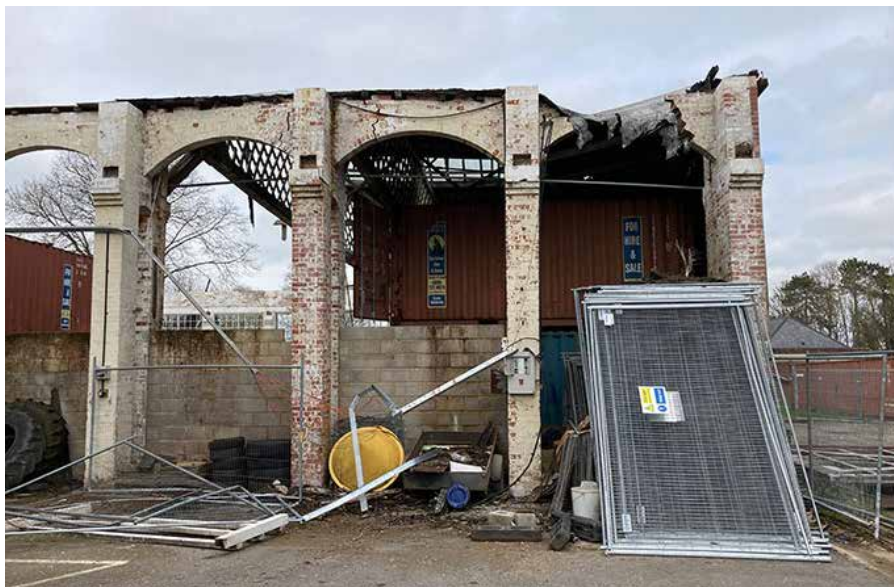
*Central brick arcading with missing roof*

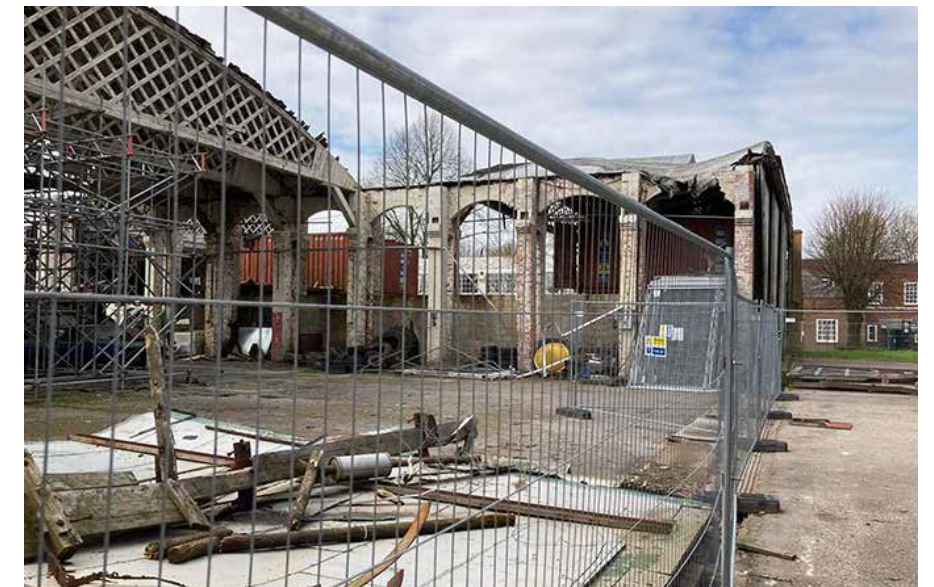
*Worst area of collapse*

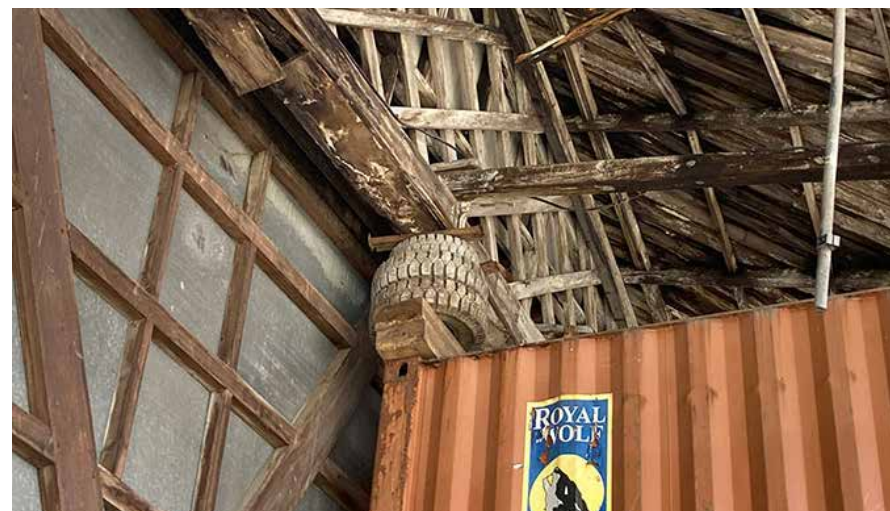
*Temporary support to Belfast truss*

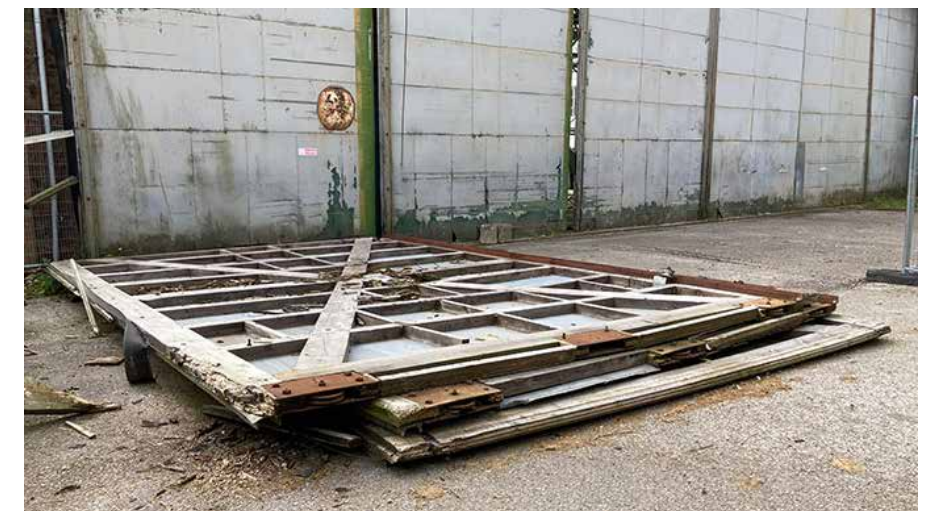
*Collapsed hangar doors.*

7.4f Repair and reinstate main sliding hangar doors, plus canopies above.

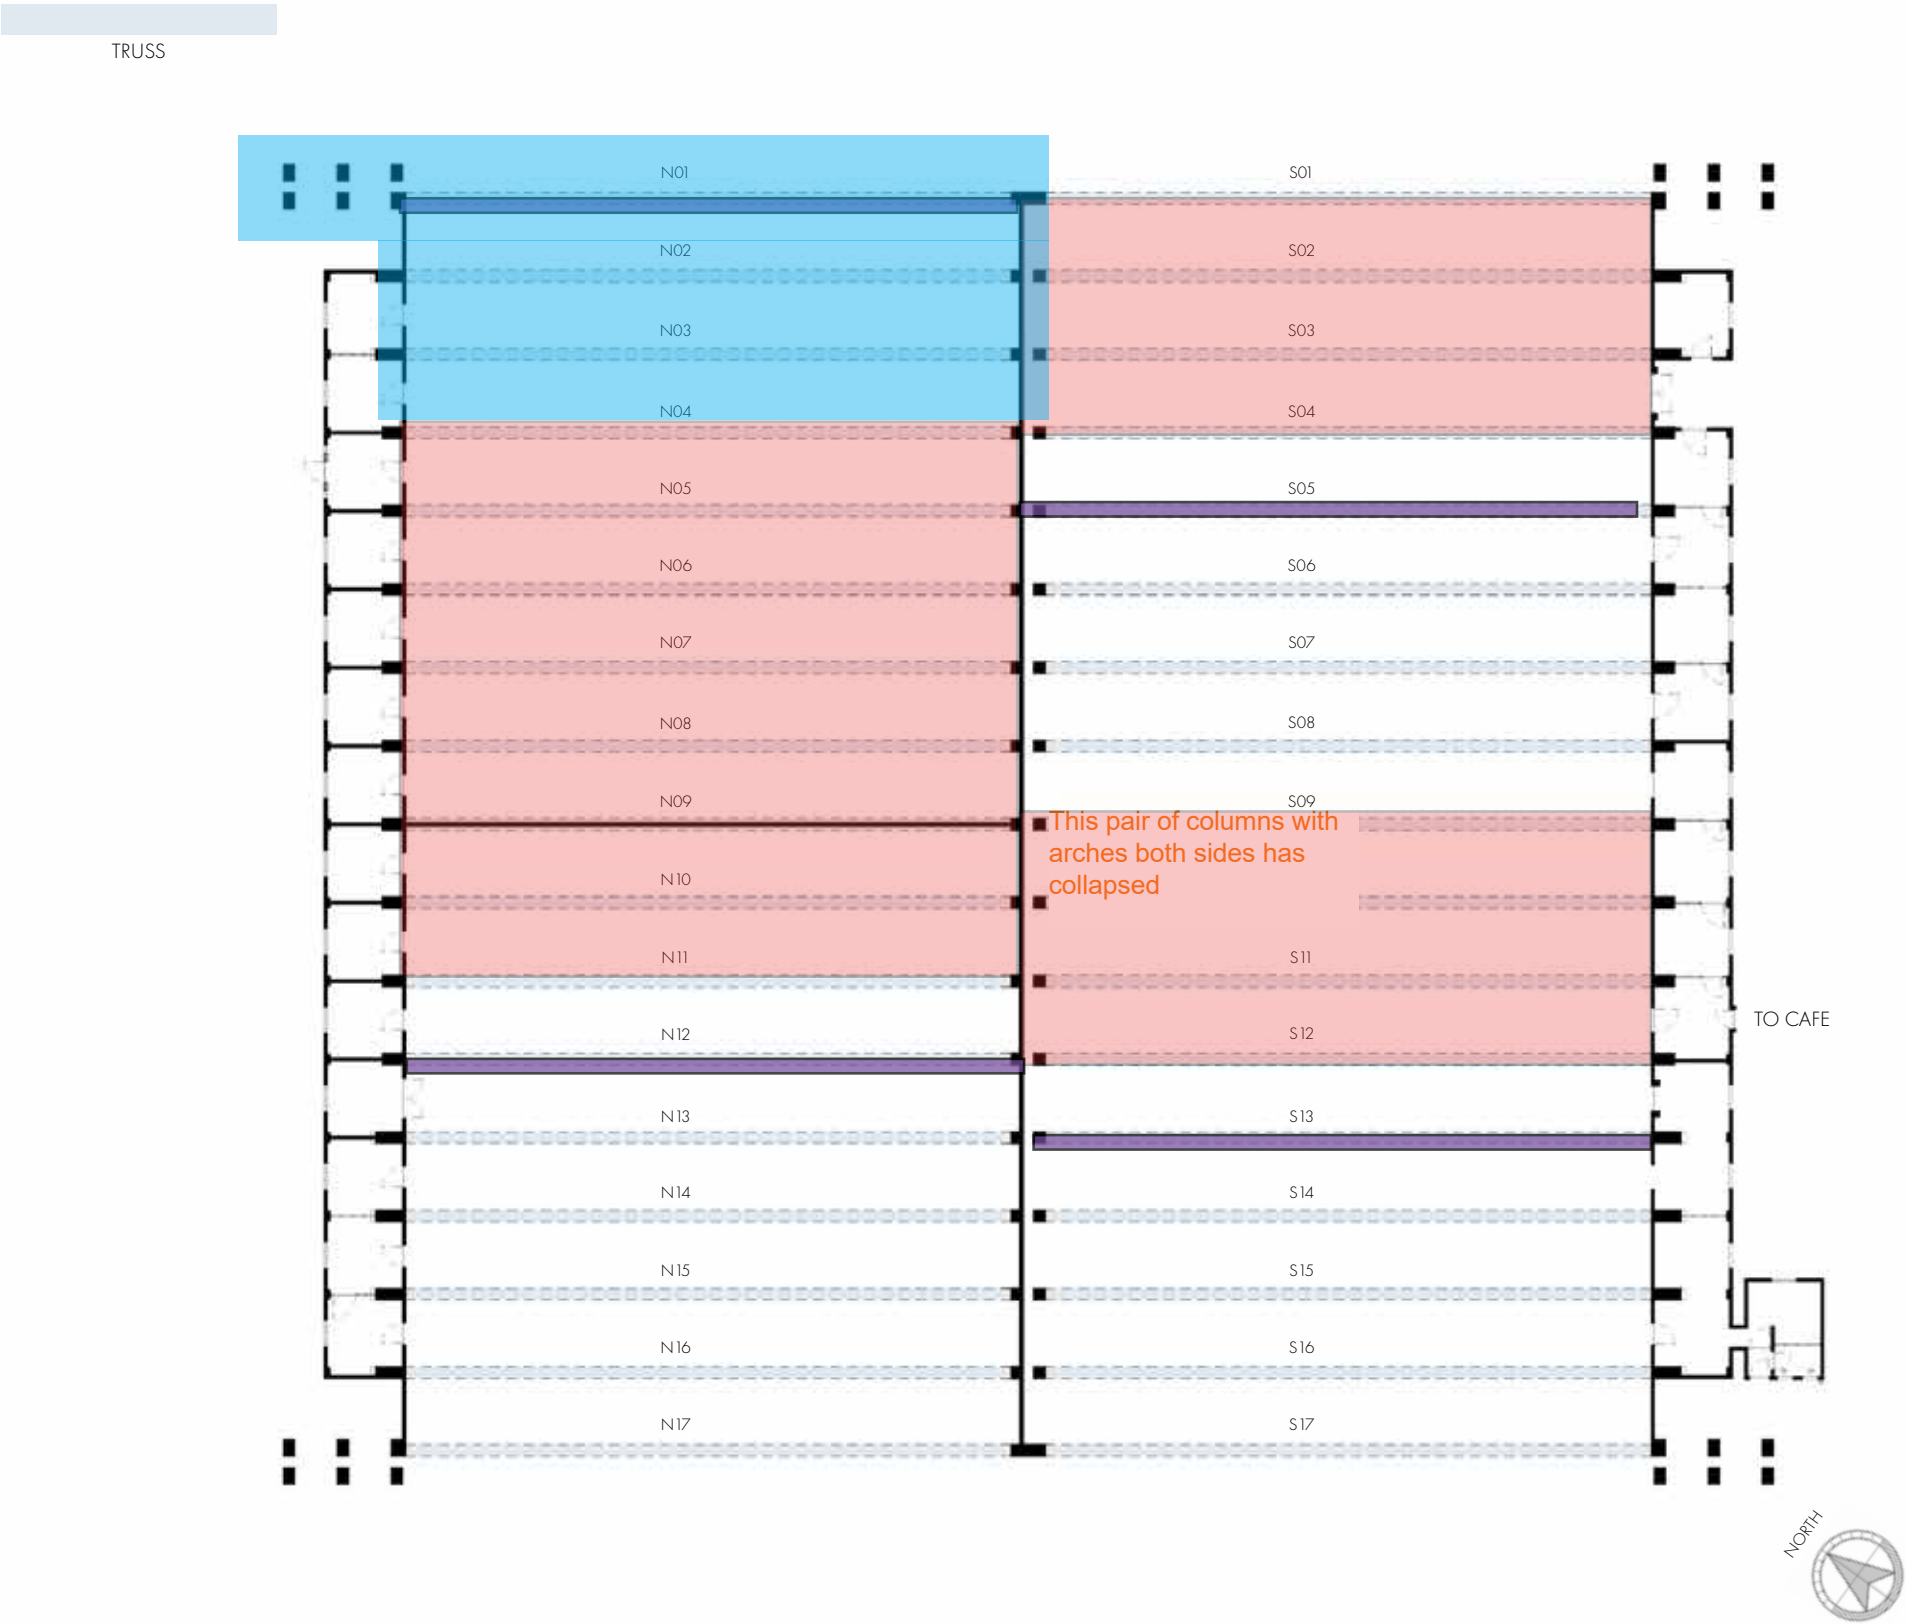
Location of Existing Trusses- Truss Location Plan 2017 Report

- Indicates collapsed roof and trusses.
- Indicates truss identified as potentially repairable by Tim Ratcliffe in April, 2023.
- Remaining trusses in poor condition unlikely for viable repair.
- Truss N01, N02, N03 damaged in storm of 21st. Jan. 2024, together with north-west brick gantry pier and damage to central arches where indicated in blue.

**3.0 Repairs to masonry structure:** All to be carried out in strict accordance with Structural Engineer's specification, including construction of central arches where collapsed (**including north central arches damaged in storm of 21st. Jan. 2024**), all to match existing. Repair / stitching of brickwork to all areas of Hangar 3, including the sloping buttresses along each flank wall and the brick gantry towers supporting the main hangar door runners. **North-west gantry tower damaged in storm of 21st. Jan. 2024 to be rebuilt like for like.**

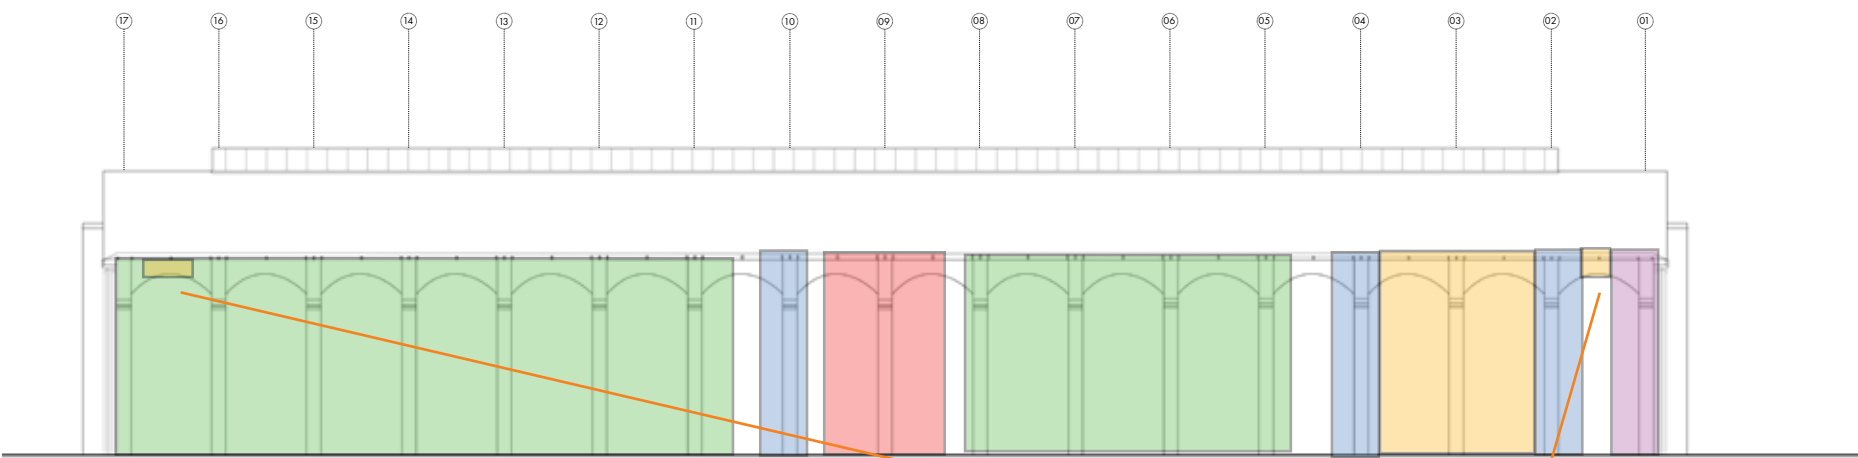
SECTION C - CENTRAL MASONRY COLUMNS

SECTION TAKEN ALONG CENTRAL VALLEY GUTTER LOOKING NORTH, INDICATING LOCATION OF COLLAPSED COLUMNS & ARCHES

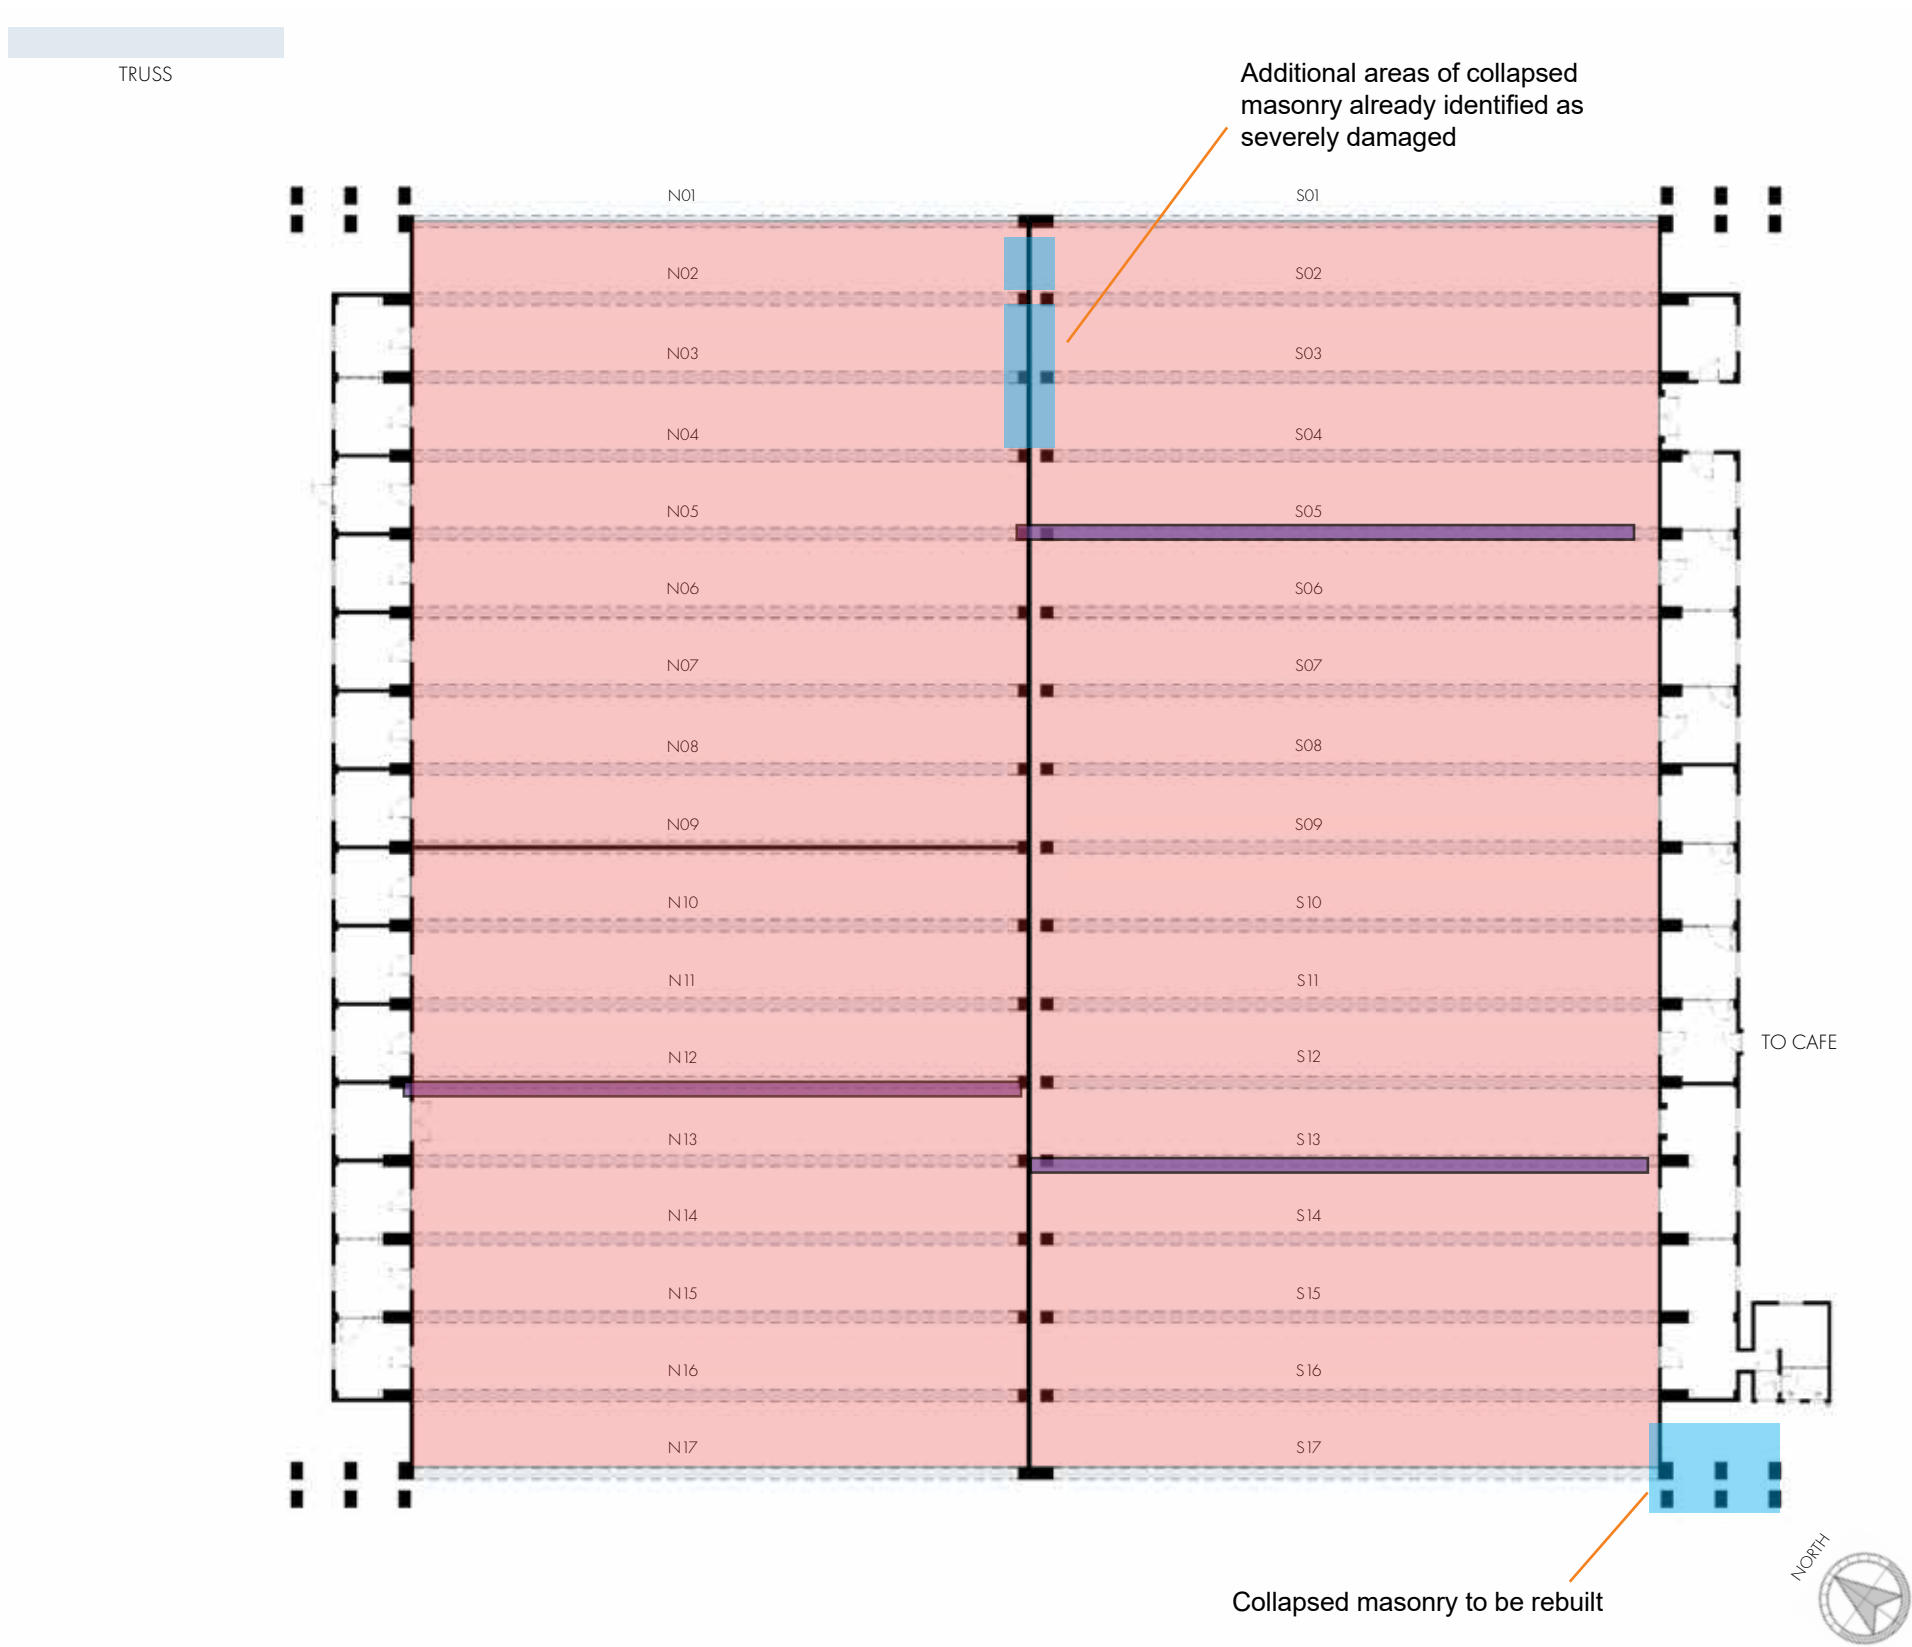
Location of Existing Trusses- Truss Location Plan 2017 Report

Additional extent of collapsed brickwork
