# OLD SARUM AIRFIELD

## HANGAR 3

### CONDITION REPORT - 2023

## **OLD SARUM AIRFIELD – HANGAR 3 CONDITION REPORT – 2023**

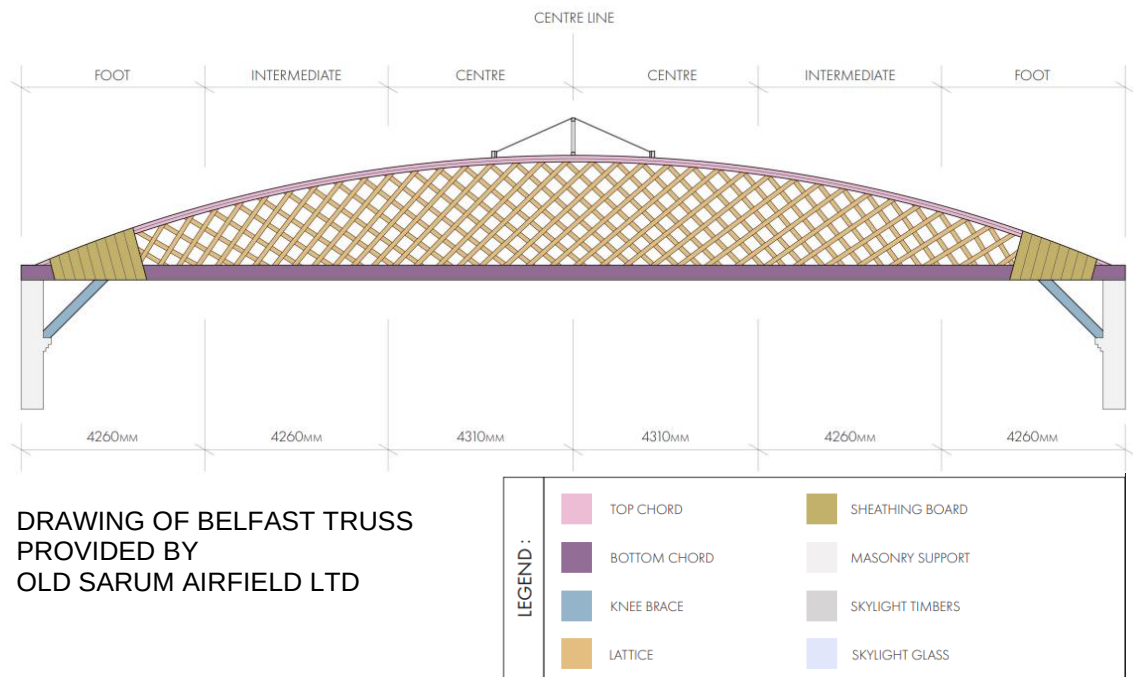
**At the time of the inspection, of the 34 Belfast trusses supporting the hangar roof, 14 had collapsed to the ground (8 on the south side and 6 on the north side), and a lot of the remaining trusses were in poor condition.**

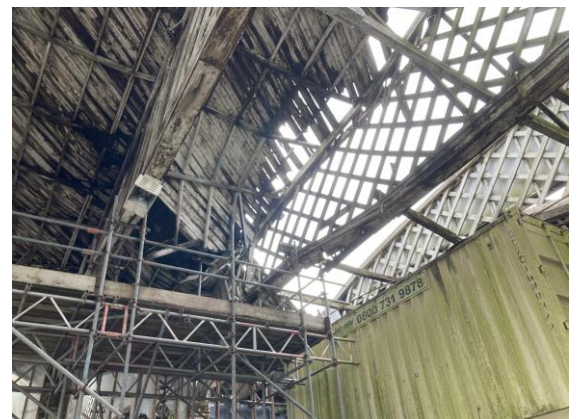
2.1.3 Of these 20 trusses, about 6-8 of them have failed, with key elements (such as the bottom chord, etc) having rotted through. These trusses are no longer repairable.

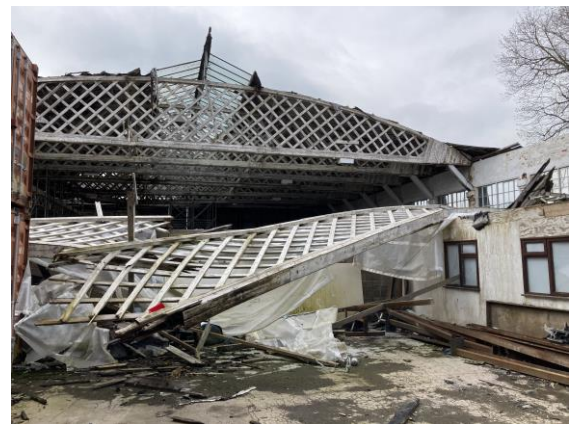
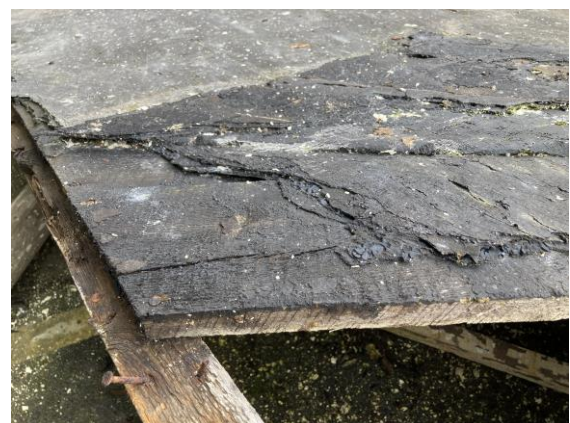
- 2.1.9 The original roof covering to the collapsed sections seems to be bitumen/tar applied directly to the boards. Over this are later layers of bitumen/tar reinforced with glass-fibre mesh (check for asbestos). Leaks through this covering, and around the edges have caused collapse of the roof structures. When replacing the covering, thought could be given to using other materials (at Hooton Park, modern profiled metal was used).

- 2.1.10 The central valley gutter, running the length of the roof, could not be accessed at the time of the inspection but appears to be formed in timber boards with a bitumen/tar lining. Localised leaks in this gutter have contributed to the rotting of the ends of some of the trusses. Replacement of the gutter lining may be best in a modern metal (at Hooton Park stainless steel was used, with rubber expansion joints at 20m intervals).

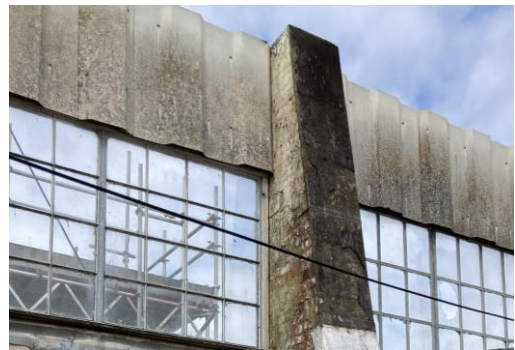
- 2.2.1 The profiled asbestos-cement cladding should be tested. Its removal is desirable, unless it is shown to be completely stable and safe, and is of historical interest.

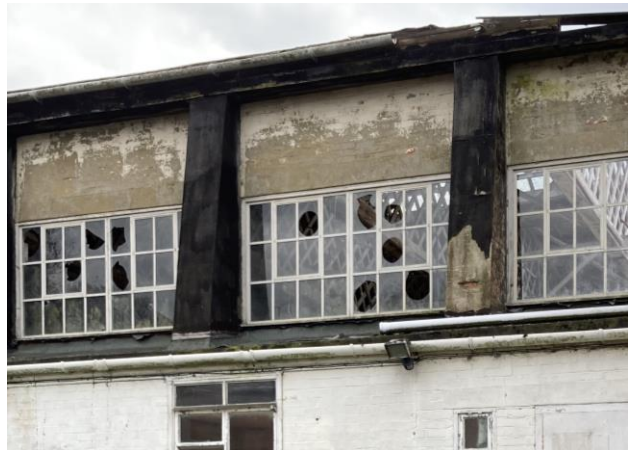
- 2.2.2 There is some cracking to the external render and there are patches where it is failing (particularly on the sloping faces of the buttresses). Some localised repairs and patching are required. Most of the visible brickwork seems sound, although eroded and damaged bricks to the buttresses need replacing, along with some other localised repairs and pointing.

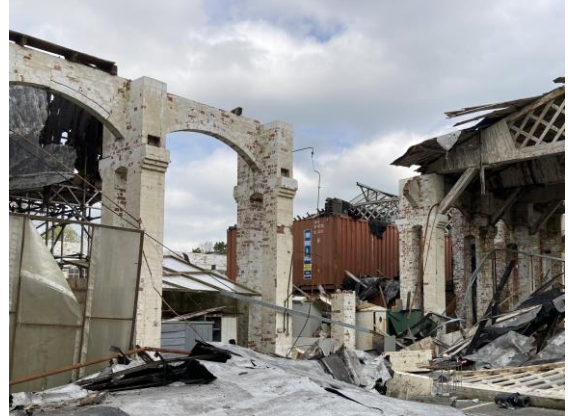
- 2.3.1 One pair of columns has collapsed near the centre of the spine wall, along with the arches either side. This has also caused some localised movement cracks in adjoining arches. It should be possible to rebuild the collapsed pair of columns and arches, and then consolidate and point-up the cracks in the adjoining arches, without having to disturb or dismantle any more brickwork.

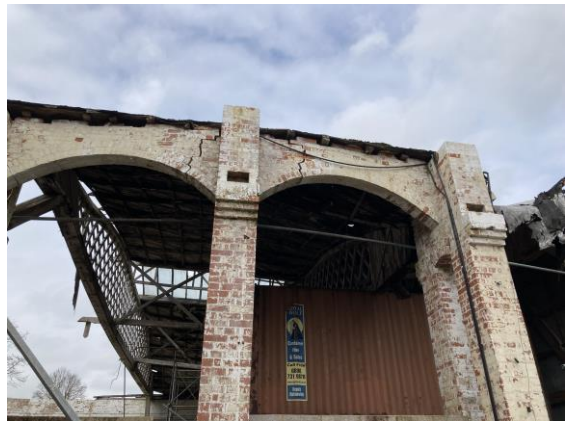
- 2.3.2 Further damage has been caused to columns and arches towards the east end of the hangar. The end arch has collapsed and a column has been twisted, causing cracking in the arches either side. A conservation structural engineer should be asked to advise, but it is likely two pairs of columns will have to be dismantled and rebuilt, along with the arches. The twisted column looks precarious, and advice should be sought on the need to prop it for now.

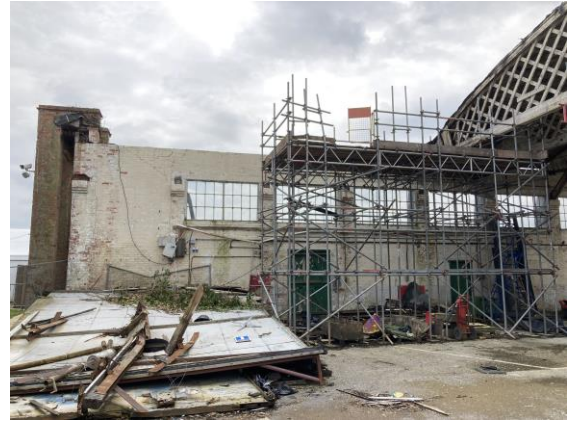
- 2.4.1 The doors to the southern opening were lying on the ground at the time of the inspection; one had fallen but the rest were lowered to prevent further collapse. These should be inspected in more detail and repaired and reinstated where possible. Even in cases where they are beyond repair, it is worth keeping the running wheels and other fittings, plus metal cladding, for reuse.

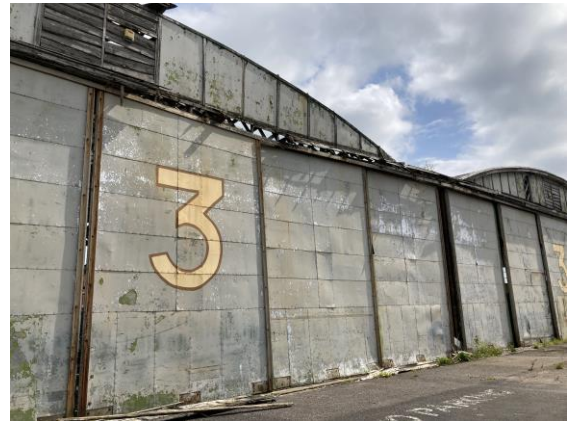
- 2.4.2 The other three sets of doors remain in-situ, but cannot be opened, partly because of damage to the tracks and runners, at the bottom and top respectively, but also because the Belfast trusses supporting them are dropping and twisting. Retention and repair of these doors is desirable, but it is assumed they will need to be lifted out in order to repair the tracks and rails, plus canopies over. A structural engineer will need to be involved with decisions about moving and repairing them.

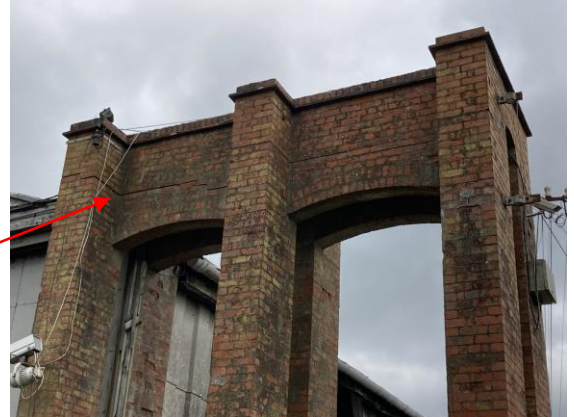
- 2.5.2 The metal door runner rails at the tops of the towers are rusting. Some may be coming loose and all need to be checked and repaired to ensure the doors can function again. The metal fixings are built into the brickwork and are rusting, causing a horizontal joint to open up. Hopefully it will be possible to simply replace the fixings but, if not, the top ten courses will need to be dismantled and rebuilt.

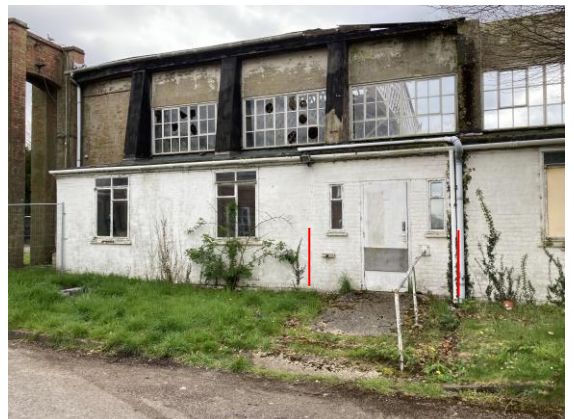
- 2.6.1 The exact configuration of the lean-tos isn't completely clear, but could be established with a little more investigation. Two vertical joint lines towards the eastern end of the north annex (red lines on photo) indicate the section between them is a later infill.

Different internal door lintel details may help understand the original layout, and blocked arches suggest some annex rooms opened directly into the hangar.

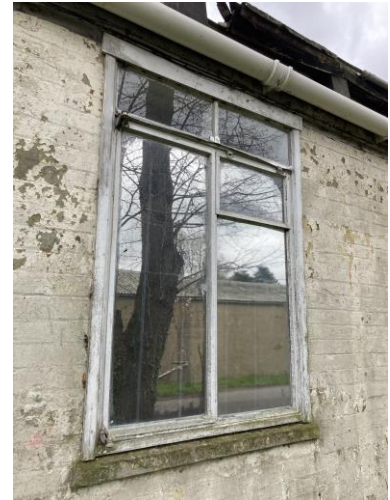
2.6.3 Most of the original window openings are fitted with metal frames set within timber frames (photo shows one on the north side). It is thought, from records, these were fitted in 1928. As the metal frames were too small for the openings, timber frames were added with extra 'lights' above. The metalwork needs some minor repairs and redecoration, whereas, in some cases, rot in timber cills and frames require more extensive repair. Although it should be possible to repair most of the timber frames in-situ, it may be better to temporarily remove the metal frames to allow better access to the more damaged ones.

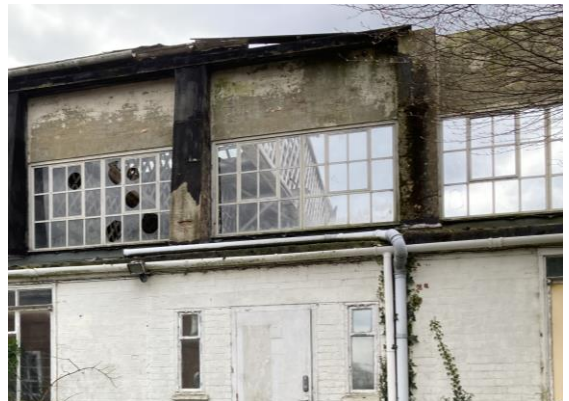
- 2.8.1 The remaining guttering on the hangar is feeding water into the walls. New cast iron gutters and downpipes should be installed along both sides of the hangar, in association with reinstatement of the roof structures and coverings. Most of the eaves boxing is missing and/or damaged and needs rebuilding, to fix the gutters to.

Plastic rainwater goods to the annexes need overhauling, and thought should be given to replacing them in cast iron.
