# Drainage Report

**FAIRCLOTH CONSTRUCTION LTD**  
**ROYAL MAIL, BRUNEL ROAD**  
**SALISBURY**

**Q DRAINS LTD**  
**Surveyor:**

**Royal Mail Salisbury - CCTV Survey Report : 29/10/25**

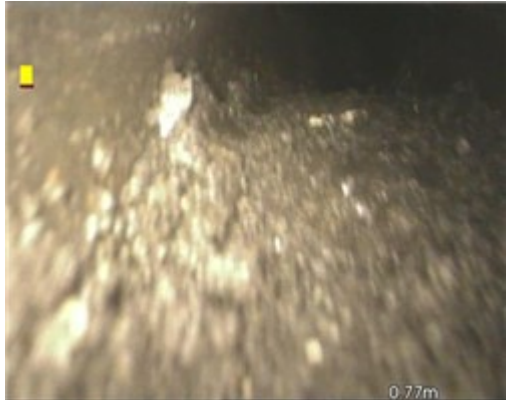
| Pos | Video Ref | Code | Description | Image |
|---|---|---|---|---|
| 00.77m | 0:00:28 | DER | Settled deposits coarse: 40%<br>Cross sectional area loss -<br>Severity 3 | Image Provided - Ref: 0_2<br> |

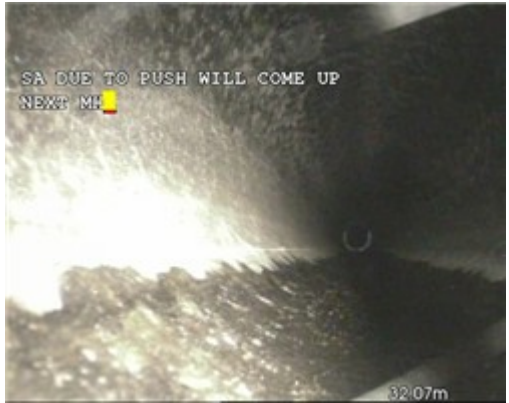
| Pos | Video Ref | Code | Description | Image |
|---|---|---|---|---|
| 32.07m | | SA | Survey abandoned<br>UNABLE TO PUSH ANY<br>FURTHER - WILL OVERLAP<br>FROM OTHER END | <p>Image Provided - Ref: 1_9999</p> |

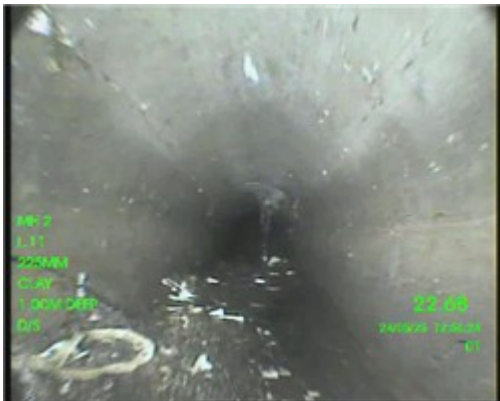
| Pos | Video Ref | Code | Description | Image |
|---|---|---|---|---|
| 22.68m | 0:01:23 | DER | Settled deposits coarse: 15%<br>Cross sectional area loss -<br>Severity 3 | Image Provided - Ref: 3_2<br> |

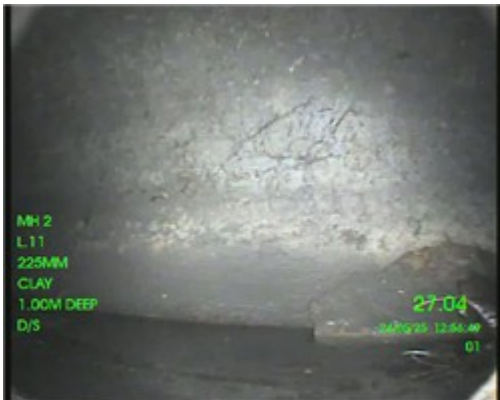
| Pos | Video Ref | Code | Description | Image |
|---|---|---|---|---|
| 27.80m | | MHF | Finish node type, manhole<br>DROPS INTO MAIN LINE OFF<br>BOUNDARY | Image Provided - Ref: 3_9999<br> |

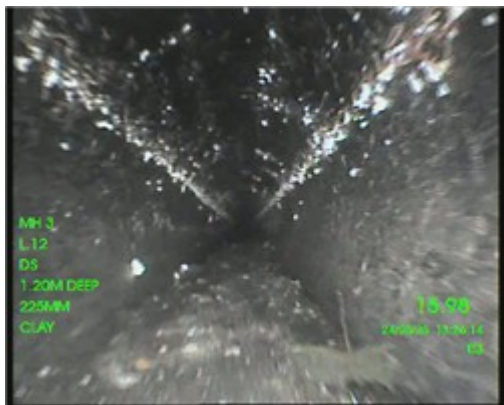
| Pos | Video Ref | Code | Description | Image |
|---|---|---|---|---|
| 15.98m | 0:00:29 | DER | Settled deposits coarse: 15%<br>Cross sectional area loss -<br>Severity 3 | Image Provided - Ref: 4_2<br> |

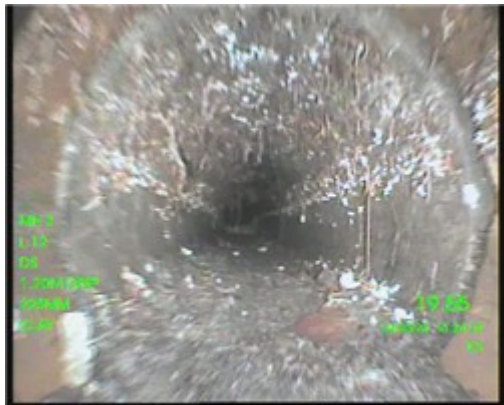
| Pos | Video Ref | Code | Description | Image |
|---|---|---|---|---|
| 19.55m | 0:00:04 | DER | Settled deposits coarse: 30%<br>Cross sectional area loss -<br>Severity 3 | Image Provided - Ref: 4_3<br> |

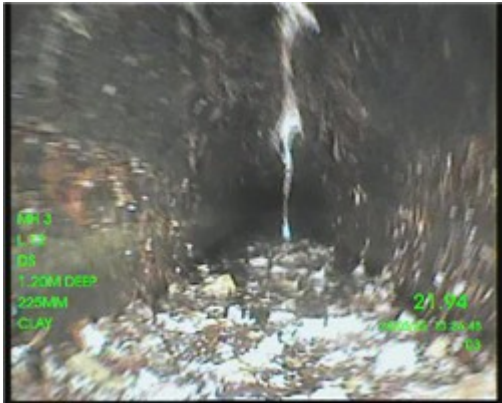
| Pos | Video Ref | Code | Description | Image |
|---|---|---|---|---|
| 21.94m | 0:00:20 | DER | Settled deposits coarse: 40%<br>Cross sectional area loss -<br>Severity 3 | <p>Image Provided - Ref: 4_4</p> |

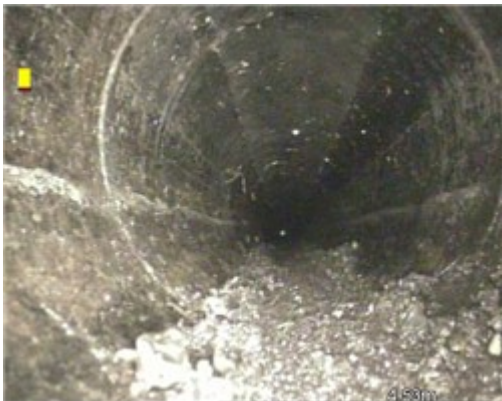
| Pos | Video Ref | Code | Description | Image |
|---|---|---|---|---|
| 04.53m | 0:00:26 | DES | Settled deposits fine: 10%<br>Cross sectional area loss -<br>Severity 3 | Image Provided - Ref: 6_2<br> |

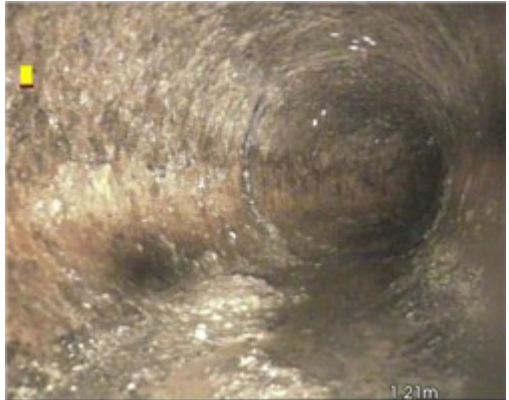
| Pos | Video Ref | Code | Description | Image |
|---|---|---|---|---|
| 01.21m | 0:00:43 | LRH | Line of drain/sewer deviates<br>right [half] | Image Provided - Ref: 7_2<br> |
