# 10 Linleys

## Structural Survey Report

Project Reference: M2-3316

Document Reference: RE-01\_P2

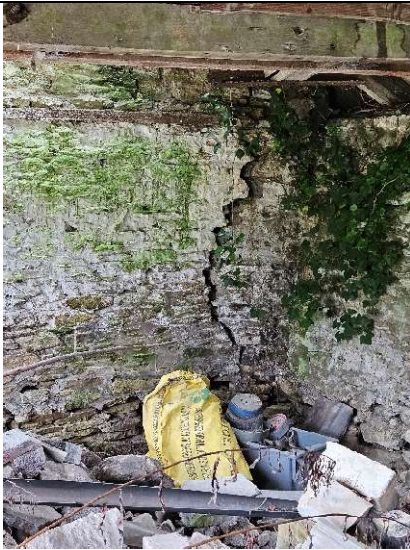
- Large vertical crack to West gable visible internally and externally.
- Northern wall which is alongside the main road is retaining, floor level internally is lower than external ground level. It has various minor cracks and areas of loose mortar.
- Eastern wall is of modern concrete blockwork construction.

*Masonry crack*

The west gable has a significant crack near the junction with the northern wall. This will need to be stitched up using stainless steel helical bars set in resin, and the stonework and mortar locally reinstated. More generally, the stonework will need to be cleaned up, and any areas of loose mortar / stonework will need to be repaired. An alternative to this solution would be to demolish the gable wall and keep the stones, and rebuild with a dense concrete blockwork core on a mass concrete footing.

It is proposed to cast a new ground floor slab with insulation on top. The total build up thickness will in all likelihood mean that the new formation level is below the level of the bottom of the existing foundations. We would therefore recommend that the west gable and north elevations be underpinned to a suitable depth, in sequence with each bay not exceeding 1.0m. An alternative to the underpinning would be to rebuild the gable wall as discussed above, and also rebuild the side wall, on a suitably deep mass concrete strip footing.

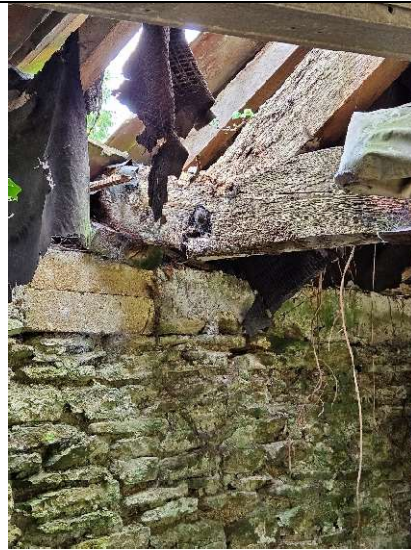
- There are 5 No. timber trusses, numbered 1 to 5 on the survey plan.
- Bearing of Truss 1 is damaged / cracked at northern end. It is currently propped by a single acro.
- All trusses have evidence of previous repair work.
- Northern purlin between truss 2 and truss 3 is cracked at mid span.
- The majority of timber rafters appear in reasonable condition. There are a few damaged rafters which will need replacing.
- The southern elevation consists of timber posts supporting steel channel eaves beams which support the trusses / rafters. The steel beams display signs of corrosion throughout and appear to have deflected excessively.

*Failed truss bearing*

The timber roof structure, which consists of cut rafters and purlins supported on timber trusses, appears to be in poor condition. There is evidence of previous repair work to the trusses, there is a failed truss bearing and there is also a failed purlin. The current architectural proposals include new internal partition walls to be built in line with trusses No.2 to No.5. We would suggest making those walls structural in order to provide additional support to the trusses. Truss No.1 however will need to be repaired by bolting a new timber alongside the bottom boom to reinstate the bearing's structural integrity.

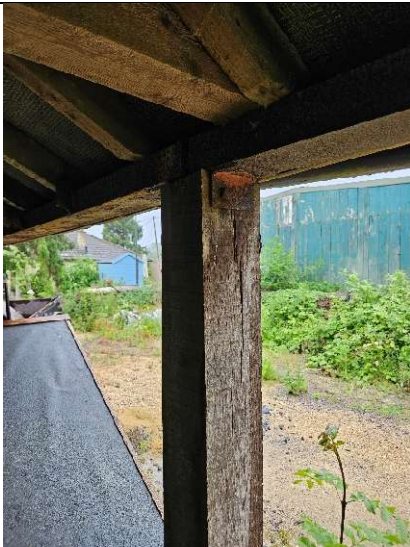
*Timber / steel roof support*

The south elevation will be closed up as part of the refurbishment work, with new external timber walls. We would recommend using the new structural walls to make the existing steel / timber structure redundant, with the timber trusses and rafters supported on the new structural wall.

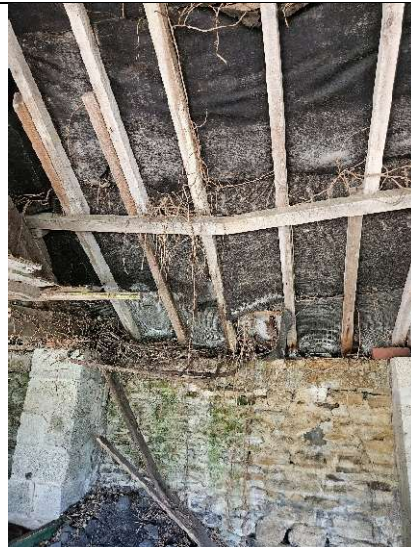
*Failed purlin*

The damaged timber rafters and purlins will need to be replaced or repaired by bolting new timber alongside.
