# Tottenham House: Condition investigation of prescribed areas to timber structures

Site note B15 for 21 May 2025, job no. 446-49

The aim of this survey was to investigate prescribed outstanding areas of various timber structures for their construction and condition throughout the main house and north courtyard as per instruction document reference '2025-05-07 *Timber Investigations – outstanding items*'. Where applicable remedial advice has been provided

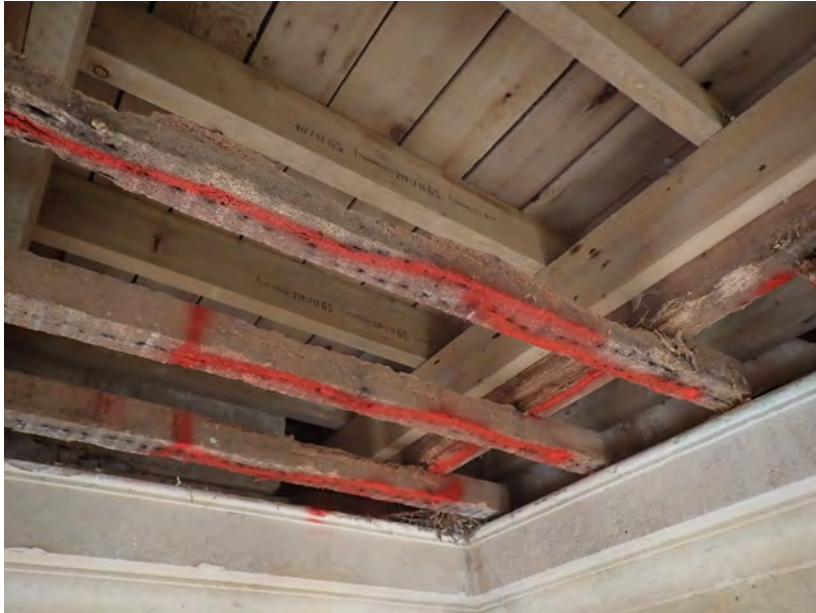
**Fig 1:**

South Pavillion, north-east corner;  
showing decayed ceiling joists and  
decay to the easternmost secondary  
beam

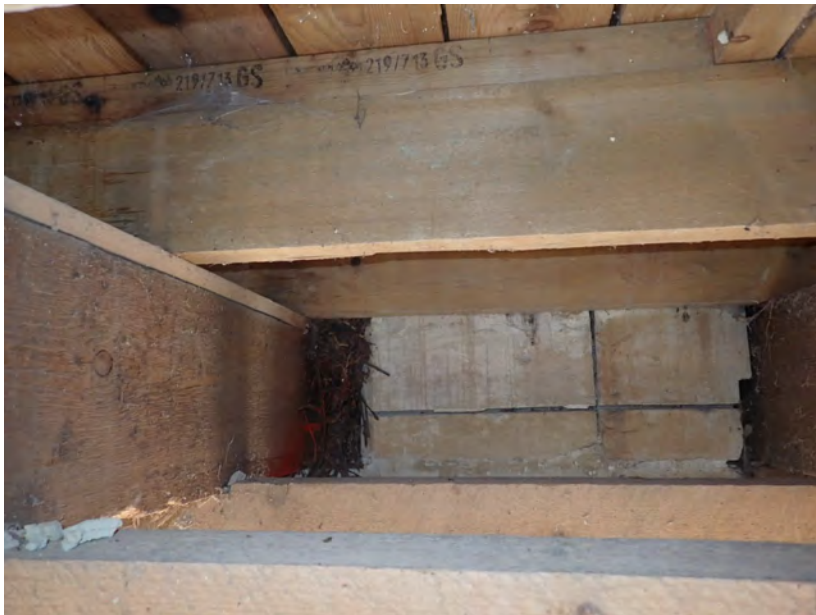
**Fig 2:**

South Pavillion, west wall; showing  
ceiling joist bearing ends

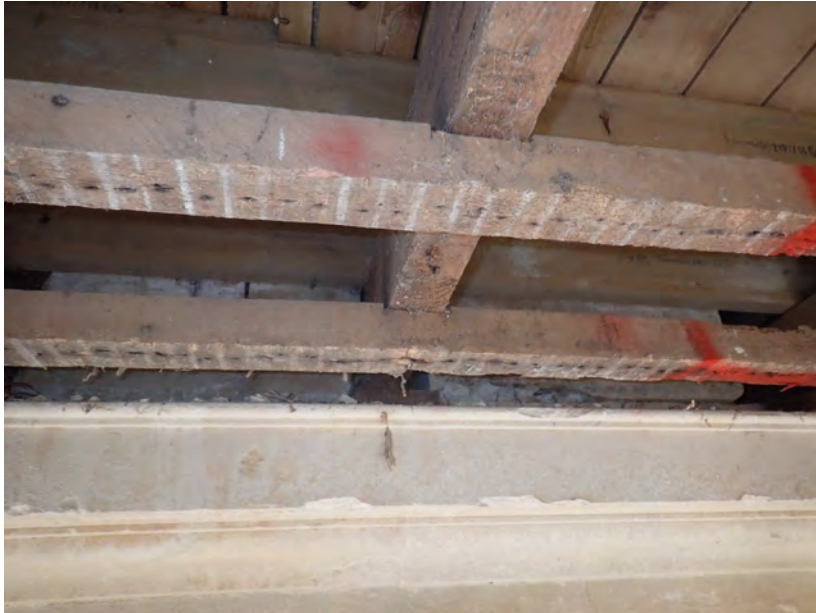
**Fig 3:**

South Pavillion, north wall; showing the middle secondary beam which was sat on a timber pad in the north wall

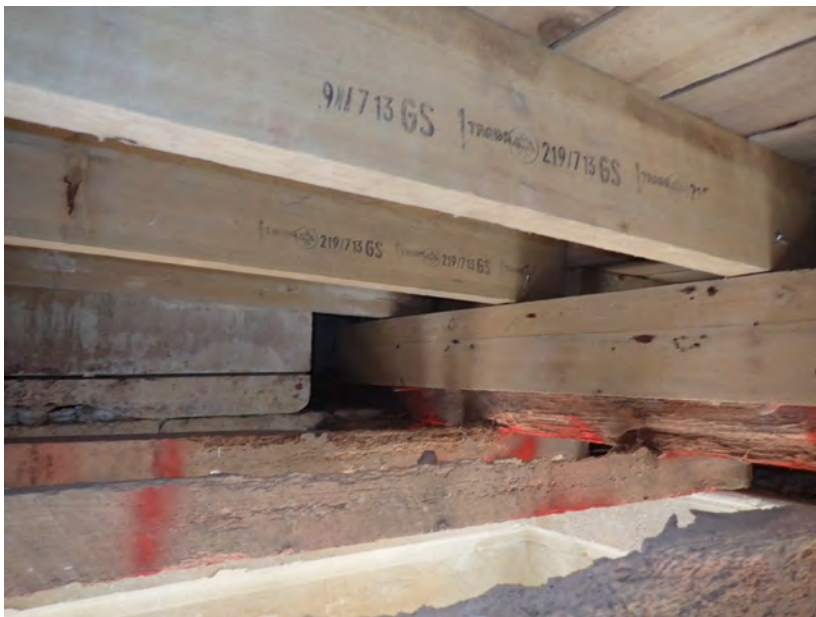
**Fig 4:**

South Pavillion, north wall; showing the westernmost secondary beam which was found to be decayed at its bearing end

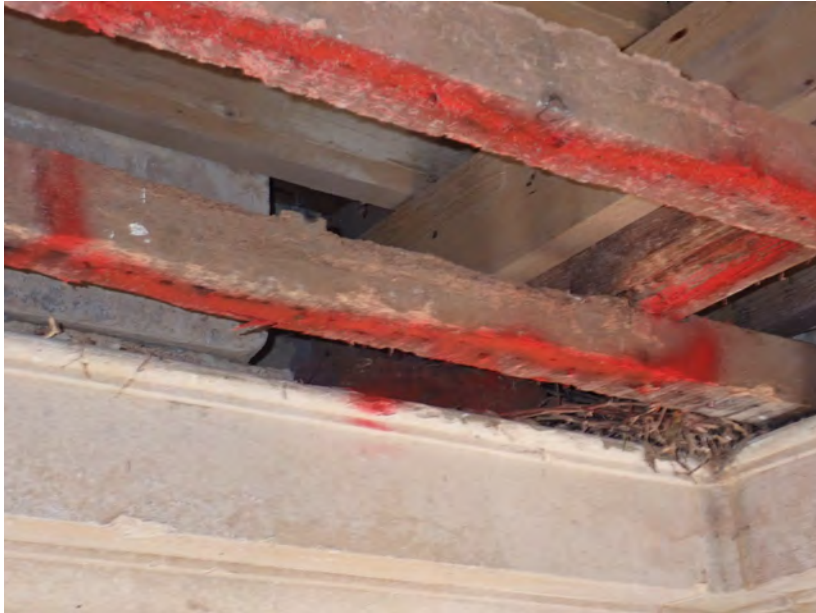
**Fig 5**

South Pavillion, north-east corner;  
showing decayed secondary beam  
bearing end and ceiling joists

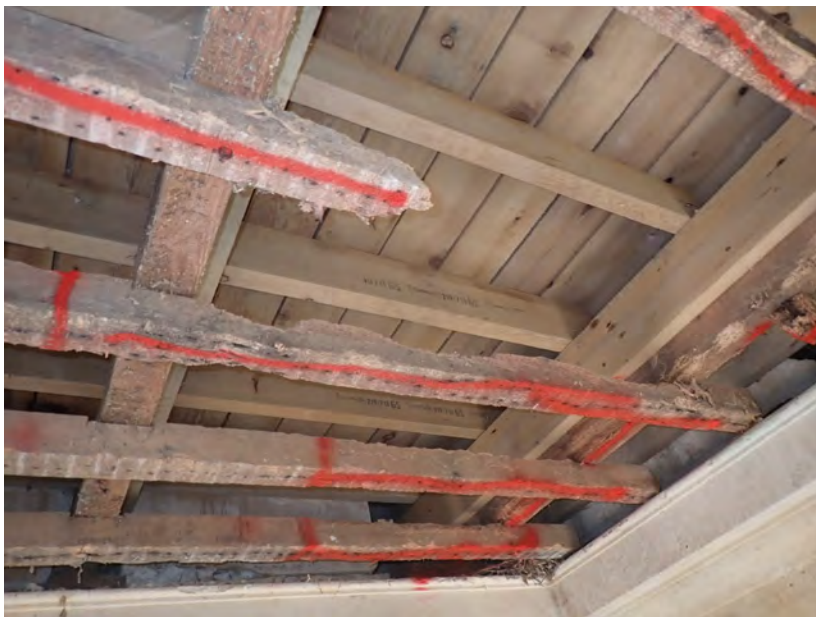
**Fig 6**

South Pavillion, wide view of north-  
east corner; showing decayed ceiling  
joists, with a section of one missing

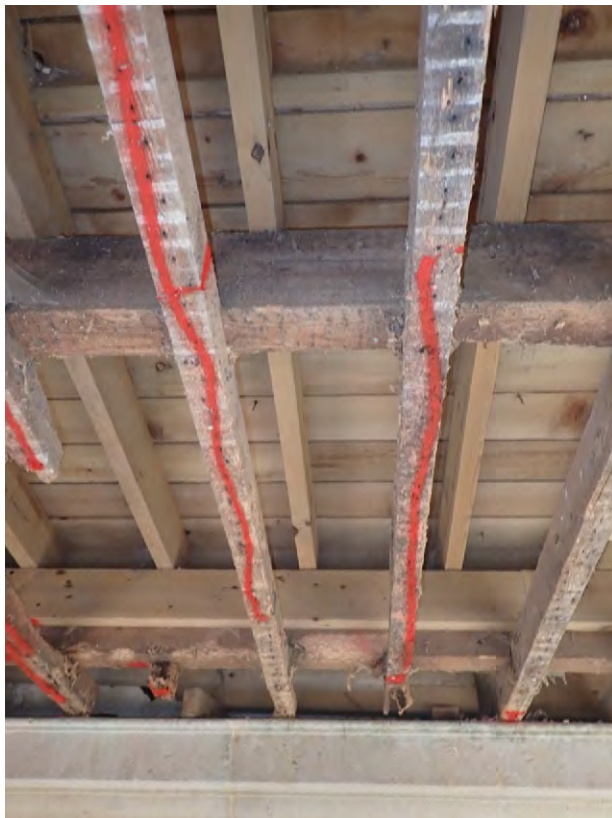
**Fig 7**

South Pavillion, 5th and 6th ceiling joists from north in east wall; showing decay to ceiling joists

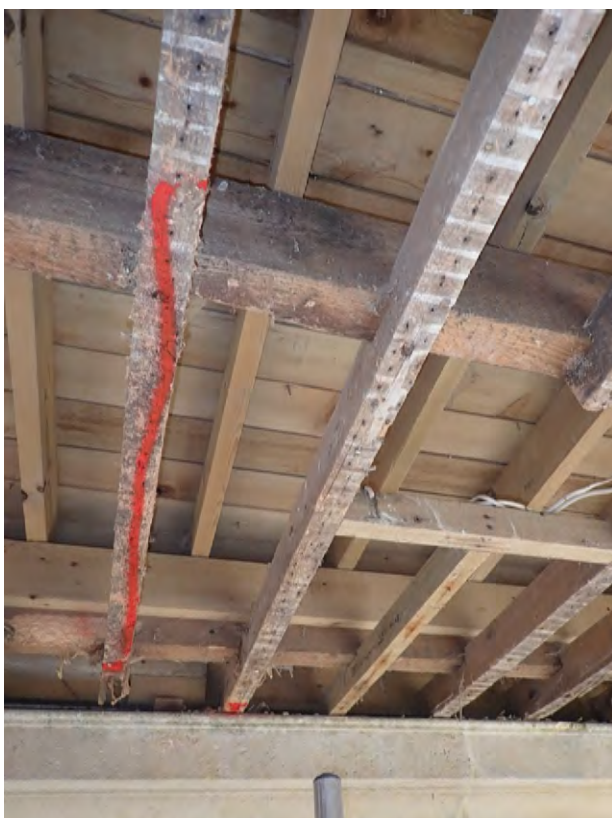
**Fig 8**

South Pavillion, 6th and 7th ceiling joists from north in east wall; showing decay to the ceiling joist lengths and bearing ends

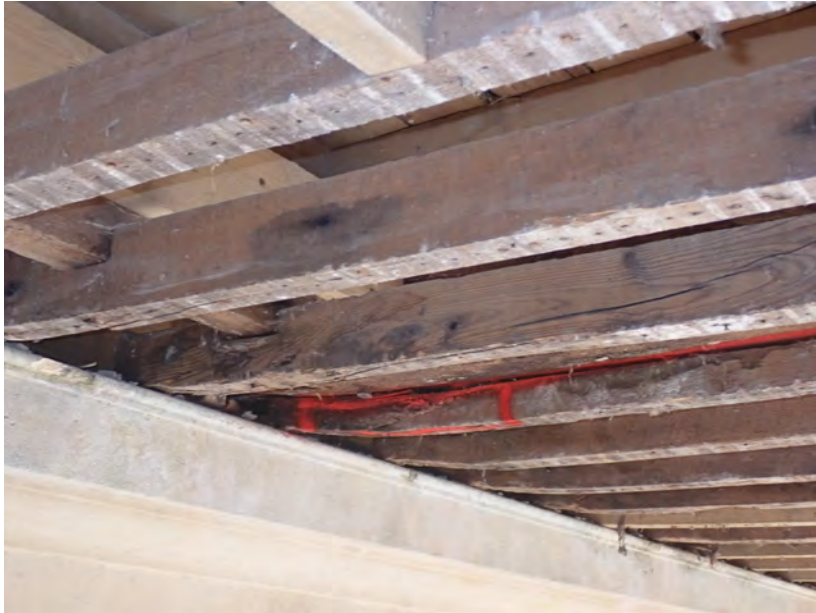
**Fig 9**

South Pavillion, looking from north to south; showing deflection, splitting, and decay to the ceiling joist below the primary beam central to the area

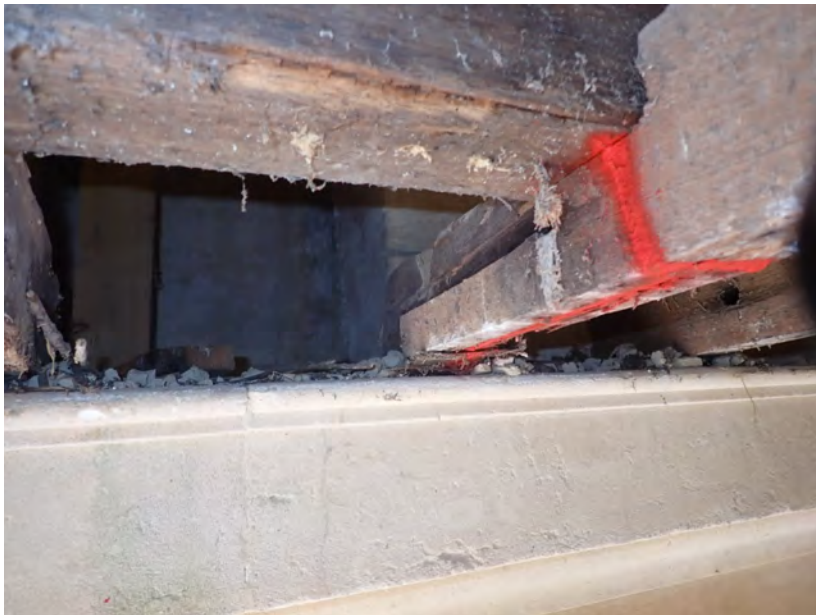
**Fig 10**

South Pavillion, north half of west wall; showing notching to the bearing end of a ceiling joist

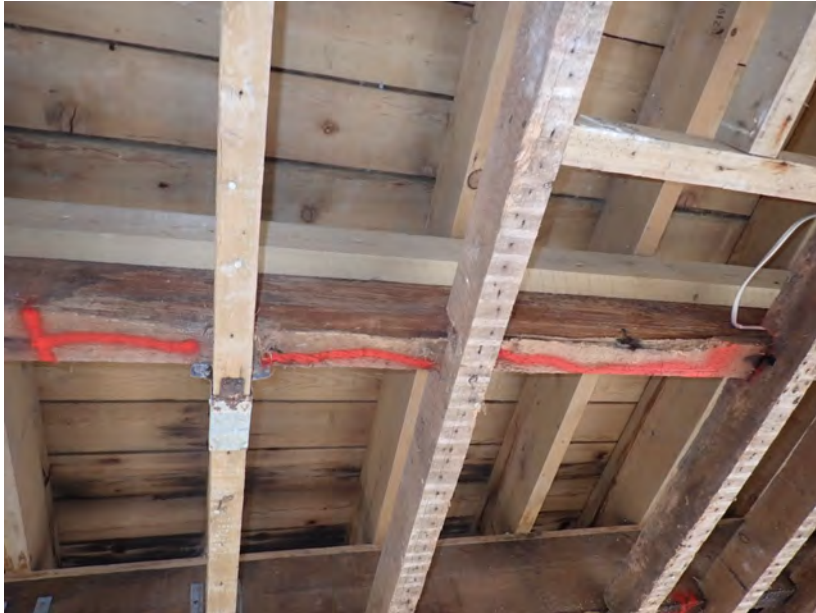
**Fig 13**

South Pavillion, middle secondary beam in southern half of pavillion; showing loss of cross-section due to partial decay to the underside

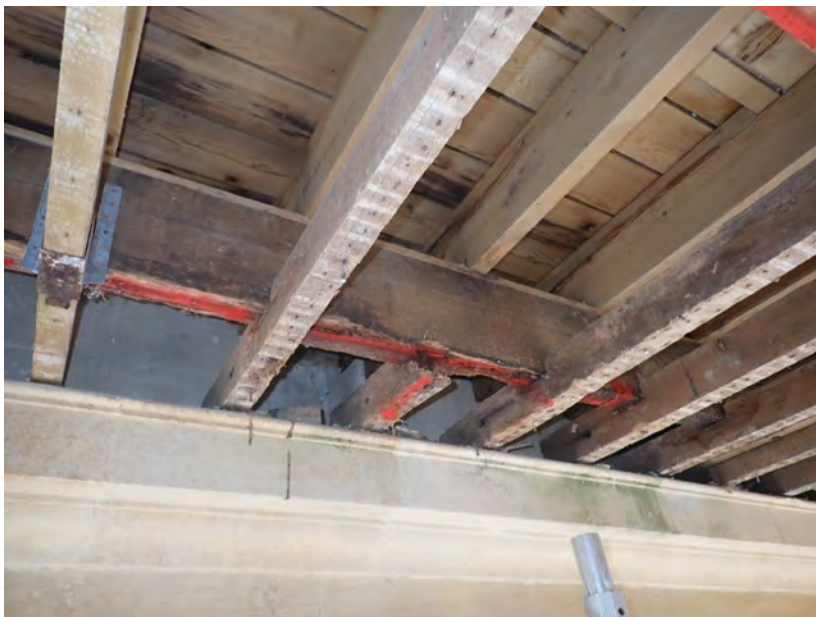
**Fig 14**

South Pavillion, north end of decayed section of western secondary beam, central area; showing a broken ceiling joist, the connection detail of newer joists, and decay to the secondary beam

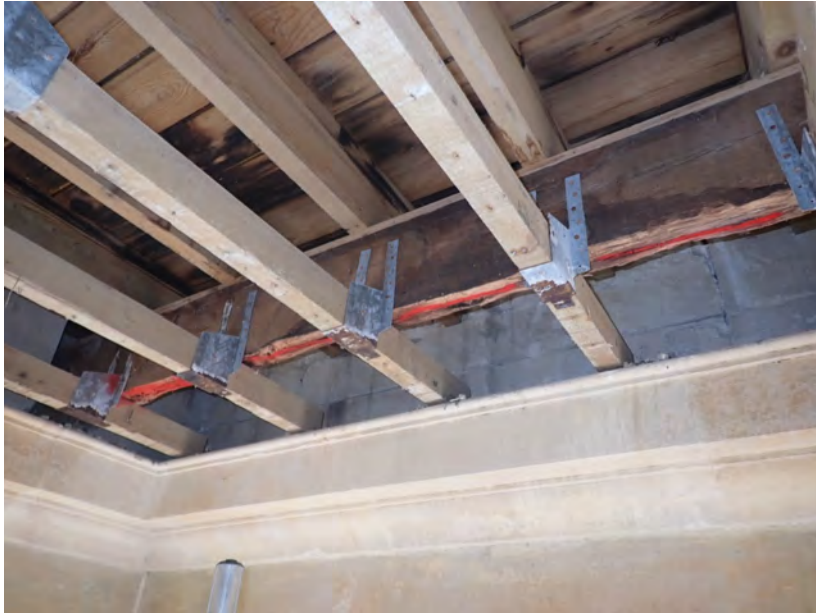
**Fig 15**

South Pavillion, south end of western secondary beam; showing partial decay to the secondary beam to which the newer ceiling joists are hung

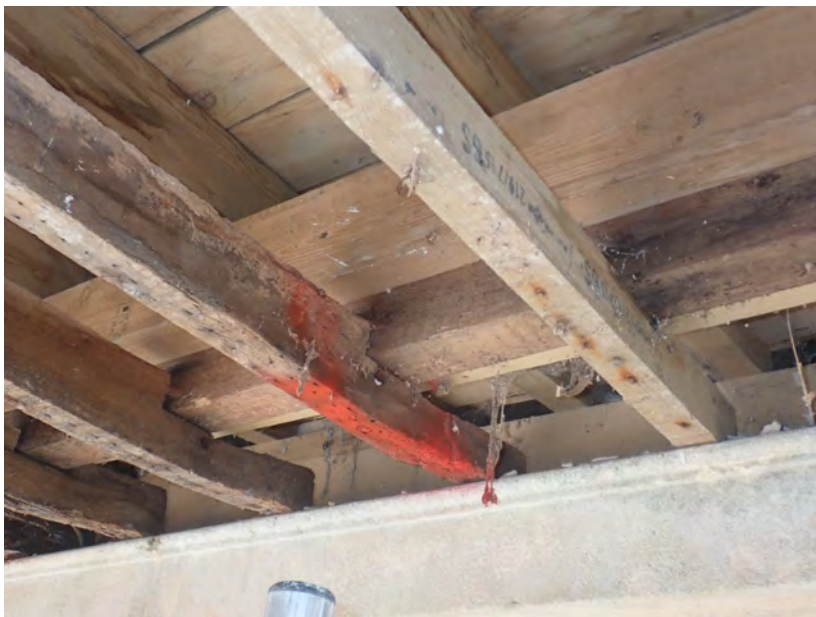
**Fig 16**

South Pavillion, north-east corner of south half of pavillion; showing deflection and notching to a ceiling joist

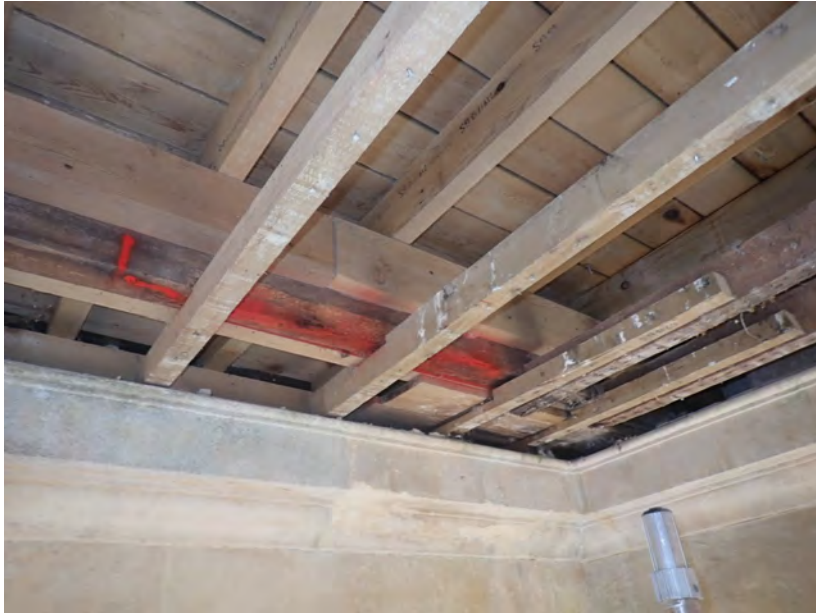
**Fig 17**

South Pavillion, south-west corner; showing the easternmost secondary beam, with new partner timbers either side, but decay to its bearing end and ~10% cross-section loss along its length

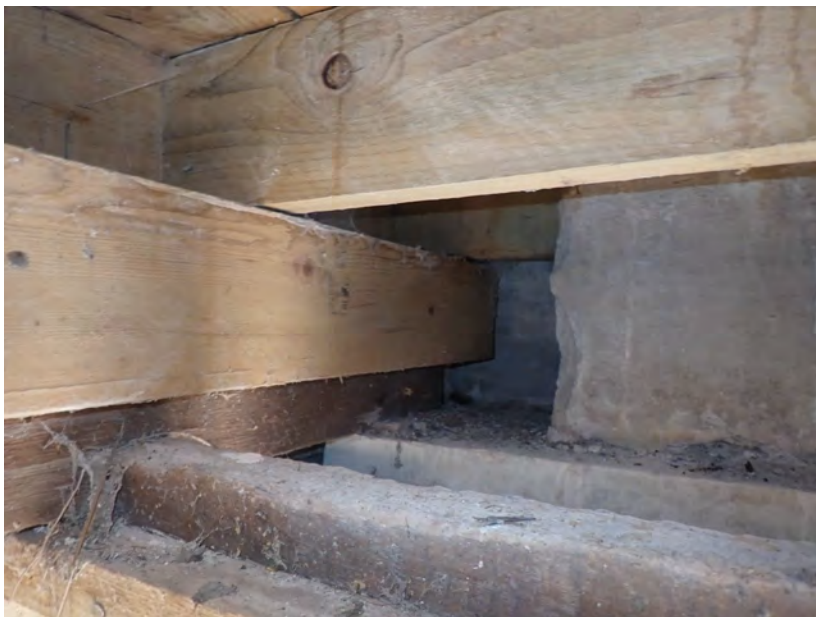
**Fig 20**

South Pavillion, south-east corner;  
showing air gaps at wall

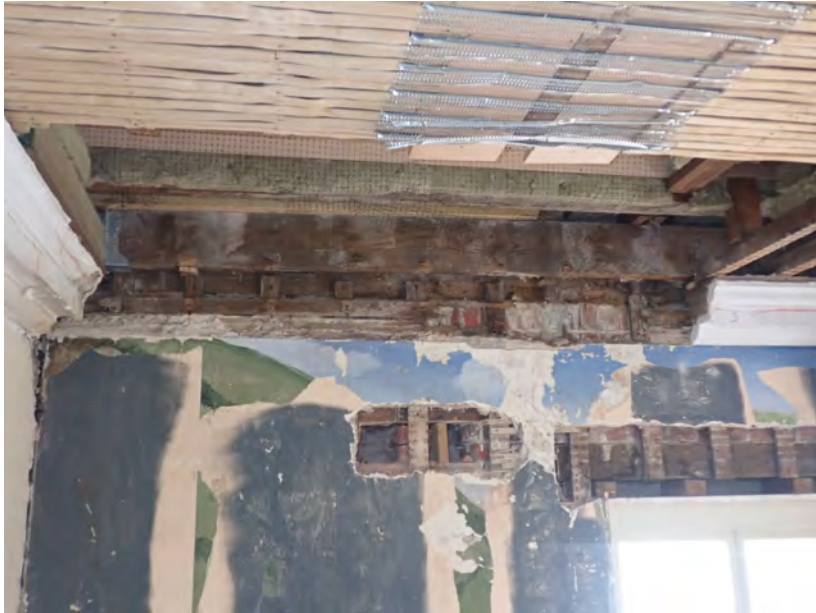
**Fig 21**

| REFERENCE | ITEM | ABA/AA/Size Group<br>OBSERVATIONS | H+R OBSERVATIONS | RECOMMENDATIONS | CLIENT<br>COMMENTS |
|---|---|---|---|---|---|
| <b>SNB15.1.1</b> | S16 Wall plate:<br>Roof void north side | Severely decayed plate observed on site. Flight holes are large and suggest potential death watch beetle activity. Timber specialist to confirm that the infestation is no longer active and confirm that the infestation has not spread to other timber elements within the roof void. As well confirm the extent of decay | <p>Construction: Rafter plate forming the north and east perimeter to area S16. Corner connection strengthened via a corner tie. Corner tie providing structural bearing to the north perimeter secondary beams east end</p> <p>Condition: Structural decay from historic wet rot and death watch beetle activity noted to multiple timber structures in contact to the north and east perimeter walls. All deep moisture contents <b>too dry to suggest active infestation</b>. Decayed items included; north perimeter <b>rafter plate</b> for the full span of the room at <b>~3.8m</b>. Structural decay to the east perimeter rafter plate from the north-east corner for up to <b>~750mm</b>. Structural decay to the <b>corner ties</b> north bearing end for up to <b>~200mm</b>. Structural decay to the north perimeter secondary beams east bearing end (where it meets the corner tie) for up to <b>~400mm</b></p> | <p><i>No chemical treatment required in relation to fungal decay or wood-boring beetle infestation</i></p> <p><i>Structural Engineer to comment</i></p> <p><i>The decayed sections of rafter plates should be cut back to sound material and replaced with new to match existing. The decayed corner tie should be replaced entirely in like-for-like. Allow for structural partnering to the decayed secondary beam under the direction of the SE. All new timber in contact with the masonry wall head should be fully isolated using continuous lengths of standard plastic damp-proof material</i></p> | |

S16, north wall; showing a general view of the section of wall with decayed wall plate

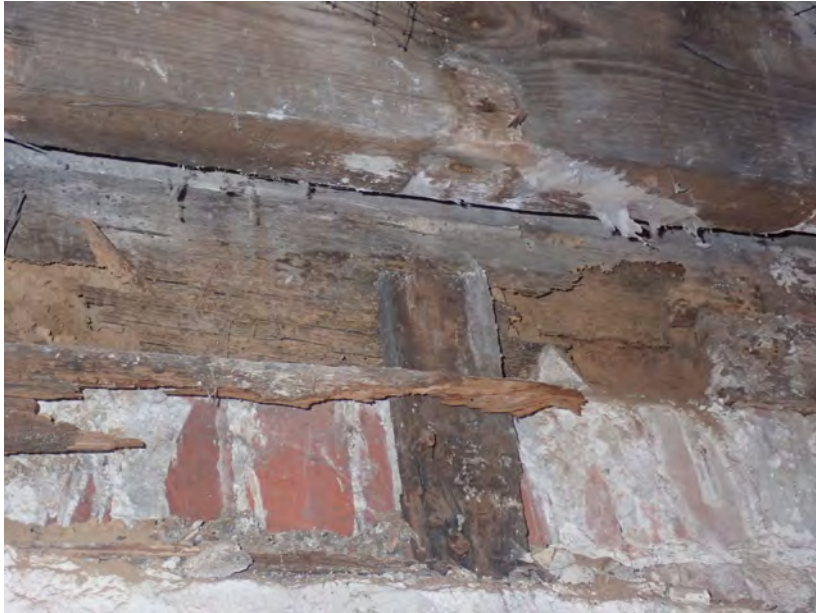
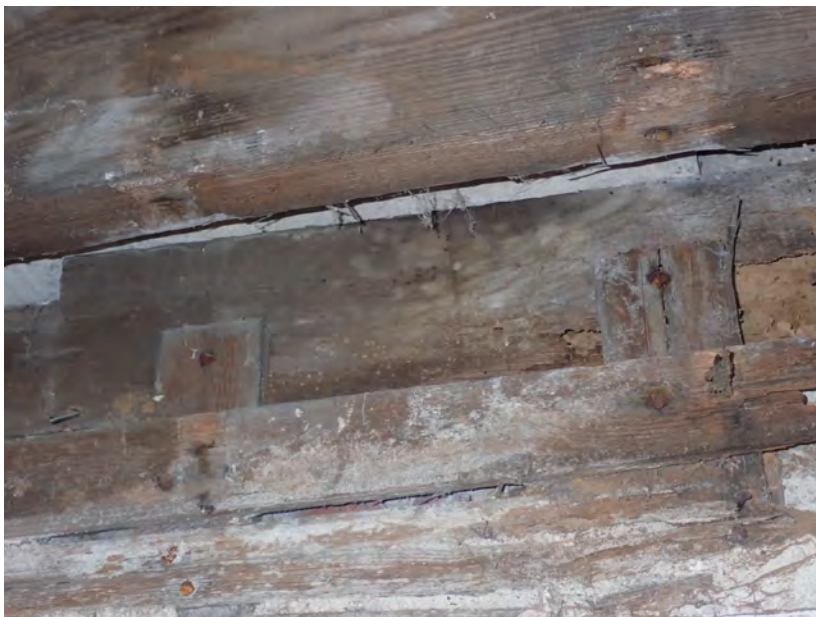
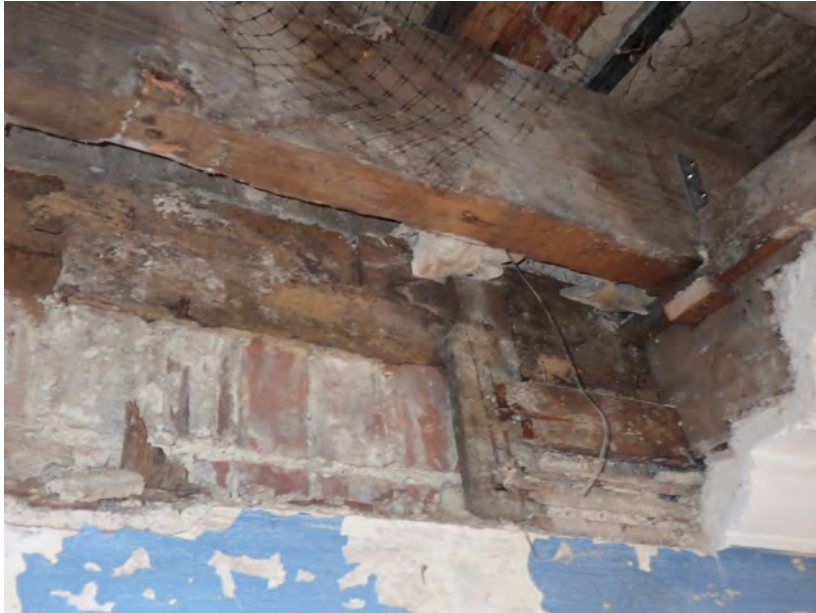
S16, north wall; showing decay to the wall plate

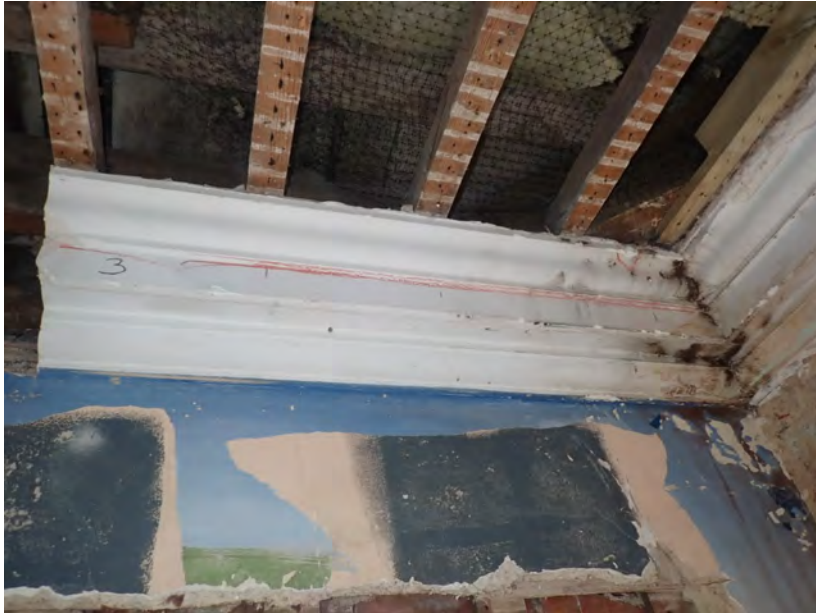
**Fig 27**

S16, north-east corner; showing the limited access to the wall plate - decay was detected through drilling

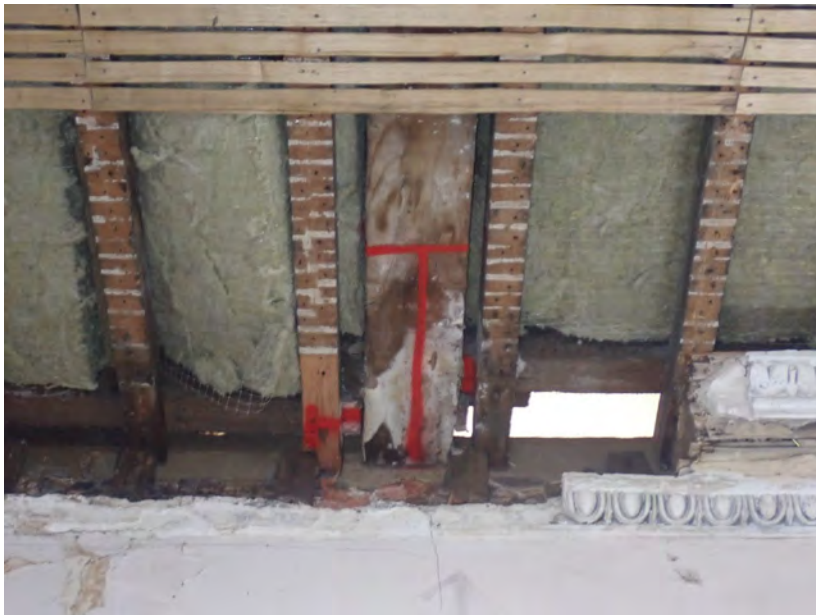
**Fig 28**

| REFERENCE | ITEM | ABA/AA/Size Group<br>OBSERVATIONS | H+R OBSERVATIONS | RECOMMENDATIONS | CLIENT<br>COMMENTS |
|---|---|---|---|---|---|
| <b>SNB15.1.2</b> | F11 Roof truss:<br>North bearing end of roof truss within south roof void adjacent to proposed C34 chimney stack | Truss observed to be hollowed towards northern end. Timber specialist to review and confirm the extent of decay and percentage loss of section | <p>Construction: Principal room truss running in north-south orientation over the F11 passageway. Truss tie beam providing structural support to the adjacent east and west secondary ceiling beams. Multiple embedded bonding timbers identified within masonry wall directly beneath truss end bearing</p> <p>Condition: Structural decay from historic wet and dry rot activity noted to multiple timber structures in contact to the internal north wall. All deep moisture contents too dry to suggest active infestation. Decayed items included; truss tie beams north bearing end subject to structural decay for <b>~480mm</b> from the face of the wall. <b>2no.</b> adjacent (east and west) secondary beams tenoned into the tie beam also structurally decayed for their tenons + <b>~100mm</b>. Structural decay also detected to <b>3no.</b> embedded oak <b>bonding timbers</b> set beneath the truss end for their full extents at <b>~600mm</b></p> | <p><i>No chemical treatment required in relation to fungal decay or wood-boring beetle infestation</i></p> <p><i>Structural Engineer to comment</i></p> <p><i>The decayed bearing end of the tie beam and secondary beams to be cut back to sound material and replaced/supported under the direction of the SE. Allow for cutting out approximately &lt;1800mm linear of decayed bonding timbers in a hit-and-miss fashion and infilling with suitable masonry</i></p> | |

F11, north wall; showing decay to the tie beam ~480mm, and to the secondary beams which were tenoned in. The eastern beam was decayed at its bearing end, the western at its bearing end plus ~100mm

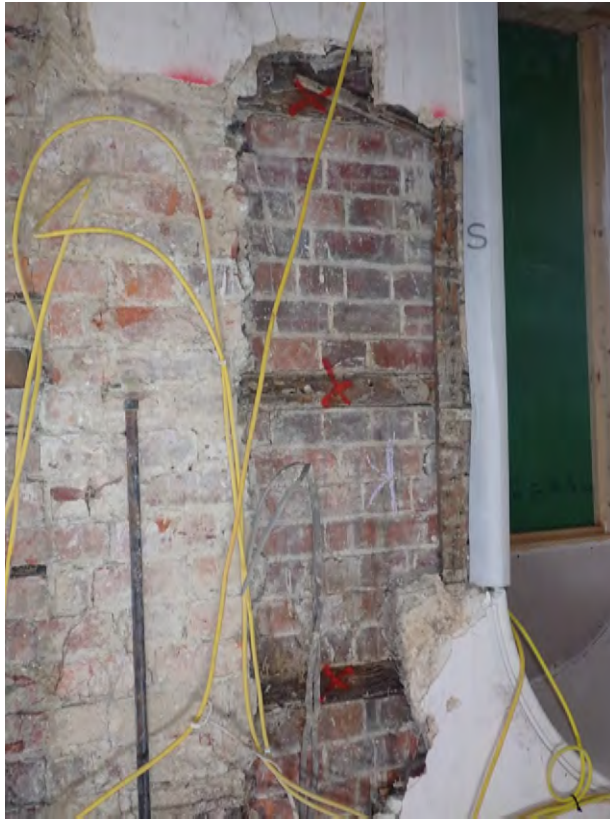
**Fig 29**

F11, north wall; showing decayed embedded bonding timbers. These were decayed ~600mm, their full extents

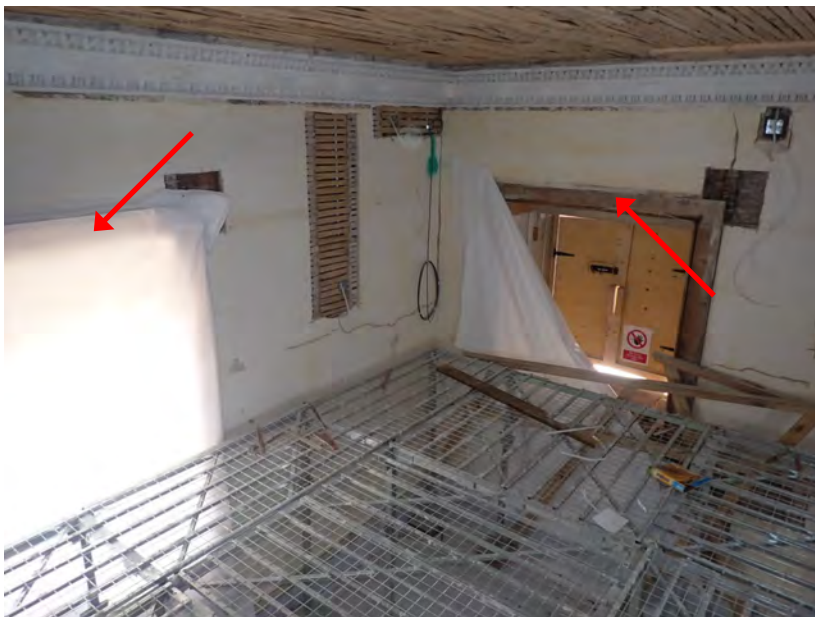
**Fig 30**

S13, south-east corner; showing 2no. Lintels for investigation. These were not of timber but were of flat brick arches

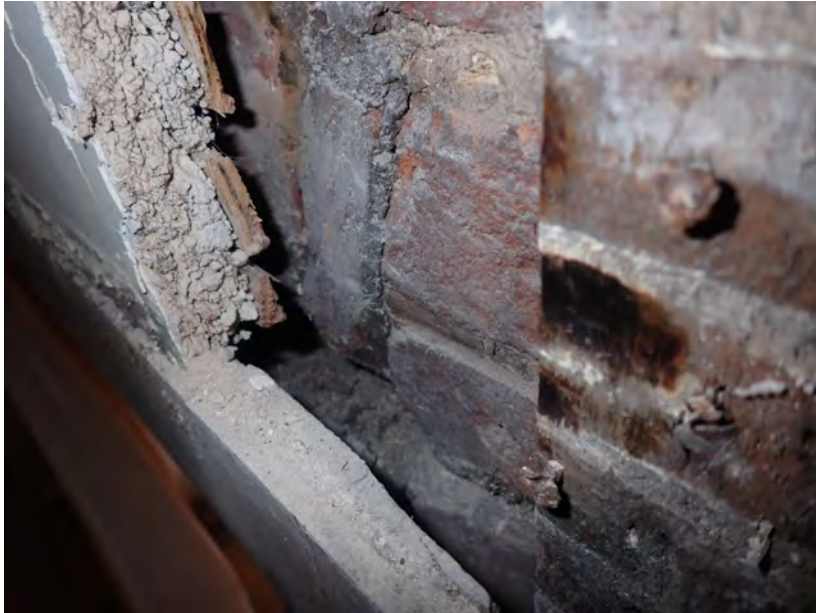
**Fig 31**

S13, east wall; showing 1no. lintels for investigation which was not of timber but were of flat brick arches

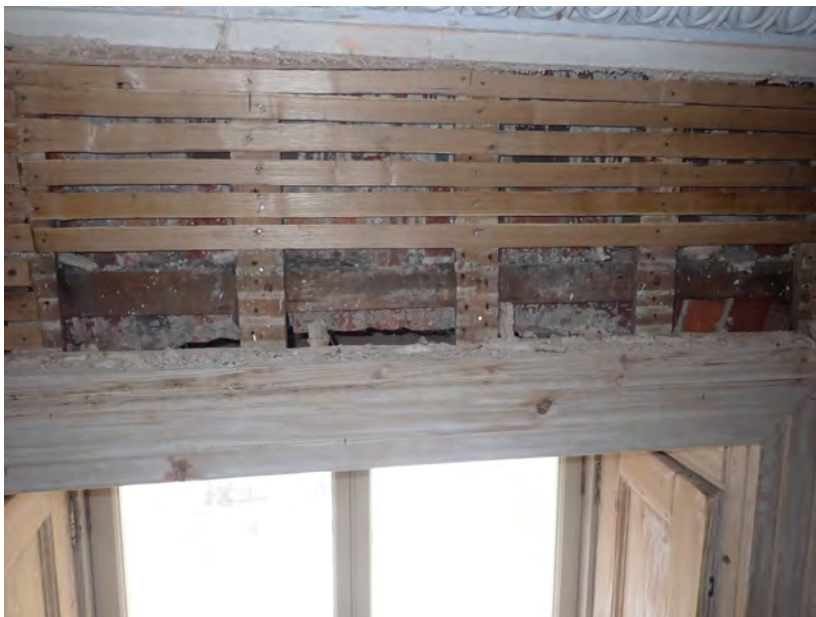
**Fig 32**

S6, west wall; showing the lintel to be of brick not timber

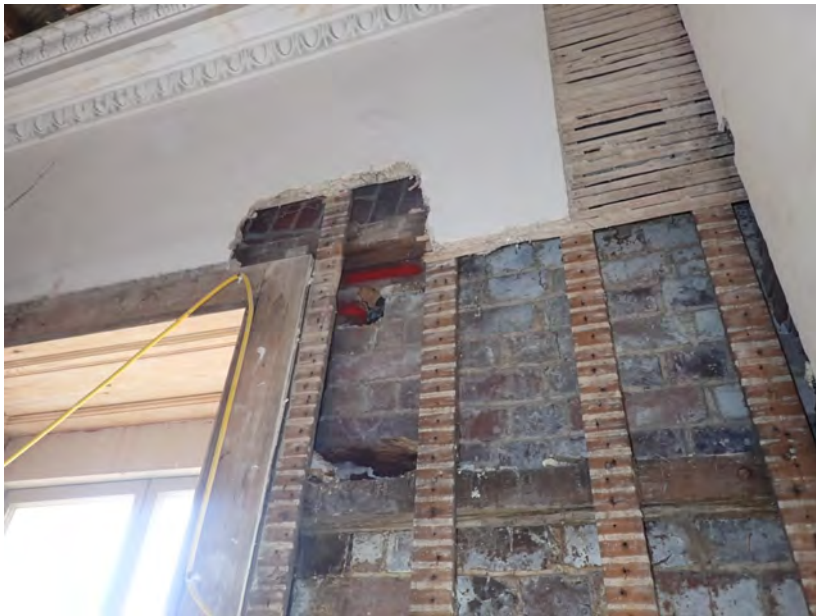
**Fig 33**

F5, east wall; showing decay to the underside of the lintel and the timber pad due to wood-boring beetle

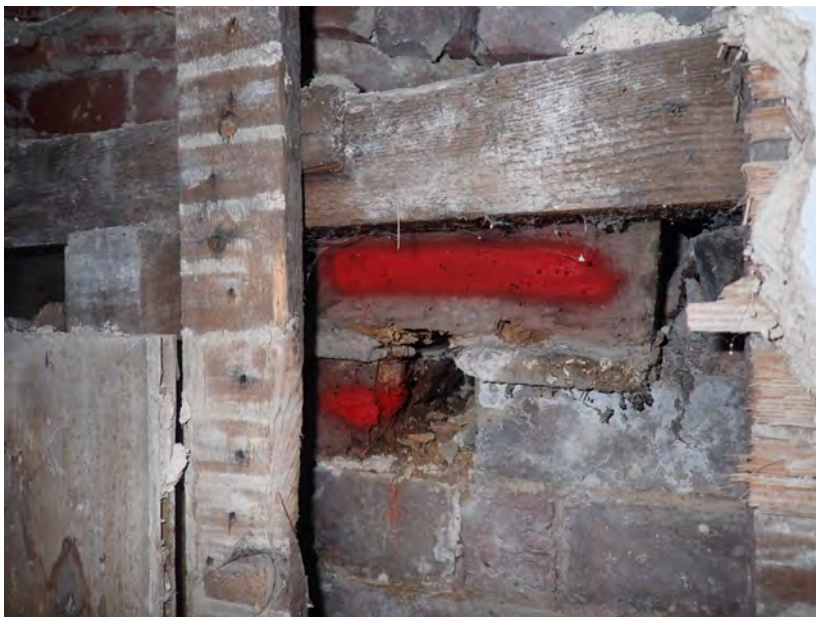
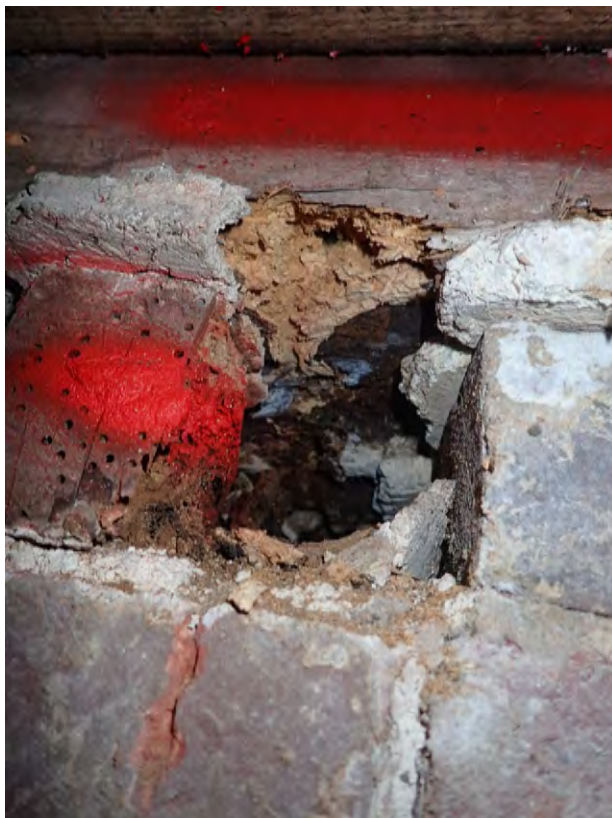
F5, east wall; showing further detail of the lintel decay

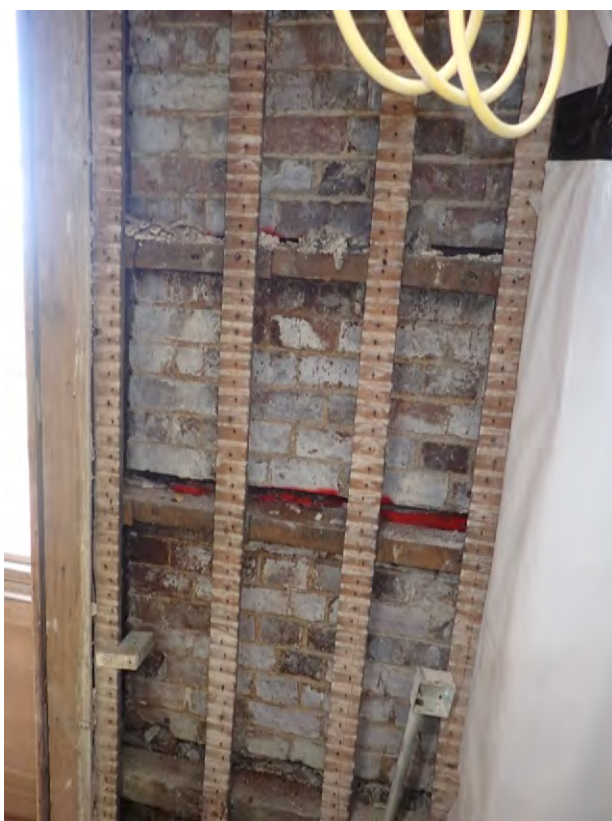
**Fig 36**

F5, east wall; showing decayed embedded bonding timbers

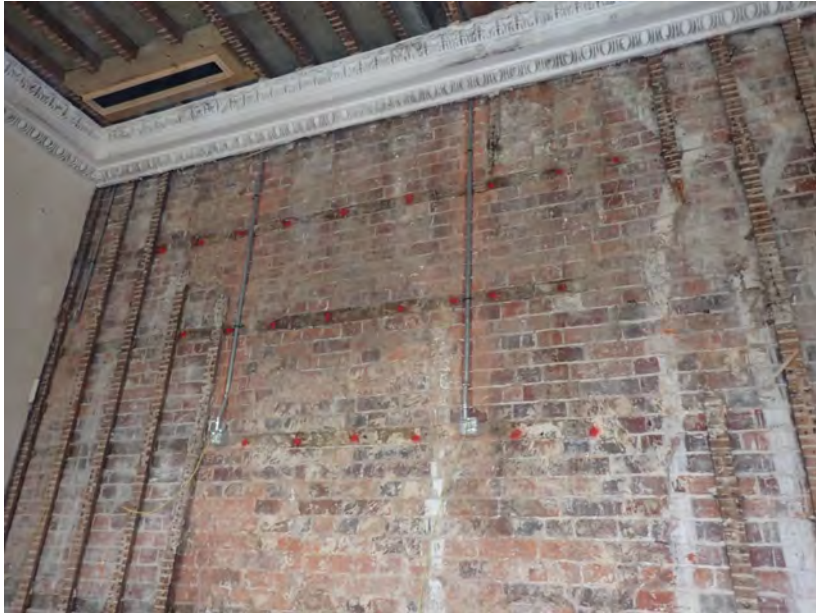
**Fig 37**

F5, west wall; showing decayed embedded bonding timbers which were decayed ~3.2m, ~2.5m, ~2m from top to bottom - timbers behind the floor and cornice were anticipated to follow this pattern

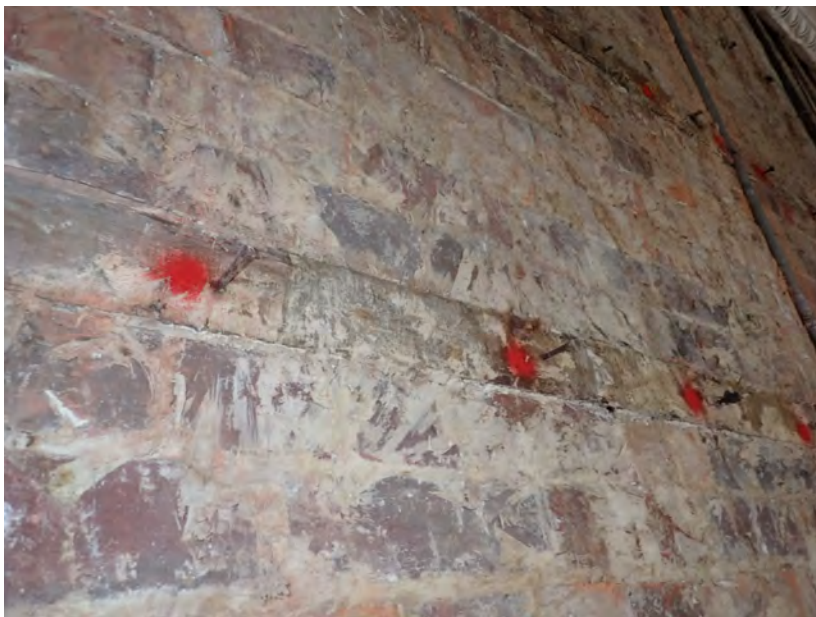
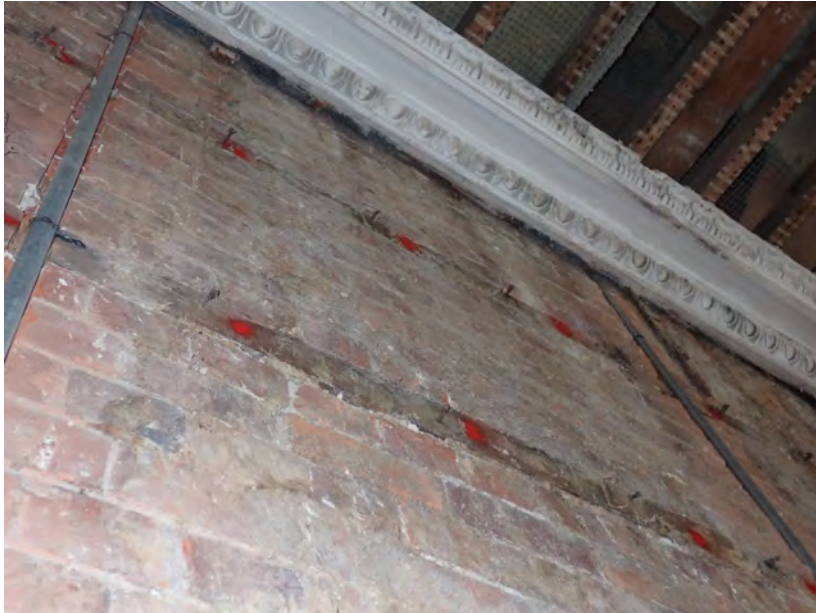
F5, west wall; showing further detail of decayed embedded bonding timbers

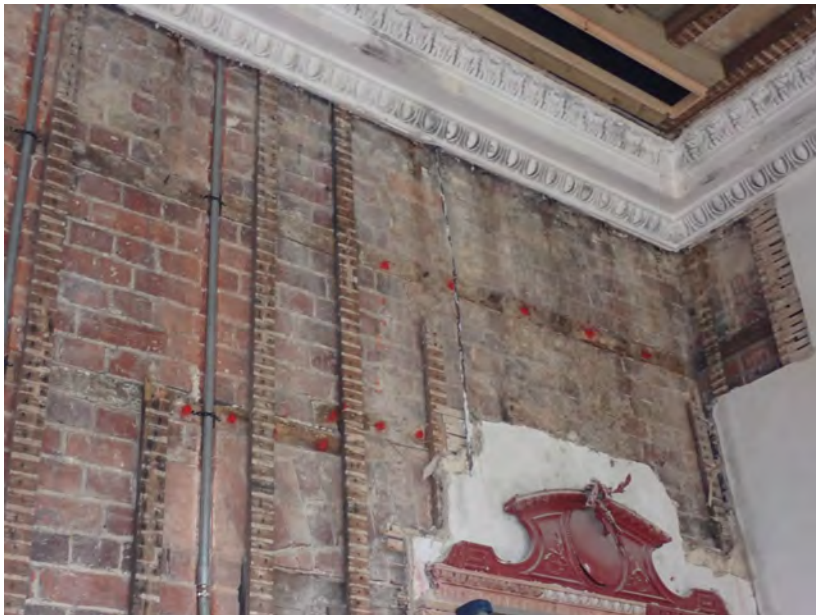
**Fig 40**

F5, west wall, north half; showing decayed embedded bonding timbers ~2m, ~300mm, ~500mm from top to bottom

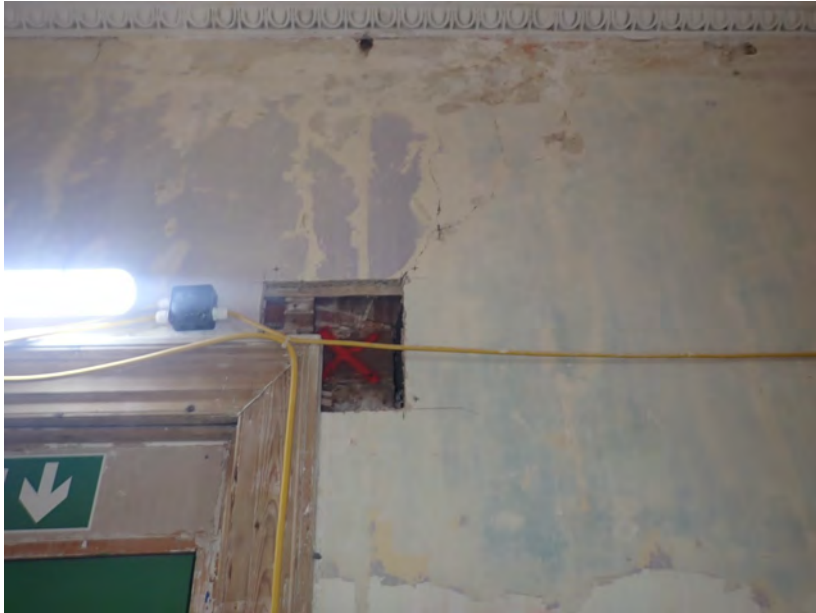
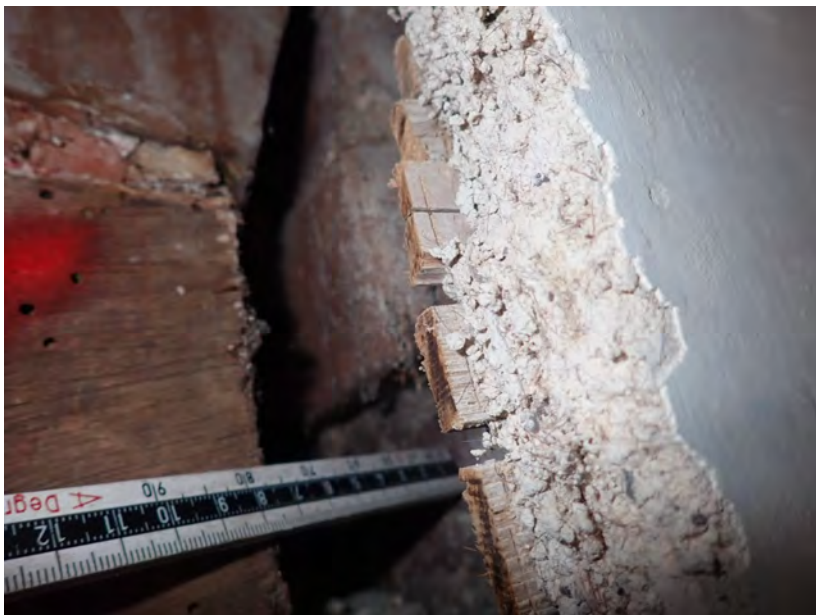
F6, north wall; showing cracking to the brick and plaster around the lintel, the brick arch above which was found to have no bearing - Structural Engineer to comment

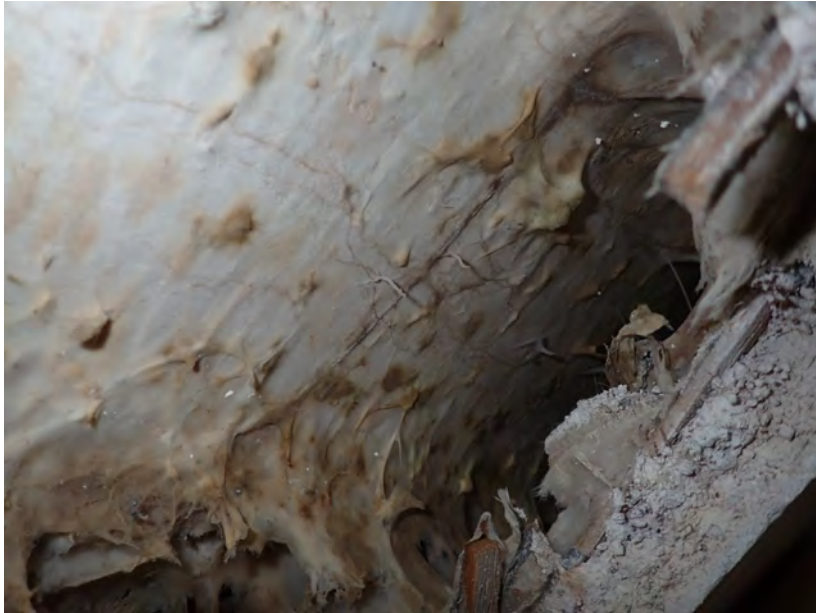
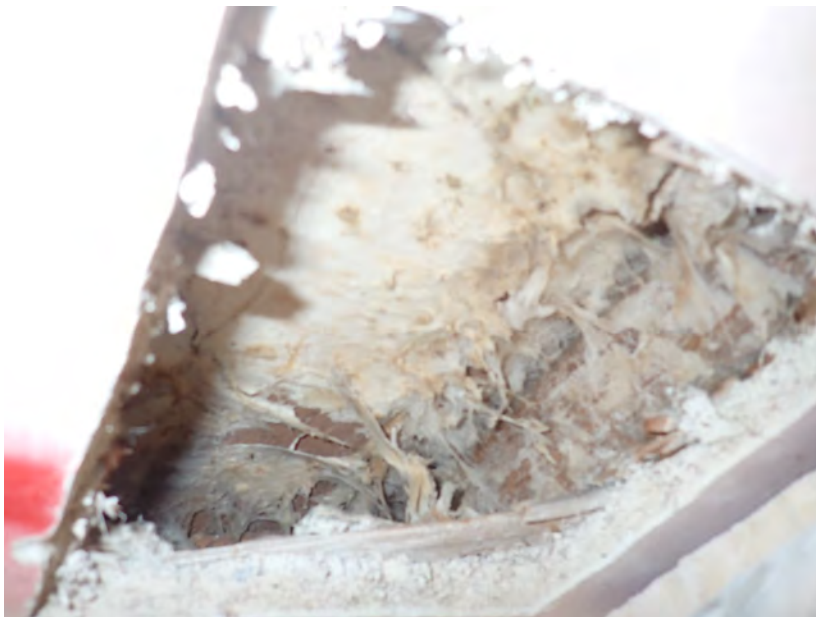
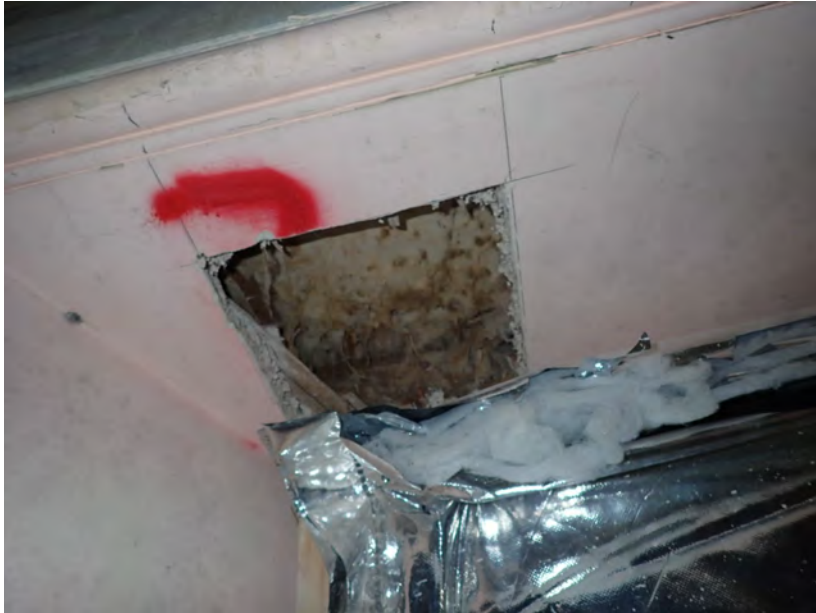
G19; showing mycelium to the void in which the lintel was contained

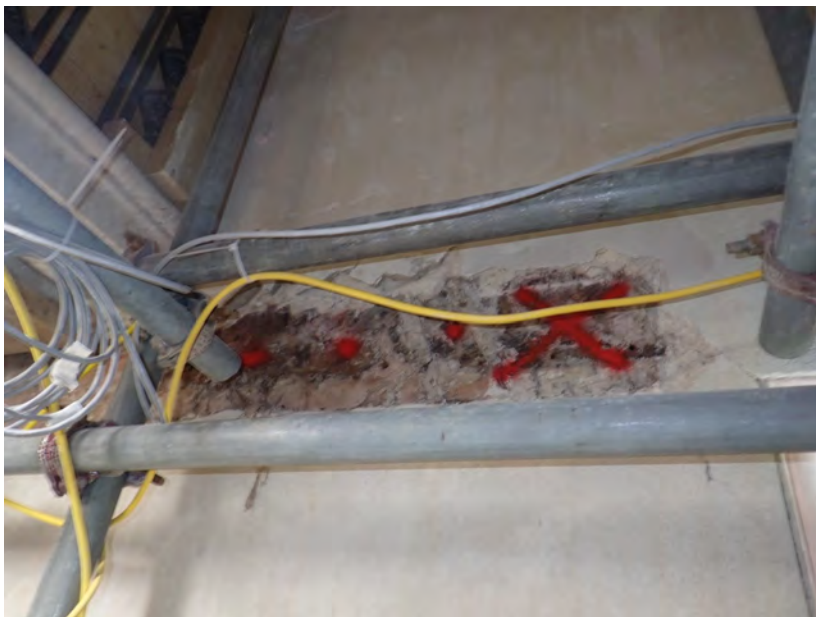
**Fig 46**

G19; showing extent of decay to the lintel
