# Tottenham House: Condition investigation of prescribed areas to timber structures

Site note B15 for 21 May 2025, job no. 446-49

The aim of this survey was to investigate prescribed outstanding areas of various timber structures for their construction and condition throughout the main house and north courtyard as per instruction document reference '2025-05-07 *Timber Investigations – outstanding items*'. Where applicable remedial advice has been provided

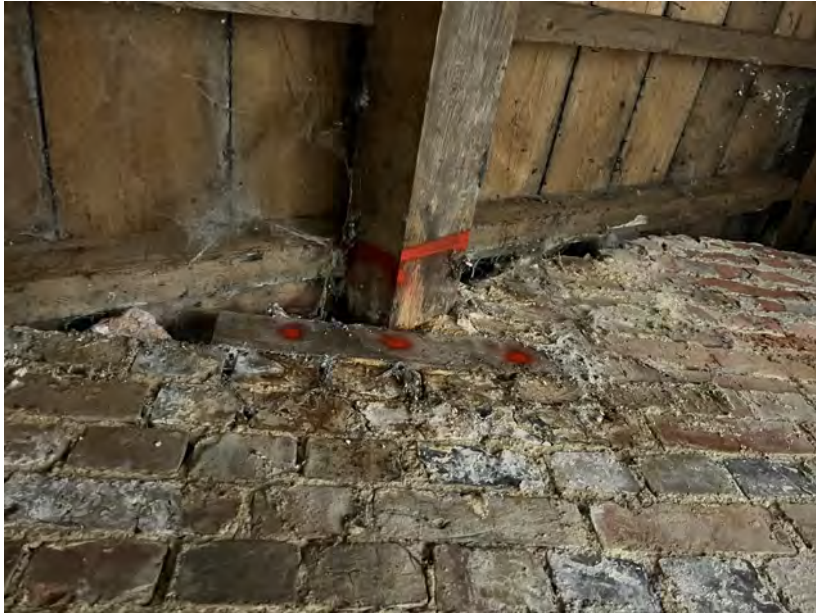
**Fig 47**

| REFERENCE | ITEM | ABA/AA/Size Group<br>OBSERVATIONS | H+R OBSERVATIONS | RECOMMENDATIONS | CLIENT<br>COMMENTS |
|---|---|---|---|---|---|
| | | | Condition: Structural decay from historic and active wet and wood-boring beetle activity noted to multiple timber structures in contact to the external south and west perimeter walls/parapet gutters. Deep moisture contents recorded as highly elevated at ~20%, which is high enough to support wood-boring beetle infestation and almost high enough to support wet rot decay organisms. Decayed items included; south pitch purlins west bearing end structurally decayed for ~150mm from the face of the wall, also the purlin timber pad beneath for its total length/section. Structural decay to the west perimeter wall embedded ceiling beam for ~2.1m. Structural decay also to the south perimeter parapet gutter rafter plate for ~300mm to its south end | The decayed bearing end of the purlin to be cut back to sound material and replaced/supported under the direction of the SE. Allow for the decayed sections of rafter plate to be cut back to sound material and replaced with new to match existing. Allow for cutting out approximately 2100mm linear of decayed embedded ceiling plate in a hit-and-miss fashion and infilling with suitable masonry. All new timber in contact with the masonry should be fully isolated using continuous lengths of standard plastic damp-proof material | |

G40 west gable; showing decayed embedded purlin pad and purlin. The pad is decayed to full length and purlin is decayed to 150mm

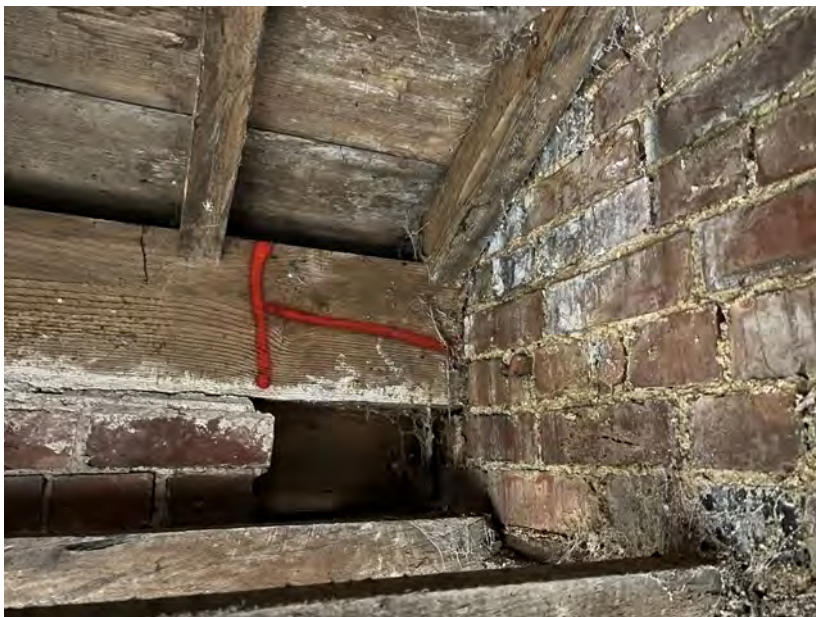
**Fig 48**

G40 west gable; showing embedded rafter plate with decay to 300mm of it's length

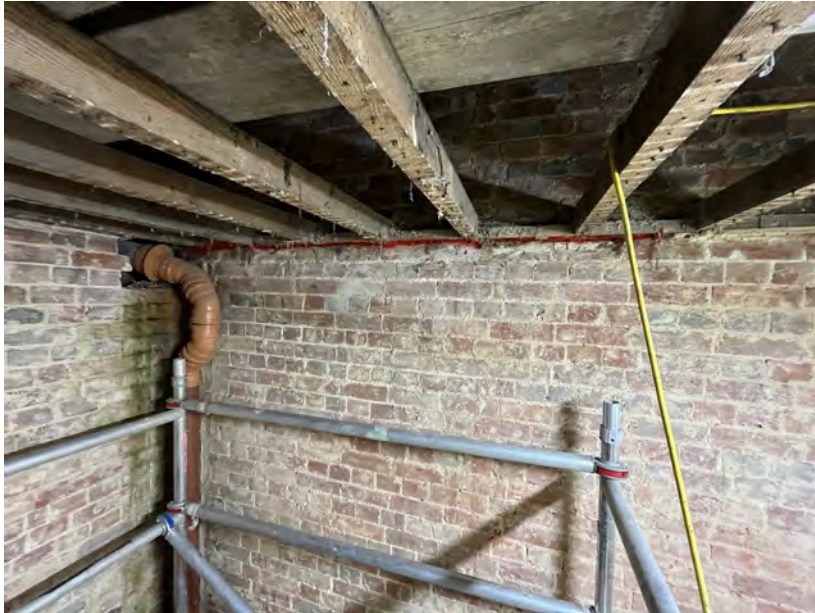
**Fig 49**

G40 south-west corner; showing embedded wall plate with decay to 2.1m along it's length

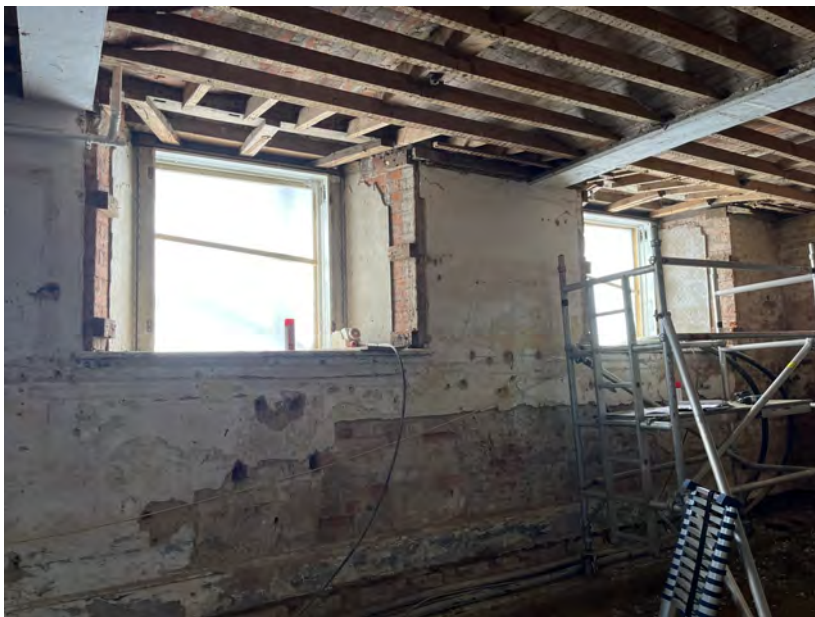
**Fig 50**

B53; showing general view of south windows. No decay present

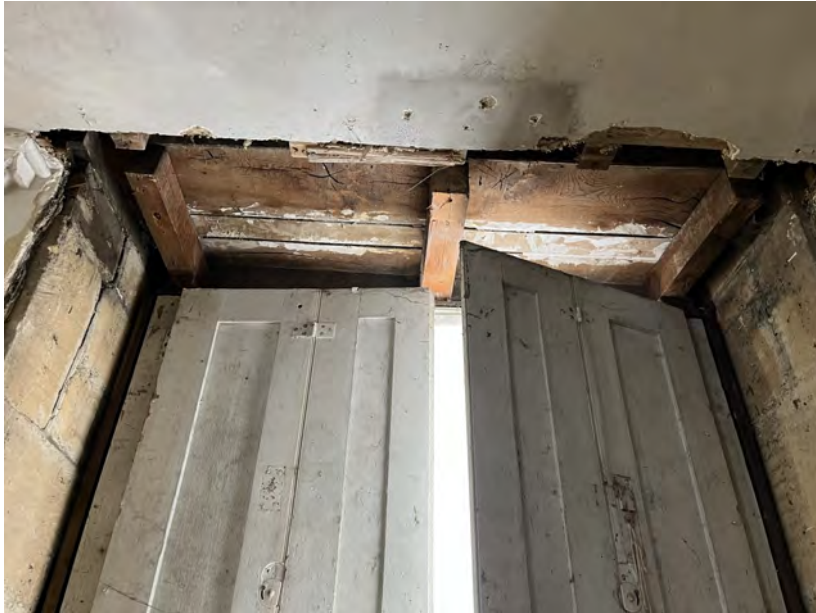
**Fig 51**

B17 north-west window; showing oak timber lintel in good condition. No decay present

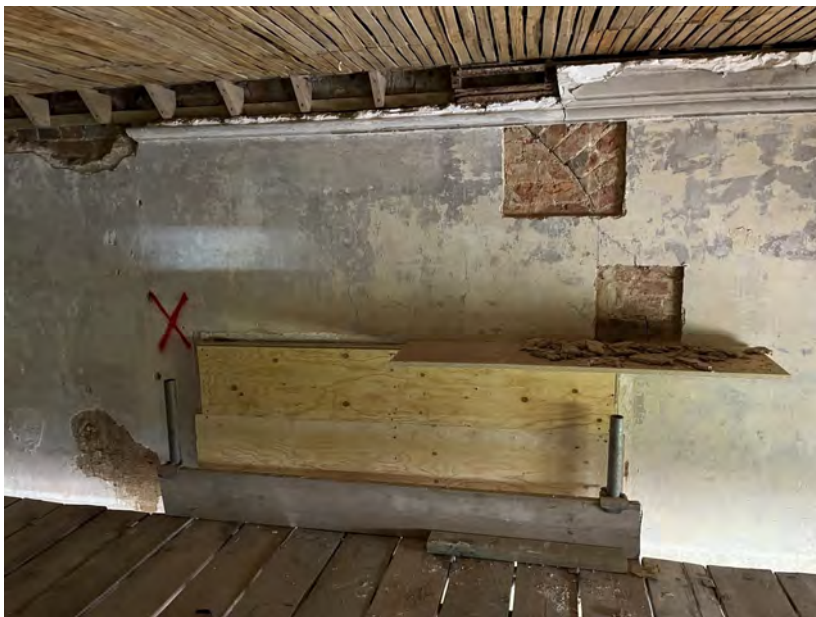
**Fig 52**

G24 north wall; showing decay to the west bearing end. No access to the lintels pads or it's full condition
