## **SPECIFIC DEFECT REPORT**

**Baldham House  
Baldham, Seend  
Melksham  
Wiltshire  
SN12 6PW**

**SPECIFIC DEFECT REPORT  
IN RESPECT OF  
Baldham House  
Baldham, Seend  
Melksham  
Wiltshire  
SN12 6PW**

**DATE OF INSPECTION  
Thursday 25<sup>th</sup> September 2025**

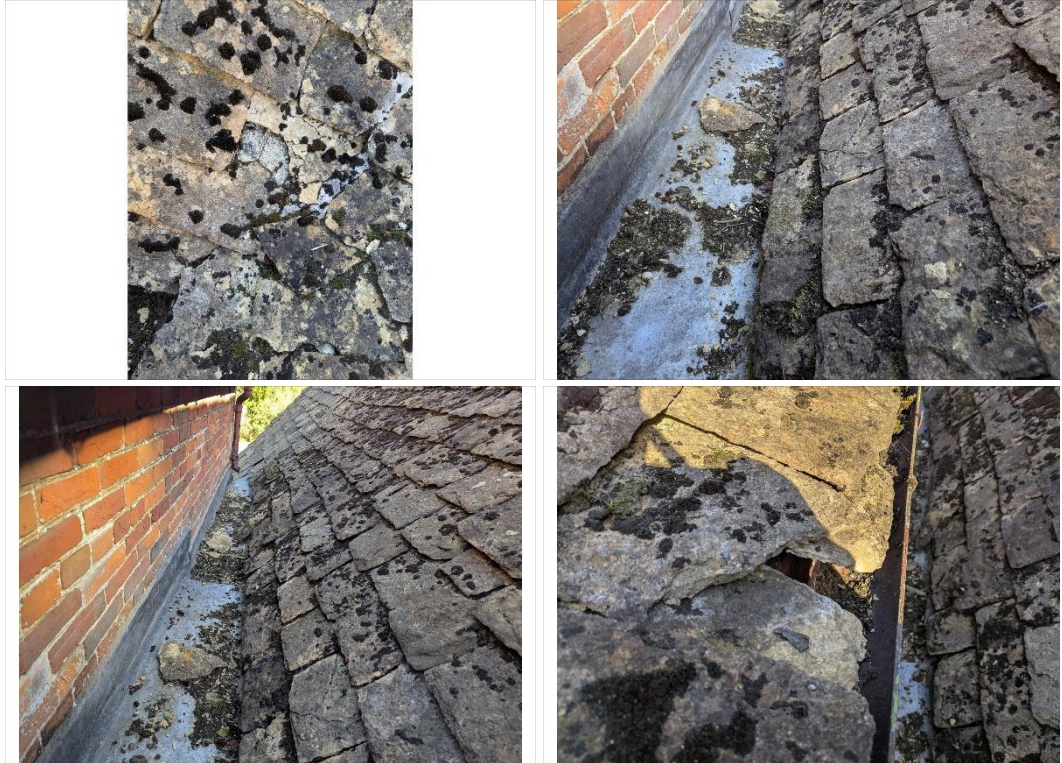
Externally the roof slopes are covered with diminishing Cotswold stone slates. There is extensive frost damage and wear to the stone slates.

**Damaged Cotswold stone slates.**

Given the overall condition of the roof coverings, it is our opinion that stripping and re-covering the roof slopes is now essential and should be undertaken as a matter of urgency. There is a high risk of regular water ingress into the roof voids due to the lack of underfelt and condition of the stone slates externally. This is likely to result in irreparable decay and damage to the original roof structure, original embedded structural timbers and original lath and plaster ceilings (which would be irreplaceable). Therefore, the condition of the roof is considered to put this Grade II Listed asset at significant risk. If left for an extended period the property could fall into a derelict state.

Finding enough Cotswold stone slates for use over the entire roof slopes is unlikely to be feasible to achieve in the required timescales. As the slates are diminished, specific

numbers of different sized slates will need to be sourced. Sourcing and locating this number of slates will be extremely difficult, if possible at all, as they are no longer manufactured and would need therefore to be salvaged. The cost is also likely to be prohibitively expensive.

It is our opinion that it would be possible to salvage enough slates for use on the outer roof slopes, with imitation stone slates on the inner roof slopes. The imitation stone slates are convincing in appearance from close up and will weather and match with the original ones. It would therefore be difficult to tell the two apart when they have been installed. The inner roof slopes are not in any event visible from ground level and this would therefore preserve the appearance of the building. By taking this approach, the original timbers and lath and plaster ceilings can be protected and this would provide long term protection of a Listed asset. The imitation slates are also likely to be lighter and therefore place less stress on the roof frame.

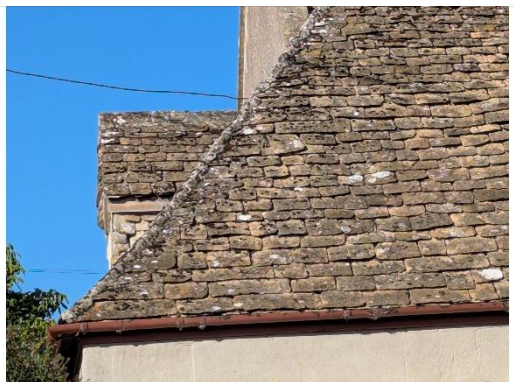
The ridges are finished with ridge tiles bedded in mortar, which is extensively deteriorated. The rear hip is formed with mortar laid over the tiles, which is deteriorated and damaged.

**Deteriorated hip detail to the rear right-hand side.**

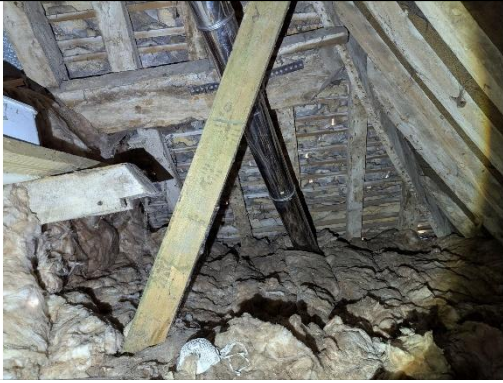
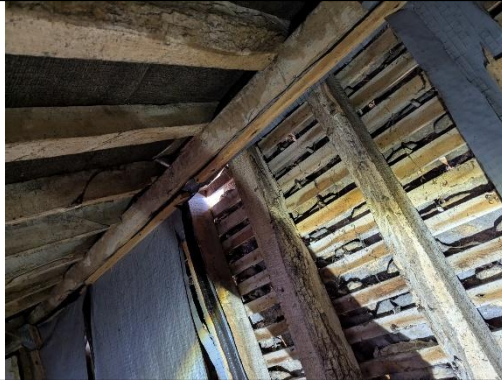
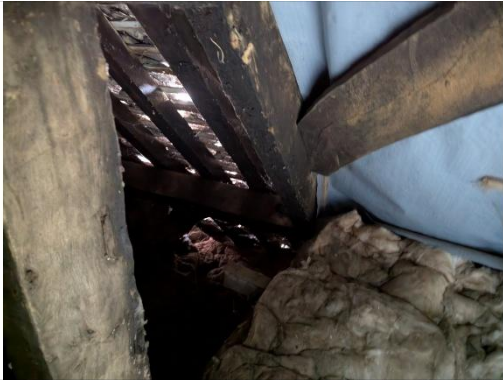
The rear roof slope is unfelted and there are multiple areas of daylight visible within the roof void. This creates a significant risk of wind-driven rain penetration given the exposed position of the property. Plastic underfelt has been installed to the inside of the roof structure, but this will not be effective as the material is not lapped into a gutter.

**Unfelted rear roof slope with daylight visible in many areas.**

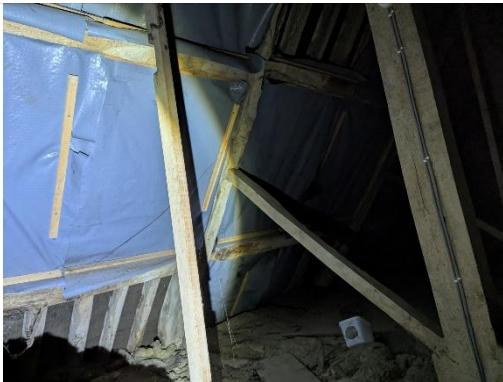
The remaining roof slopes are lined with vapour impermeable bitumen underfelt. The underfelt is of an age where it will have a limited lifespan. That being said, it does appear to be serviceable to the upper sections of the roof slopes in some areas, but it is deteriorated around the eaves and edges. Plastic material has been installed to the front roof slopes internally, presumably in an attempt to address water ingress. However, this is not a suitable repair as the underfelt will need to be lapped into a gutter.

**Plastic underfelt installed internally to the front roof slope.**

When the roof coverings are stripped, a budget should be allowed to treat wood boring beetle and carry out timber repairs. The use of a vapour permeable underfelt should be considered and it would also be sensible to upgrade the levels of insulation.

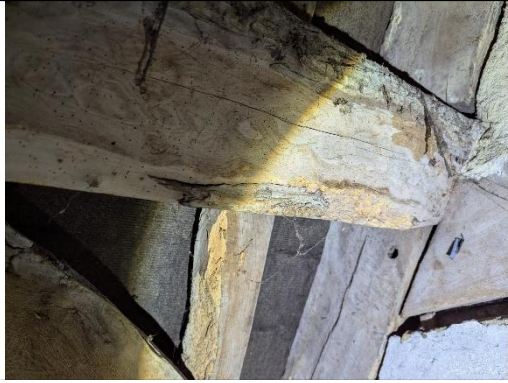
Within the roof void there is sporadic active wood boring beetle infestation. The lack of ventilation will significantly increase the risk of further infestation and timber decay.

**Active wood boring beetle infestation.**

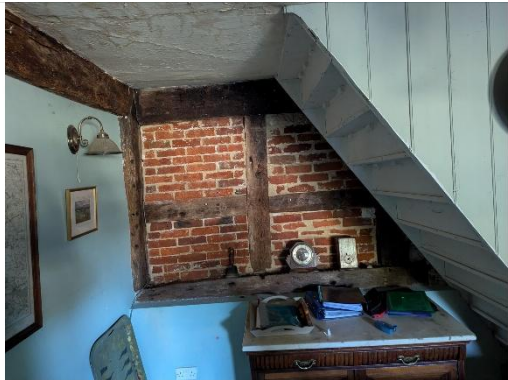
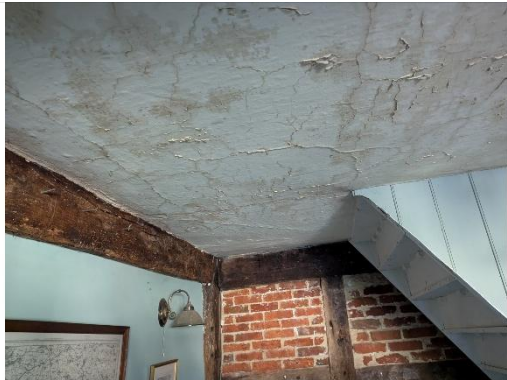
Internally at ground floor level to the rear left-hand reception room there is water damage to the ceiling and extensive dampness to the wall, which is believed to relate to an ongoing but intermittent roof leak.

**Water damage to the ceiling and wall within the rear left-hand reception room.**

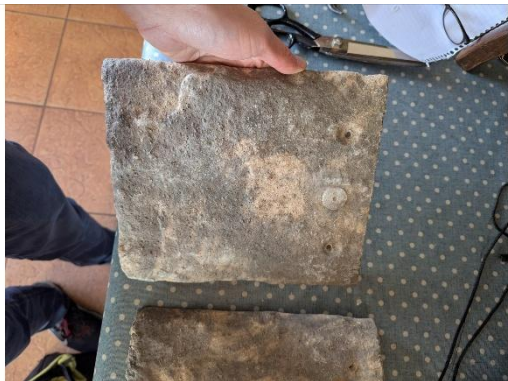
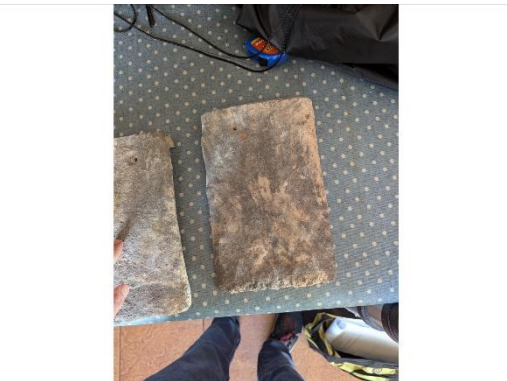
**Modern imitation slates are convincing in appearance.**
