## LACOCK ABBEY, WILTSHIRE

### WORKS TO RE-BUILD DEFECTIVE CHIMNEY

### JUSTIFICATION AND HERITAGE IMPACT STATEMENT

# CHIMNEY STABILITY AND CONDITION REPORT

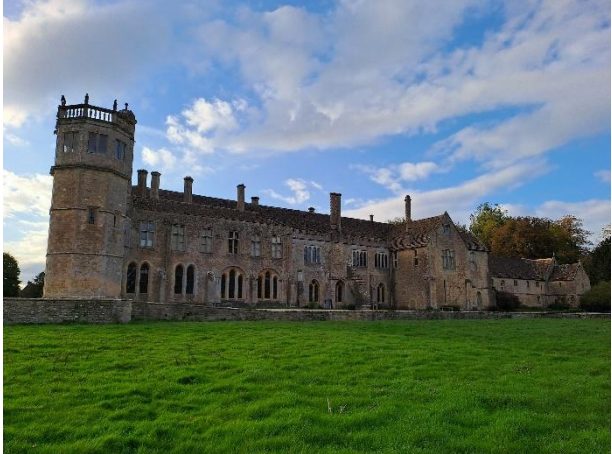
| East elevation of Abbey – chimney stack where works are proposed (referred to as ‘chimney’ below) visible, third stack from left. | South east elevation of Abbey – (‘chimney’ stack not visible from this angle). |

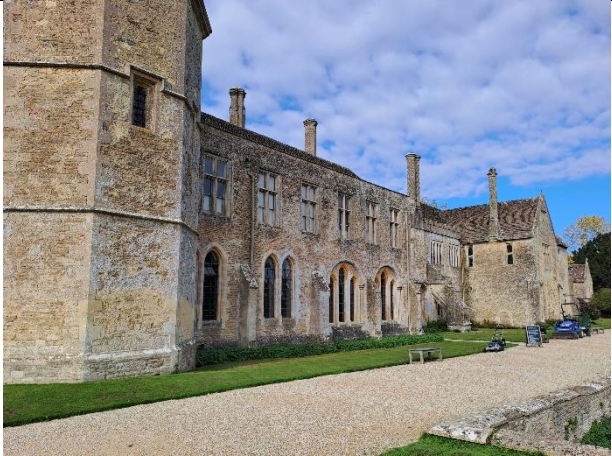
| South end of Abbey east elevation – 'chimney' visible, first stack visible to left of tower in foreground. | South end of Abbey east elevation – 'chimney' visible, third stack from left. |

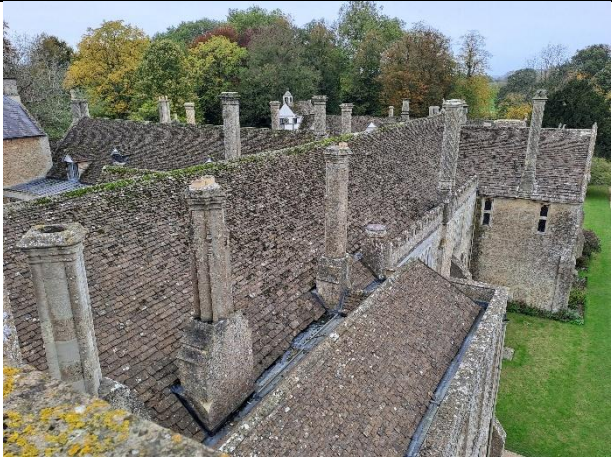
| View of east elevation roofs, from tower at south east corner. 'Chimney' stack second from left, with two clay pots. | View of roof and chimneys from south east by tower. 'Chimney' stack is third from left. |

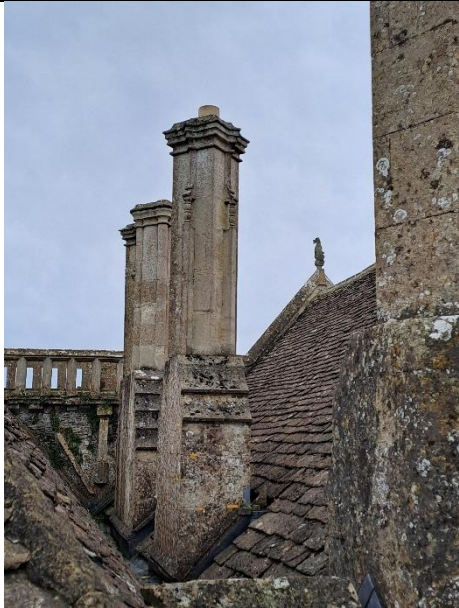
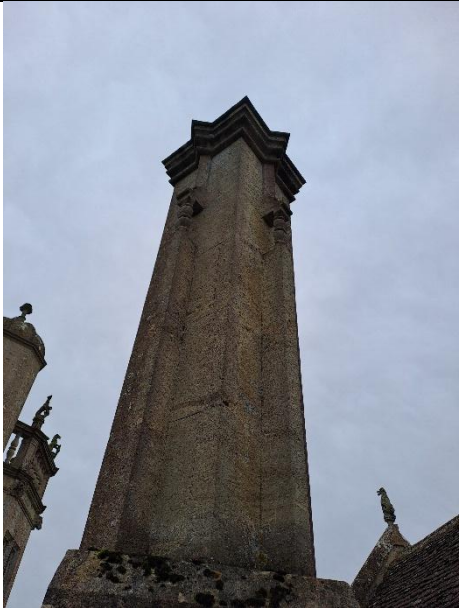
| <p>View of 'chimney' stack from north.</p> | <p>View of 'chimney' stack from north.</p> |

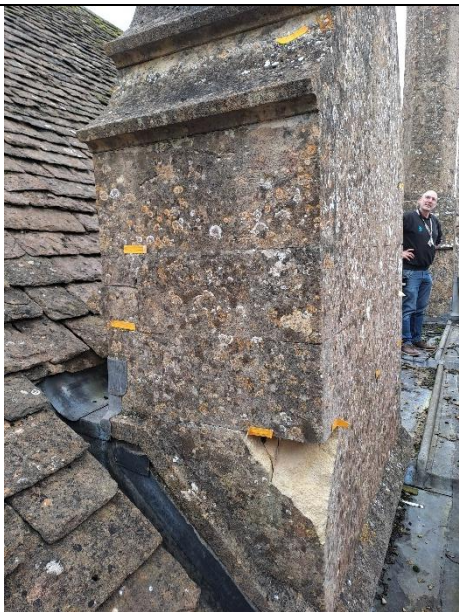
| <p>South side of 'chimney' stack – iron cramps causing movement and fracturing in stonework.</p> | <p>Sections of fractured stone fallen from 'chimney'. On going corrosion of the iron cramps likely to cause more loss and instability.</p> |

It is proposed that the chimney would be carefully dismantled, the existing iron cramps removed and the existing mortar cleaned off. The chimney would then be re-built re-using as much of the existing stone as possible in an appropriate lime mortar to match the existing. Any new stone required would also be to match the existing.

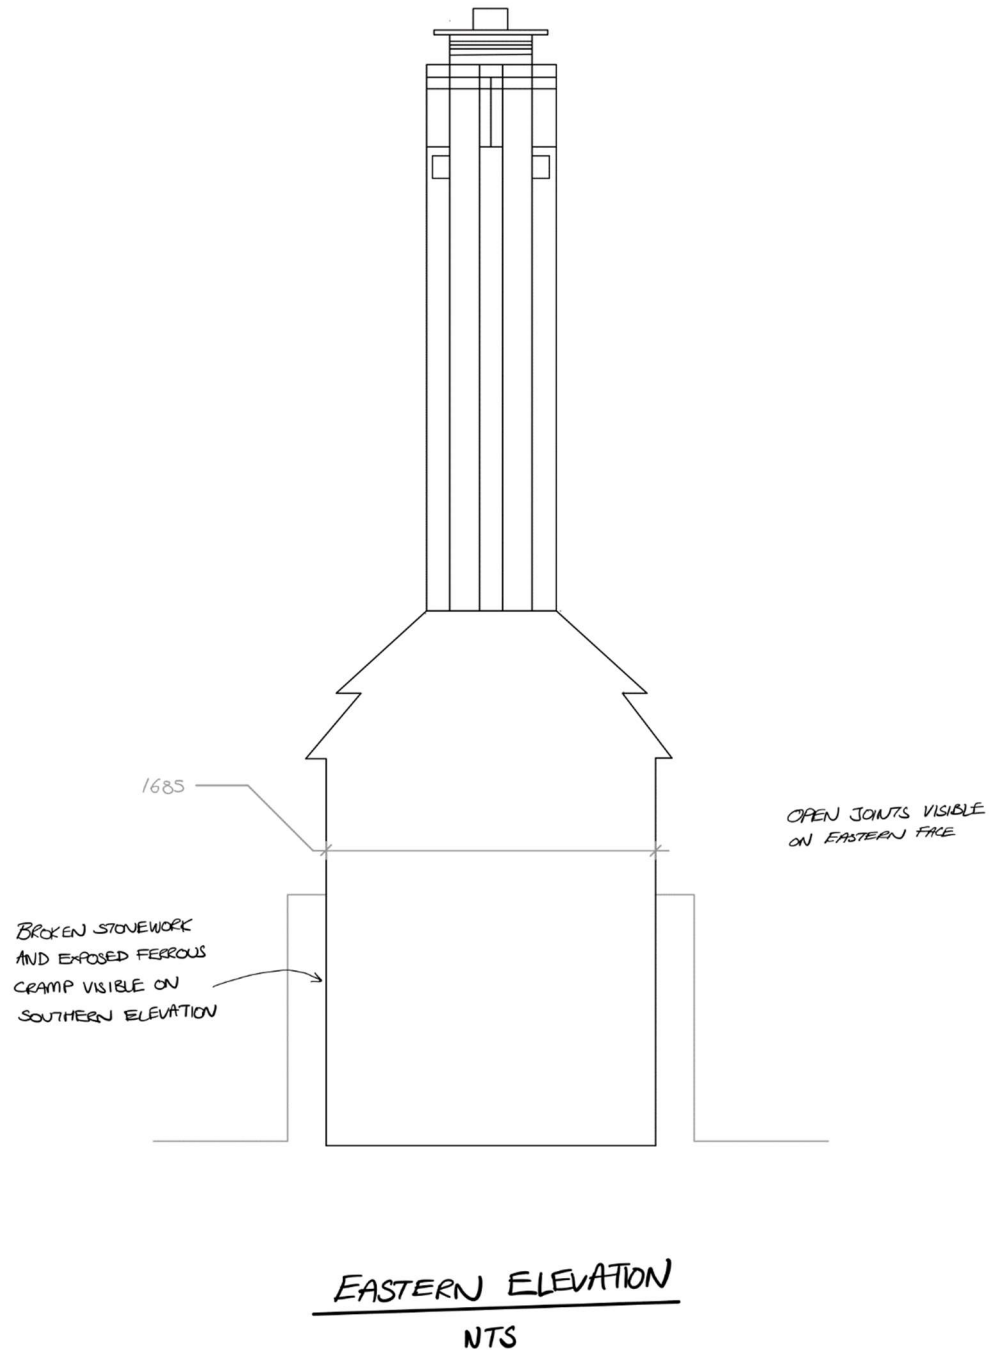
Figure 2 – Sketch of Eastern Elevation

- 5.3 Measurements were taken of the adjacent roof truss structures with the view to analyse whether some form of temporary stabilisation could be introduced to restrain the chimney. As shown on the sketch in Appendix A, the difference in the height and scale of the adjacent roofs would make even stabilisation very difficult. At lower levels lateral restraints could be introduced, however this would have a minimal impact on providing restraint to the exposed upper section of the chimney. Introducing such restraints would also require penetrating through the roof finishes. Such action would both potentially damage the historic roof fabric, and risk water ingress through otherwise weatherproof finishes.

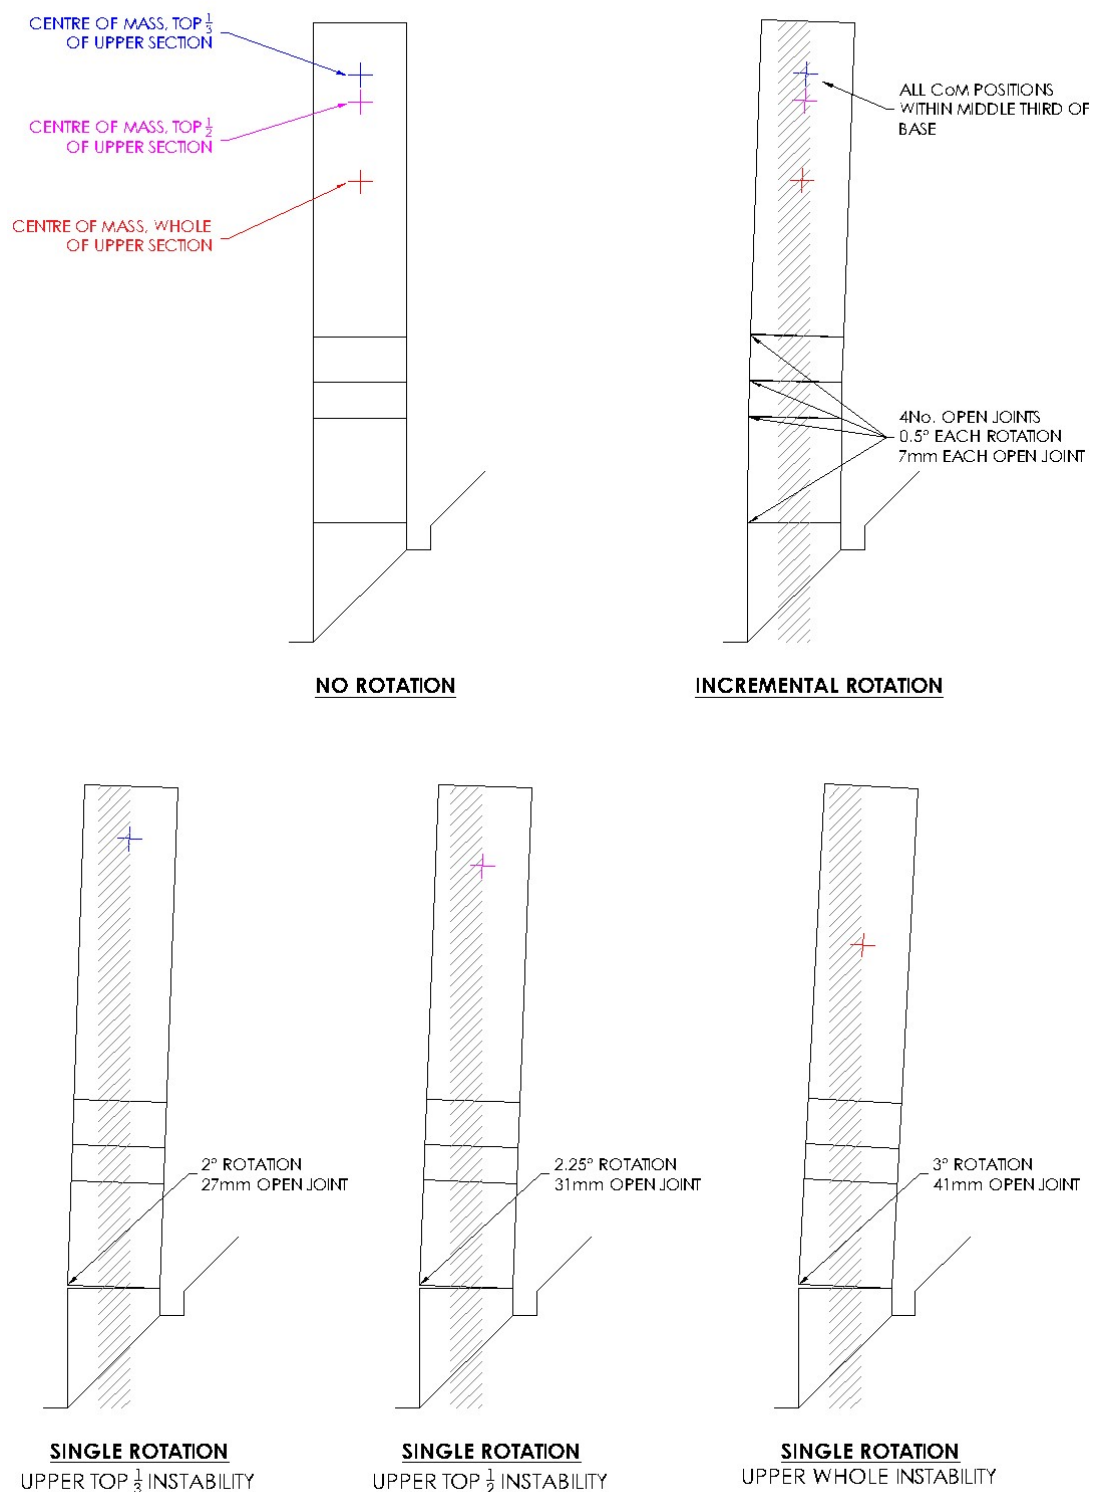
Figure 4 - Sketch of Chimney Instability (rotation only)

- 4.3 The sketches shown in Figure 4 show the centres of mass of the upper chimney section in relation to the middle third of the base under various scenarios of rotation. Given that there are cramps within multiple joints and levels, the sketch showing incremental rotation would be more realistic. As shown, with four corroding cramp positions, each causing jacking of 6mm, the open joints at the face would be 7mm. All three centre of mass positions analysed would remain within the middle third. However, if there were any additional joints with the same expansion, or multiple joints with a lesser expansion, the chimney could become unstable.

- 4.4 The above comments are on the theoretical assumption that all the jacking would occur on one face (east or west) only. In reality the chimney is already showing open joints on all four elevations.
- 4.5 Open joints throughout the structure would reduce the overall lateral resistance of the panels, making the chimney more susceptible to overturning via wind forces.

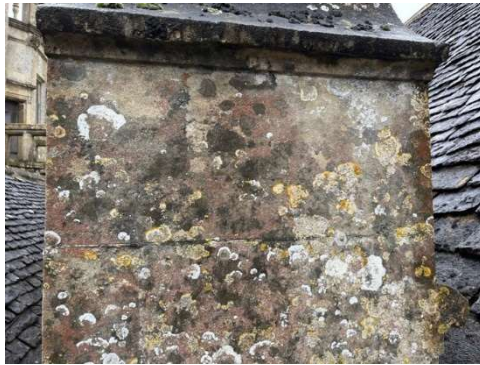
- 3.1 The lower section of the chimney had several cracks and open joints in the stone. These issues were visible on all faces of the chimney.
- 3.2 The pattern of deterioration was symptomatic corroding cramps within the stonework, which was corroborated by the removal of loose broken stonework (see photographs).

Higher level of base section, north elevation.  
Open horizontal joints in the stone.

- 6.1 Temporary stabilisation of the chimney would be difficult and not without risk to otherwise stable sections of the roof structure.
- 6.2 The chimney should be carefully dismantled to expose all ferrous cramps. These cramps should then be removed, and any significantly broken stonework replaced. All undamaged sections of stone should be cleaned back and set aside for reuse.

- 6.3 All new fixings within the stonework should be stainless steel.
- 6.4 Temporary support of the upper section of the chimney may be possible if the ferrous fixings are all accessible with localised stone removal. However it should be noted that given the pattern and extent of the open joints it is assumed that these fixings occur throughout the lower section, and on all faces.

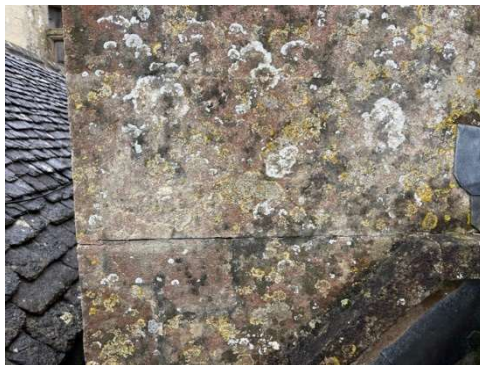
Lower level, north elevation.  
Open horizontal joints in the stone.

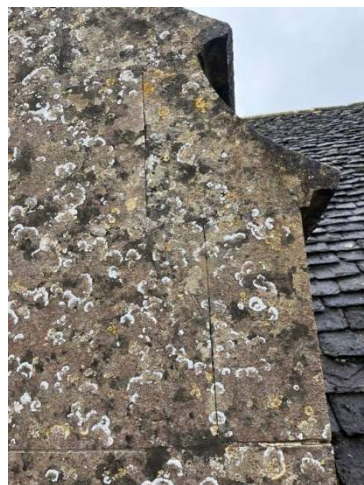
East elevation.  
Open vertical joints in the stone

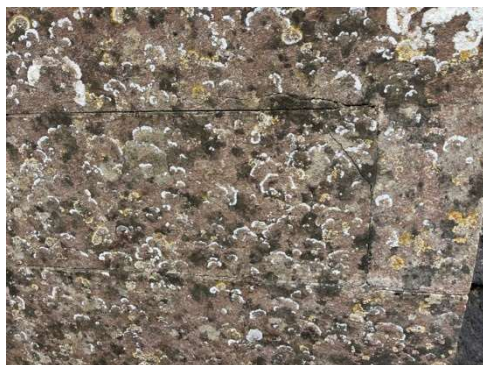
Lower level, east elevation.  
Diagonal cracking across corner of  
stone, offset from edge of chimney.  
Open horizontal joints above.

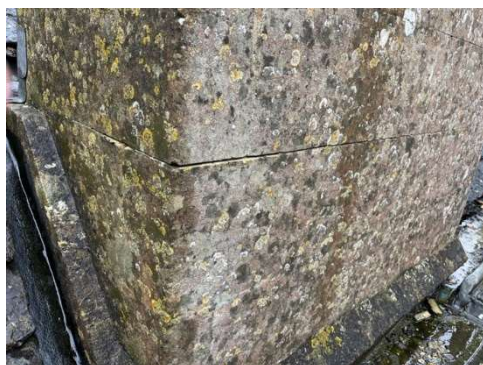
South east corner.  
Open horizontal joints continuing  
around face of chimney. Diagonal  
cracking across stone – see next  
photograph.

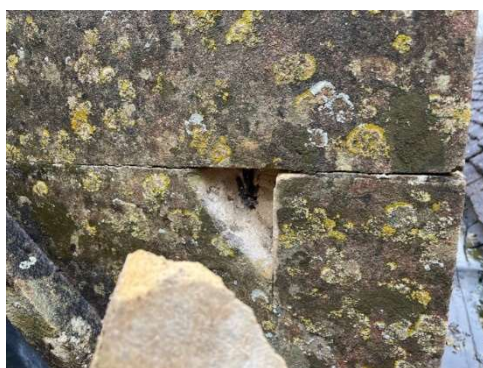
- 4.1 Failure of the chimney structure could either occur through loss of material, instability through rotation, or a combination of both issues.
- 4.2 The corroding cramps had already caused the loss of material (corners of stone blocks) to break away in two sections, as shown on the photographs. Significant continued loss of material could impact on the overall structural base and reduce the middle third position of stability. In such a case, the following comments regarding the rotational stability would need to be reviewed.

South elevation.  
Expansion of corroding cramp  
causing fractures in the stone. Corner  
of stone loose and removed.

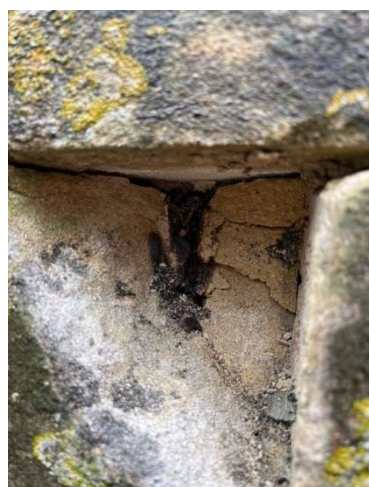
Closer image of the corroding  
cramp, showing continued cracking  
to internal section of stone.

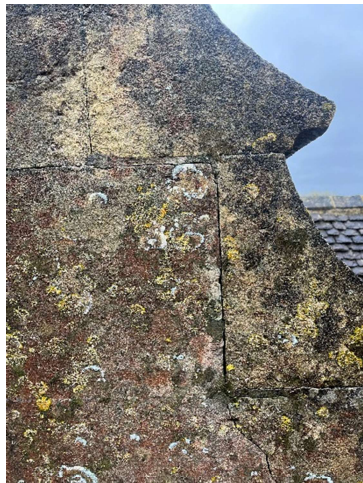
West elevation.  
Open stone joints leading down to cracked stone.

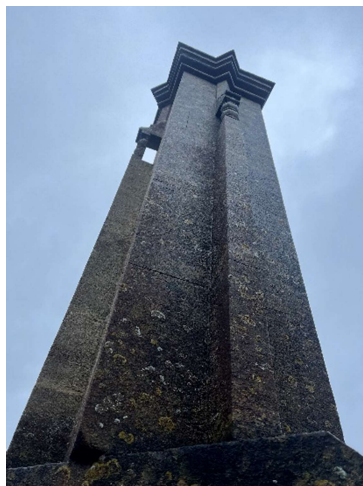
- 3.3 The upper section of the chimney was not inspected in close detail, however cracking and open joints were not clearly visible. The approximate dimensions of the upper section of the chimney were based on laser measurements taken from the valley box gutter. These dimensions have been used for the preliminary stability analysis.

Upper section of chimney over.  
Top moulding approximately 5.2m above valley gutter (base of exposed chimney).

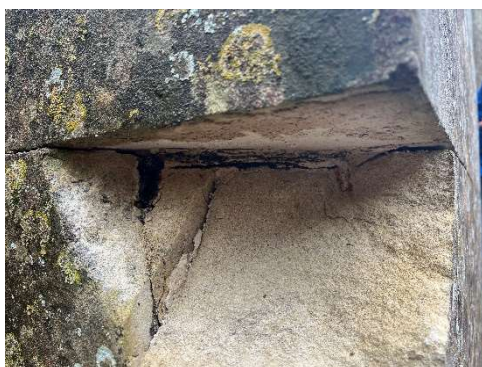
Corroding cramp causing fractures in stone and loss of material.

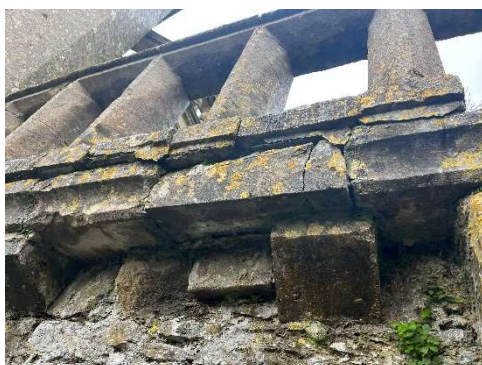
- 3.7 The galleried rooftop walkway over the southern elevation had sections of broken and damaged stonework beneath the balustrade (see photograph). The underlying cause of this was unclear, and adjacent stonework appeared to be in a reasonable structural condition. As with the chimney, any cracking of the stonework would allow for water ingress which could cause ongoing issues if there are any ferrous fixings within the stone.

- 5.4 The damage to the stonework below the galleried walkway was not considered to be symptomatic of any ongoing issue, and assumed to be local to that area.

Damaged section of stone below edge of galleried roof to south of inspected chimney.

- 6.5 The localised damage to the galleried should be carefully removed and the backing, undamaged section cut back to a clean face. Replacement stone facing should be fixed using stainless steel resin anchors.
