# NO.10 THE CLOSE

North Walk, The Close, SALISBURY SP1 2EB

## SUPPORTING STATEMENT INCLUDING DESIGN AND ACCESS & HERITAGE IMPACT ASSESSMENT

OF STRUCTURAL REPAIRS TO ROOF TIMBERS  
to accompany a Listed Building Consent Application

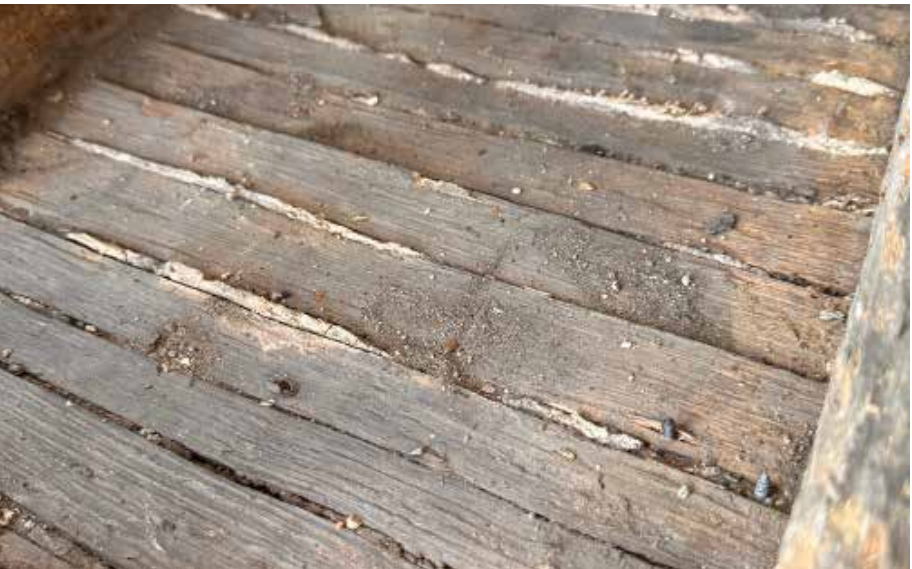
- Replacement/recovering of perished plaster surfaces in ROOF B:**  
The plaster finishes in the attic of the main house (Roof B) are in reasonably poor shape, due partly to their age, but mainly due to the way in which the laths have been very closely fitted in areas, leaving little room for the lime plaster to leach through to form the plaster ‘key’ (see image below right). The western attic room has already been replaced with plasterboard some time back, but the remaining lath and plaster ceiling has also now extensively failed. Undulations of the plaster skelings is pronounced, and there is loss of key on all surfaces as a result of the tightly spaced laths.

PHOTOS THIS PAGE:  
Above: Overtight spacing of laths - limited space for plaster to form ‘key’  
Top right: Remaining lath and plaster ceiling in attic  
Bottom right: Indicative condition of sloped skelings

- Replace the attic ceilings with a woodwool boarding to take a new lime plaster finish.
- Repair the skelings using stainless steel washers and wire to pull back the loose areas of plaster (where still intact) back to the rafters. Missing sections of plaster will be relathed to take 3 coat traditional haired lime plaster. All surfaces will be given a fine lime plaster over skim prior to decoration.

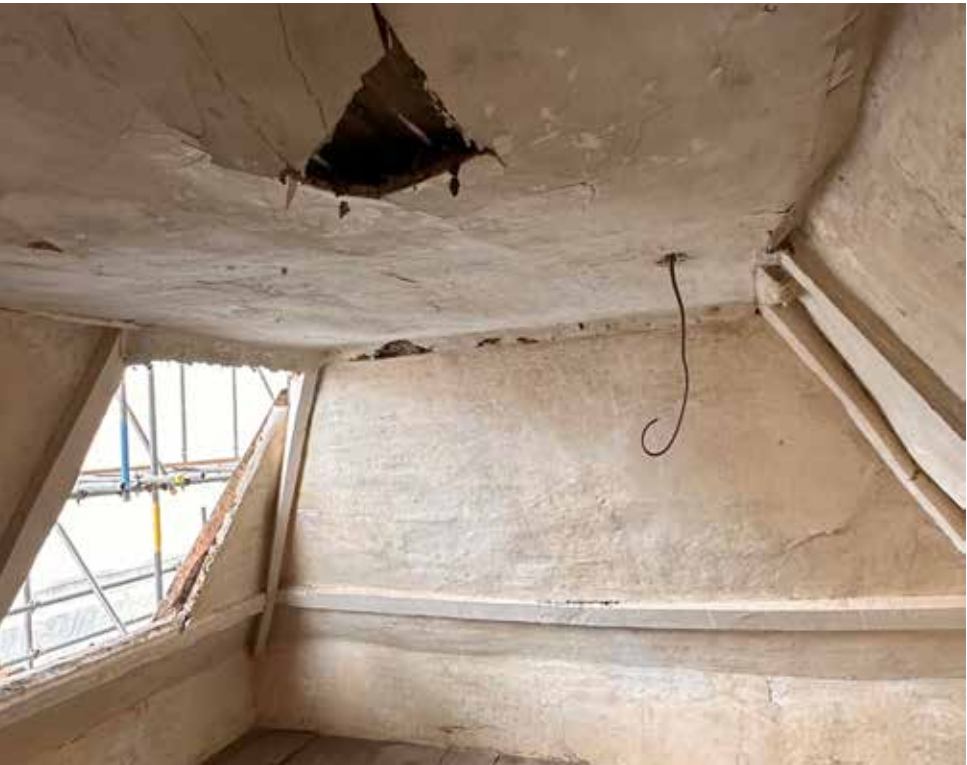
Condition assessment has concluded that these surfaces are all now at risk of sudden failure in places.

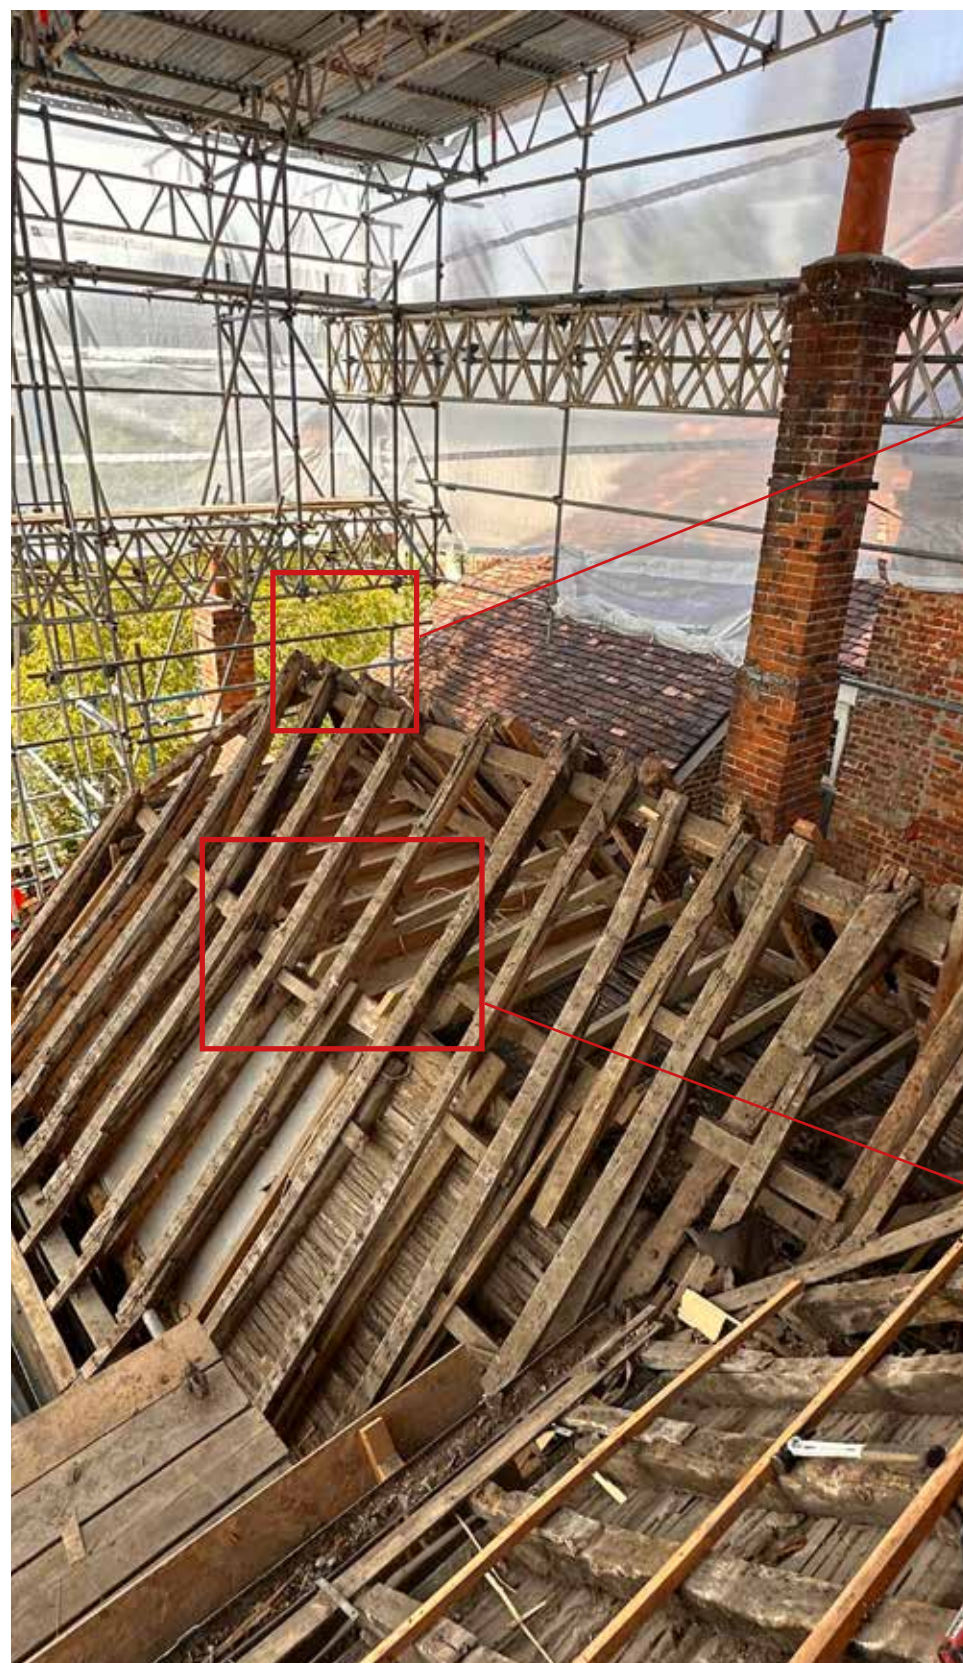
Far left - Roof C - eastern slope

The rear roof over the southern range has been found to have a cracked purlin on the east side, that has led to a slow roof collapse over time. Uncovering has revealed that the roof pitch has been maintained by the continuous overlaying of packing pieces onto the tops of the rafters. The purlin was never replaced, simply plated and the continuing roof 'sink' has continued.

Combined with the extent of timber decay and general health of the structure, the engineer has condemned the roof being simply recovered without intervention. His report forms part of this submission.

- Insert new rafters set between the existing structure, to replace the support for roof coverings and mitigate stability issues caused by the progressive ‘dropping’ over time.

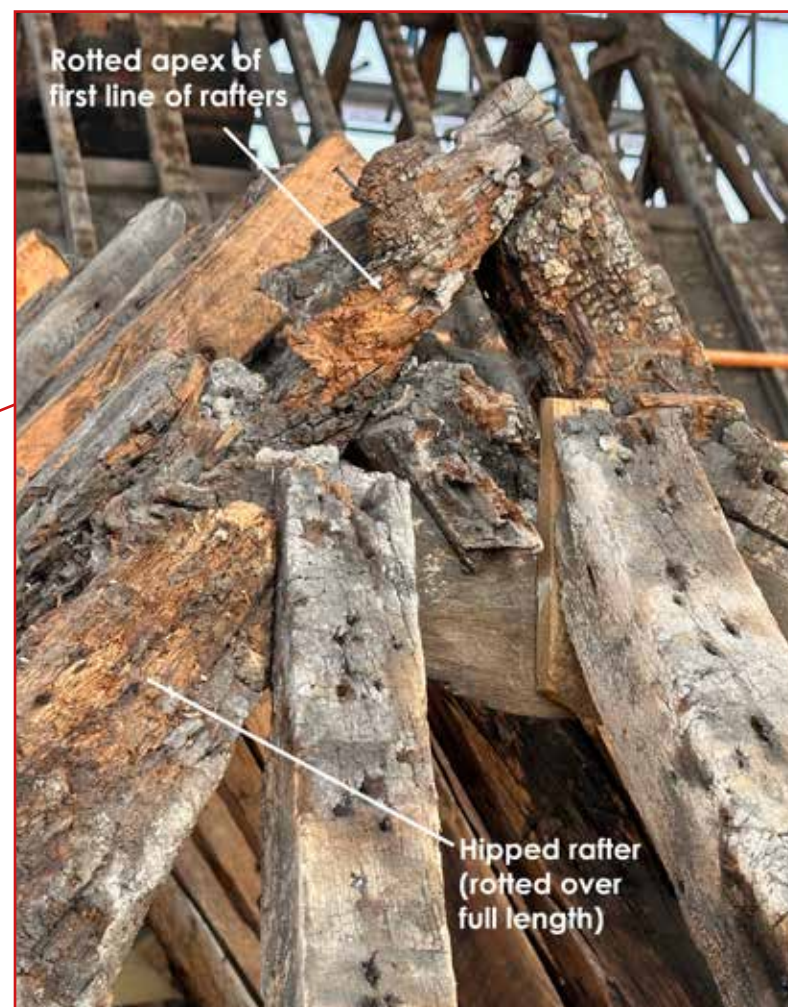
Top right: Condition of timbers on half-hipped end

- Two hipped rafters have rotted beyond repair and creating the new hip is not feasible over the top of the existing, as it is to go between and above the side slopes.
- A band of lath and plaster at the top of the skelining slope would be removed on both sides, to insert the new tie beams for each rafter.

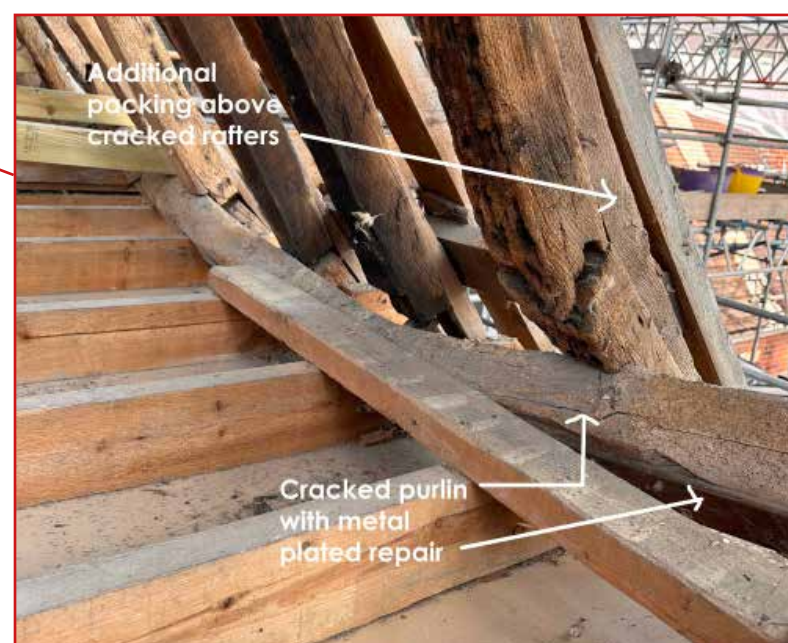
Bottom right: cracked purlin and rafters on eastern slope

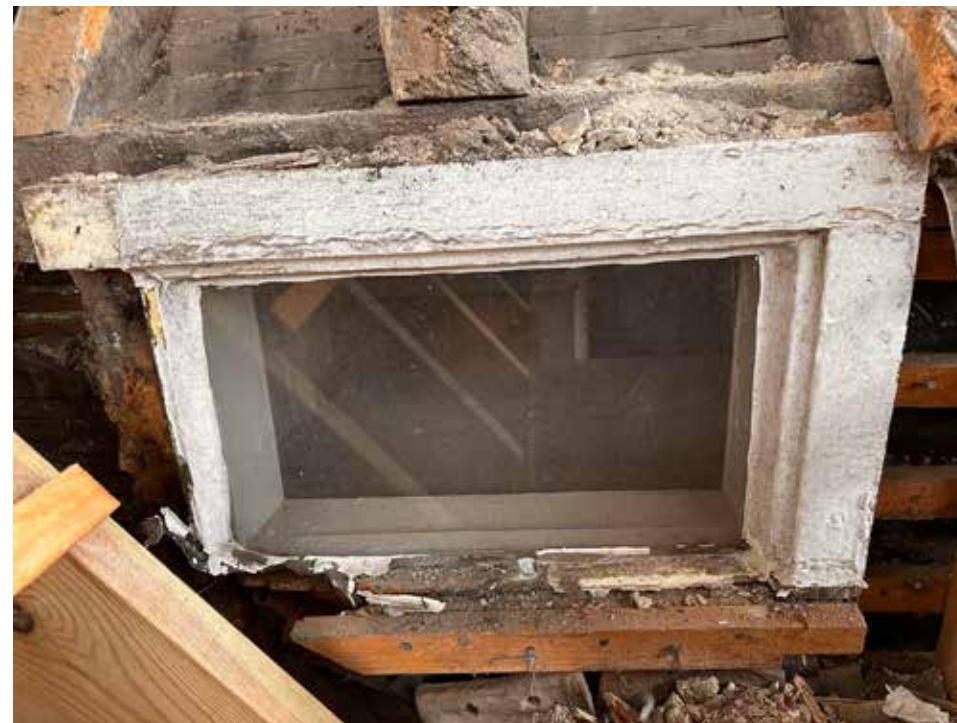
- Attic window adaptation: A small fixed light on the south elevation of the house, which gives natural light onto the attic staircase, would be extremely close to the new straightened roof pitch and the new valley gutter and tiling come across the bottom corner (see photo to the right). This window is not original and either late 19th or early 20th century, with modern beading and float glass. The section of frame to be cut out had already suffered rot from the valley gutter proximity. Keeping the window at it’s current size would create an inherent defect and increase risk of further deterioration rot due to likely water ingress. The determination has been to reduce the window size by half, to ensure the roof pitch passes below it. **See elevations provided.**

*Top: Attic stair window light*

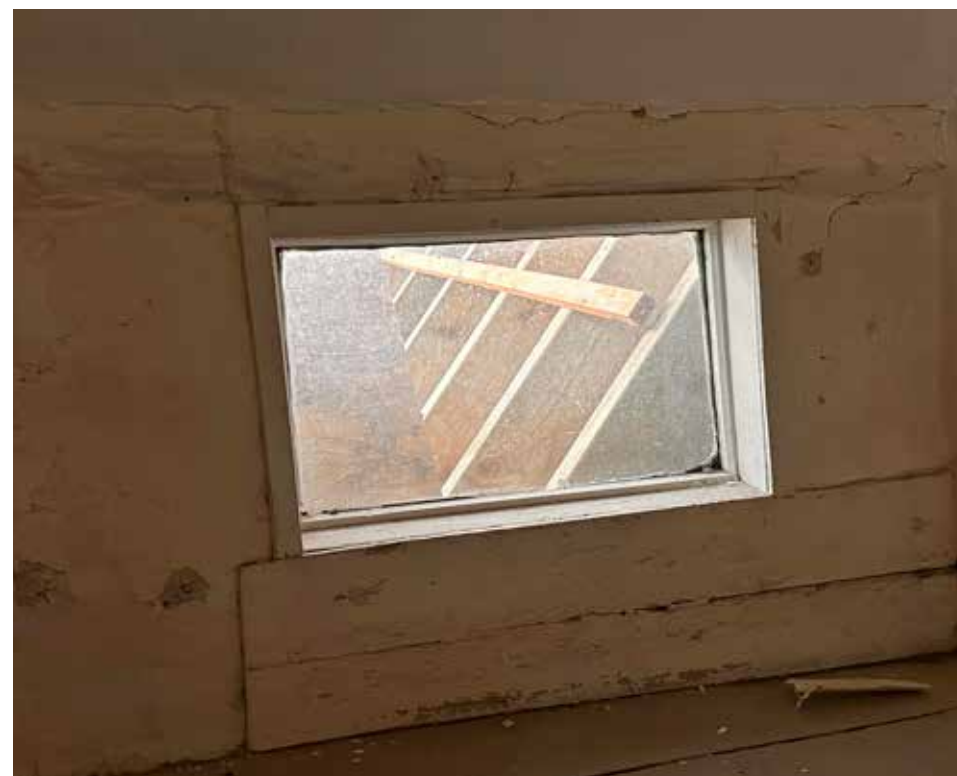
*Bottom: Attic stair window light viewed from inside with oblique view of new timber roof structure*
