**REFURBISHMENT AND ALTERATIONS**

**10, North Walk,**

**PROPOSED**  
**SCHEDULE OF WORKS**  
**FOR REPAIRS AT ROOF LEVEL**

following inspection after strip for roof re-covering

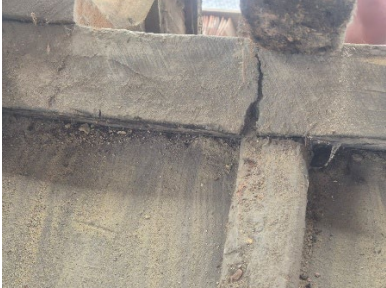
| ITEM | DEFECT | IMAGE ILLUSTRATION | PROPOSAL<br>(STRUCTURAL ENGINEER'S<br>CONFIRMATION WITH ML ON SITE<br>SHOWN in RED) |
|---|---|---|---|
| High level purlin | Cracked through in one place | | Assume strapping in place with metal plate/bracket fitted to back face<br><b>TBC by S.E</b><br><b>S.E confirmation that no strapping is required in this location, forces are low and with limited movement potential</b> |

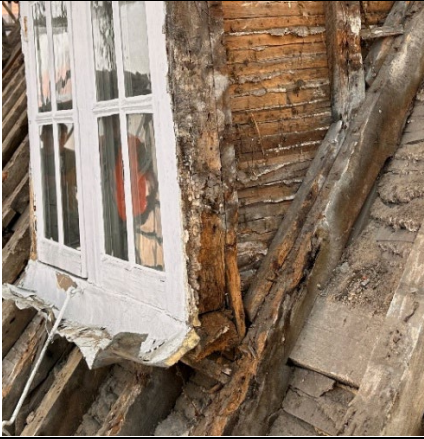
| ITEM | DEFECT | IMAGE ILLUSTRATION | PROPOSAL<br>(STRUCTURAL ENGINEER'S<br>CONFIRMATION WITH ML ON SITE<br>SHOWN in RED) |
|---|---|---|---|
| Dormers 01 and 02 | Defective flashings around the base of the window have allowed water ingress which has rotted the bottom ends of the window frame on both sides, and part of cill plate<br><i>Note that the window frames are very thick, and still performing structurally</i> | | Carry out spliced and pieced in timber repairs with new timber, selected to match existing window frame timber type. Retain as much of existing fabric as possible. Sand remaining frame well, fill any sections of additional minor rot with two-part resin filler and redecorate, <i>Note: discussion on site was to remove window and frame and do the works on the bench, that would require temporarily propping dormer cheeks and roof above.</i> |

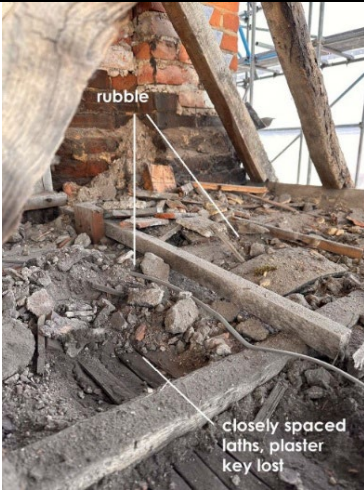
| ITEM | DEFECT | IMAGE ILLUSTRATION | PROPOSAL<br>(STRUCTURAL ENGINEER'S<br>CONFIRMATION WITH ML ON SITE<br>SHOWN in RED) |
|---|---|---|---|
| Rubble fill | Additional weight created from unwanted debris that has been left within the ceiling voids | | To be carefully removed, and area gently vacuumed out avoiding further damage or break off plaster 'shots' |

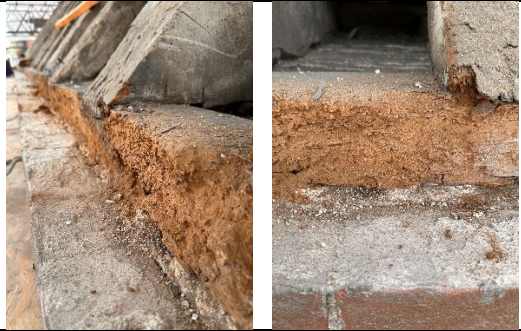
| <b>Rotted sections of timber</b> | all loose frass should be removed where it has potential to hold condensation or moisture against the timber. | | Gently scrape back and remove the powdery and very badly rotted/loose sections of timber wall plate areas, back to reasonably solid wood, and vacuum to remove. Apply Ronseal Wood Hardener to any remaining sections where slightly softer, but still maintaining shape. |

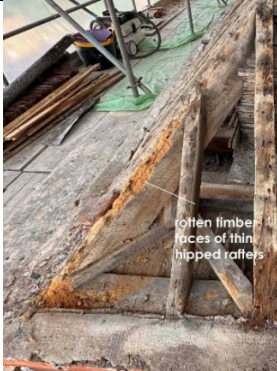
| <b>Providing sufficient fixings for re-covering</b> | Locations as shown on plan where rotten timbers may no longer provide sufficient width of base or anchor points for refixing battens and roof coverings | | Fix supplemental sections of treated softwood either side of hipped rafter, where hip section has rotted away. Vacuum up and remove timber frass and rotted material. |

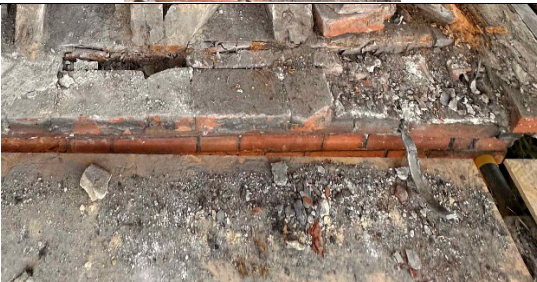
- The mortar bed for the top course of brickwork at eaves has failed, and bricks require refixing on the north elevation before gutters can be refitted.

| <b>Eaves brickwork</b> | Brickwork loosened and mortar failed | | Carefully salvage all loose bricks, scrape back and remove remaining loose mortar bed. Relay brickwork to recreate existing stepped eaves line in new mortar bed – NHL 3.5 in order to firmly take gutter fixings.<br><i>Note: discussion on site was to include ss angle fixings behind the brick to provide added strength</i> |

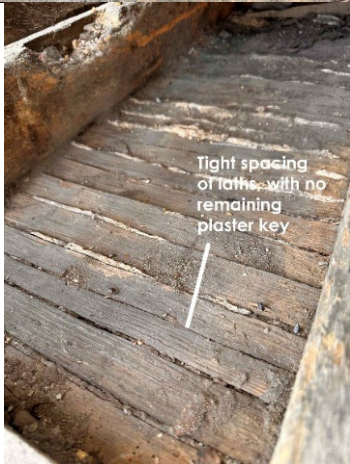
- The lath and plaster to the attic rooms of Roof B have been poorly done with very little spacing between the laths, that gave limited key for holding the plaster in place. This is also true of the ceilings to the first-floor bedrooms. There is ongoing risk of this plaster failing suddenly and falling in large sections.

| <b>Lath and plaster internal finishes</b> | Loosed plaster key to areas of ceilings, skellings and dwarf walls due to poorly fitted laths giving little space for suitable plaster 'key' between. A considerable risk is that of sudden and extensive plaster failing with sections of both wall and ceiling falling down/off unexpectedly. | | <b>Tests: 'push' tests from inside the rooms of the attic and the first-floor bedrooms and review from areas visible above.</b><br><br><b>client decision (for safety reasons) to secure the lath and plaster ceiling and avoid any catastrophic fall occurring.</b><br><br><b>Fit 9mm plasterboard to underside of existing ceiling, up to edge of existing covings, and skim finish with gypsum multi-finish plaster to take paint finish.</b> |

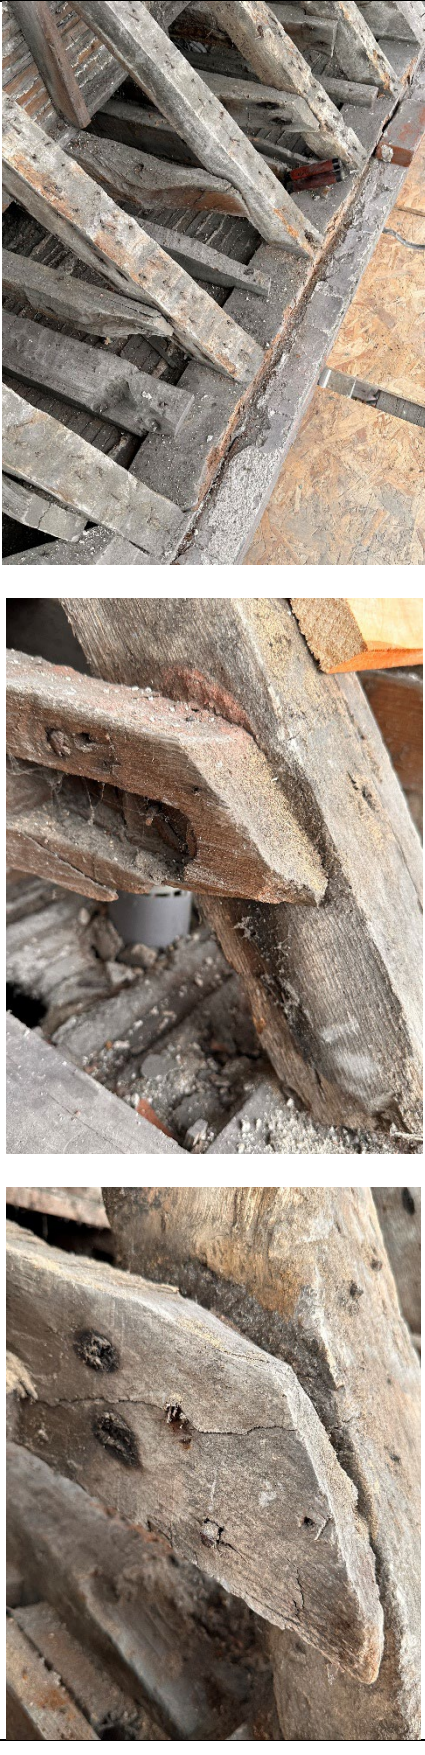
| <p><b>Additional support to attic floor</b></p> <p><b>(SJ flagged with ML during site visit 11.08.2025)</b></p> | <p>The attic lath and plaster walls are resting on the floorboards of the attic supported by the floor joists. These joists are nailed into the side of the rafters.</p> <p>The joist ends have been tapered and shaped with a scooped out end that thins as where it fixes onto the rafter (reasons unknown but currently assumed to be either so the hand forged nails would adequately connect into the rafters, or to ensure there was sufficient space to get a hammer into the gap) These fixings are old and evidently rusted and there is no way of telling how secure these fixings are.</p> <p>The joists are further supported by sub-joists, which span between wall-plate and truss tie beam, however, there is some risk that these nails will finally fail and shear, allowing the floor support to drop.</p> <p>The recommendation would be to provide some further fixings to cover the eventuality of any failure of these nail fixings whilst this section of the building is more easily accessible. This could be done by either a couple of screw fixings through the timbers, or some timber packing/block sections between the floor joist and the ceiling joist below.</p> | | <p>Recommendation by S.E would be to fit some timber packers between the joist ends and support below, to transfer and spread more of the support down to the wallplate, rather than simply relying on the nail fixings. This would need to be done on all the accessible timber ends on both the north and the south elevations of Roof B.</p> <p>Sketch drawing provided on site by S. J is included within the drawings at the end of the report.</p> <p><b>Note re practicality on site:</b><br/> <i>It is acknowledged that screw fixings to supplement the existing nails would require pilot holes drilled through the timbers, given the likely hardness of the wood. In some locations, there are also limited options for being able to find suitable 'meat' in the tie to put another screw through. It is also recognized that the shape, size and form of all the timbers are different and vary enormously across the length of the roof. In some areas, this will likely mean that packing would need to be done in short lengths, rather than a long timber covering multiple rafters - there would need to be a spread across two rafters minimum as given the offset between the joist positions, tackling the block packing on a single rafter by rafter basis would not be easy to achieve given the rotation of the packing block.</i></p> <p><i>It might be best to consider using a mixture of each option, to best suit each situation.</i></p> <p><b>This work would be desirable, but the complexity/reality of achieving the repairs is acknowledged – this can be open for further discussion on site following assessment of the practicality of executing the proposed strengthening.</b></p> |

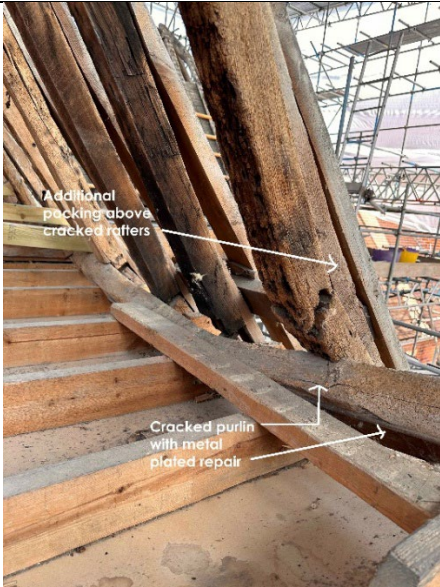
- There is a crack in a high purlin in Roof B (P1)
- There is structural failure of a purlin in Roof C (P2). This is an old fracture/split, causing the purlin to bend and drop and the hipped end of the roof is therefore unstable. This break has been fitted with a steel angle historically and the rafters where dropped have had packing additions fitted to their tops to form a roof profile that allows recovering. Works did not address the primary issue, likely due to the complexity of the roof construction over the historic open hall element. The roof needs further strengthening.

| ITEM | DEFECT | IMAGE ILLUSTRATION | PROPOSAL |
|---|---|---|---|
| <b>Roof structure failure and cracked purlin/rafters</b> | Historic cracking and dropping, with subsequent plated repair. Dropping has caused cracking through several rafters on the north side, which have since been 'packed out' to give an improved profile to the roof. Roof integrity unable to be guaranteed | | <p>Detail to resolve structural integrity provided by <b>S.E</b></p> <p>Install new treated sw timber rafters between each of the existing rafters in the southern end of the roof between truss T3 and hipped end (ie. over bedroom area only). Improve triangulation of roof by inserting 2 ties/high collars between each rafter, with bolted and plated connections between collars and new rafters. Lower tie beam to sit in below line of cracked purlin.</p> <p>Works may require removal of plasterboard ceilings, <b>although if the ceiling can be retained, that would be preferable.</b> It will also require the removal of 150mm band of lath and plaster skeling on west side of roof to insert tie beams.</p> <p>Note that level of new tie beams set below purlin will result in a ceiling line below head of window at west end of room, if reinstated. Recommendation is for sawn treated timber to be used for lower tie beams and painted in with the plaster ceiling above (or timber boarded ceiling could be fitted over if the plasterboard is removed, and similarly, painted in).</p> |

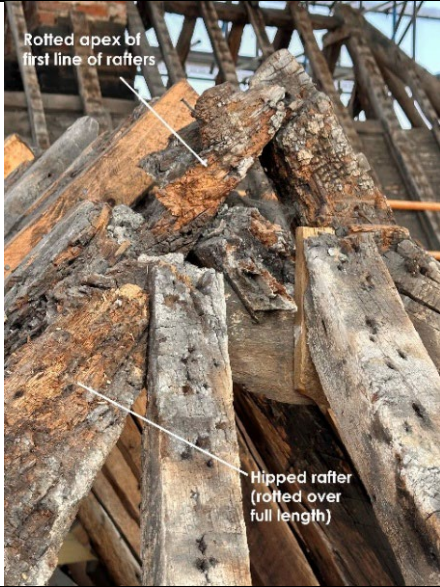
- The hipped rafters of Roof C on the south end are entirely rotted out and loose, and these now need wholesale replacement. Where these meet, the apex of the main rafters to this location requires additional timber fitted to provide serviceable fixing point for the new hipped rafters.

| ITEM | DEFECT | IMAGE ILLUSTRATION | PROPOSAL |
|---|---|---|---|
| <b>Hip rafters</b> | Wholly decayed hipped rafters at west end – failing structure and giving no support for roof coverings | | <p>To be replaced with new treated sw timber to reform hipped end and provide sufficient fixing for roof coverings.</p> <p>Note that apex of adjacent rafters (as pictured here left) will require supplementing with a further timber plate, to provide appropriate fixing point for new hipped rafters to fix up to.</p> |

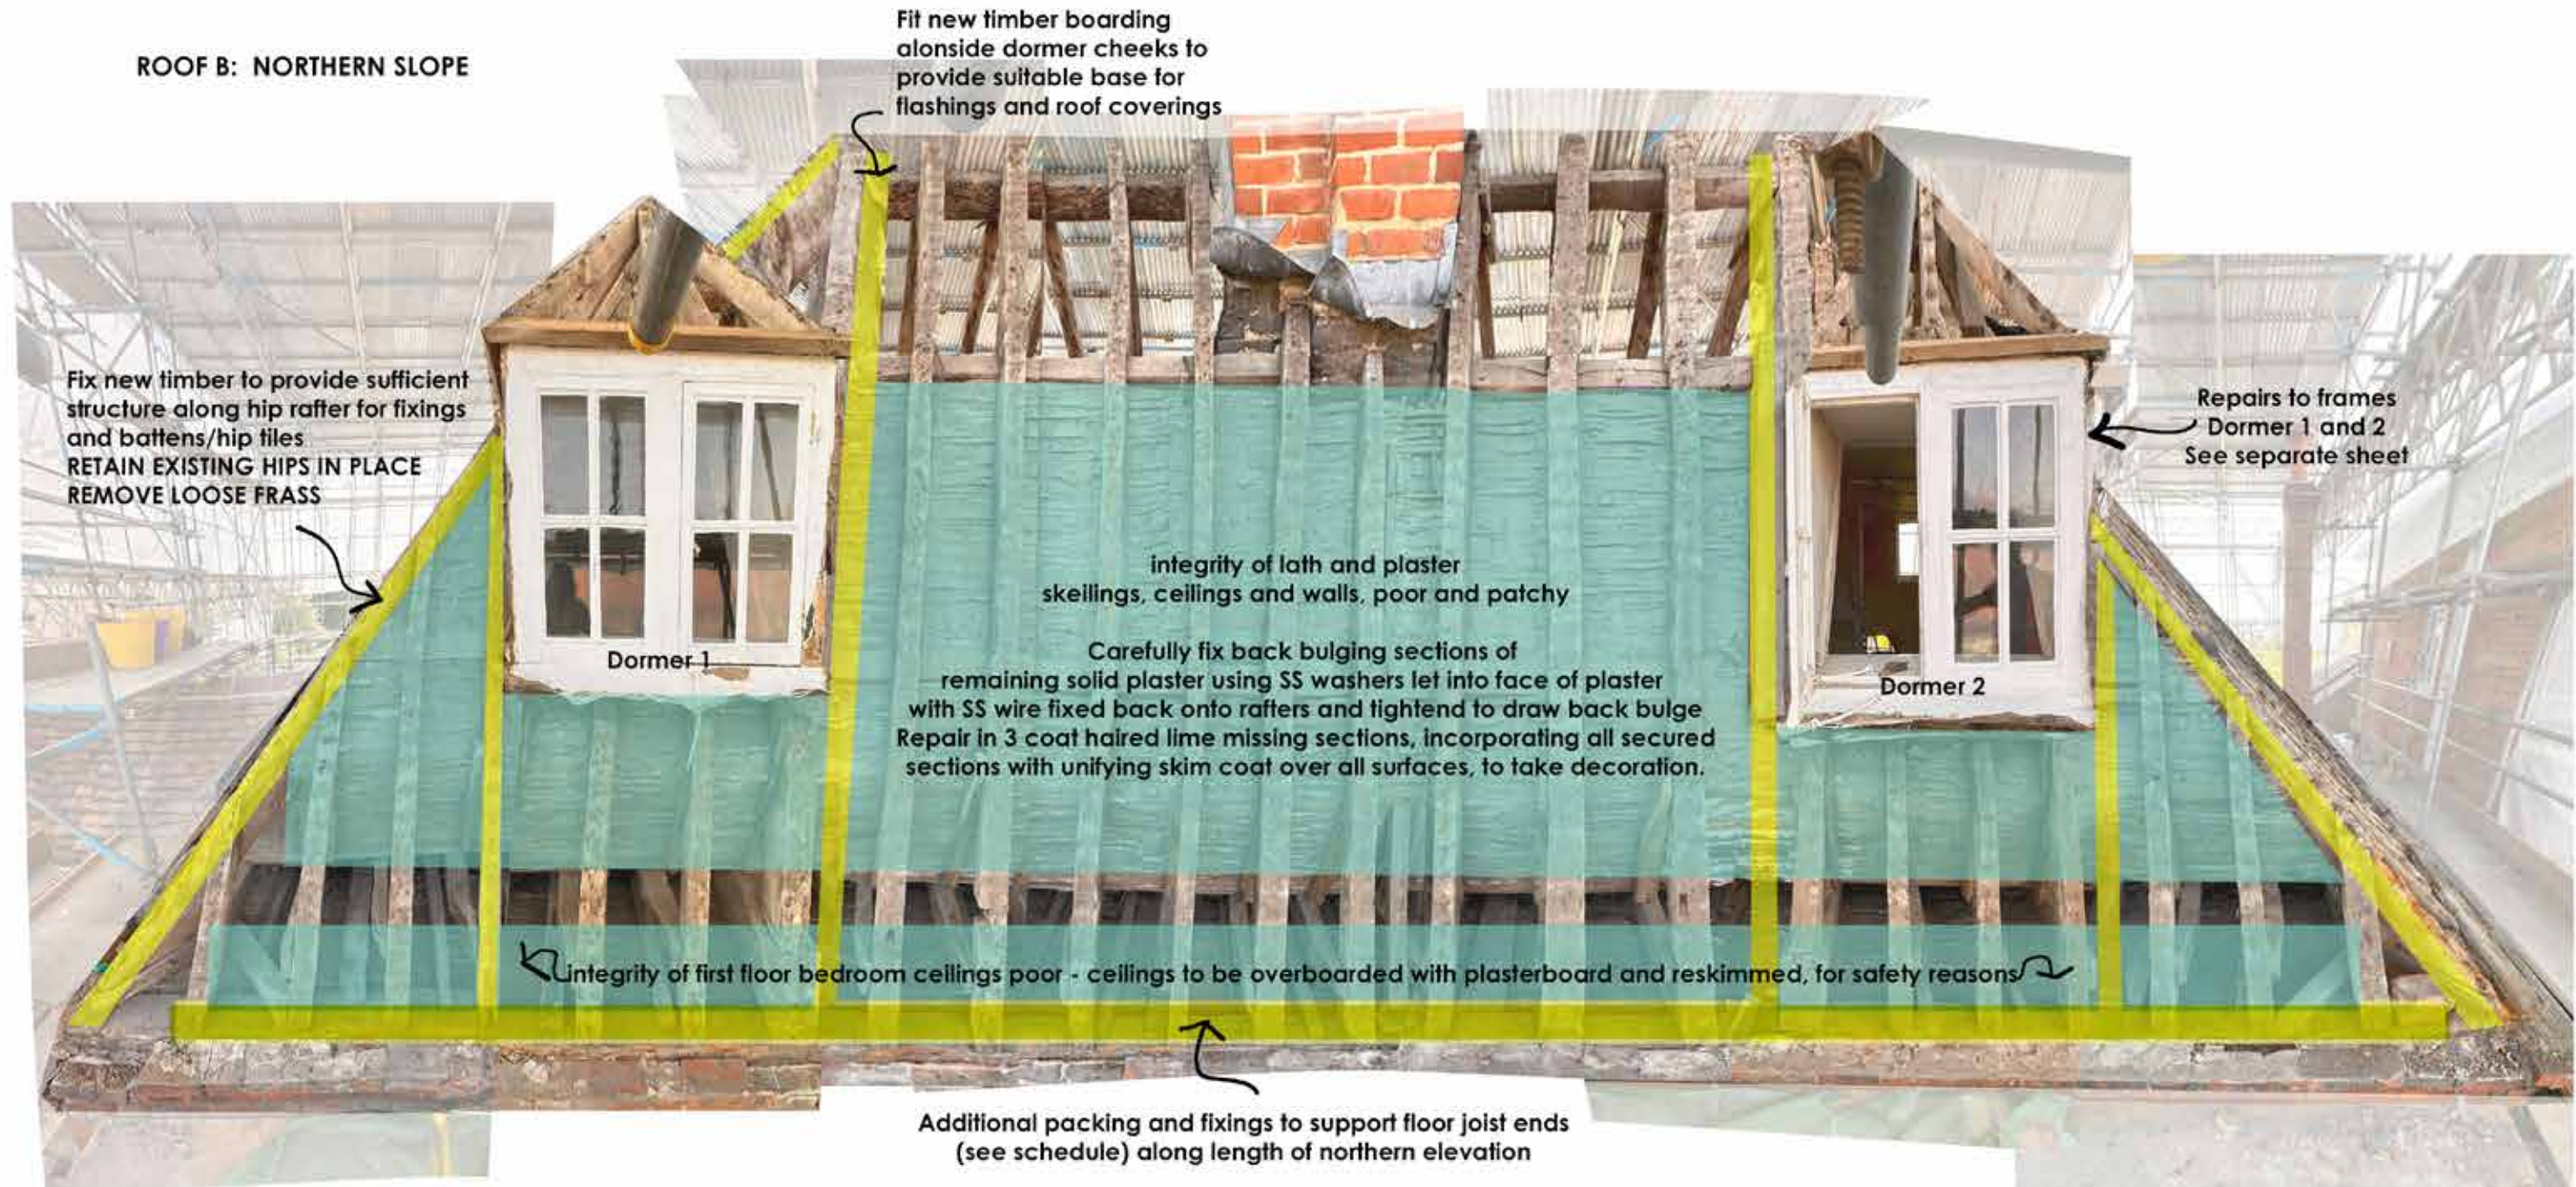
## ROOF B: NORTHERN SLOPE

- The dormers on the north elevation of Roof B have not been fully weathertight and water ingress has led to some damage to not only their frame surrounds, but also the two main trusses T1 and T2. Adjacent to Dormer 2 there has been some slump in the roof form.

■ NEW TIMBER REPLACING EXISTING ROTTEN STRUCTURE

■ ADDITIONAL TIMBER TO STRENGTHEN AND TO PROVIDE SUITABLE FIXINGS FOR ROOF COVERINGS
