# Mompesson House

## Condition Report

### Condition survey of North East Bedroom Ceiling

Report prepared for:  
**Josephine Flye/The National  
Trust**

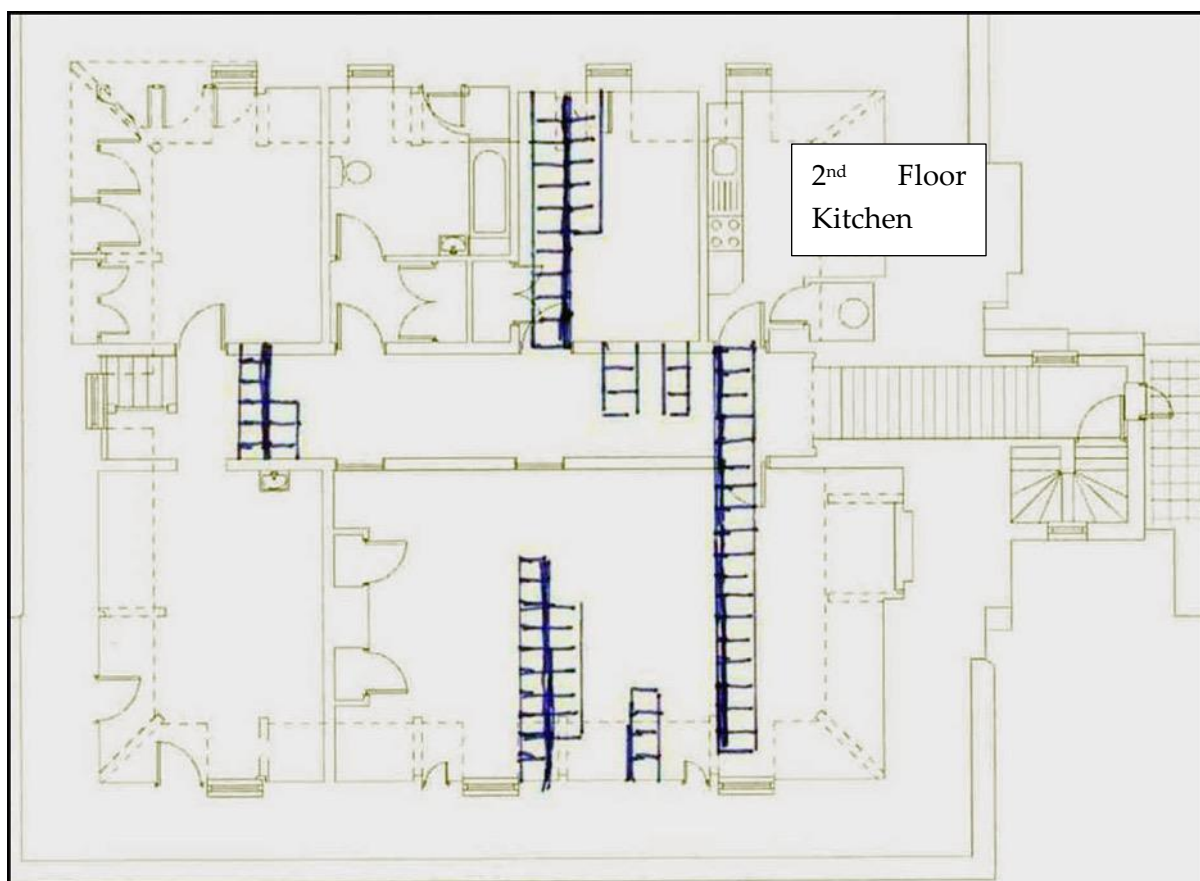
Fig 1: Mompesson 2<sup>nd</sup> Floor- Floorboards lifted and exposed structure from CCW 2012 Survey Report.

From the above it may be seen that main beams (according to the report some 350x350mm in size) run from north to south with 50mm wide joists spaced at approximately 39cm centres running from east to west between beams the upper floor and the ceiling utilise the same timber structure for support with the effect that all floor loads are transferred to ceilings and any flexing of structural timbers affects ceilings immediately below.

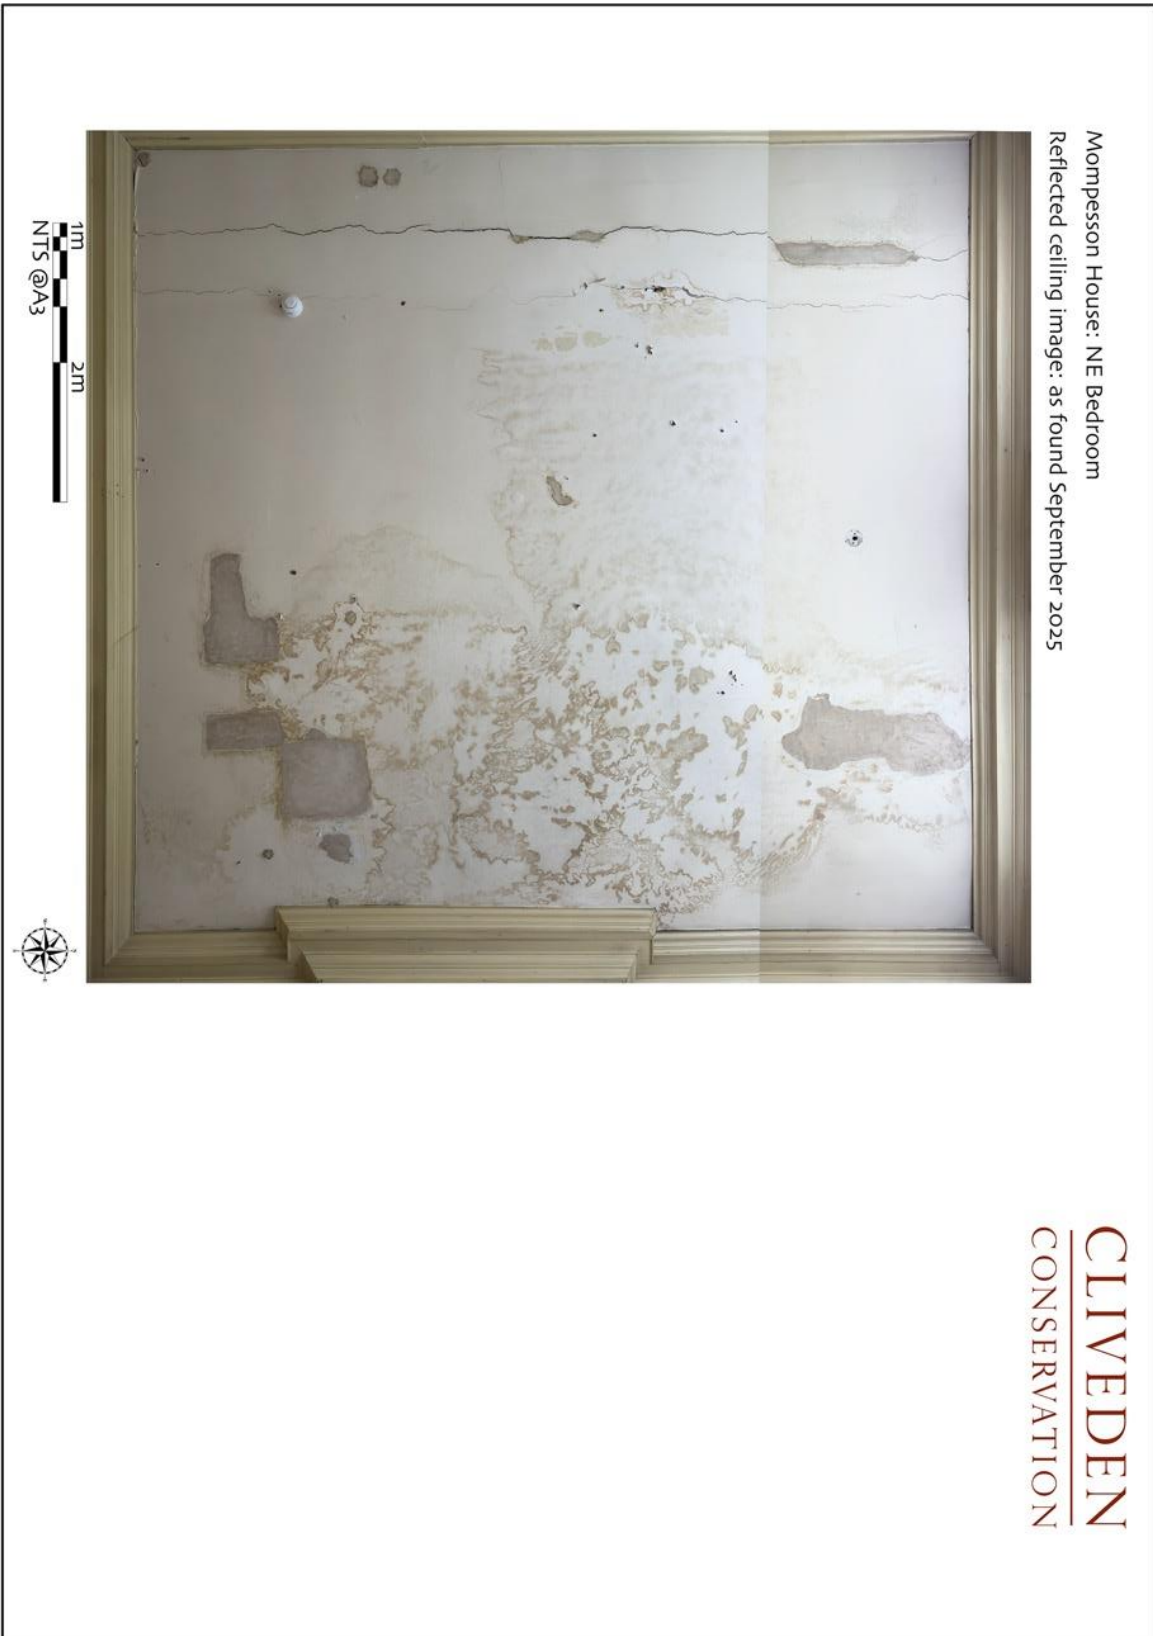
The ceiling is intact albeit with cracking running from north to south along the western edge co-incident with the position of a main north to south beam. There is another minor area of cracking to the north east. Areas adjacent to this cracking exhibit minor flexing but not serious detachment. The cornice, which is of modular wooden construction exhibits cracking at junctions of wall and cornice and one some joints between constituent elements most noticeably at mitre joints.

Fig 2: Mompesson House: NE Bedroom ceiling as found September 2025 (CCW/RR)

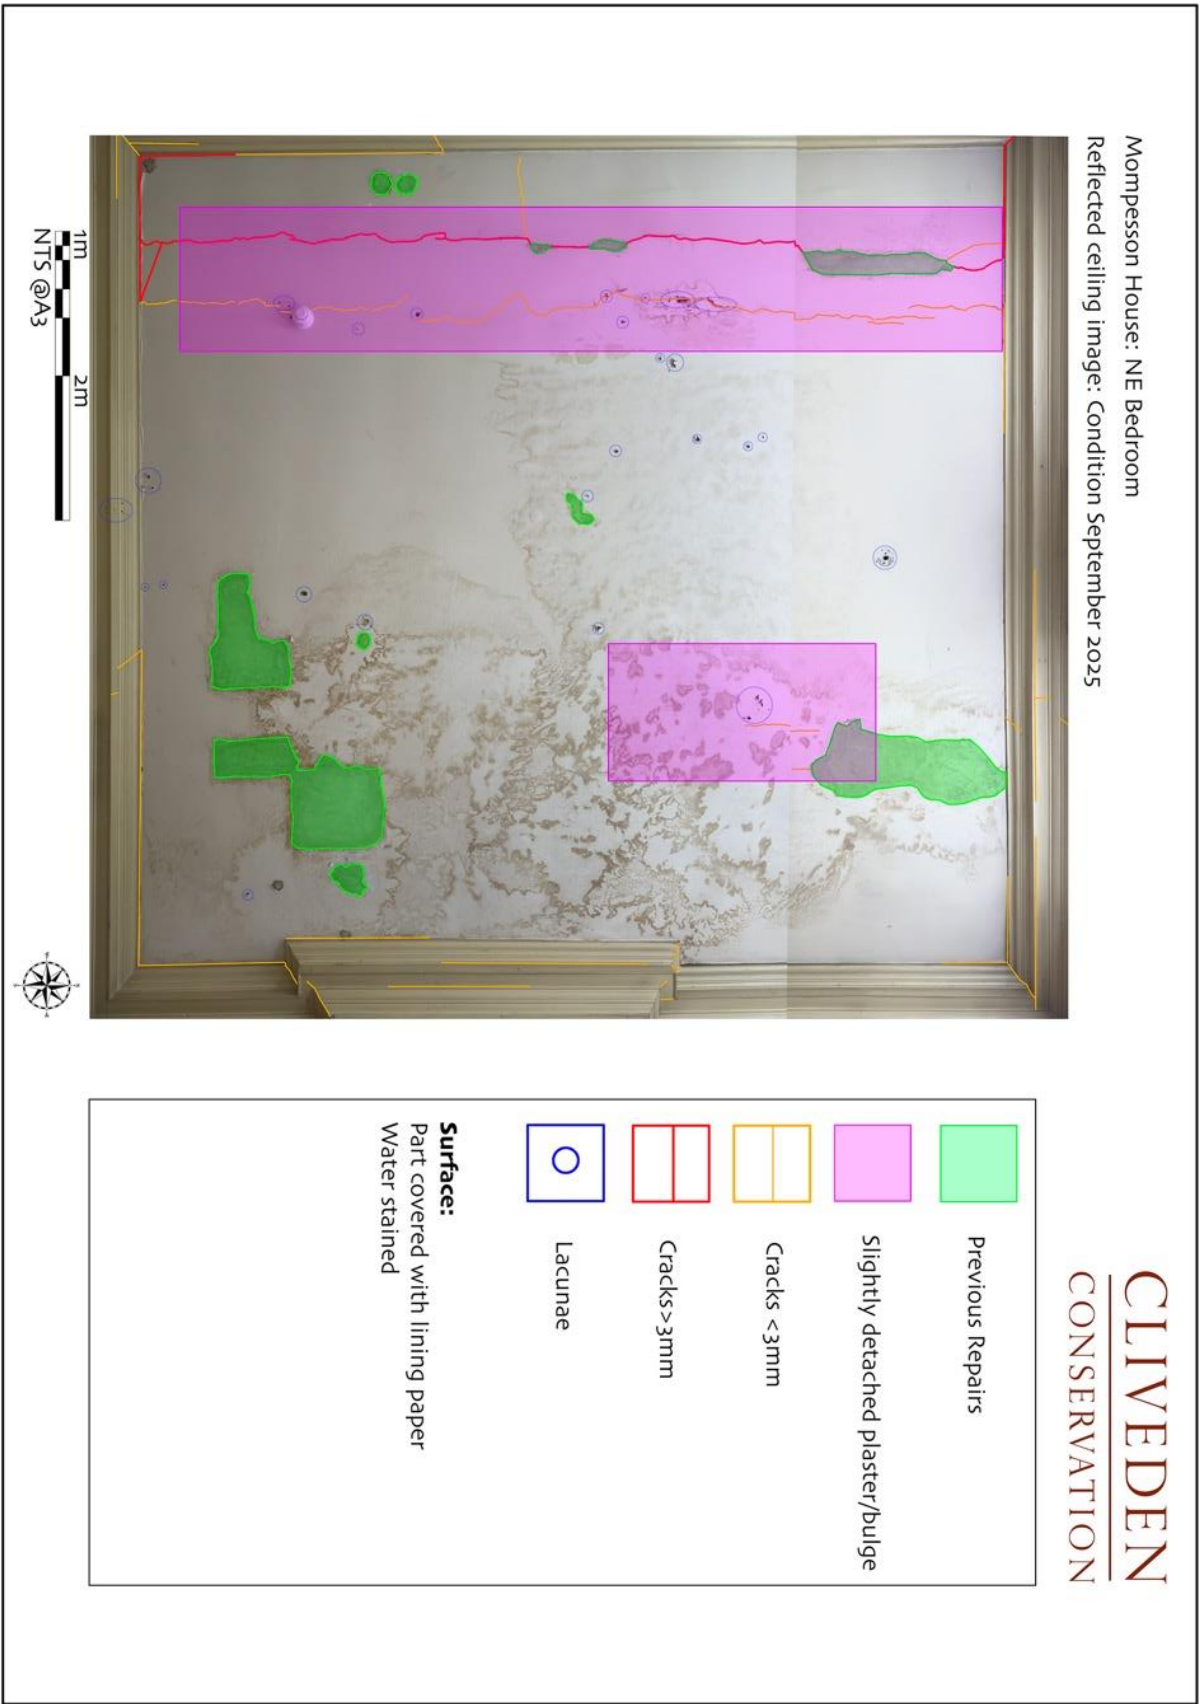
Overall, the surface is water stained and the remnants of lining paper is loosely bonded. There are several areas of what appears to be lime mortar repair undertaken presumably to replace losses caused by water ingress and by stresses caused by flexing of the main beam. In general, these repairs are satisfactory although a couple of the smaller fills within the cracking pattern to the west edge are loose and will need removal prior to any conservation of the ceiling.

Other elements of damage creating small lacunae within the ceiling plaster have been caused by the removal of fittings and associated fixings. These are minor in nature and can be easily filled over.

Fig 3: Mompesson House NE Bedroom: Condition September 2025 (CCW/RR)

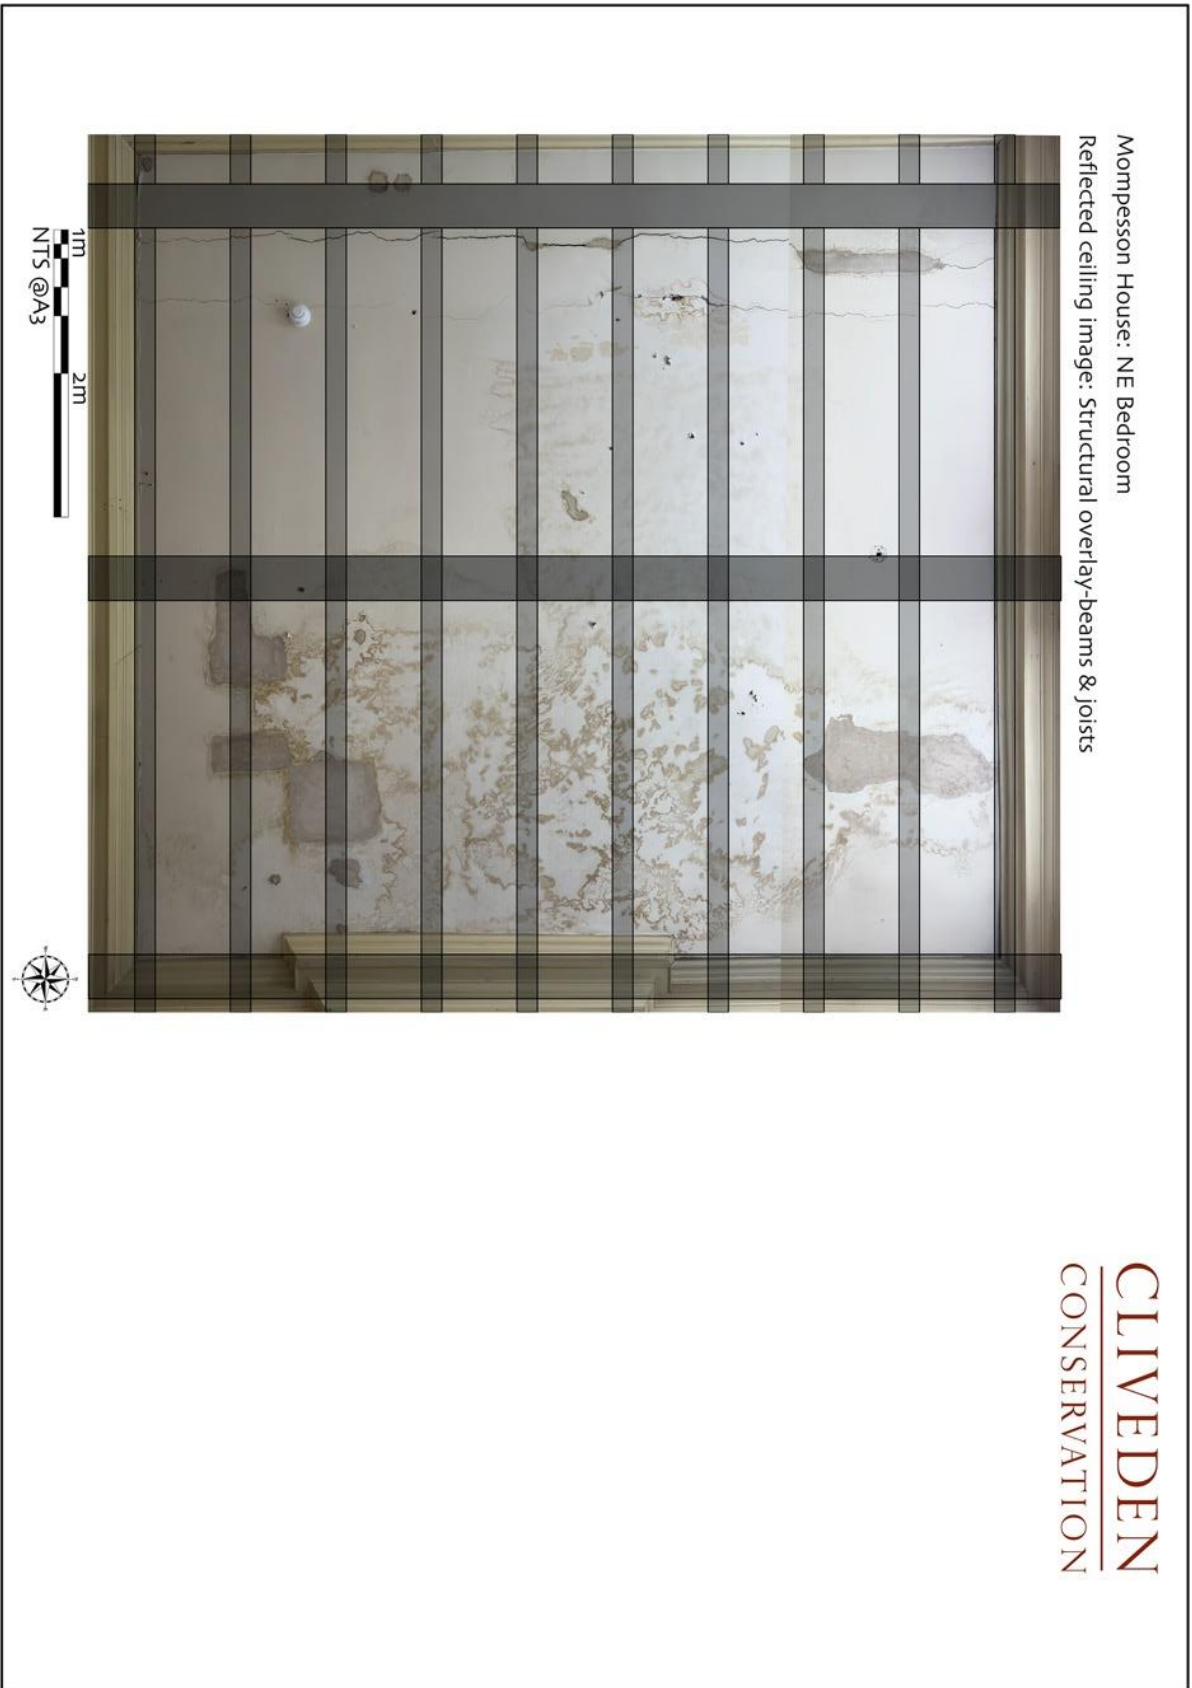
Fig 4: Mompesson House NE Bedroom Ceiling: Structural overlay (Part conjectural) (CCW/RR)
