**Mompesson House North East bedroom project**

**A report on the current condition of the woodwork with advisory  
comments on conservation methodology**

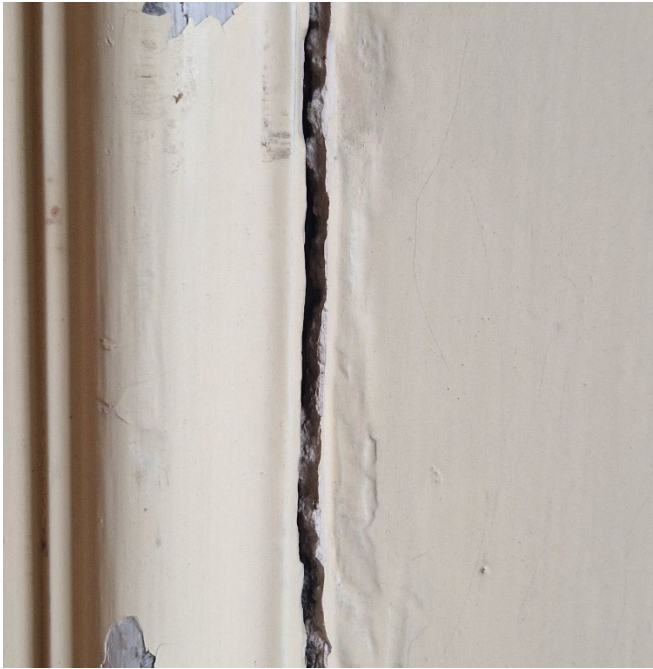
The upper bolection moulded panels have various issues. Most show signs of shrinkage, probably due to the previous use of the room with high humidity and heat. Within the normal expected fluctuations in panel sizes as RH changes, it can be assumed that the panels are now reasonably stable. Many panels have a thick build-up of old paint layers along what was the panel to moulding contact point.

Detail of a panel on the west wall showing panel shrinkage and the paint build up.

Some panels have shrunk leaving gaps between them and the moulding edge, these will need fillets added to them to enable the panel to be fixed against the rebate of the moulding firmly. Others move when pressed against and so cannot be painted without leaving unstable gaps, due to the retaining nails bending. To minimise any shadow marks being imbalanced inner panels may require fillets to be added to both sides rather than just one.

As part of the redecoration of the room, the panels should be cleaned back to remove the paint build up which is now away from the mouldings due to the panel shrinkage to enable fresh paint to be applied across the panel and mouldings. Before this can be done the bolection mouldings need stabilising.

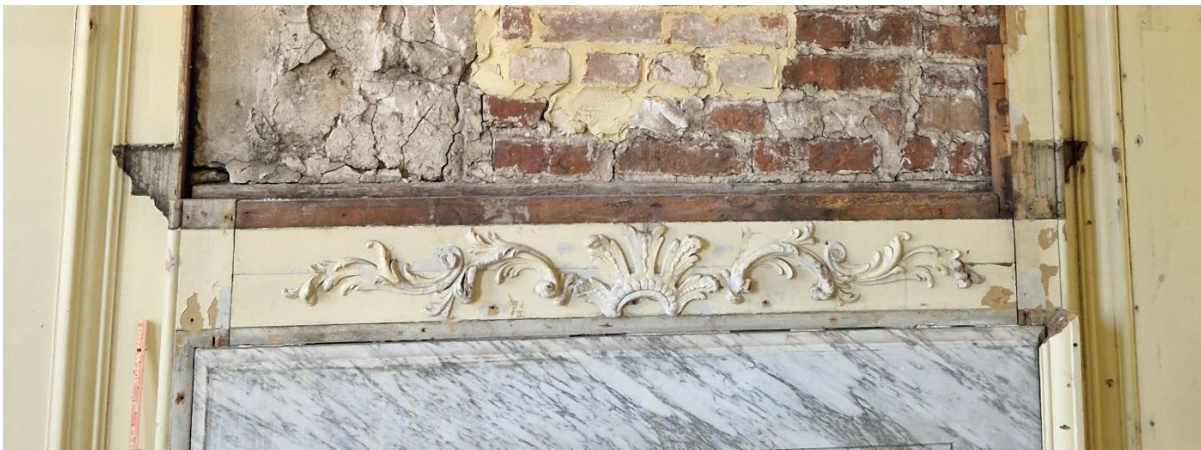
### **Fireplace wall PE-3.1**

All of the missing mouldings can be determined by existing details. The LH stile can be patched to match the existing rail.

Research by others has concluded that the area above the mantle shelf is a flat and flush panel like the one in the Drawing Room. Ghost marks and the tenon into the PH stile show the size of the cross rail above and gives the panel size.

The current Bolection moulding and panel over fireplace is correct size but panel made up of random boards that don't match other panels. The board widths are possibly too narrow relative the other inserted panels. None of the other panels have boards with endgrain joints. Redecorating may not mask these discrepancies, so consideration should be given to replacing panel. Other than changing the boards the overall look would be unchanged. The panel would then match the other panels in the room, with no end grain joints. The other panels will give the average board width to copy, so may be 4 boards, c300 mm each.

Like all replacement pieces, the new panel board should be made of well-seasoned pine, acclimatised to the RH in the room. This should ensure that relative movement is minimal and not lead to joint failure and paint cracking.

The LH stile below the cut line could be lifted off by prising it off the return board. The horizontal panel with the papier mache decoration could also be removed at this point. The board is either attached by tenons or pinned directly on to support battens.

Due to the nature of the repairs required to the papier mache decoration to the board, it would be beneficial to remove the board to facilitate this. The board can then be reinstated after the rest of the work has been completed.

During the repair and replacement of the fireplace wall, it would therefore be sensible to fix the mantel shelf and the top architrave of the fire surround in a way that allows them to be removed – perhaps screw fixed, but not filling over in the first instance.

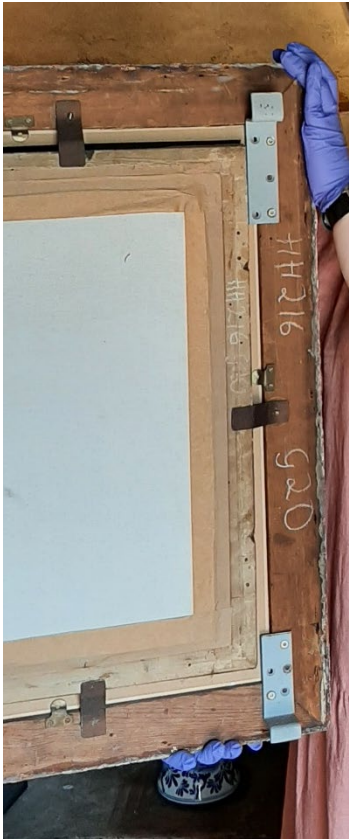
Alternatively, the mouldings can have right angle stepped brackets fitted that engage behind the rails on the top and bottom register of the panel wall. The top bracket has a longer arm to engage behind the panel to remain in place when lowered in place.

Examples can be seen at Ham (in image) or Petworth.

Access to the wall to carry out masonry repairs has been mentioned. In addition to this, the panel over the fireplace may require infrequent but regular removal to inspect the wall. The Bolection moulding frame can be attached to the wall either on slotted screw fittings or mirror plate brackets.

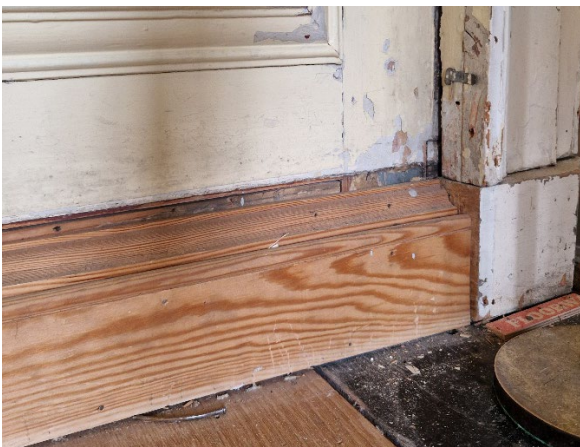
**South wall below PS-3.2**

Some of the skirting boards have been replaced with matching mouldings and timber. The skirting boards have, in places along the south and east walls, been dropped and run parallel to the floor resulting in wider gaps between the skirting and lower panels. This may be to accommodate

movement in the floor make up. The incorrect gap between skirting and panels is more noticeable than to the floor.

The misalignment of the skirting against the lower panels looks wrong. Correcting the gap between lower panels and the skirting I think is key to allowing the room to read correctly. Simply moving the displaced skirting boards up will leave a large gap between the skirting face board and the floor.

As the incorrectly located boards are all made from new timber, it would be justified to replace the face boards with wider boards that can be scribed against the floor to fit the contours. Other gaps to original skirtings can be taken as the datum gap.

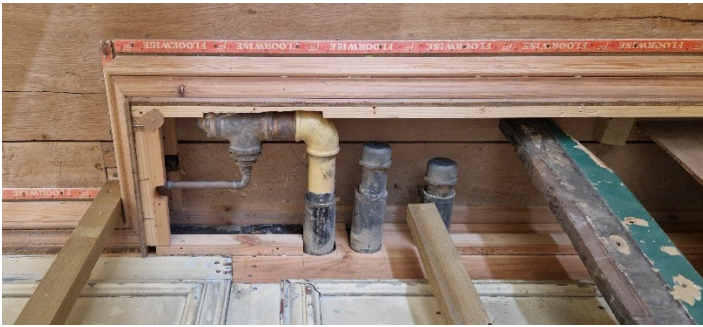
The skirting protrusion into the room is being investigated to establish whether the various plumbing piping can be removed to allow the skirting to run round the wall edge.

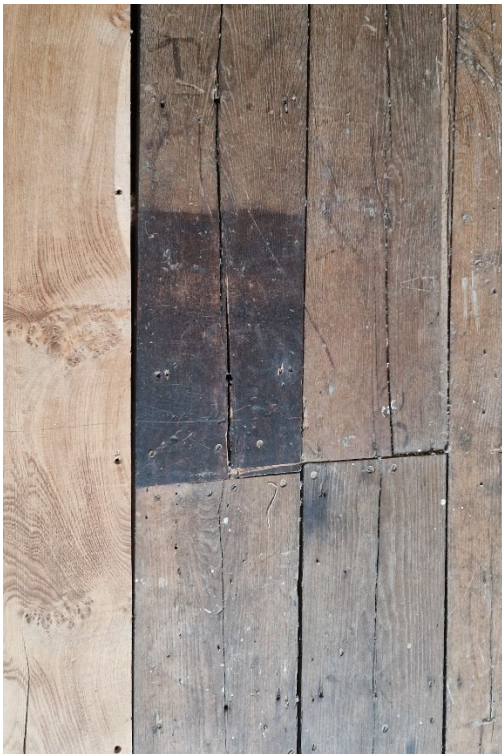
The floor has been laid down in a very random manner with new boards let in. Some boards were clearly against the skirting, as in the image above. Possible options are to leave the floor as it is or attempt to clean the dark boards and balance up the colour on the other boards. The floor should not be sanded. It may be that the floorboards are a random selection salvaged from around the property and so the discrepancies can be left as part of the history of the building.

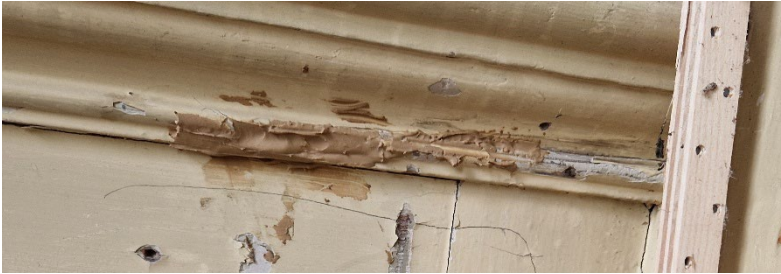
Dado above PE-2.2 to left of fireplace is split and filled with a mastic

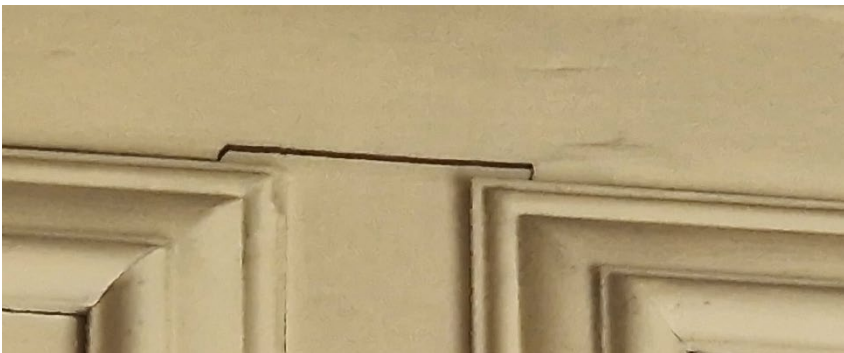
West wall stiles have dropped along top register and wall bounces when pressed suggesting that the noggins or other fixings may have failed.

The west wall requires some upper panels to be removed to correct issues with the inner panels. This will allow the wall to be investigated. With the skirting boards taken off, the bottom register rail can be lifted up by appropriate lifting kit to push the stiles up. The stiles can be attached to the wall by new fixings through the face into blocks acting as spacers off the wall and folding wedges placed under the bottom rails under the stiles to offer further stability. The skirting board can then be reattached.
