| Client: Mr O & Mrs E Collins.<br>Bewley Cottage, Bowden Hill,<br>Lacock, SN15 2PW | | Drawing: Existing North & South<br>Elevations | | <b>DOLMAN</b><br>ARCHITECTURAL DESIGNERS BUILDING SURVEYORS<br>COST CONSULTANTS CDM PRINCIPAL DESIGNERS | |
| Project: Fire Damage Repairs to<br>Cottage | Drawn: JAG<br>Drawing number: 4430-03 | Date: 26/08/2025 | Scale: 1:50<br>@ A1<br>Rev. B | Sussex House<br>Bath Road<br>Devizes<br>Wiltshire SN10 2AF | Tel: 01380 729456<br>Web: www.dolmansurveyors.co.uk<br>Email: info@dolmansurveyors.co.uk |

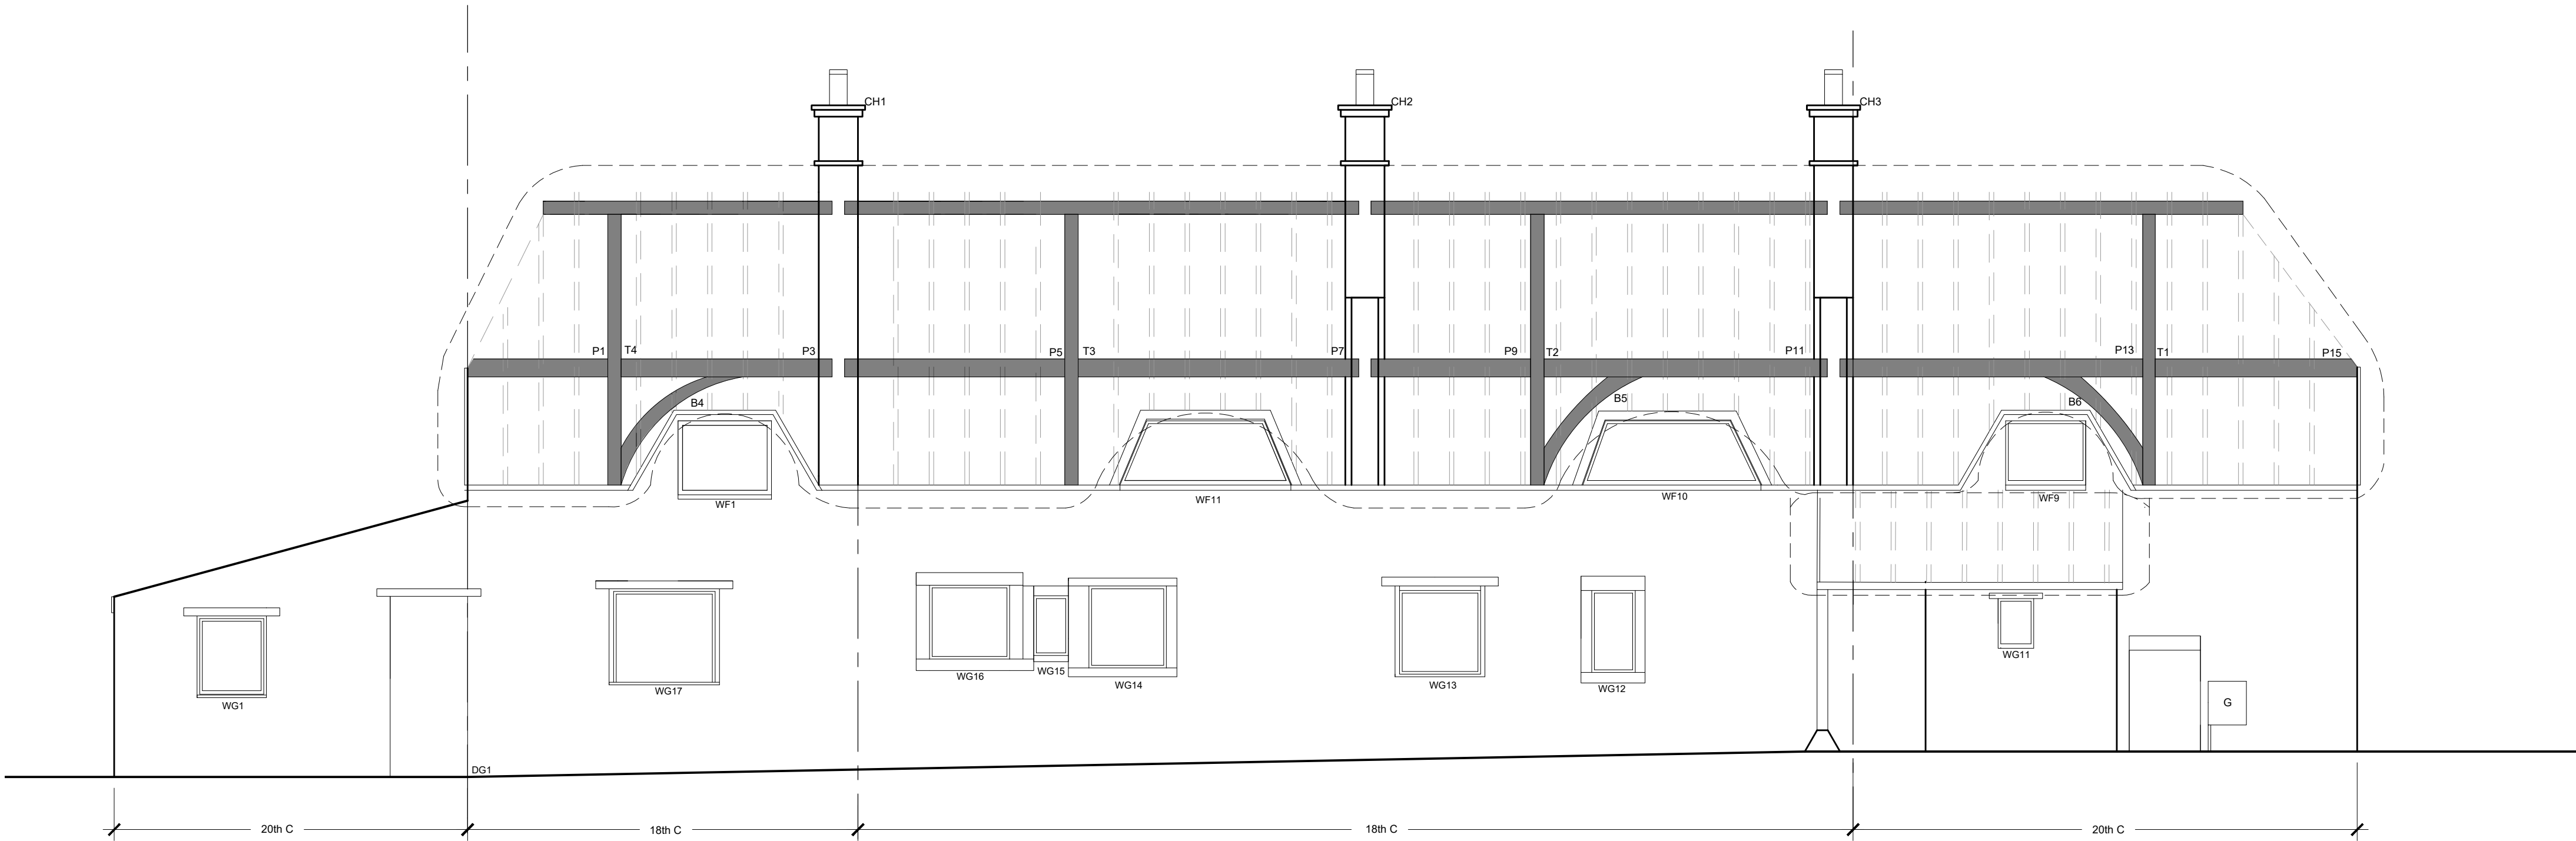
Existing North Elevation  
Scale 1:50

**Note - Post Fire Condition**

- Thatch - combed wheat reed 100% loss
- Concrete tile to lean to - salvagable
- Rafters - softwood - 100% loss
- Green oak roof structure - raised collar trusses 90% loss:

- T1 south 50% salvagable
  - T3 south salvagable
  - T1 north 50% salvagable
- Chimneys - localised pointing & lead flashing reinstatement required. All other respects structurally sound

- Stone walls - localised wall plate level pointing to be expected. All other respects structurally sound
- Windows (frames painted timber) - WF9 100% loss

- Glass panes - WF1,3,4,5,6 & 9 have broken panes - renewal required (single except WF4 & WF6 which are double glazed)
- WG 12 & 16 have broken panes - renewal required (single glazed)

- Purlins - 100% loss
- Ridges - 100% loss
- Curved braces - 90% loss - B2 salvagable
- Verge & eaves thatch cutting boards and arris - cedar - 60% loss
- Wall plates - softwood - 100% loss

- Truss wall plates - 50% loss
