# Schedule of Works - Shaw House Ground, Mezzanine and First Floors, Melksham, Wiltshire November 2022 - May 2025

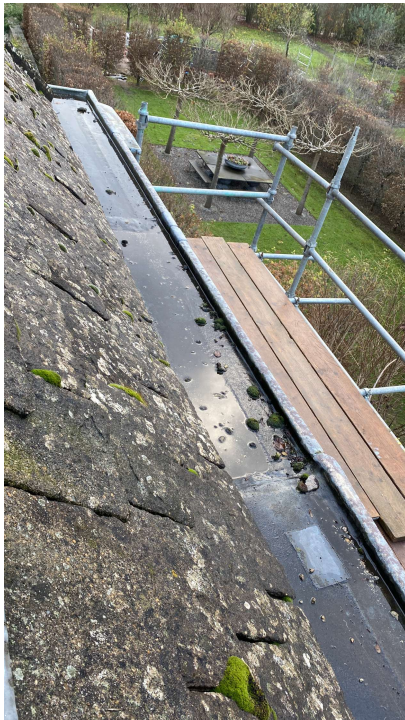
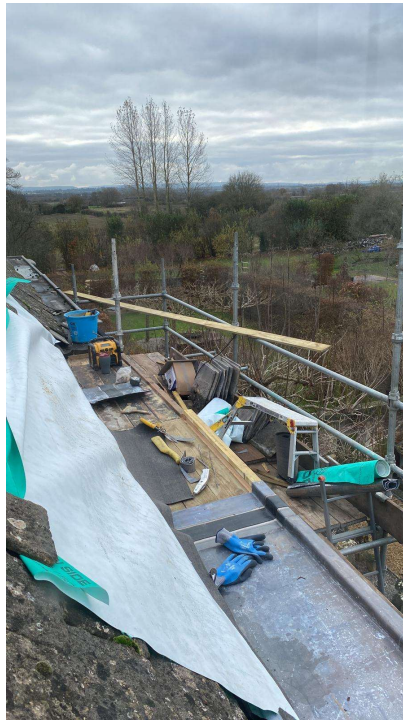
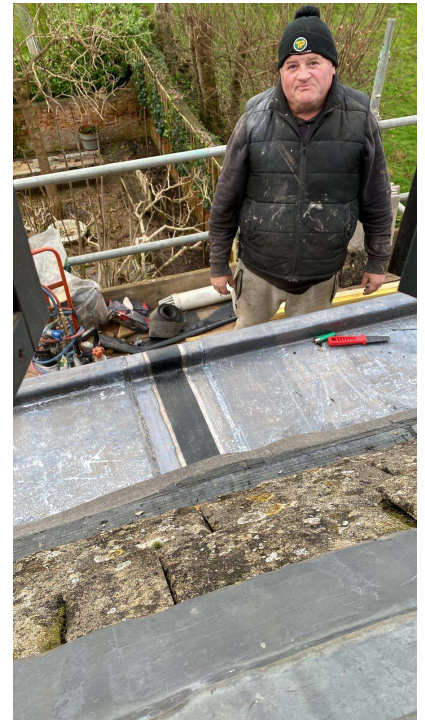
- Repairs to the south facing roof tiles on the Georgian wing, repairs to the damaged wooden frame lead lined gutters with rubber strips (see attached photos).

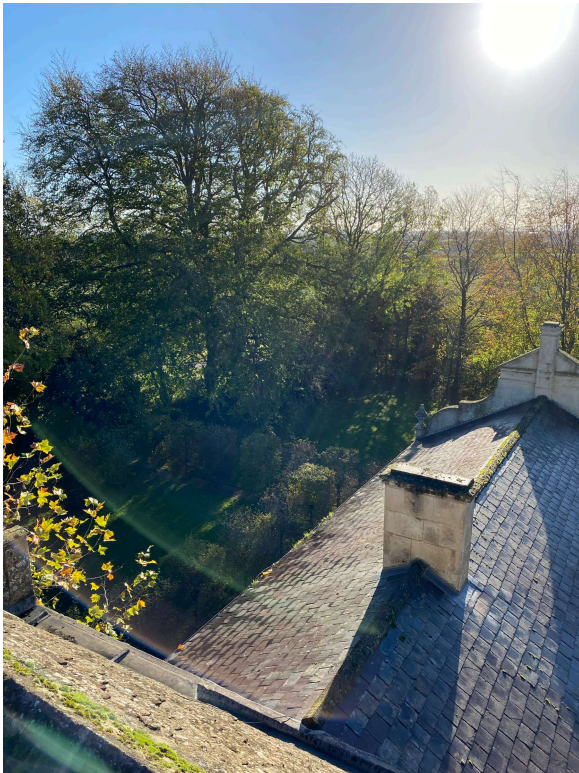
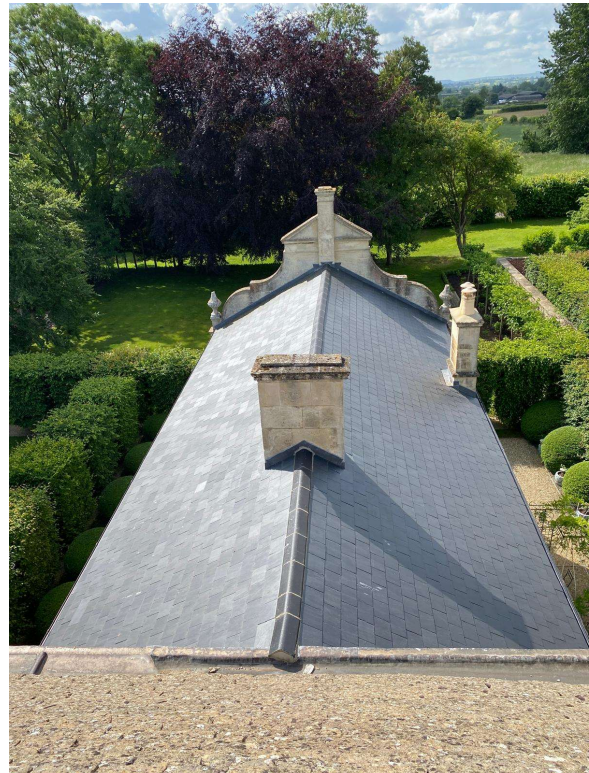
- The entire slate tiled roof on the Victorian wing had suffered from pyrite rust damage, resulting in literally hundreds of small leaky holes in the tiles. These tiles were replaced with matching slate tiles. All damaged lead work on the Victorian wing, on its two chimney stacks and on the Dutch gable were replaced with matching new lead (see attached photos) and the damaged stonework on the Dutch gable was repaired with a mix of lime render and crushed Bath stone (see photos).

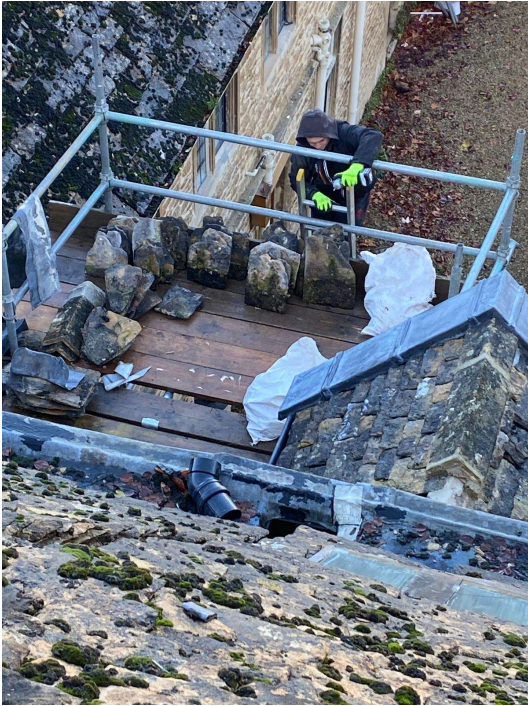
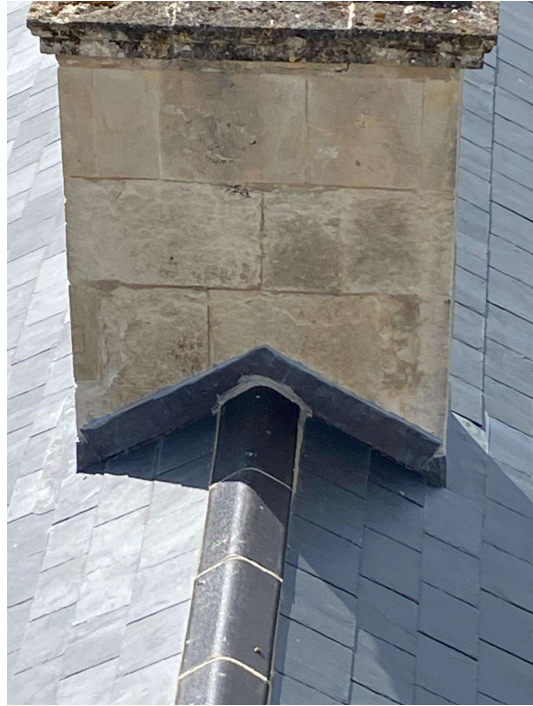
- Many dozens of Cotswold stone tiles on the Georgian wing had slipped out or were missing, leaving large gaps in the roof. Fortunately many had been caught in the lead gutters, were undamaged and were able to be reused, with the shortfall of several dozen different sizes of tiles being supplied by the roofer from his stock of vintage and new Cotswold stone tiles.
- The Cotswold stone roof on our neighbours property( Conkwell Grange) over the flying freehold, also had many missing tiles and because of the angle of their roof beams, most of this water flowed into the ceiling above our attic and

down our attic stairway into the kitchen, butlers pantry and boot room below. The roofers supplied the missing Cotswold stone tiles, made repairs and replaced the damaged lead work on a like for like basis (see attached photos).

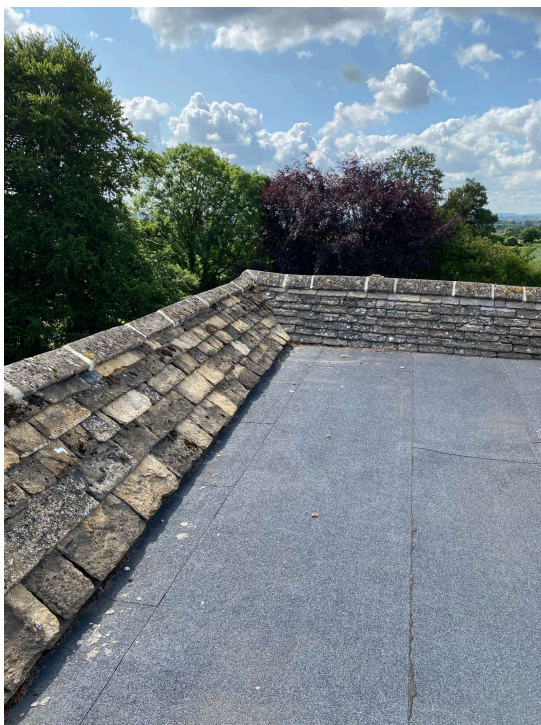
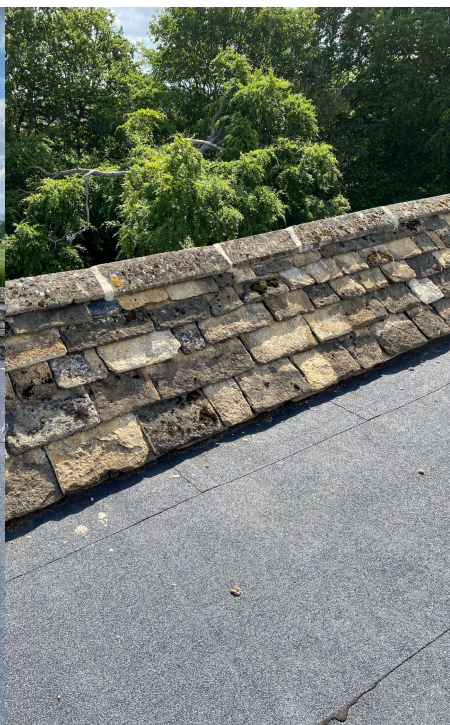
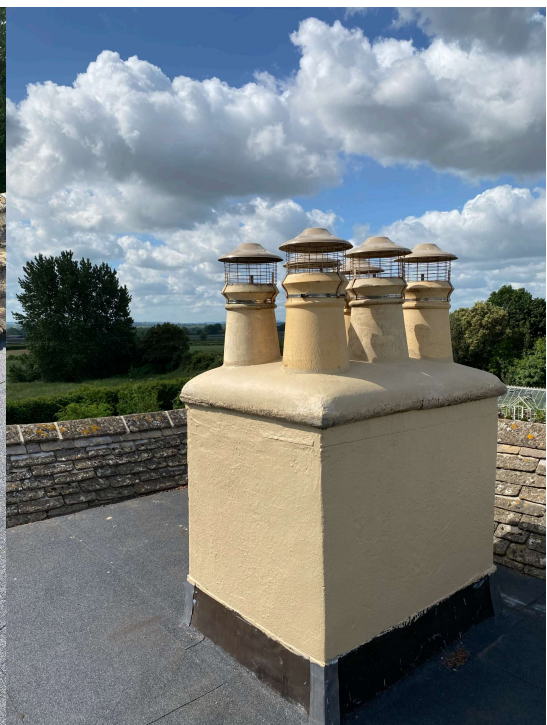
- The next phase involved installing new matching cast iron gutters and downpipes on the Victorian wing and replacing the badly damaged original south facing large wooden framed lead and rubber strip lined gutter on the Georgian wing with a matching wooden framed lead lined gutter.
- The badly cracked, often patched and leaky bitumen flat roof was removed, rock hard roof beams below it treated and oiled and new bitumen laid (see photos).

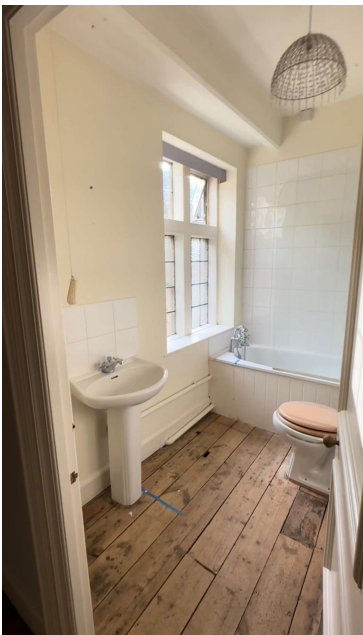
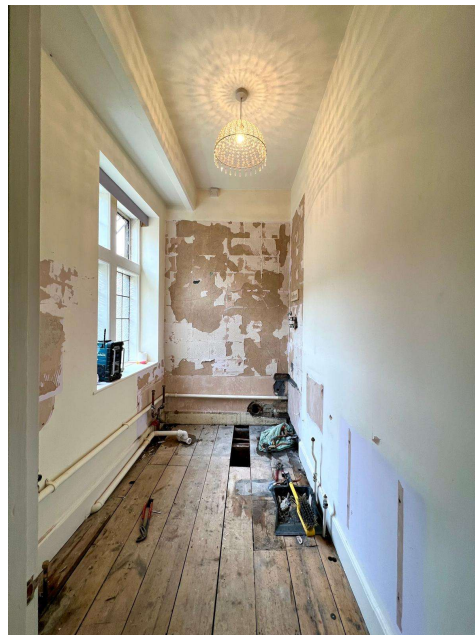
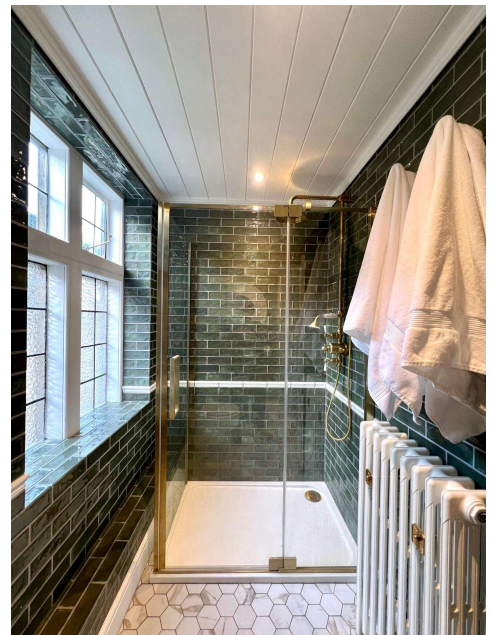
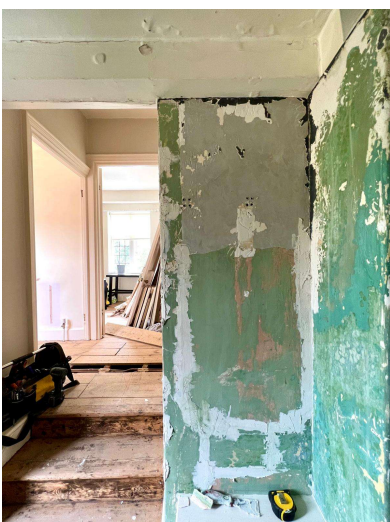
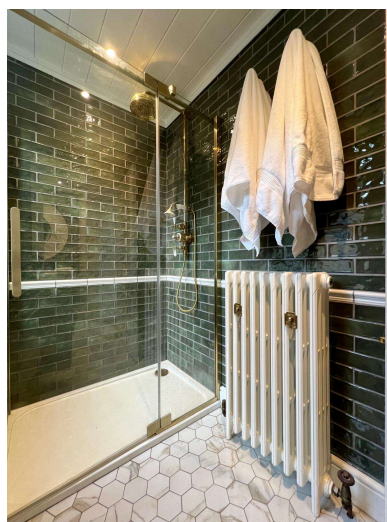
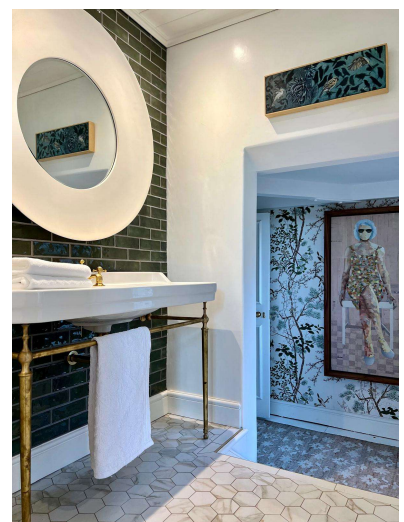
- The bathroom was re-plumbed, retiled, repainted and a new Victorian style toilet, basin and shower fittings were installed (see photos).
- Existing floor boards were repaired and fastened, skirting boards and cornicing repaired, existing doors were reused and period specific door handles and locks were installed.
- Cracks in the walls and ceilings were re-plastered in lime render and all walls and ceilings repainted white with wallpaper being applied to the small lobby and bedroom.

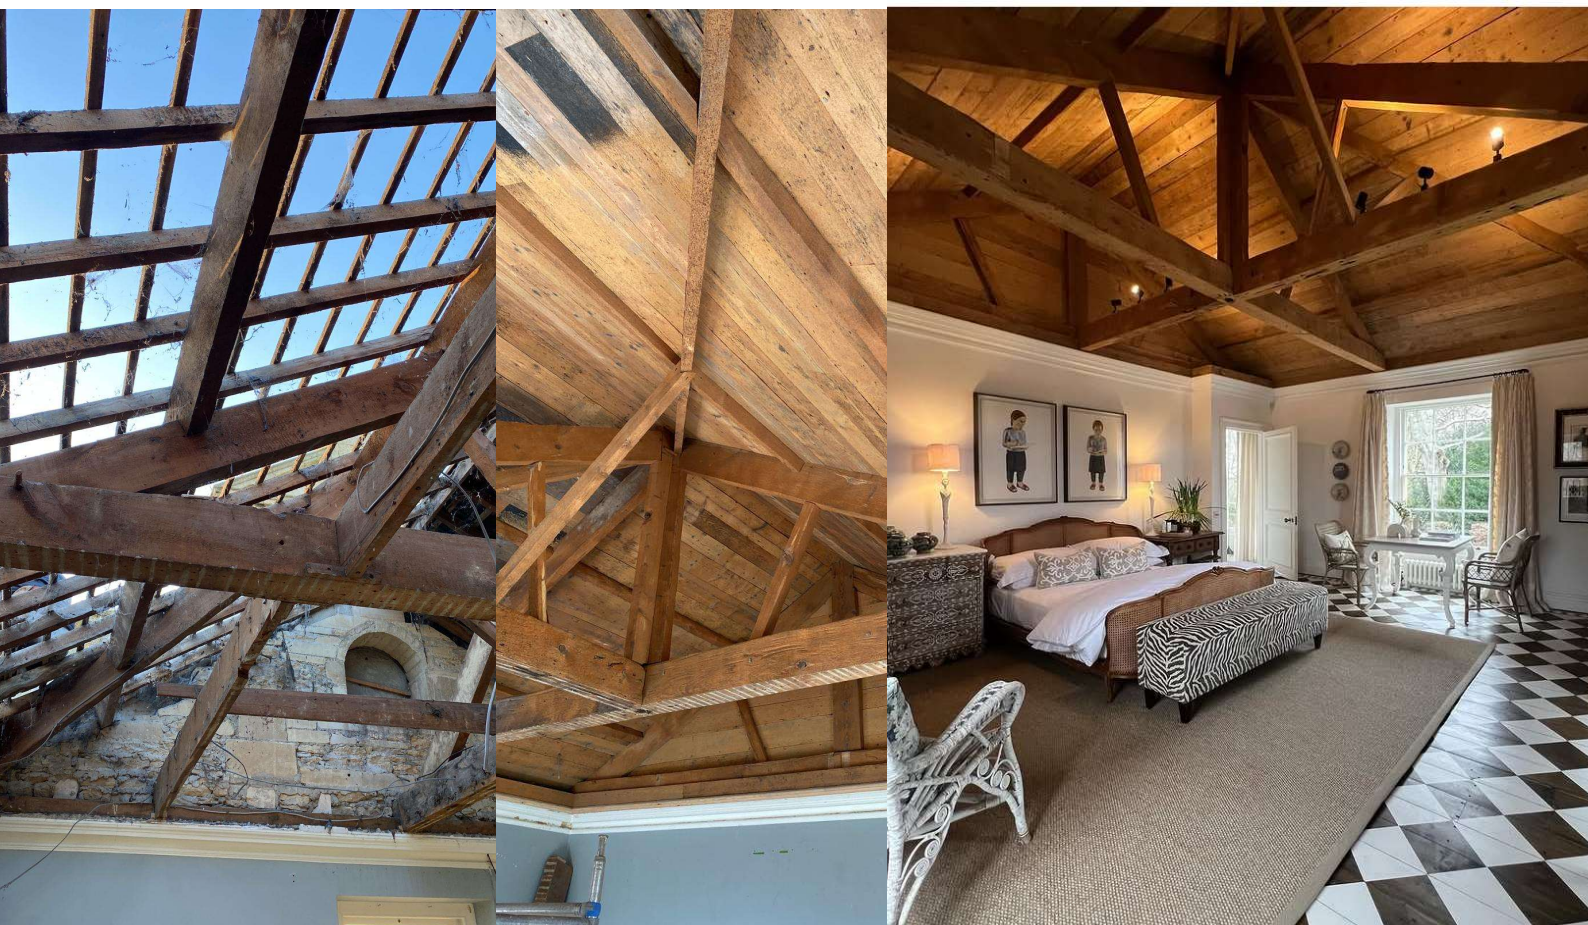
- The water damaged plasterboard ceiling was removed in this room exposing handsome wooden beams, which had woodworm and limited water damage. The damaged areas were sand (in fact glass beads) blasted with minimal impact to the timber, treated for woodworm and then oiled (see photos).

- The wooden flooring planks in this wing were badly damaged through use and so were repaired or replaced with matching timber. These floors were then varnished and painted in a traditional Victorian era checkerboard design (see photos).

- Salvaged floor boards were treated and used to line the ceiling in this bedroom (see photos) and the shortfall was made up of matching Victorian era reclaimed floorboards.

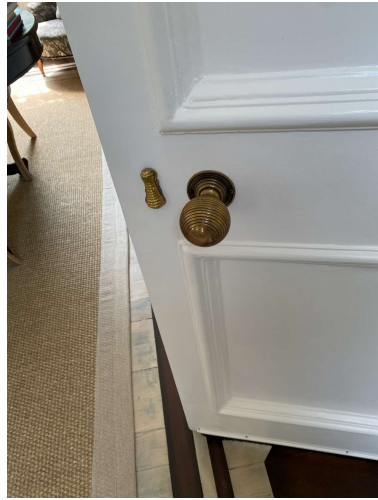
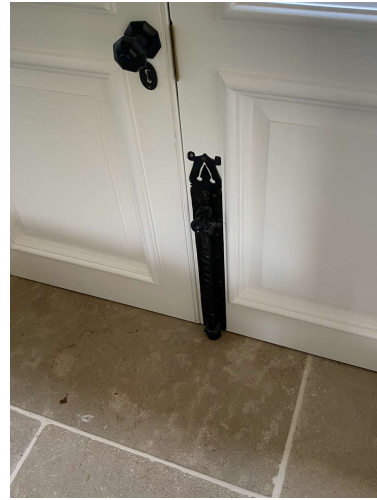
- All original doors were paint stripped, repaired and repainted and all door knobs fitted with period appropriate door knobs and locks (see photos).

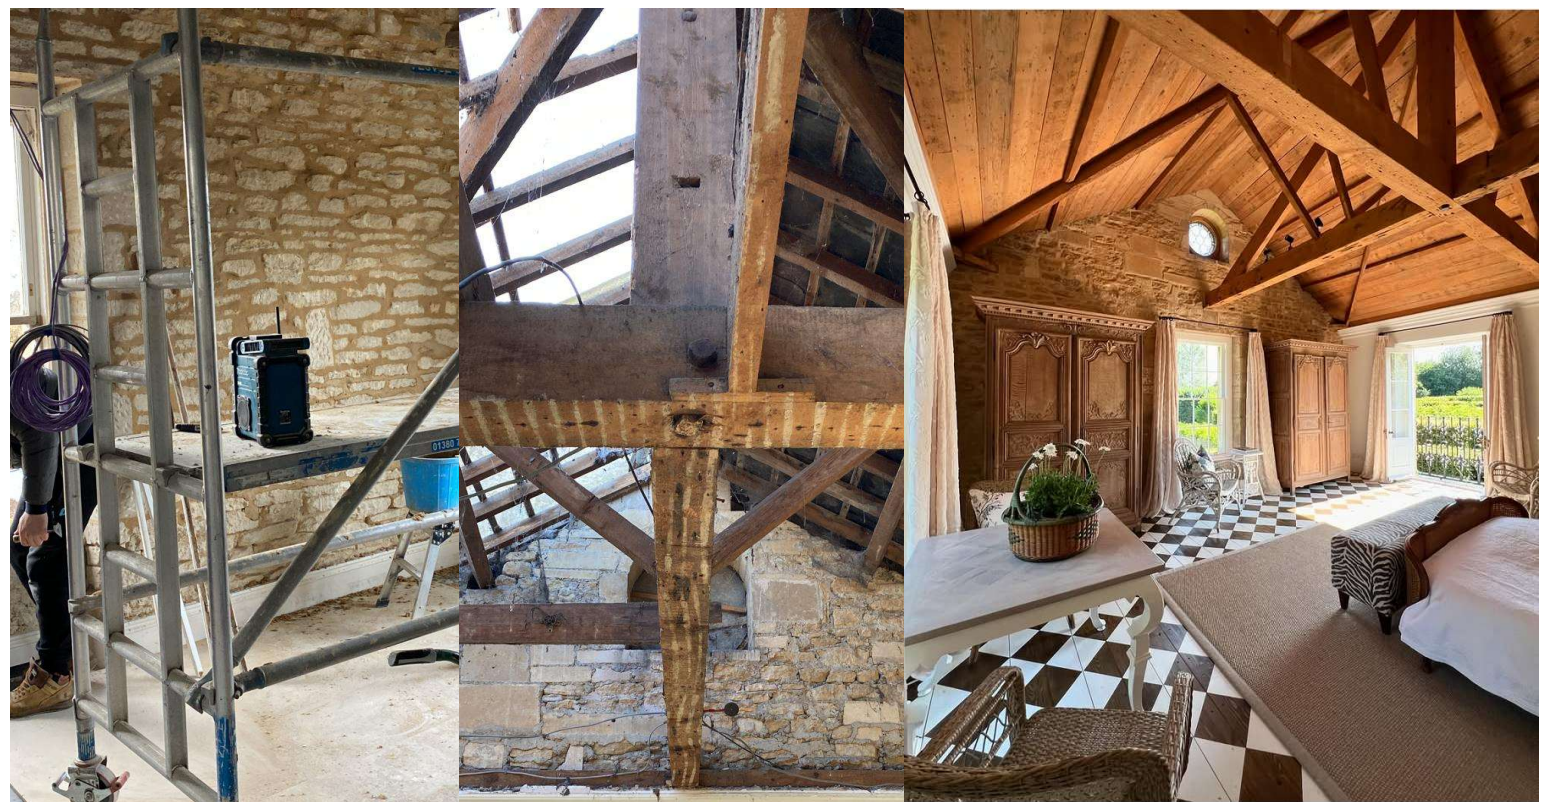
- Having dried out the east facing stone wall and repointed it in lime, exposed and treated the rooms exposed beams, due to their history and beauty and since the ceiling was of modern plasterboard, it was decided to apply for permission to leave these historic elements exposed(see photos).

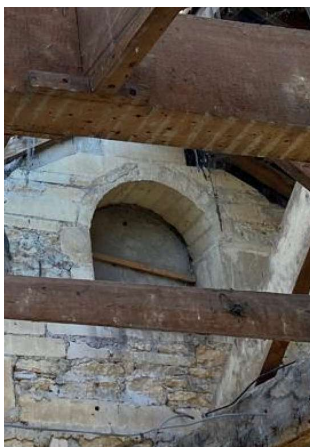
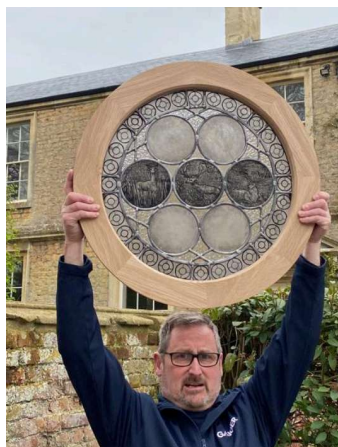
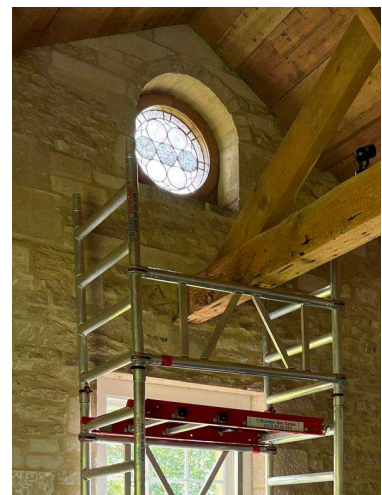
- Removing the damaged plasterboard ceiling on the east facing stone wall , exposed an original stone arch in the dutch gable filled with a broken plastic IKEA clock and chipboard backing. After consultation it was agreed that due to the shape and structure of this arch that it may have originally housed a window to bring light into the room. We commissioned a stained glass window specialist to copy the design of the stained glass window used above the front door, but to design it so that it was clearly secondary to the front facade stained glass window (see photos attached).

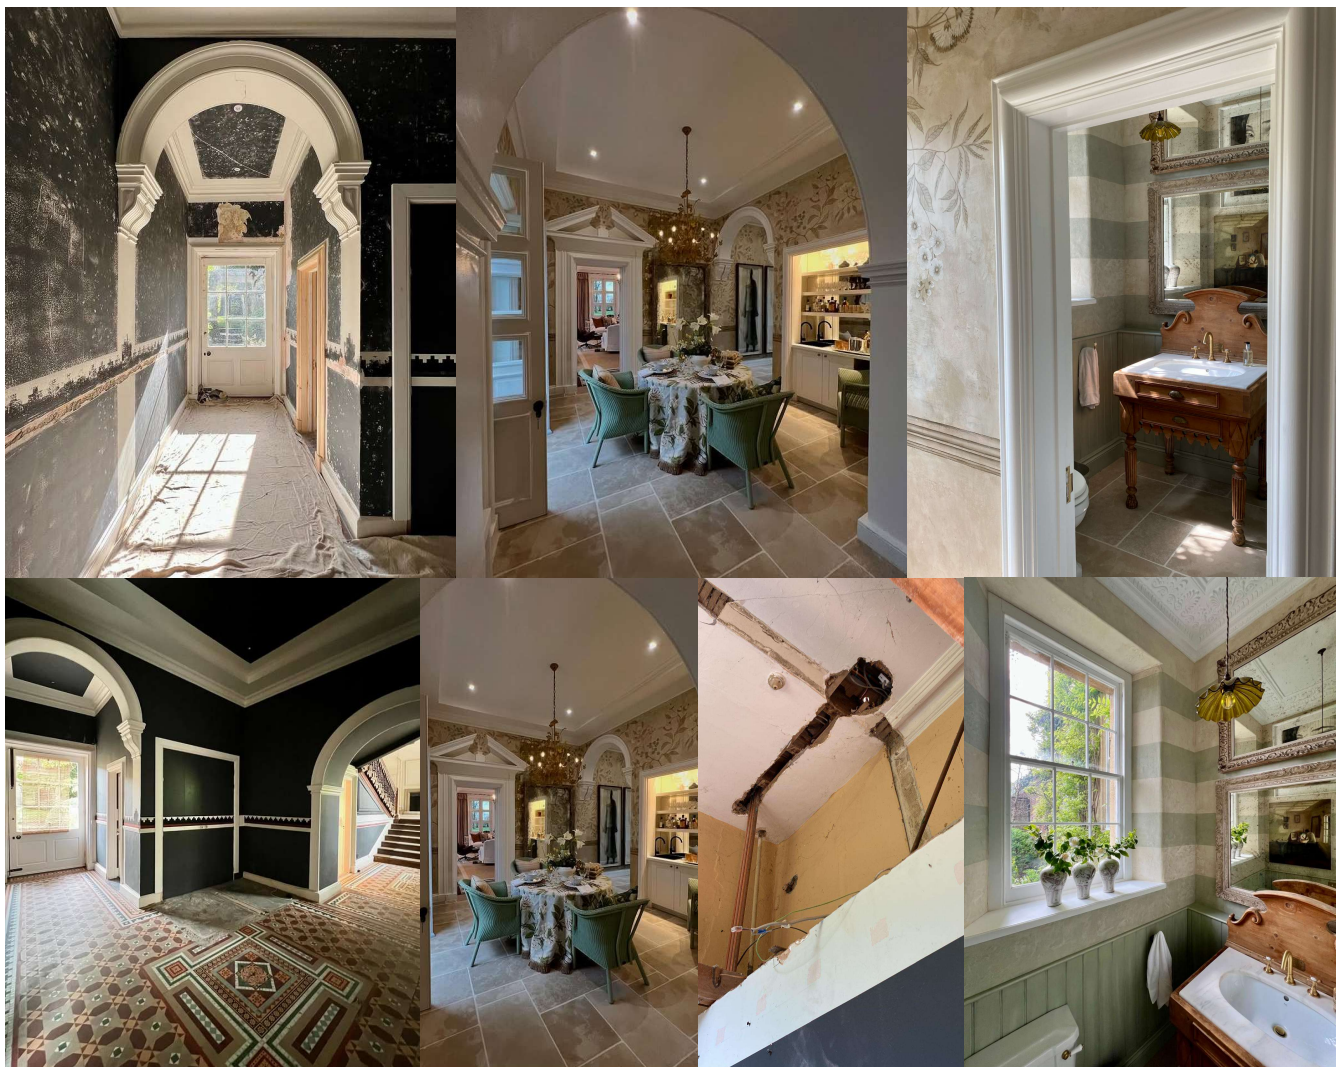
- The south facing walls, doors and sash window in this area suffered significant water damage from badly rusted gutters and blocked down pipes and so after the walls had been dried out and treated for damp, new lime render was applied and damaged cornicing, skirting boards and the large existing rear door were repaired, repainted and matching Victorian style door knobs fitted. The badly rusted historic door bolts were acid washed, repaired and reinstalled.

- The guest toilet had been modified/made smaller in the 1970's and a dropped ceiling installed, creating an open void above it (see photo). This plasterboard ceiling was removed to expose an original ceiling at the height of the small lobby ceiling. Ceiling and cornicing was repaired and decorated and an antique marble topped vanity and Victorian style basin and toilet fitted to existing plumbing. The modern hardboard door was replaced with a traditional hardwood door with detailing matching other doors in the area.

- The original tiled floor had been badly damaged and removed in areas and replaced with cement, possibly during 1970's works.
- Damaged tiling and modern cement areas were covered in a latex coating to preserve them and traditional flagstone floors laid using lime render grouting (see photos).

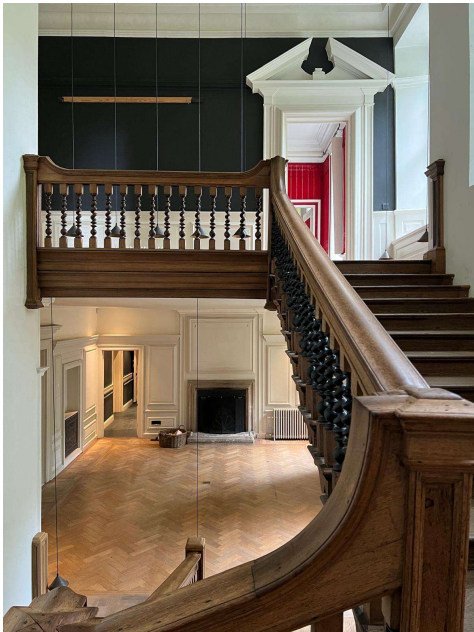
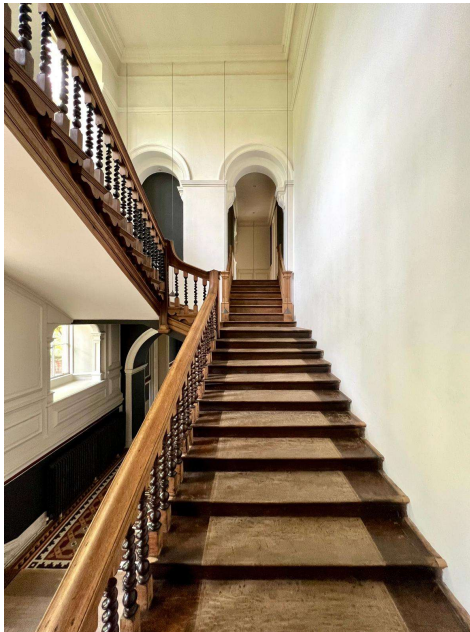
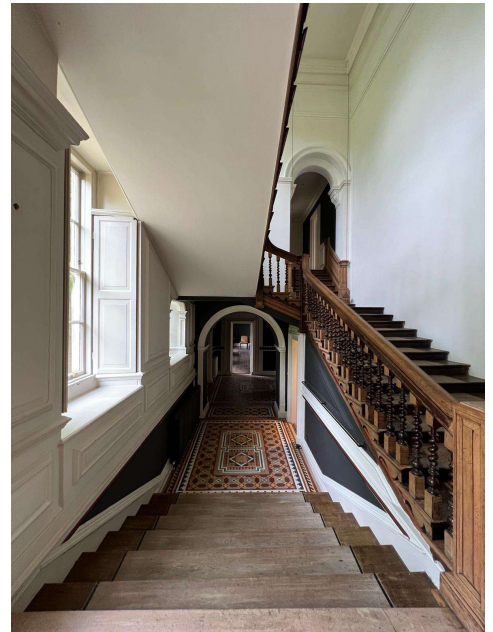
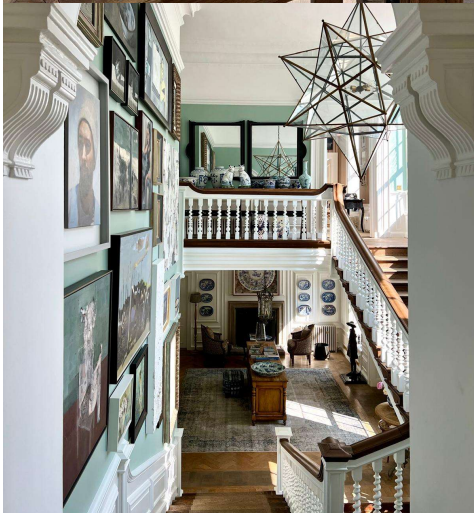
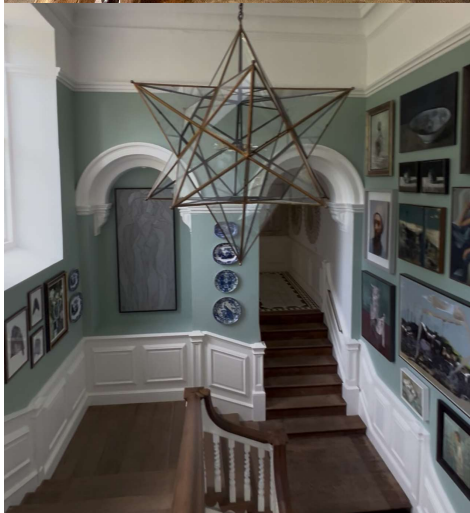
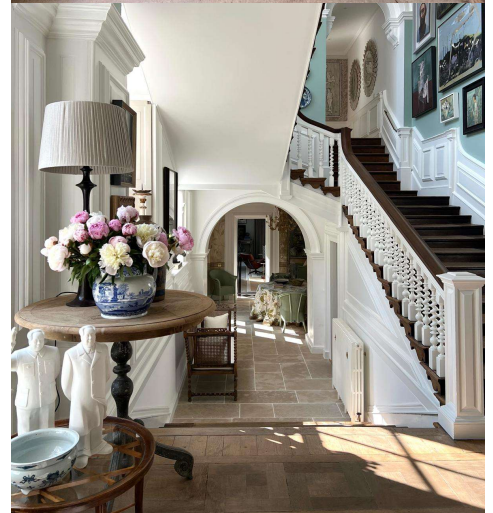
- Based on photos from the last ten years, t some point after 2015, the wooden panelling on the grand stairway had been removed and discarded. Based on these photos we have matched and refitted all the missing wooden panelling (see photos).

- Several planks, ornate treads and spindles on this stairway had subsided or suffered wear and tear damage over the centuries. All original timber has been retained, repaired, re-fitted, oiled and treated (see photos).

- The gallery ceiling above the main stairway was cracked and had a few wet spots from the leaky roof. Once these areas had dried out, these ceilings were repaired with lime render and then decorated.

- All sash windows in this area have been serviced and painted and all walls patched and painted, following which a large antique style chandelier was hung over the main stairwell (see photos).

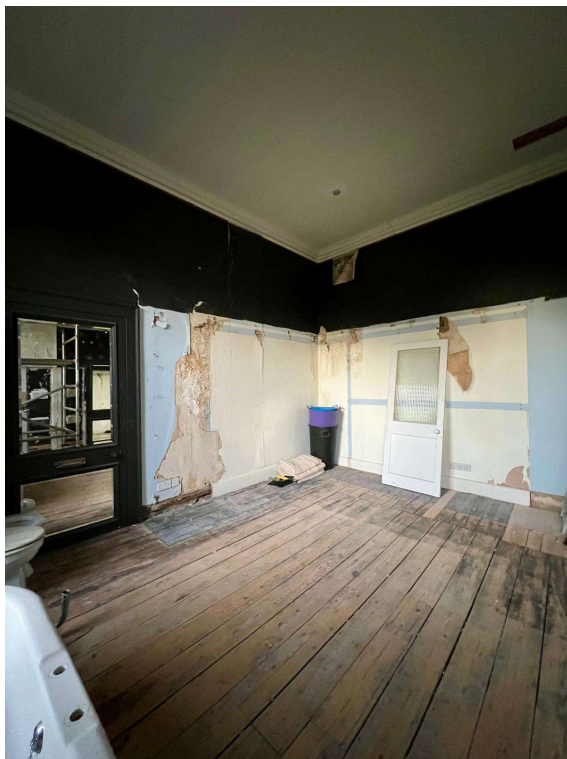
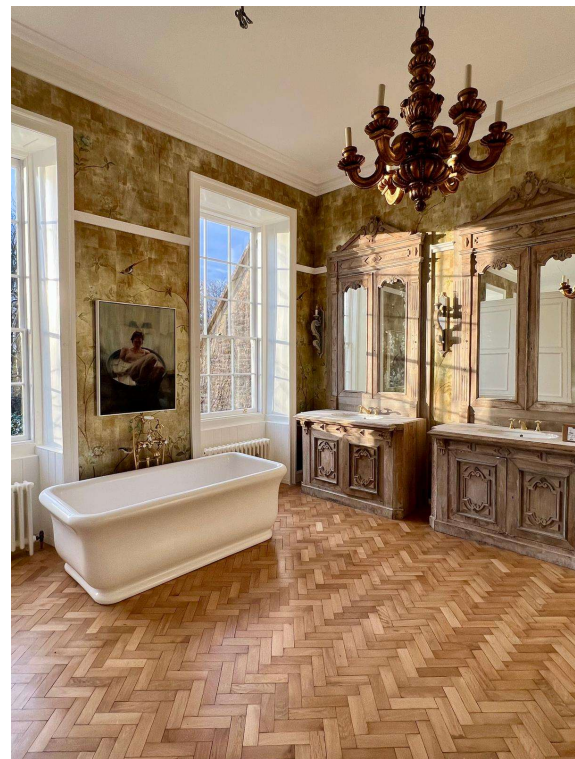
- The south facing bathroom had been spread over several rooms (previously broken up into three or four small bedrooms and a shared bathroom in the 1970's) and divided by an original ornate panelled wall, fireplace and doorway on the one side and three 1970's plasterboard walls dividing the bathroom and toilet, shower room and dressing room (see photos).

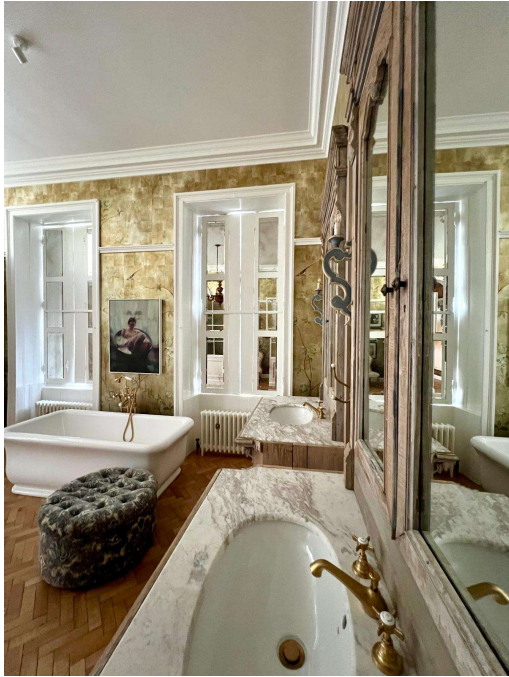
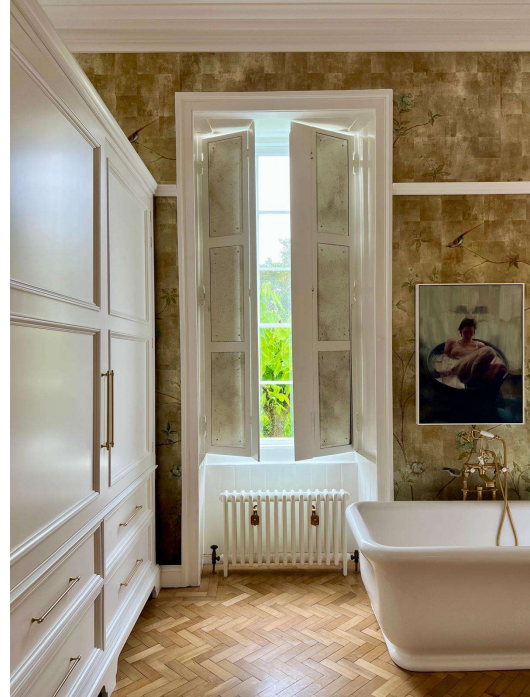
- The plasterboard walls and 1970's passage were removed, original panelling was repaired and repainted, repairs were made to the severely water damaged south facing wall. Damp render was removed, the stonework was

allowed to dry out and then repointed using lime. The walls were then replastered using lime render and the damaged south facing panelling was repaired or replaced.

- All shutters were serviced, repainted, hinges fixed and then the original antique mirrors on the bathroom shutters were cleaned and replaced (see photos).

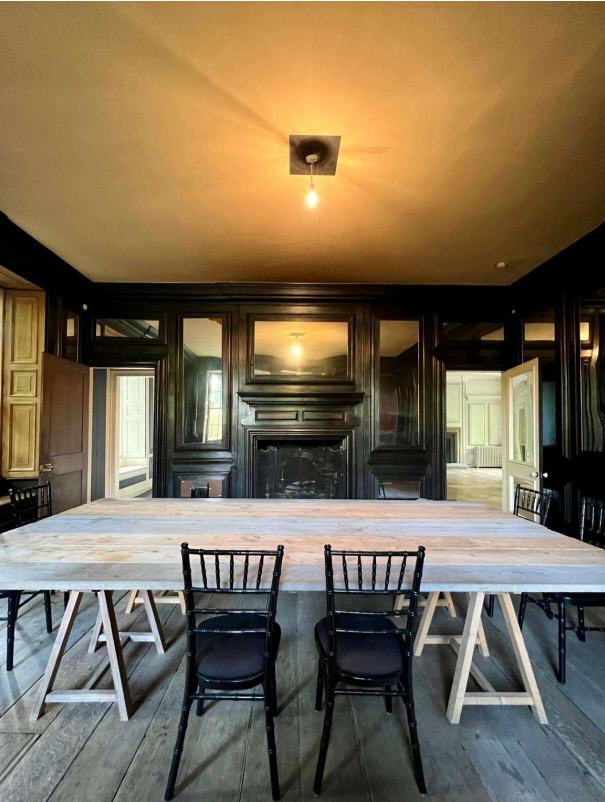
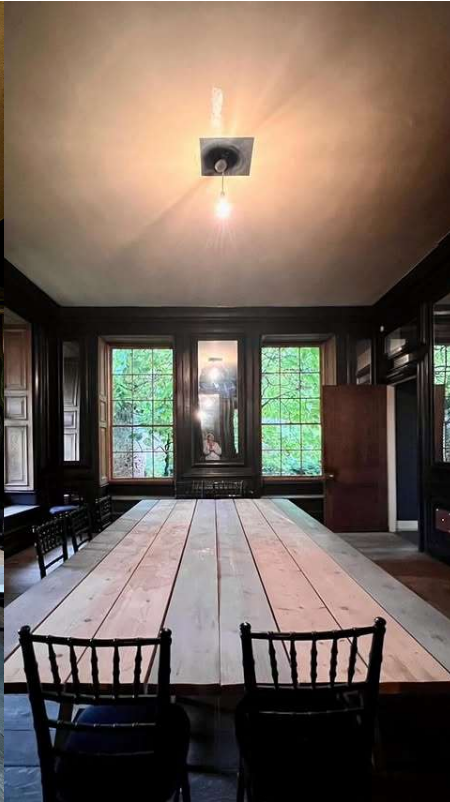
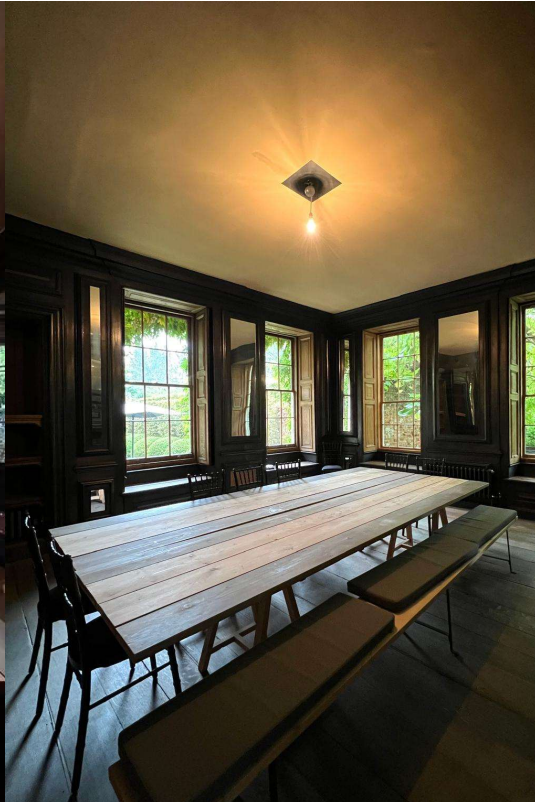
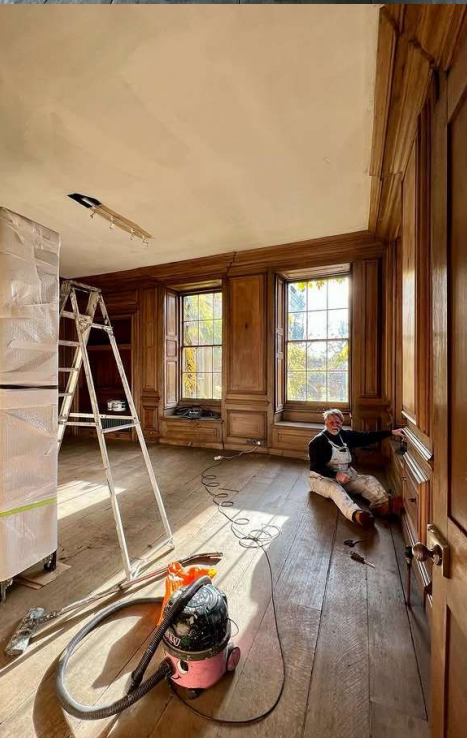
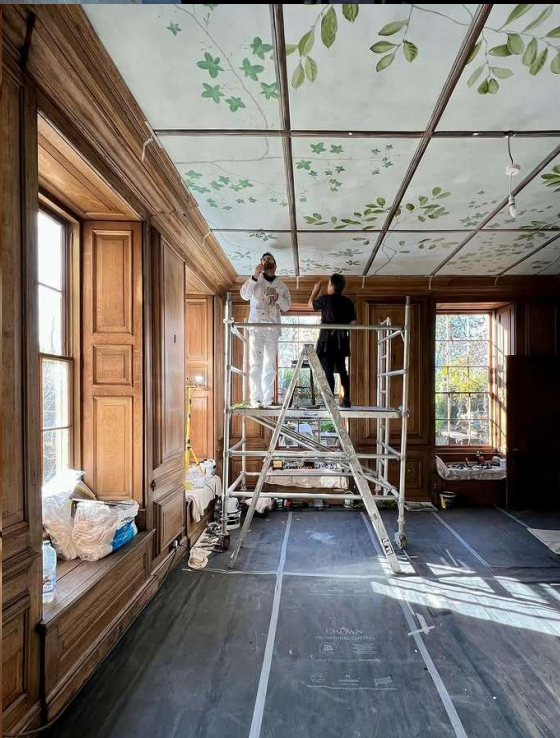
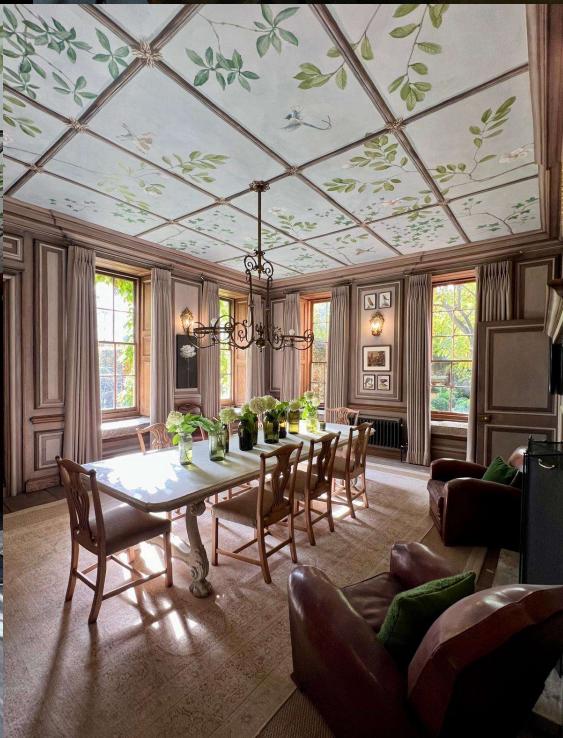
- The wood panelling had been painted Japan black, the ceiling was badly stained and the sash windows did not open with broken ropes and disconnected weights, window sills on the east side were rotten and needed replacement and there was damage to the south facing stone window surrounds (see photos).

- All black paint was scraped off to expose the wooden cornicing and it was oiled and treated similarly.
- No cracks were evident in the lath and plaster ceiling and so several coats of white breathable paint were applied before an ornate Georgian era mural was painted onto it ( see photos).

- All four sash windows were serviced, two of four badly damaged window sills were replaced with oak window sills, all were oiled and then the exterior painted in white to match the rest of the exterior sash windows.

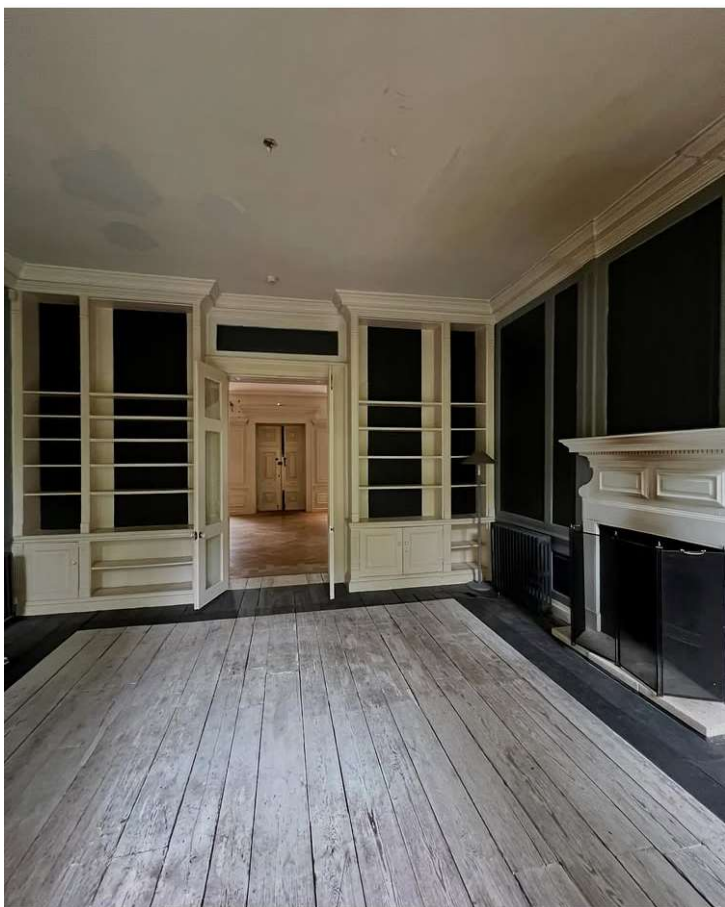
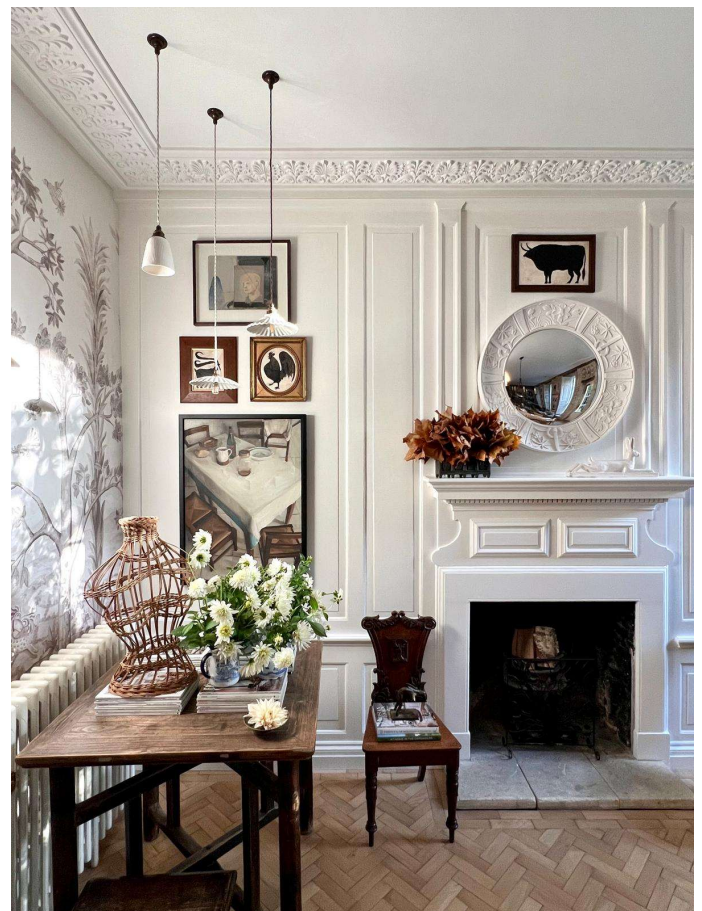
- Floors were badly damaged with several live plug wires drilled through from basement plugs. The south facing wall was very damp and the plasterboard ceiling and cornicing badly fitted, but the east facing fireplace and panelled wall were in good condition and only needed minor repairs and repainting.

- Damaged floors were replaced with reclaimed Victorian era English oak parquet flooring, damp panelling and stone pointing on the south facing wall was removed, sodden stonework was dried out with heaters and dehumidifiers for several months and the exposed stone wall repointed with lime plaster.

- The fireplace wooden surround and wall panelling were repaired and painted white and the wall around the large door onto the kitchen courtyard is now ready to be lime rendered and repainted (see photos).

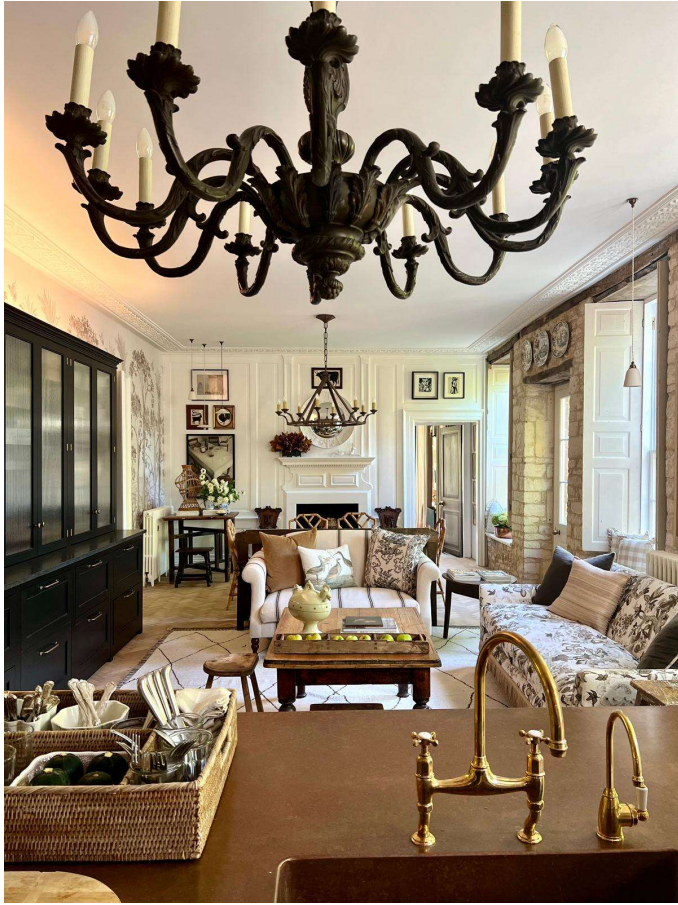
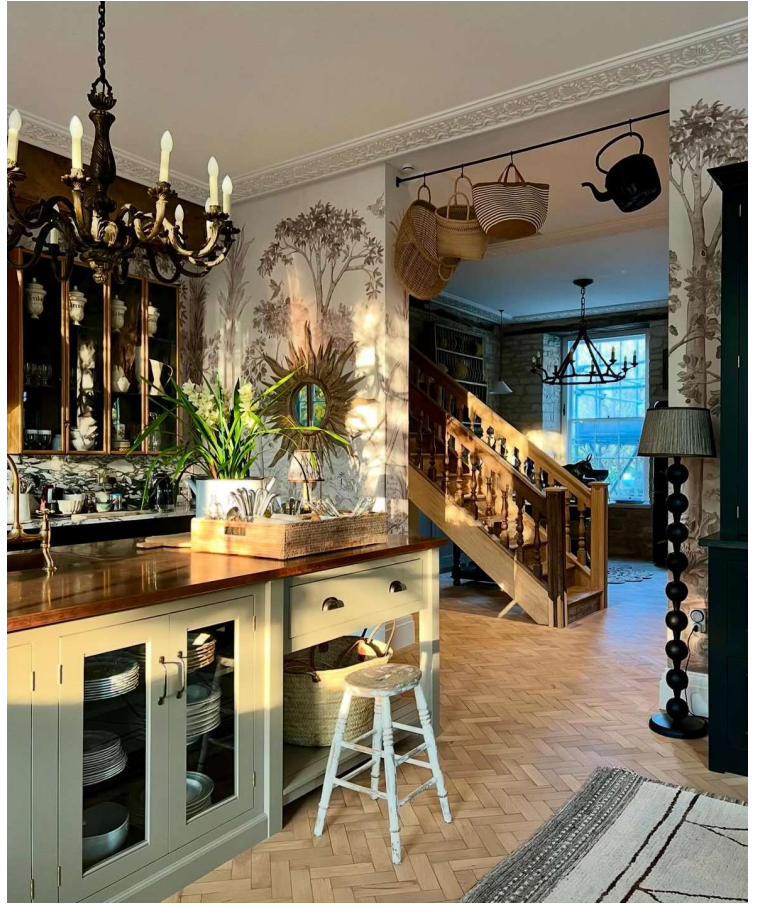
- The south facing stone wall was dried out with humidifiers and heaters for several months and then pointed with lime render.
- The doorway from the kitchen to the Butlers pantry/scullery was widened and reinforced with a steel beam to replace the badly damaged wooden lintel, as recommended by the structural engineer ( see photos).
