# Schedule of Works - Shaw House Ground, Mezzanine and First Floors, Melksham, Wiltshire November 2022 - May 2025

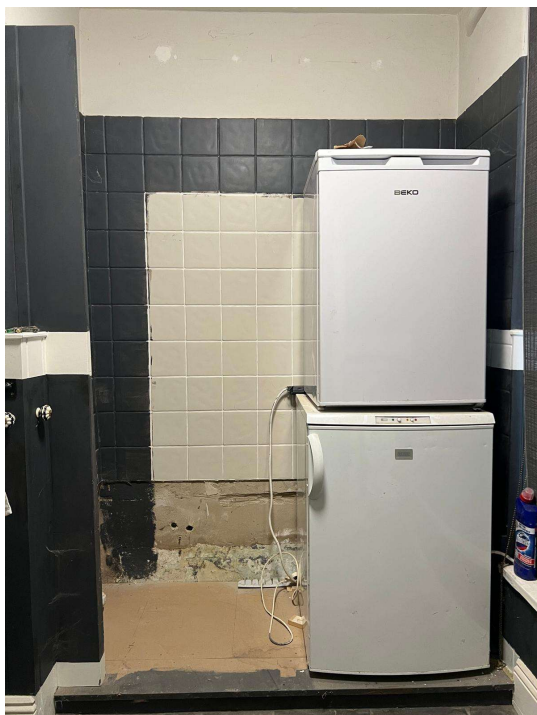
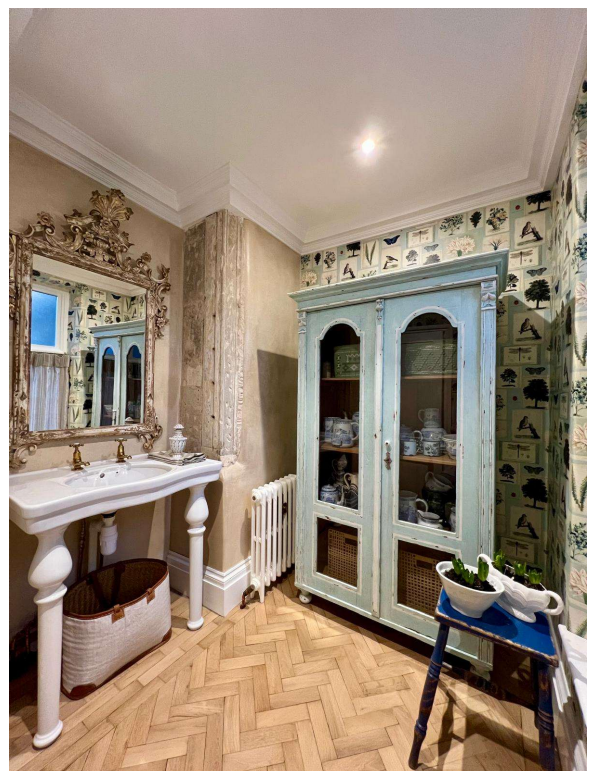
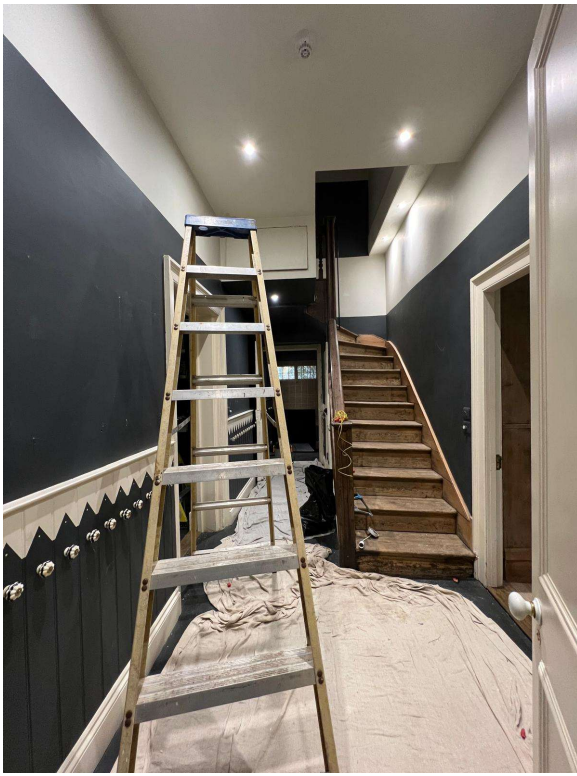
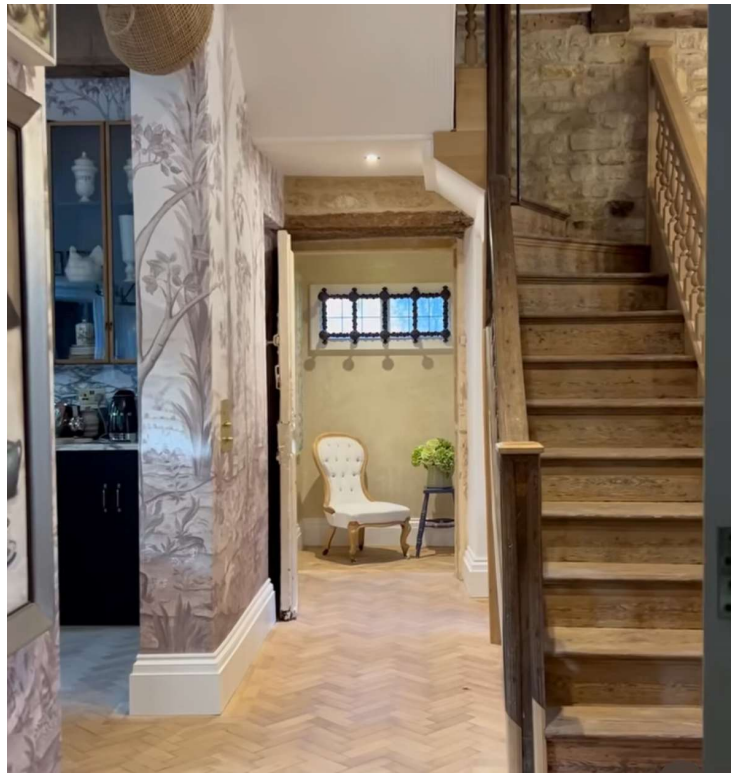
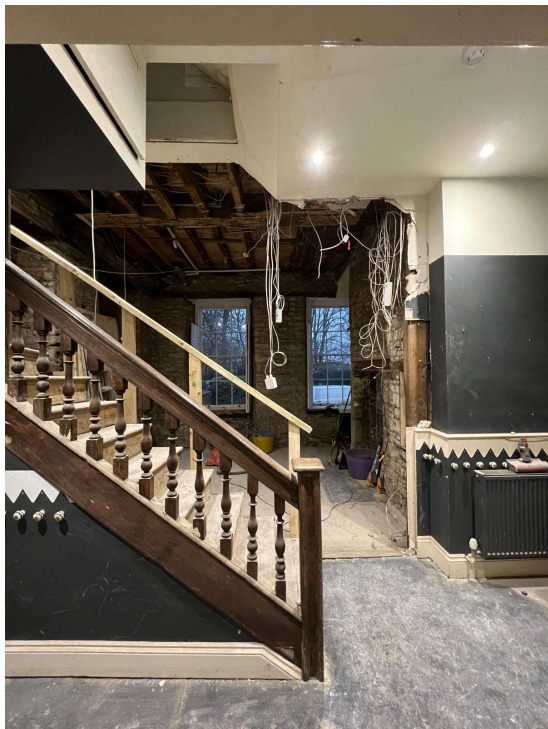
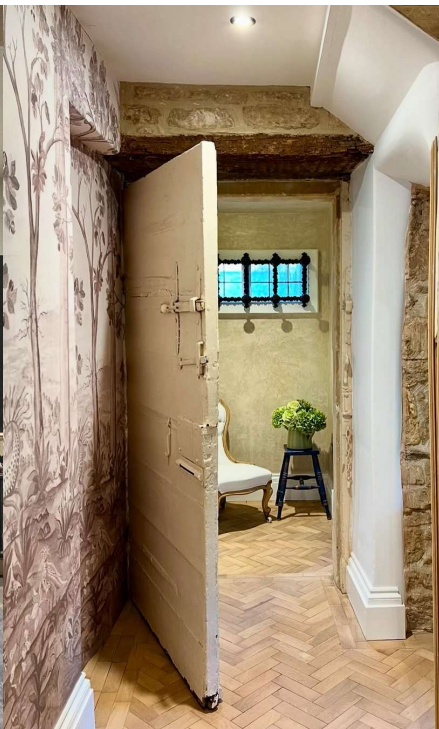
- The vinyl covered chipboard butlers pantry floor above the boiler room was unstable and since the boiler room below it had not been fireproofed/fire boarded, the crumbling chipboard was removed, the ceiling of the basement boiler room fitted with verified fire boarding, all original floor beams treated and retained and the floors replaced with Victorian era reclaimed timber (see photos).

- The boot room did not suffer from water damage as its slate roof was in good condition and so works were more straightforward. Like much of the house the floorboards above the boiler room had suffered damage from usage and the area below it required fireproofing.

- A matching Victorian style radiator was installed.
- The gardeners toilet had been used as a toilet and fridge storage area, was painted black and had bad rising damp damp. On investigation it became clear that the rising damp was due to the neighbours roof gutters and downpipes dumping large volumes of water outside this room and not being connected into any drains or runoff area. New cast iron downpipes were installed, linked to the common gutter/drainage system and a lengthy drying out period applied to the room. Once dried out, damp render was repaired with lime and all black mould removed, modern black painted concrete pavers were lifted and the floor was replaced with Victorian era reclaimed timber, the cracked toilet was replaced with a new Victorian style toilet and the original basin unit was reused( see photo).
