Our ref: SJ/23147 - LR

**RE: 10 The Close, Salisbury**

Further to your request to inspect and report on the roof over Bed 3, I report as follows.

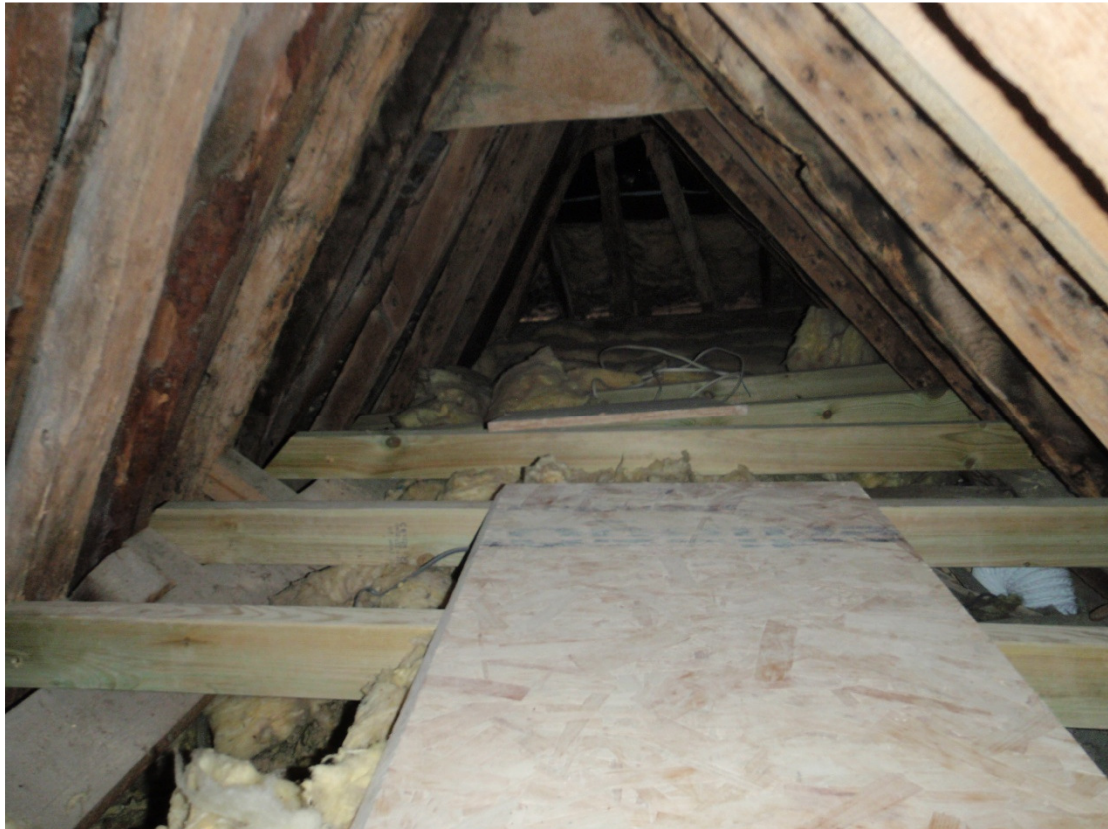
- 3.1 The roof has a high tie and so the roof space is quite restricted (Fig 1).
- 3.2 The condition of the timbers is variable with some more recent rafters having been installed on the west face in particular (Fig 2).
- 3.3 The most significant visible defect is the purlin on the east face which has fractured at the truss (Fig 3). A relatively modern purlin has been placed from

**Fig 1** View from the roof access into the loft space over Bedroom 3.

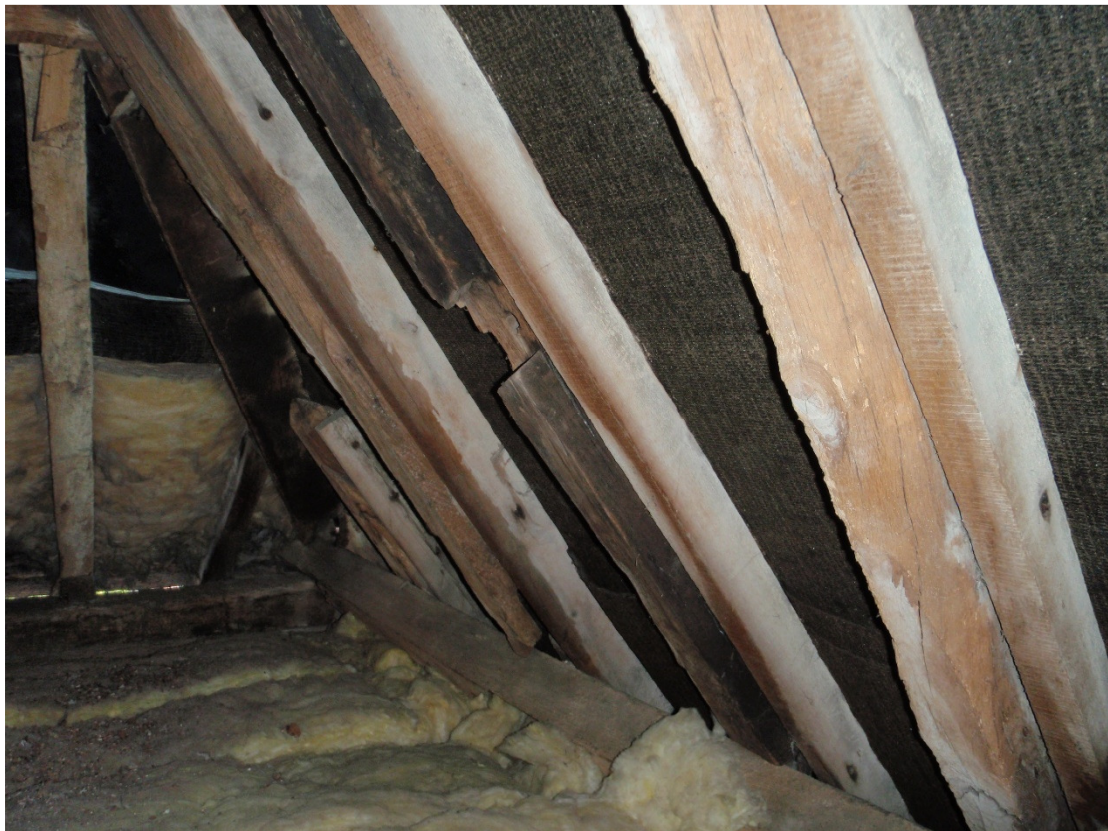
**Fig 2** Additional rafters against the original ones on the west roof slope.

- 4.2 Given the poor attempt at creating plane surfaces to the slopes of the roof it is likely that additional rafters will be needed by the side of the existing ones. We may also need to replace the purlin that fractured but would need to check the connection between the principal rafter and the tie of the truss, as well as checking on the support at the bottom of the rafters. We will also need to check the rafters to determine whether there is continuity or not, or whether we have some other means of support. As the purlin on the east has fractured, seemingly by furniture beetle infestation, it is likely that the lath and plaster ceiling may need to be removed as the weight of the ceiling and skilling is being supported by it and the bearing is extremely poor. Indeed, the ceiling in the bedroom below has a distinct curve where the skilling meets the ceiling where the purlin has failed.

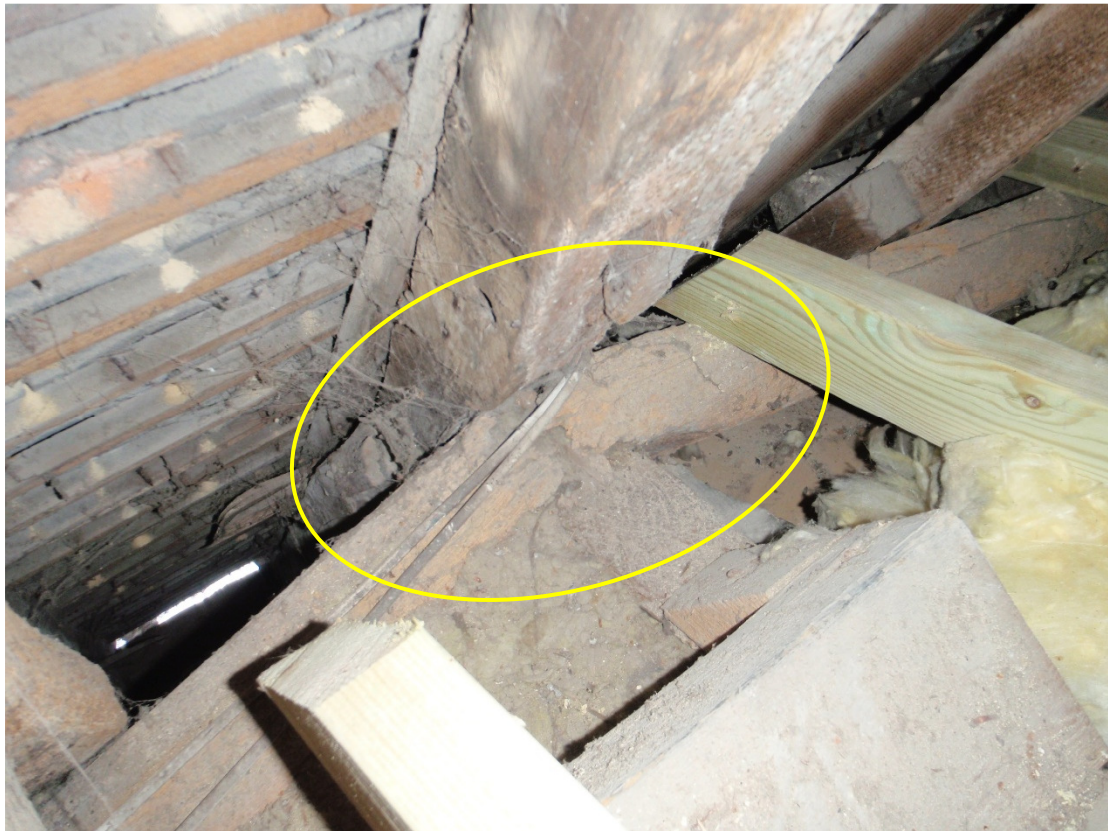
**Fig 3** Fractured purlin at truss tie, east side of roof.

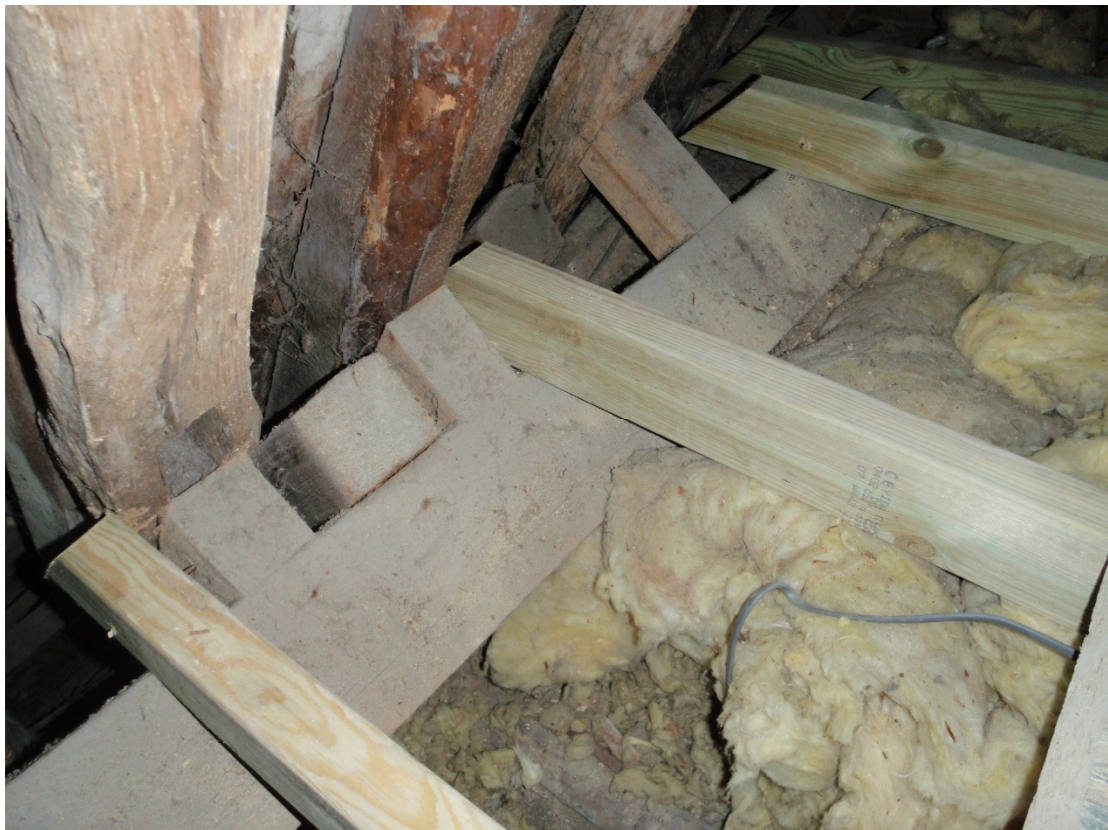
the inner wall to the truss with rafters being chocked from this (Fig 4) (please note that the modern ceiling joists have been installed to allow safe access into the roof void and can be easily removed).

**Fig 4** Packing out between rafters and more modern purlin on east side of roof.  
Note horizontal members added only for temporary access.

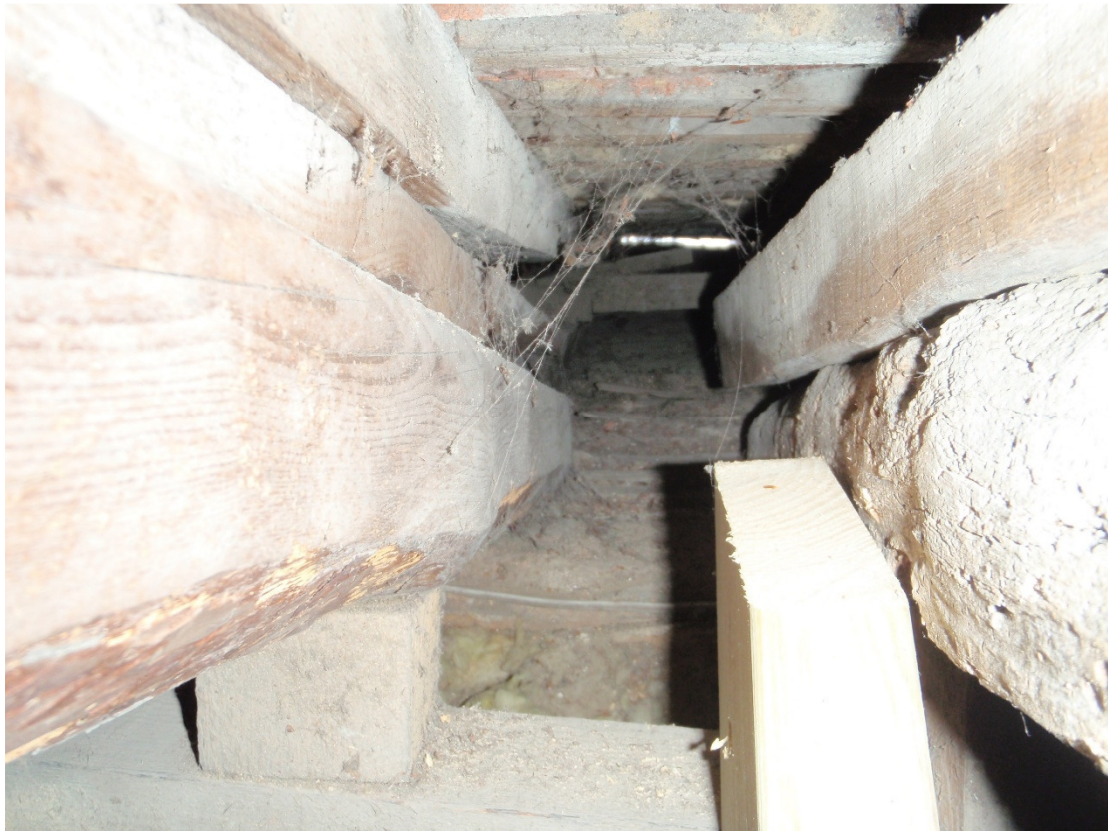
- 3.4 On the east slope, the rafters appear to stop at the ceiling level or just below and it is not clear how the battens and roof covering are being supported (Figs 5 and 6). Some rafters appear to have been added when the purlin failed but there is too much debris, insulation and other material in the space between rafters to allow a full inspection. There has been a lot of packing out of the roof where the purlin failed, in order to achieve a plane roof slope (Fig 7). This has not been carried out well.

**Fig 5** Packing of rafters on east slope looking down the skilling.

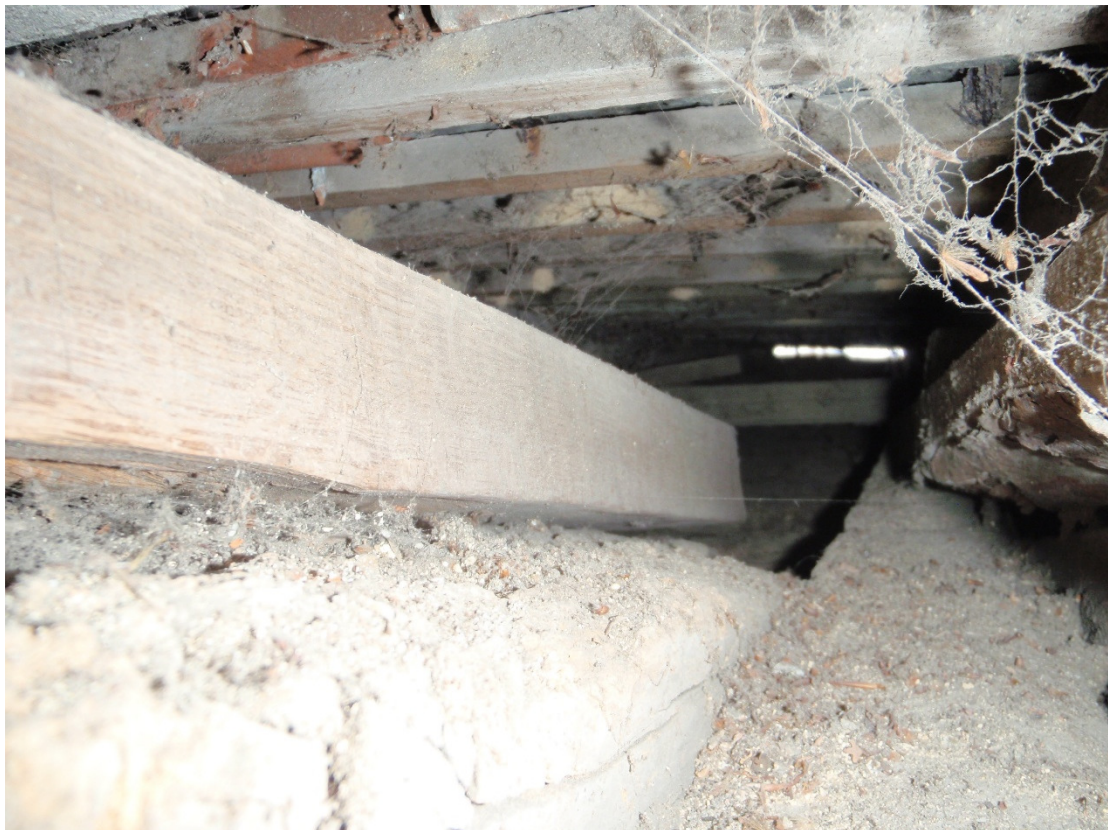
**Fig 6** Note that more modern rafters are cut just below level of ceiling – east slope.

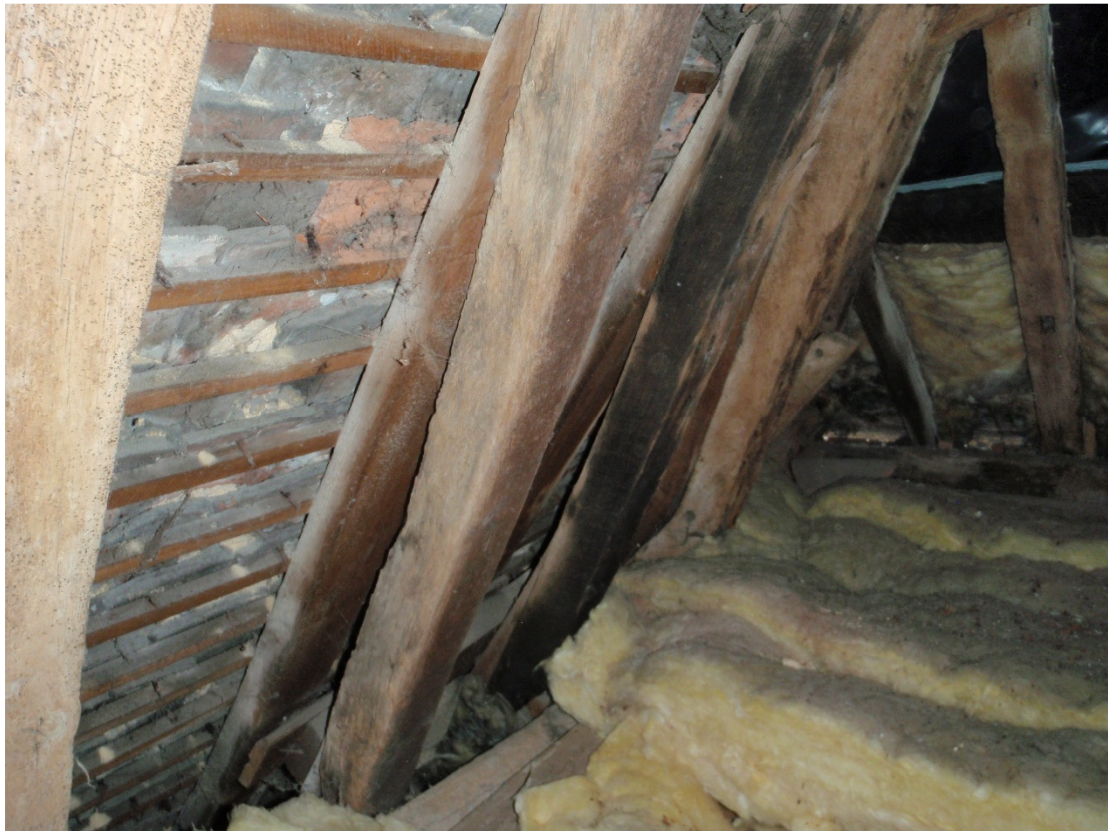
**Fig 7** Poor packing to achieve plane slope on east side of roof.

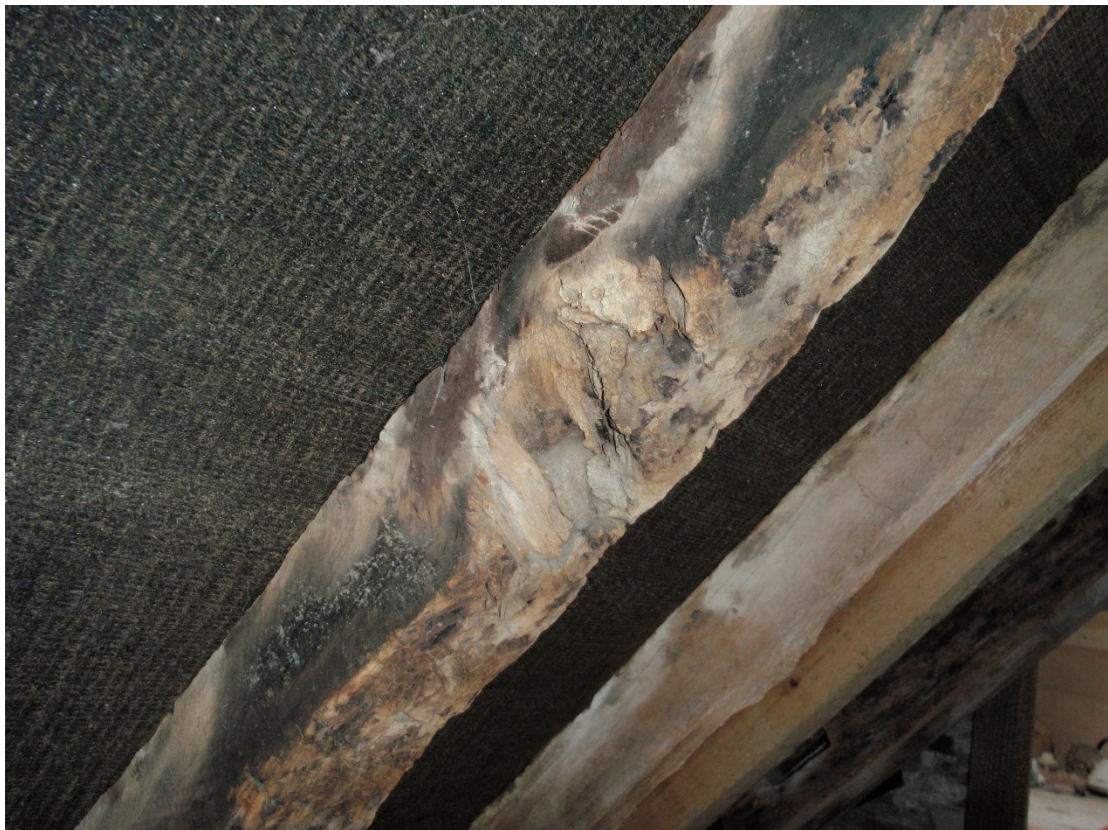
- 3.5 Some of the rafters have been weakened by significant knots (Fig 8).
- 3.6 It was noted during an earlier visit that the outer surfaces of the hip rafters and the rafters on the cropped hip were softened by water penetration, but this is not overly significant. The connection between the hip rafters and the ridge board is not very secure and will need some work carried out on it.

**Fig 8** Significant weakening of rafter due to large knot – west slope of roof.
