Our ref: SJ/23147 – LR update  
*Please quote our reference when replying*

**RE: 10 The Close, Salisbury**

Further to your request to inspect and report on the roof over Bed 3 now that the tiles have been removed, I report as follows.

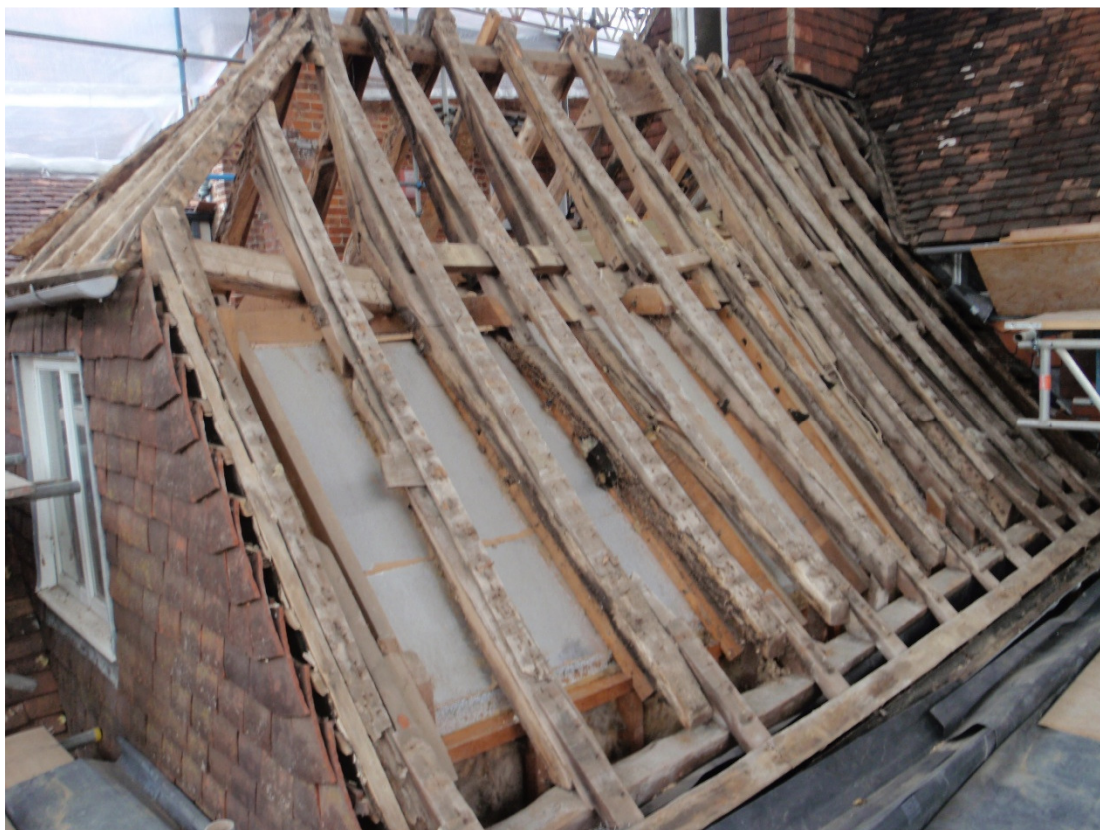
- 3.2 There are up to three timber sections at each rafter position on the east face, put in place as the purlin deflected and then failed completely (Figs 1 to 3). These have been packed out to try and create a plane surface, but which has failed over time.

**Fig 1** View of east side of roof over Bedroom 3.

- 4.1 The condition of the roof structure is very poor, and I would not be content to leave it as it is with the significant defects in major members as well as the poor condition of the rafters.
- 4.2 I have designed a raised tie truss that will support the roof and the existing timbers, skeling and ceiling. Other possible solutions are difficult to justify in terms of re-using any of the existing timbers structurally.

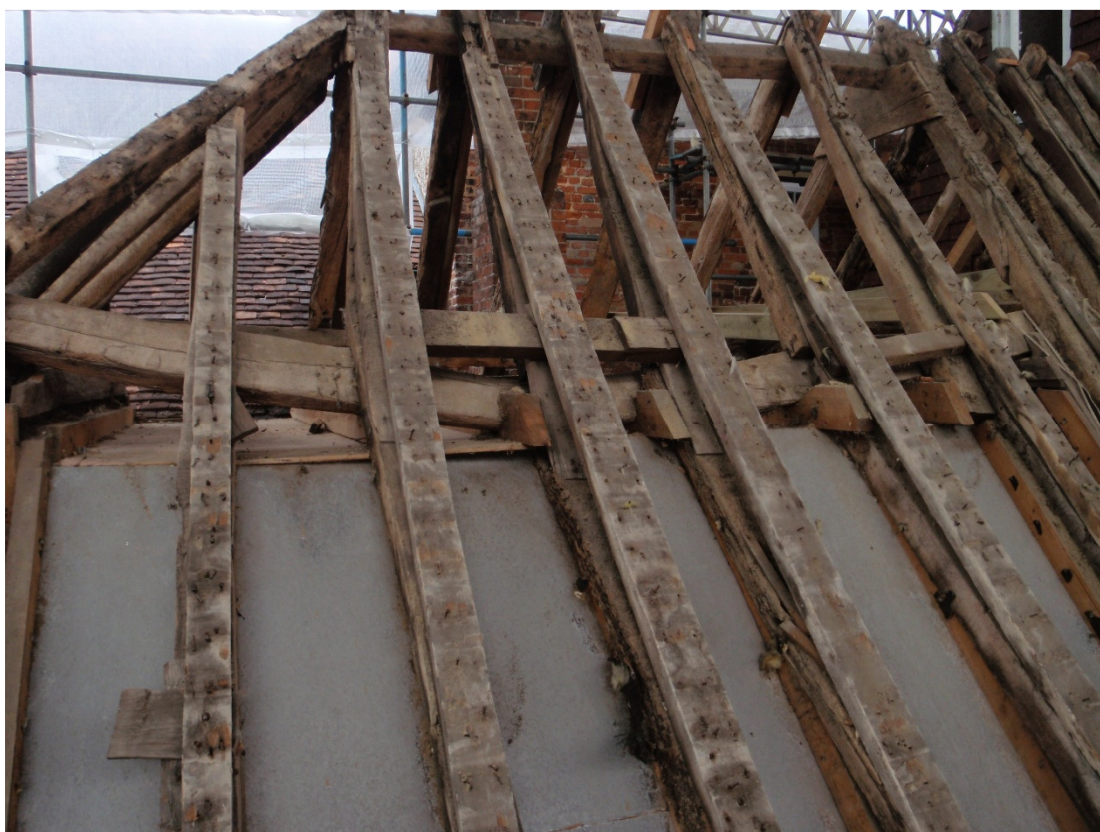
- 3.5 Whilst it may be possible to design a replacement purlin (the existing fractured one is too deflected and of small section to consider trying to repair it, and it is in the way of the bearing of a new purlin), again the rafters are of too small a section to justify.

**Fig 2** Fractured purlin and poor rafters.

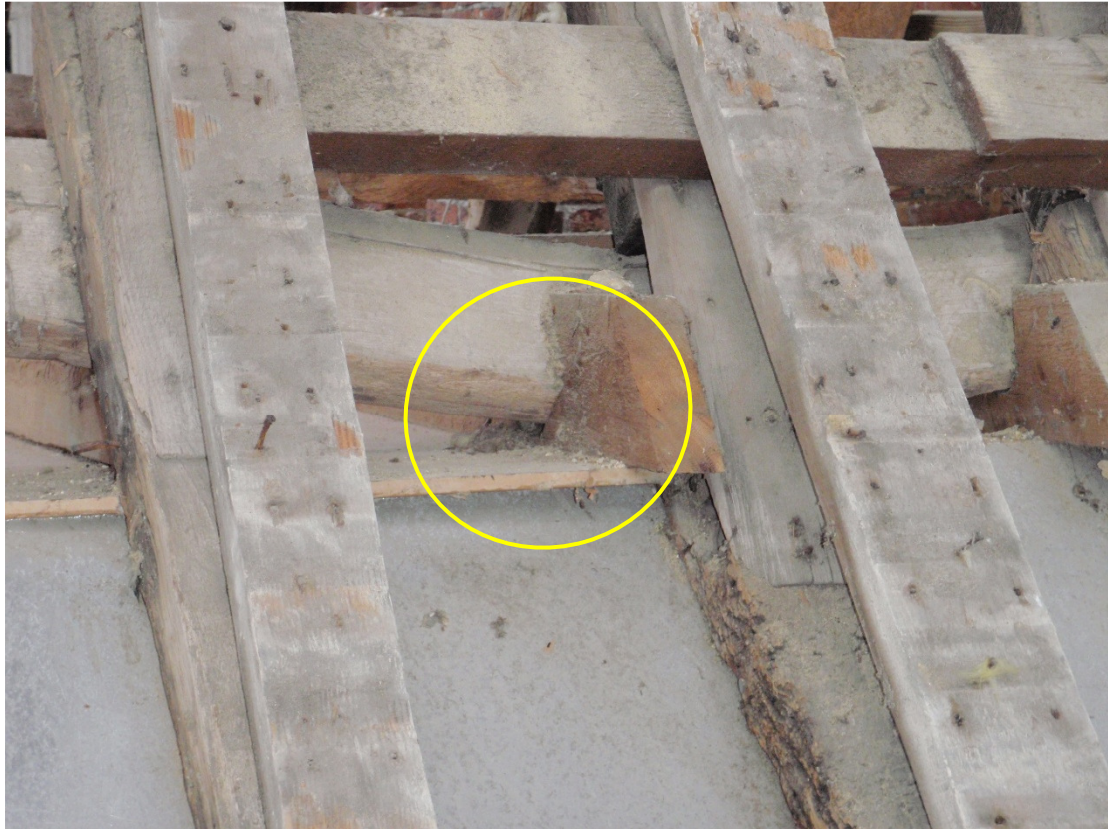
- 3.3 The ceiling ties are attached to the underside of the purlins which means that where they are attached to the east purlin, in some instances there is only 40mm of the joist attached to the purlin due to its heavily deflected shape, as well as being failed, too.

**Fig 3** Minimal amount of timber remaining to ceiling joist cut to suit purlin, which is fractured in any case.
