## Report Upon Visual Inspection

**Address:** The Barford Inn, Barford St Martin, Nr Salisbury

**Purpose of Inspection:** To carry out an inspection of a boundary wall and make remedial recommendations.

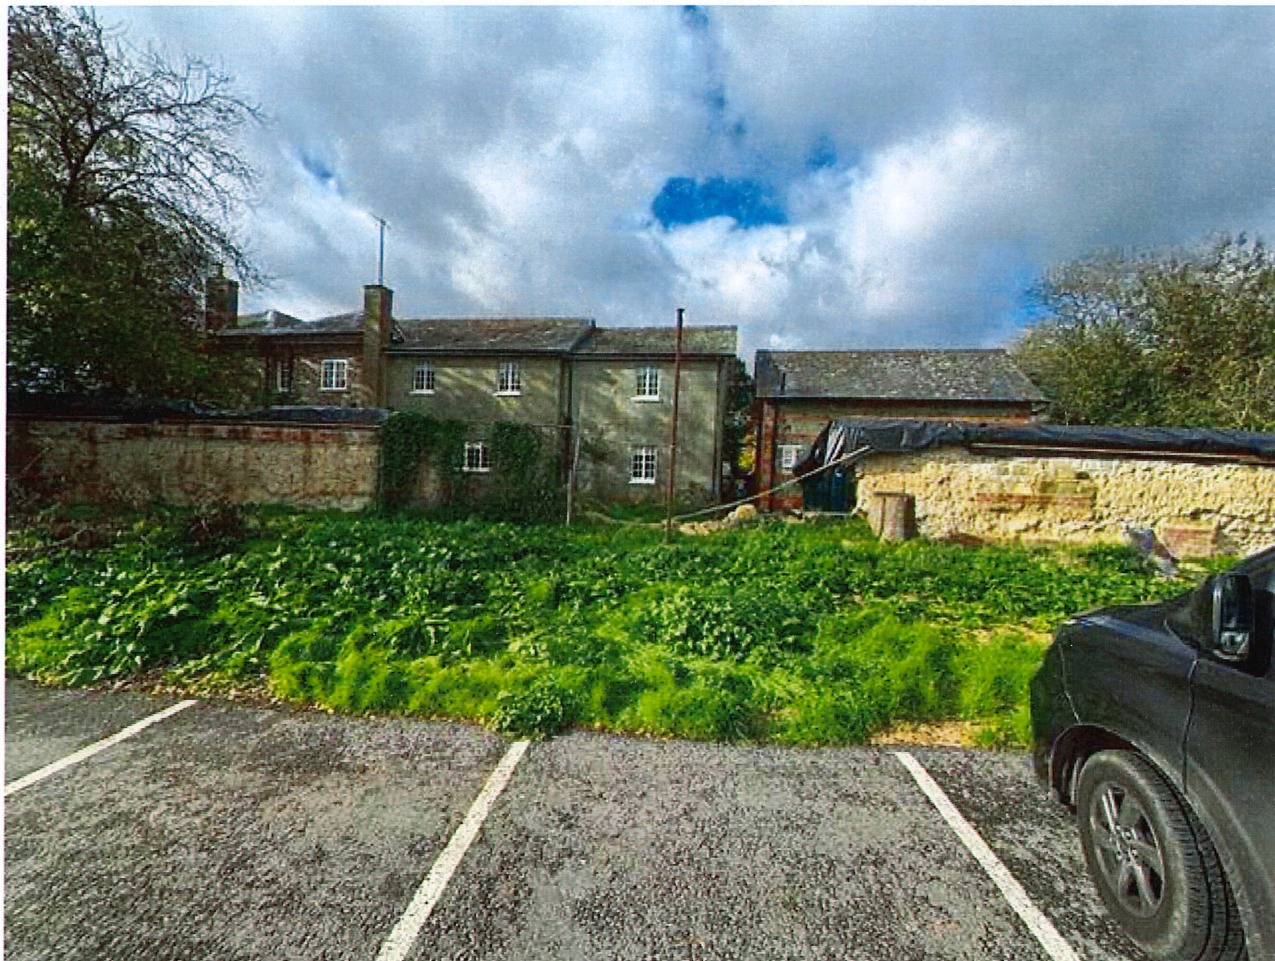
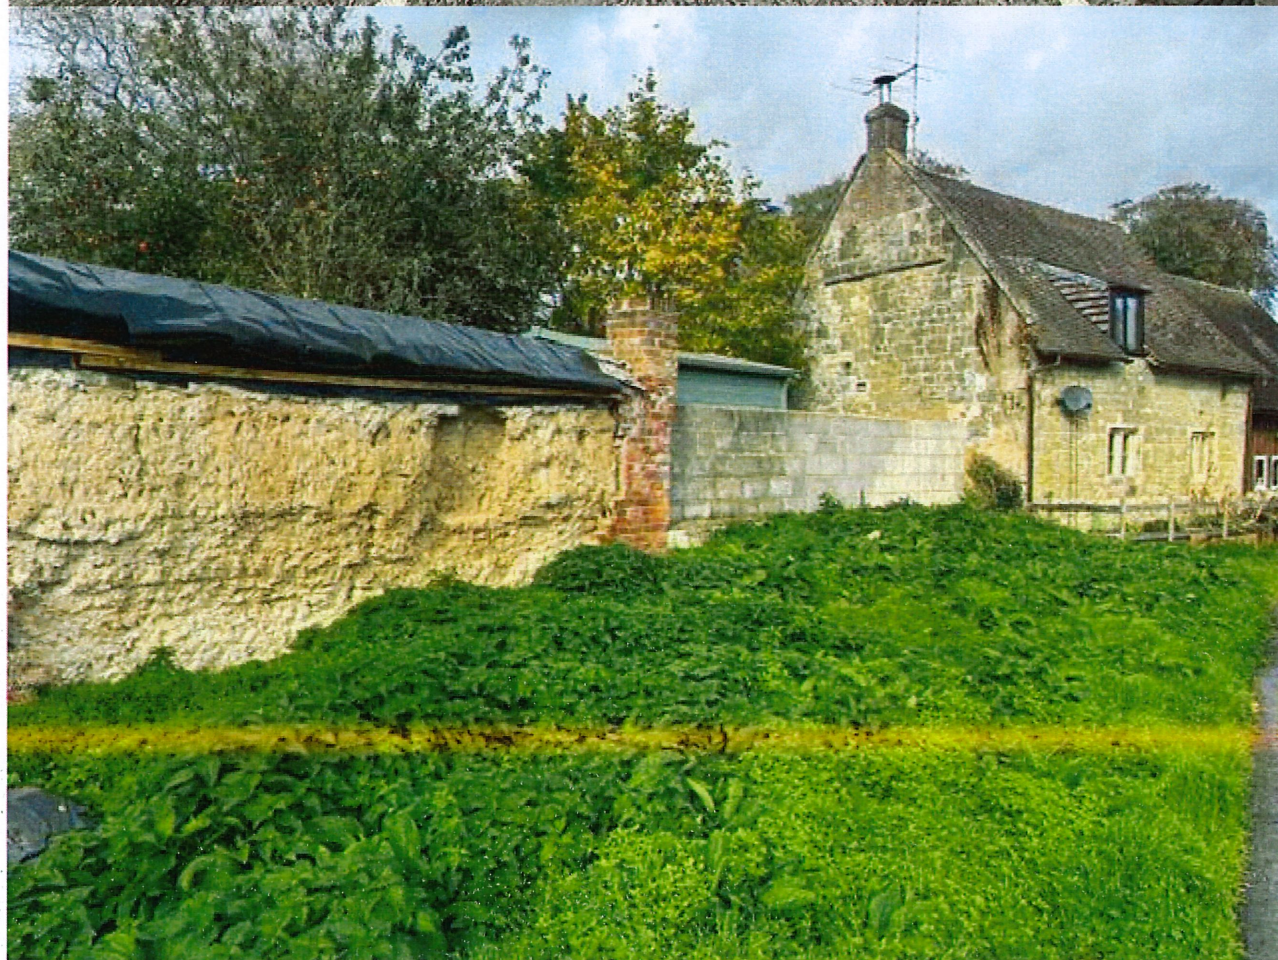
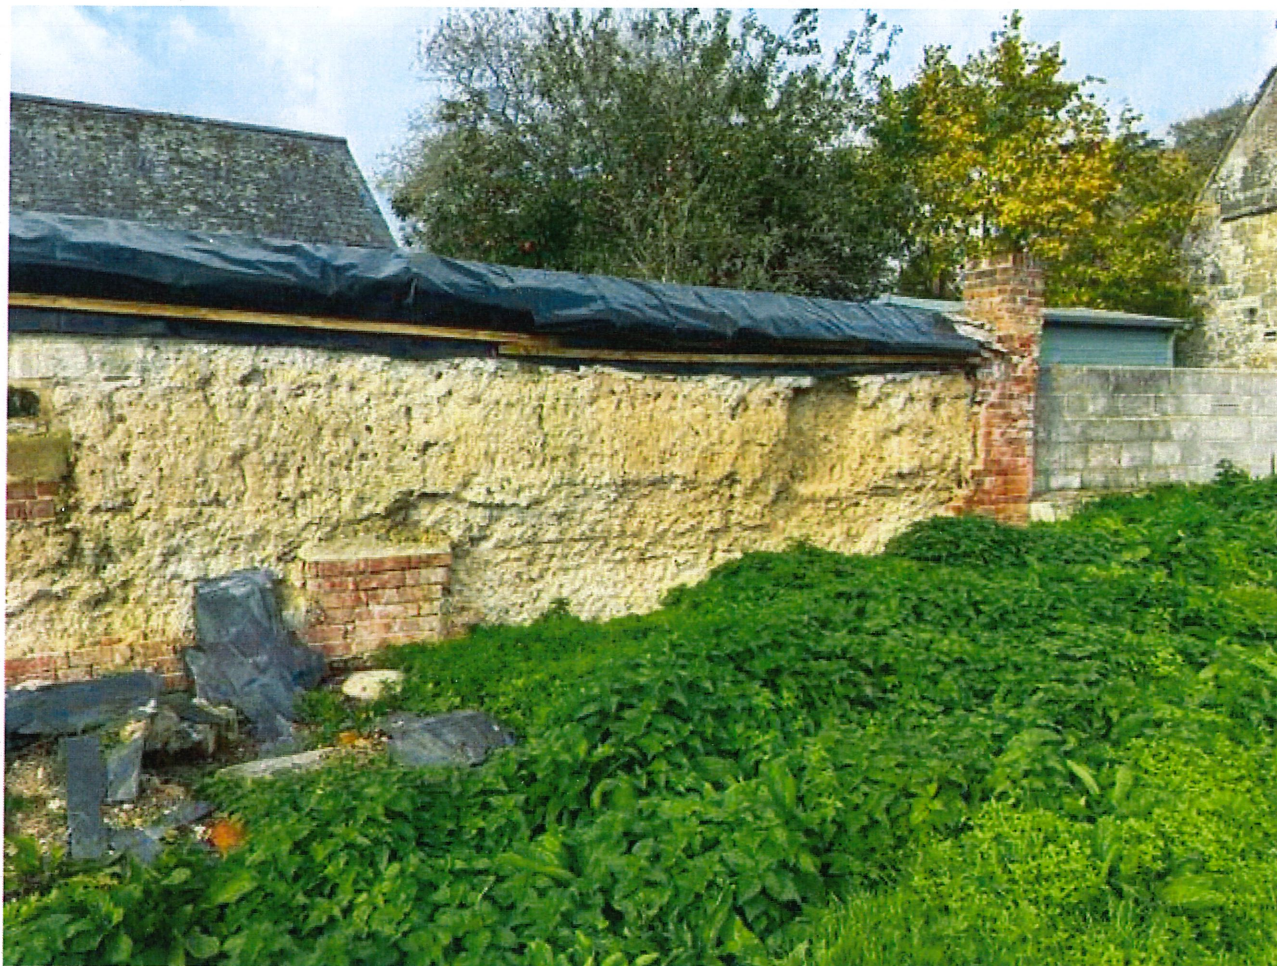
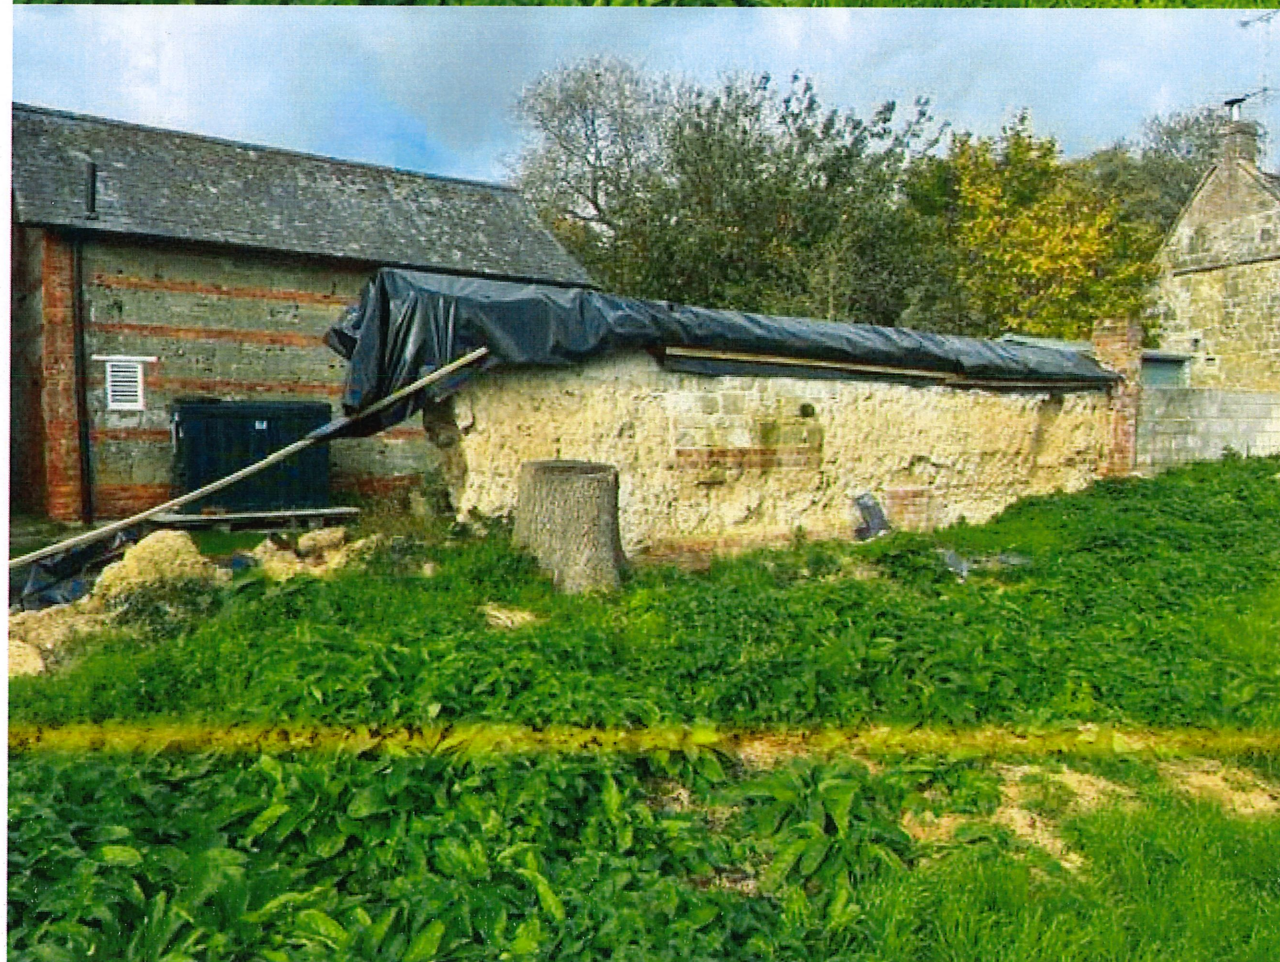
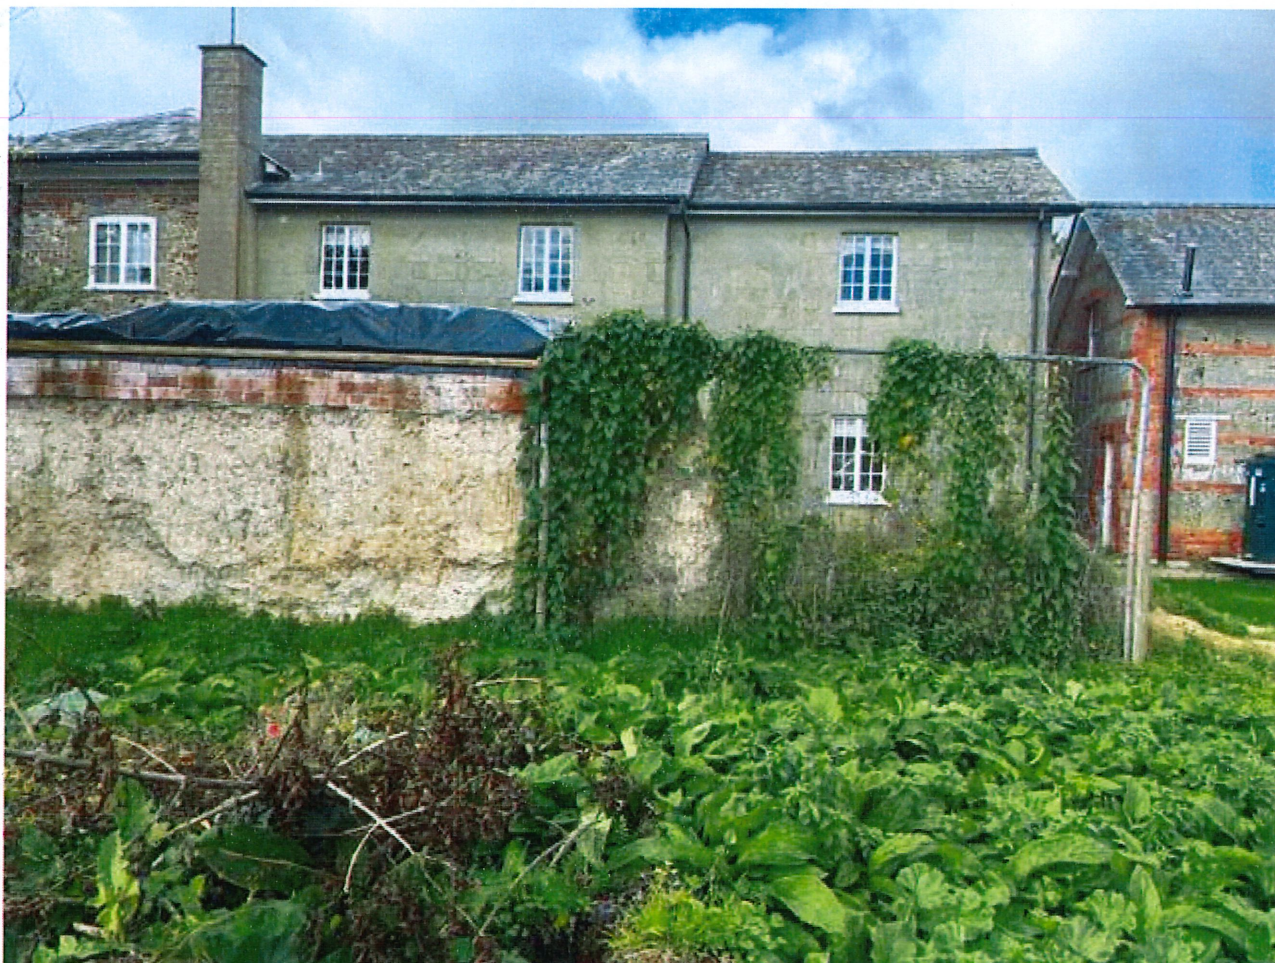
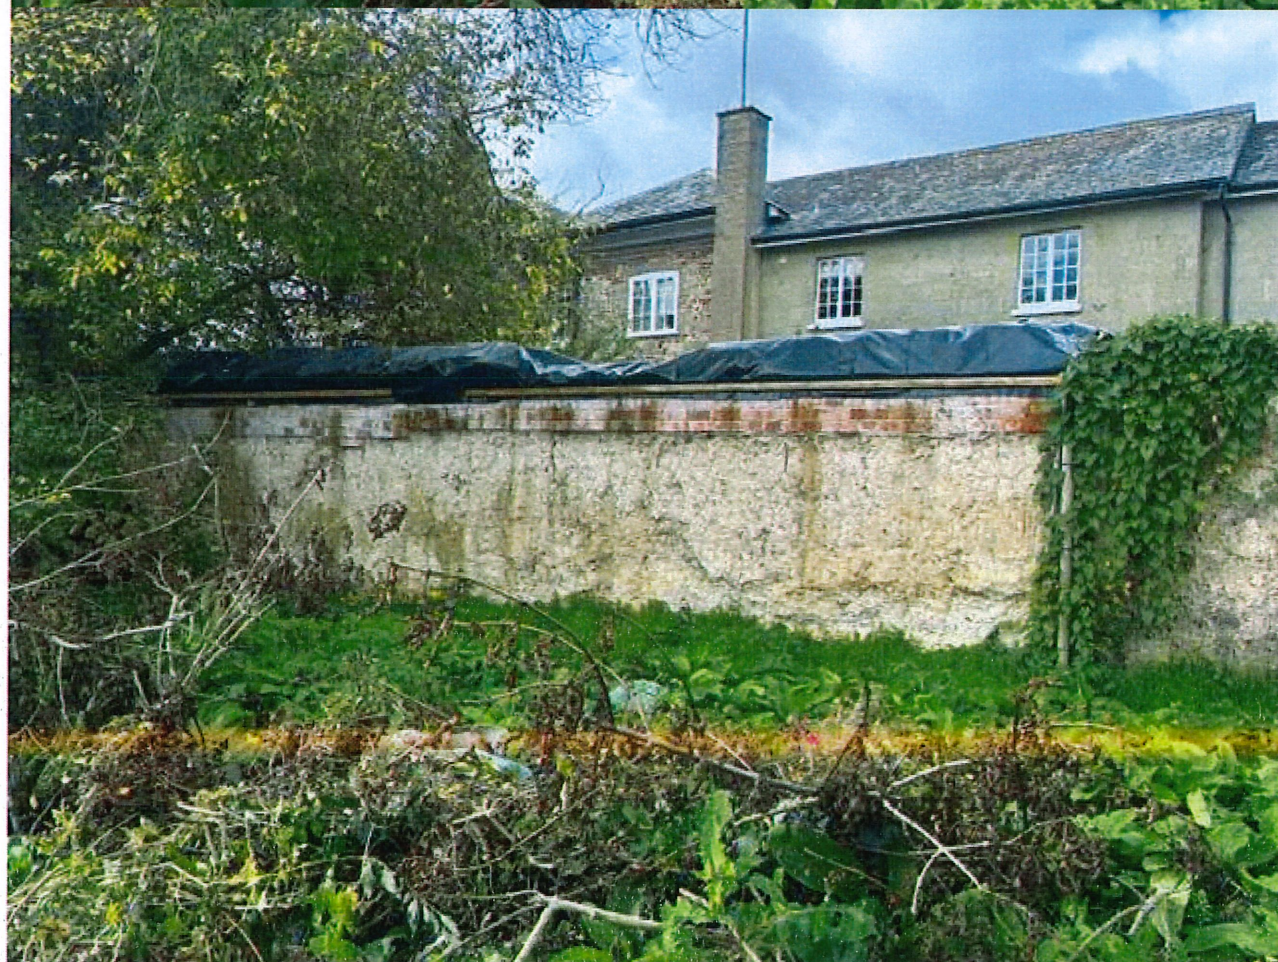
At the southern end of the wall it is about 2.0 metres high by 10.0 metres long. Along the top there are four or five courses of brick and below that it is chalk cob. The top of the wall is covered with polythene but I suspect the wall was originally thatched but more recently it was covered with slates. The brickwork was in good condition but there has been some erosion of the chalk cob particularly at low level. A concern with this length of wall is that towards the southern end there is a large tree the branches of which overhang the wall and it is likely that the branches are in contact with the top of the wall during high winds.

The middle 10.0 metres of wall is completely missing.

At the northern end of the wall it is again about 2.0 metres high and about 9.0 metres long. There is a large brick column at the northern end of the wall and brickwork along part of the bottom. There is some localized brick and stone repairs to the wall and there has been some significant erosion of the wall at the northern end. There is a very large tree stump at the southern end of this section of wall.

The wall at the northern end has already been repaired locally and there is quite a large area where the cob has eroded. I think that although it may be possible to repair this wall I consider that the most sensible solution is to take down this section of wall and rebuild it.

I would like to see the large tree reduced in size so that it cannot make contact with the wall.

Repair the 10.0 metres of the cob wall at the southern end and re-render with a lime render. Provide a good capping with a large overhang – subject to approval I suggest that this capping is slate.

Obviously the centre section of wall has to be rebuilt. My recommendation is to rebuild the wall with concrete blocks which can be rendered. This wall must also have a good capping.

Finally my recommendation for the wall at the northern end of the wall is to be rebuilt the same at the centre section.

Provide movement joints between the middle section and the two end sections.
