## Arboricultural Appraisal Report

### Subsidence Damage Investigation at:

28a Gastons Road  
Malmesbury  
SN16 0BE

| REPORT DATE: | 25/11/2025 |

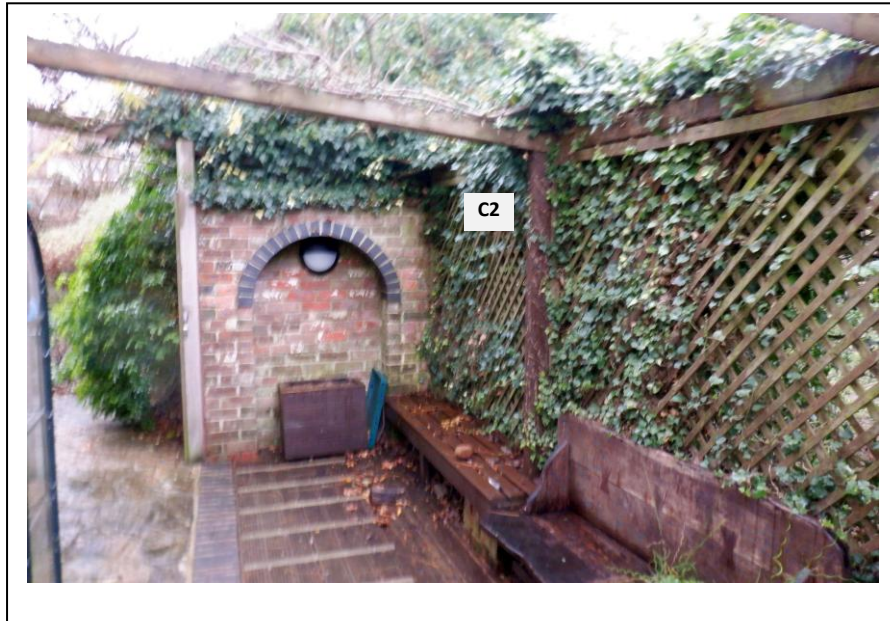
| Tree No. | Species | Height (m) | Dia (mm) | Crown Spread (m) | Dist. to building (m) | Age Classification | Ownership |
|---|---|---|---|---|---|---|---|
| C2 | Ivy | 2.3 | 50 Ms * | 6.75 | 3 | Younger than Property | No registrations<br>Third Party<br>26 Gastons Road<br>SN16 OBE<br>assumed |

View of C2

| Tree No. | Species | Height (m) | Dia (mm) | Crown Spread (m) | Dist. to building (m) | Age Classification | Ownership |
|---|---|---|---|---|---|---|---|
| Recommendation | | Do not allow to exceed current dimensions. | | | | | |

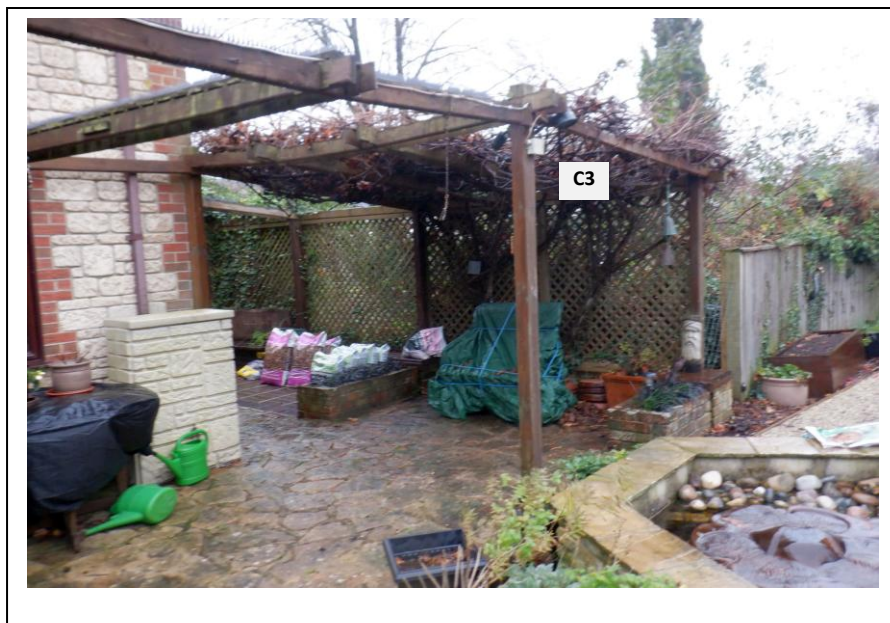
| Tree No. | Species | Height (m) | Dia (mm) | Crown Spread (m) | Dist. to building (m) | Age Classification | Ownership |
|---|---|---|---|---|---|---|---|
| C3 | Vine | 2.2 | 70 Ms * | 3 | 3.4 | Younger than Property | Policy Holder |

View of C3

| Tree No. | Species | Height (m) | Dia (mm) | Crown Spread (m) | Dist. to building (m) | Age Classification | Ownership |
|---|---|---|---|---|---|---|---|
| Recommendation | | Do not allow to exceed current dimensions. | | | | | |

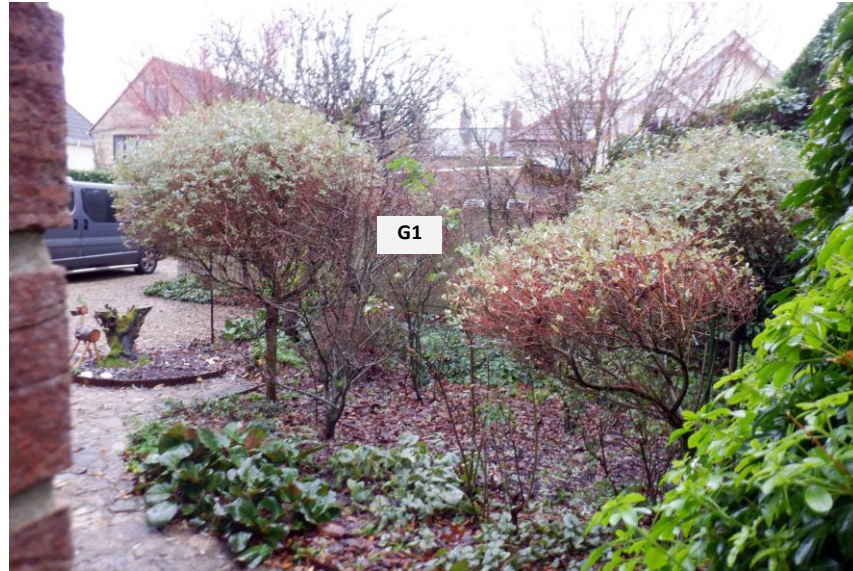
| Tree No. | Species | Height (m) | Dia (mm) | Crown Spread (m) | Dist. to building (m) | Age Classification | Ownership |
|---|---|---|---|---|---|---|---|
| G1 | Mixed species group including Salix Integra, Rose, Amelanchier, Spirea | 2 | 45 Ms * | 1.75 | 2.8 | Younger than Property | Policy Holder |

View of G1

| Tree No. | Species | Height (m) | Dia (mm) | Crown Spread (m) | Dist. to building (m) | Age Classification | Ownership |
|---|---|---|---|---|---|---|---|
| Recommendation | | Maintain broadly at no more than current dimensions by periodic pruning. | | | | | |

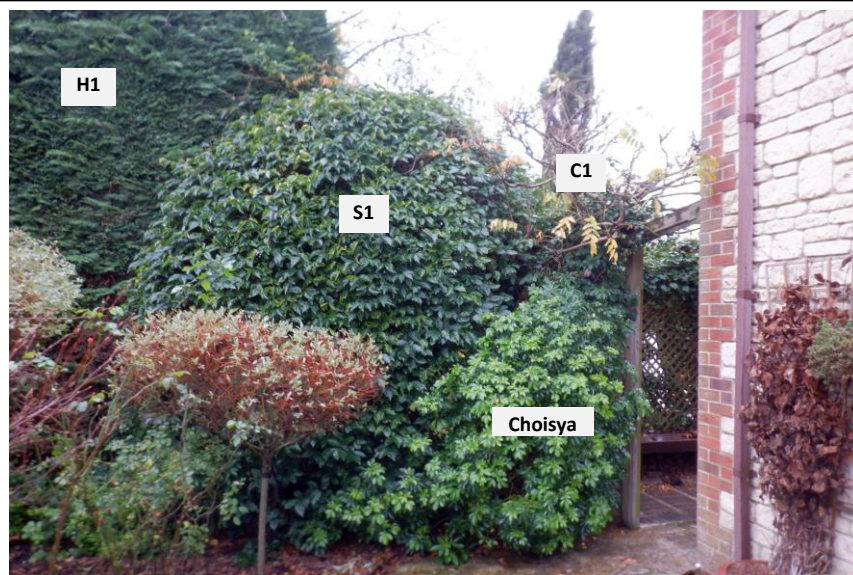
Samples recovered from TP/BH1 have been positively identified (using anatomical analysis) as Leguminosae and a broadleaved species the origin of which will be the Wisteria (C1) and the Portuguese Laurel (S1) confirming their influence on the soils below the foundations.

Irrespective of the identification of recovered root samples, the roots of the Cypress hedge (H1) are also likely to be present below foundation level in proximity to the area of movement/damage with the potential to influence soil moisture and volumes.

Based on the information currently available, engineering opinion and our own site assessment we conclude there is damage consistent with shrinkage of the clay subsoil exacerbated by the soil drying effects of vegetation. Having considered the information currently available, it is our opinion that the Wisteria (C1), the Portuguese Laurel (S1) and the Cypress hedge (H1) are the principal cause of or are contributing to the current building movement and damage.

View of S1,C1 & H1

| Tree No. | Species | Height (m) | Dia (mm) | Crown Spread (m) | Dist. to building (m) | Age Classification | Ownership |
|---|---|---|---|---|---|---|---|
| Recommendation | | Remove (fell) to near ground level and treat stump to inhibit regrowth. | | | | | |
| Recommendation | | Remove (fell) to near ground level a section of the hedge to create a minimum clearance to the affected property of no less than 8m. | | | | | |

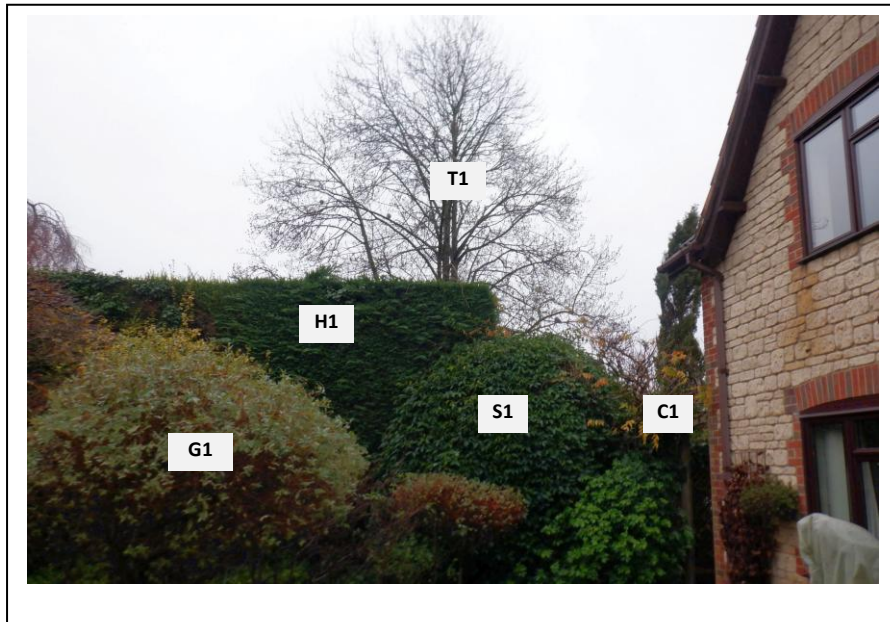
| Tree No. | Species | Height (m) | Dia (mm) | Crown Spread (m) | Dist. to building (m) | Age Classification | Ownership |
|---|---|---|---|---|---|---|---|
| T1 | Tulip Tree | 12 * | 350 * | 12 | 13 * | Similar Age to Property | No registrations<br>Third Party<br>26 Gastons Road<br>SN16 OBE<br>assumed |

View of G1, C1, S1, H1 & T1

| Tree No. | Species | Height (m) | Dia (mm) | Crown Spread (m) | Dist. to building (m) | Age Classification | Ownership |
|---|---|---|---|---|---|---|---|
| Recommendation | | Maintain broadly at no more than current dimensions by periodic pruning (Recommendations subject to review if movement persists). | | | | | |

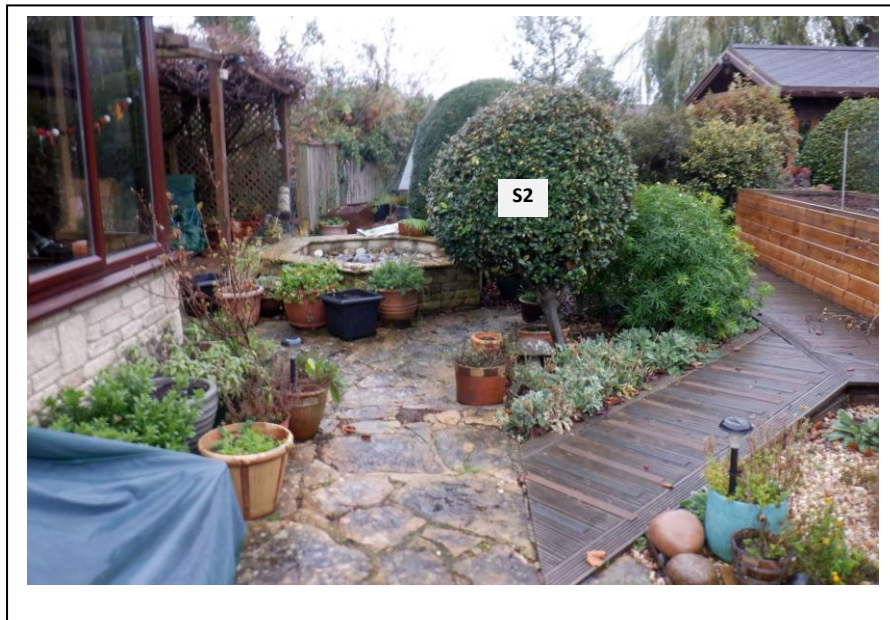
| Tree No. | Species | Height (m) | Dia (mm) | Crown Spread (m) | Dist. to building (m) | Age Classification | Ownership |
|---|---|---|---|---|---|---|---|
| S2 | Bay | 1.8 | 45 Ms * | 1.4 | 2.4 | Younger than Property | Policy Holder |

View of S2

| Tree No. | Species | Height (m) | Dia (mm) | Crown Spread (m) | Dist. to building (m) | Age Classification | Ownership |
|---|---|---|---|---|---|---|---|
| Recommendation | | Do not allow to exceed current dimensions. | | | | | |

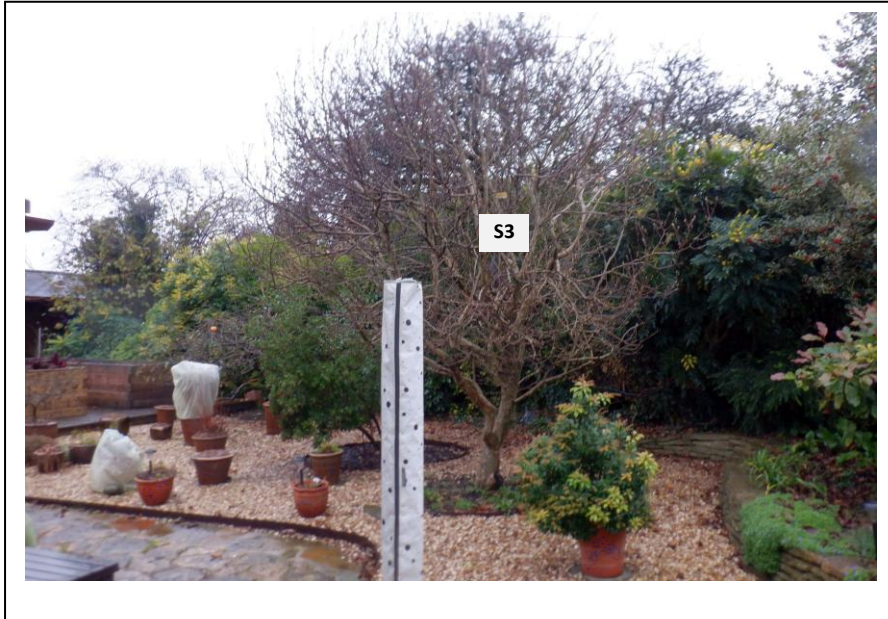
| Tree No. | Species | Height (m) | Dia (mm) | Crown Spread (m) | Dist. to building (m) | Age Classification | Ownership |
|---|---|---|---|---|---|---|---|
| S3 | Magnolia | 3.5 | 140 Ms * | 4.9 | 4 | Younger than Property | Policy Holder |

View of S3

| Tree No. | Species | Height (m) | Dia (mm) | Crown Spread (m) | Dist. to building (m) | Age Classification | Ownership |
|---|---|---|---|---|---|---|---|
| Recommendation | | Do not allow to exceed current dimensions. | | | | | |

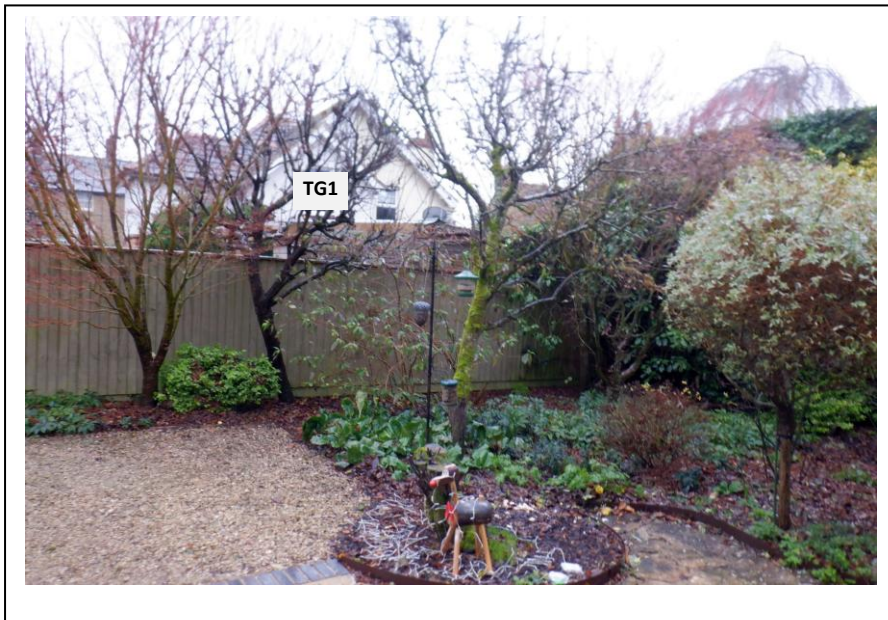
| Tree No. | Species | Height (m) | Dia (mm) | Crown Spread (m) | Dist. to building (m) | Age Classification | Ownership |
|---|---|---|---|---|---|---|---|
| TG1 | Mixed species group including Pear, Apple and Japanese Maple | 4 | 150 * | 4 | 7.5 | Younger than Property | Policy Holder |

View of TG1

| Tree No. | Species | Height (m) | Dia (mm) | Crown Spread (m) | Dist. to building (m) | Age Classification | Ownership |
|---|---|---|---|---|---|---|---|
| Recommendation | | Maintain broadly at no more than current dimensions by periodic pruning. | | | | | |
