# Appendices to

## Planning, Design & Access Statement

| <b>Proposal:</b> | Repairs to Grade II Listed Barn (retrospective) |
| <b>Site:</b> | Shrub Farm Barn, Shrub Farm, Castle Combe, SN14 7JA |

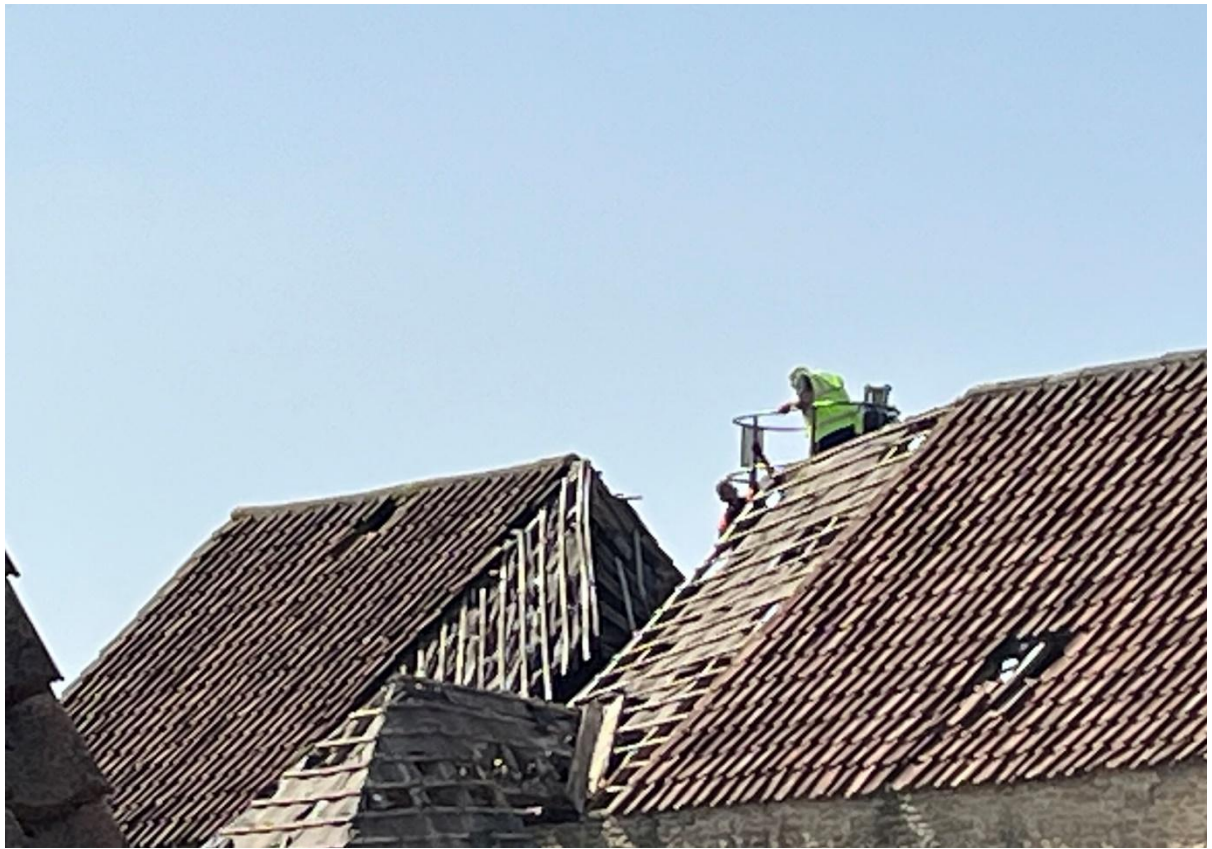
Attached as P1, for orientation, is an annotated photocopy of a photograph of the area and buildings around the old barn, taken commercially from the air about five years before the barn roof repair work started. The various buildings are identified together with the roof covering of each.

In a summary, the stable block, garages and woodshed have pantiles. They are dark red and of concrete. Pinetum Cottage to the west and the Shrub House annex known as Shrub House Cottage both have clay double romans. The old barn, before repair, had an estimated 60% clay double romans on its roof, including as the predominant covering on the four entrances, a significant strip of corrugated steel on the west side and the balance of clay pantiles.

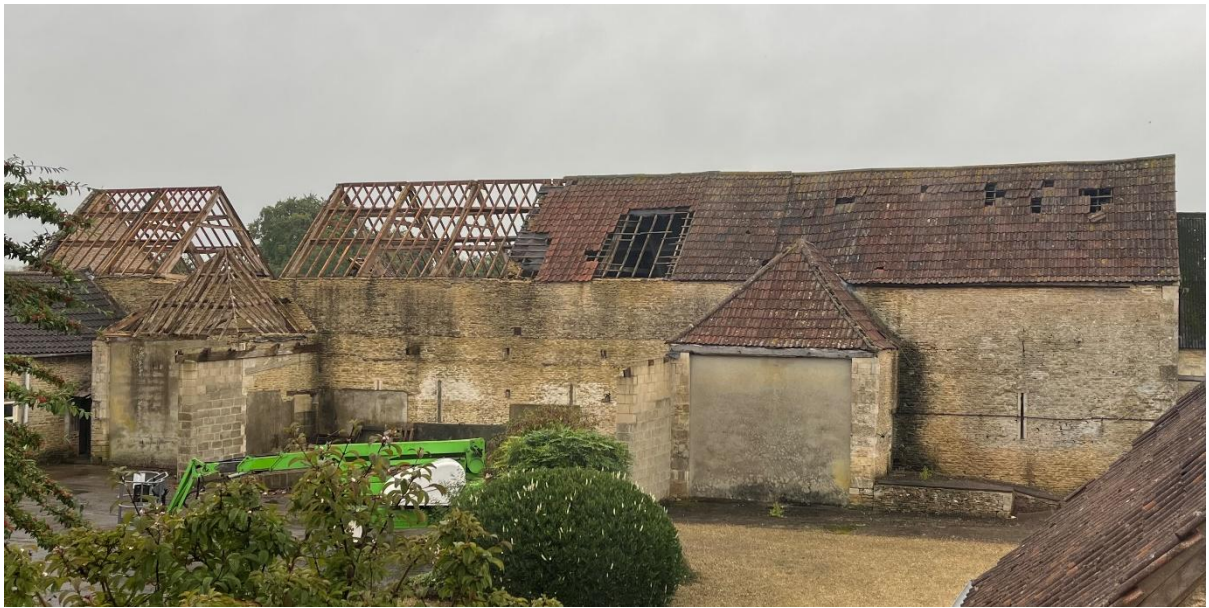
- a photograph (P2), taken in September or October 2023 as we were mending the original collapsed area, of the length of the barn from above the southern entrance on the east side to the northern end which shows clay pantiles in the foreground and clay double roman tiles from approximately midway to the north end and clay double romans on the northern entrance.
- a photograph (P3), taken in October 2023, of the length of the barn on its east side as we progressed along its length finding issues as we went.
- a photograph (P4) taken today of the east side of the barn with clay double roman tiles along its full length
- a photograph (P5) taken today of the north end of the barn with the shed with corrugated roof

P2 includes the annex (called Shrub Cottage) to the house which has clay double romans on it and which I understand was converted from cattle sheds in the late 1990s.

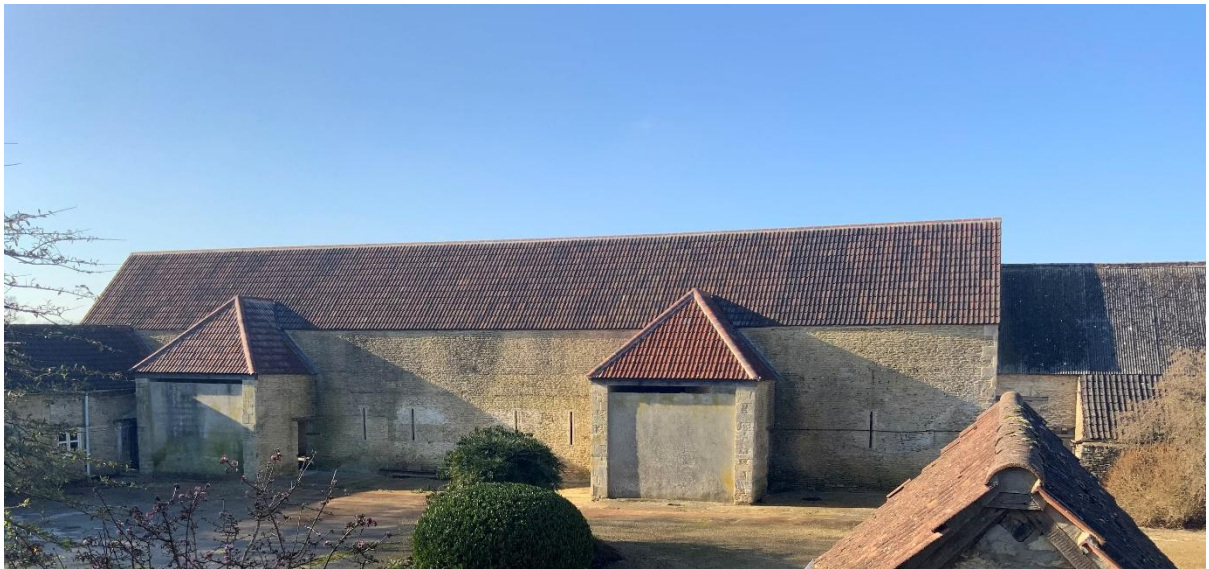
P3 includes the edge of the stable adjoining the barn which, as your Conservation Officer says, has pantiles on it. As mentioned, the pantiles are of concrete.

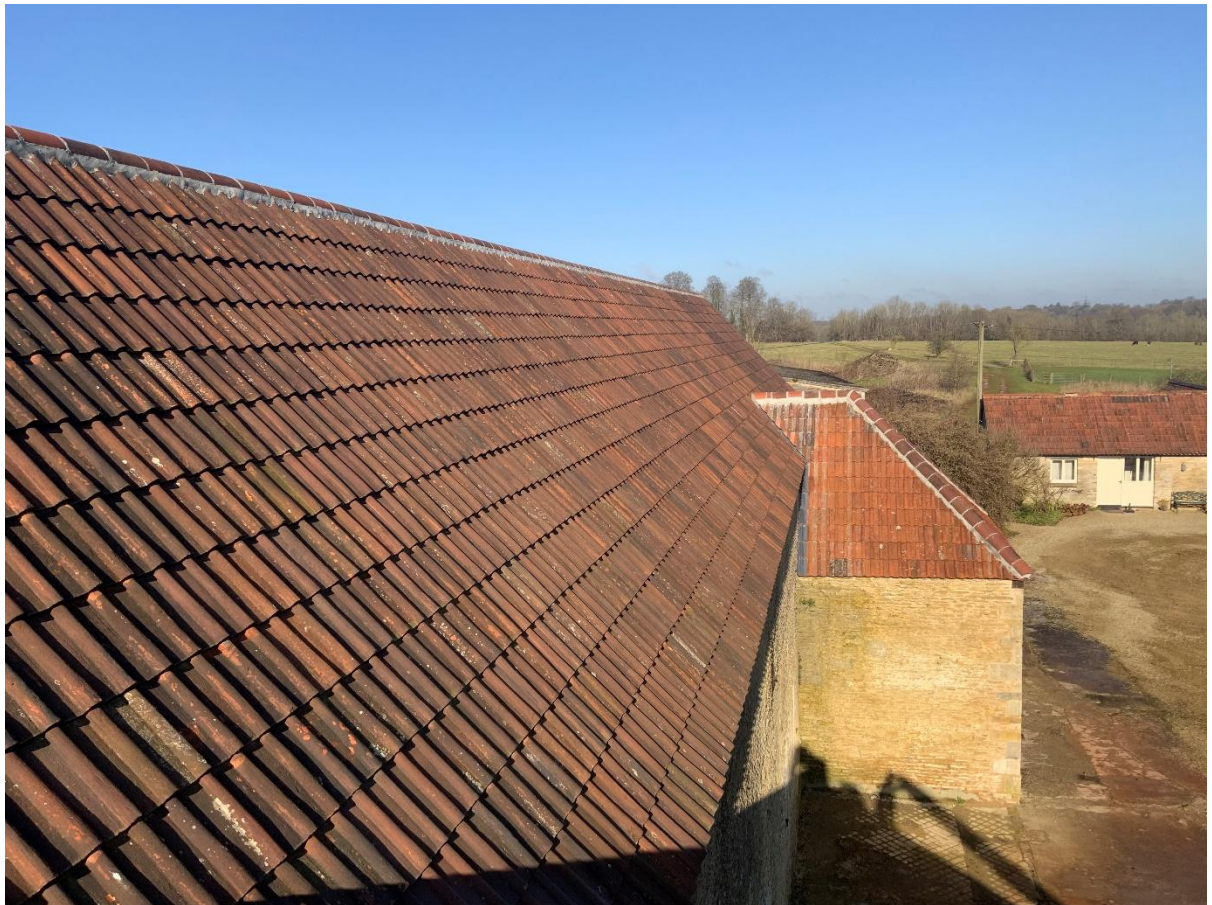
P4 shows the edge of the garage next to the annexe which is roofed with concrete pantiles as is the woodshed in the foreground of the photograph. It also shows the shed adjoining the north end of the barn which has a corrugated roof.

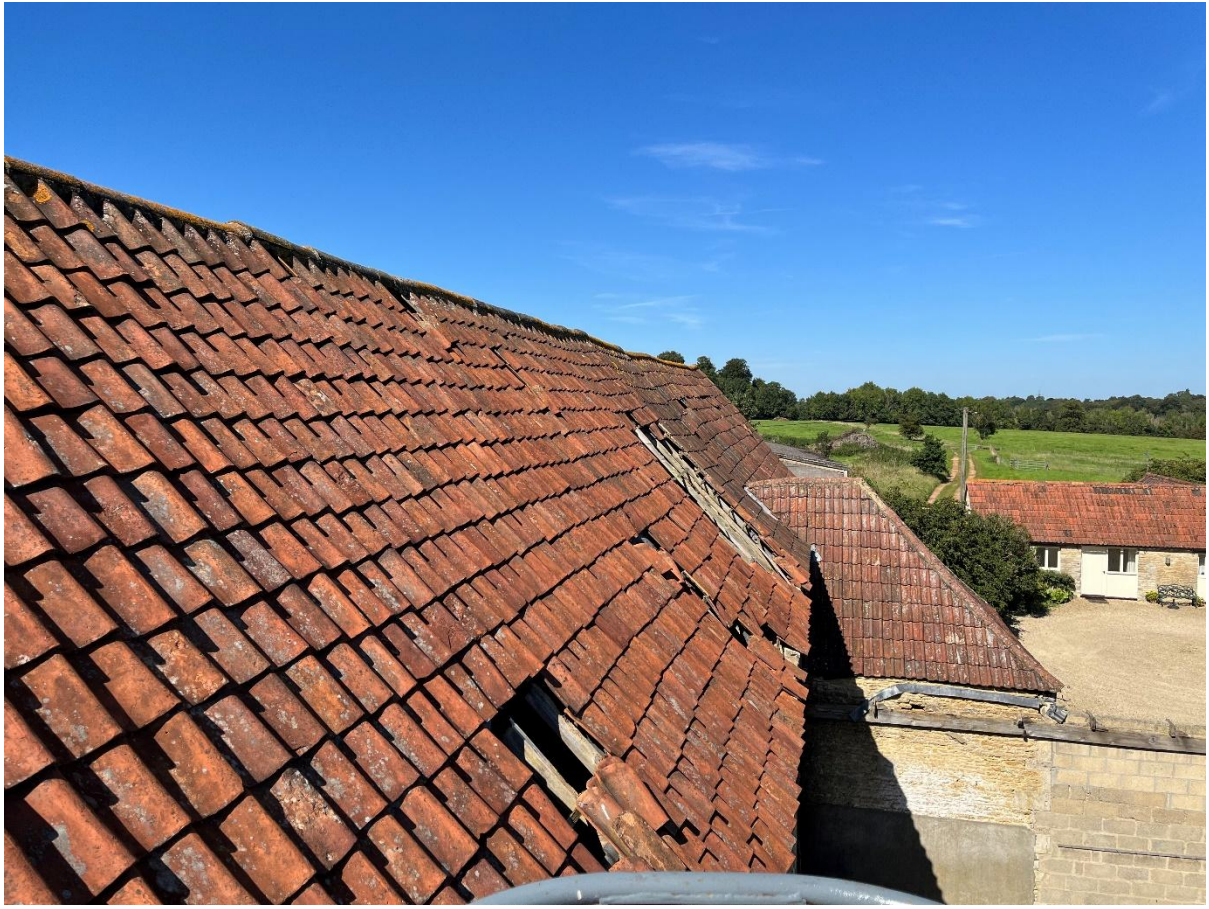
- a photograph (P6) of the west side of the barn, taken in November 2023 which shows where the double romans were on the northern half, the corrugated section and the double romans on the southern entrance. Pantiles covered from the south end to the corrugated steel.
- a photograph (P7) of the barn taken today
- a photograph of Pinetum Cottage (P8) which is about 100 yards to the west of the barn and which has clay double roman tiles.

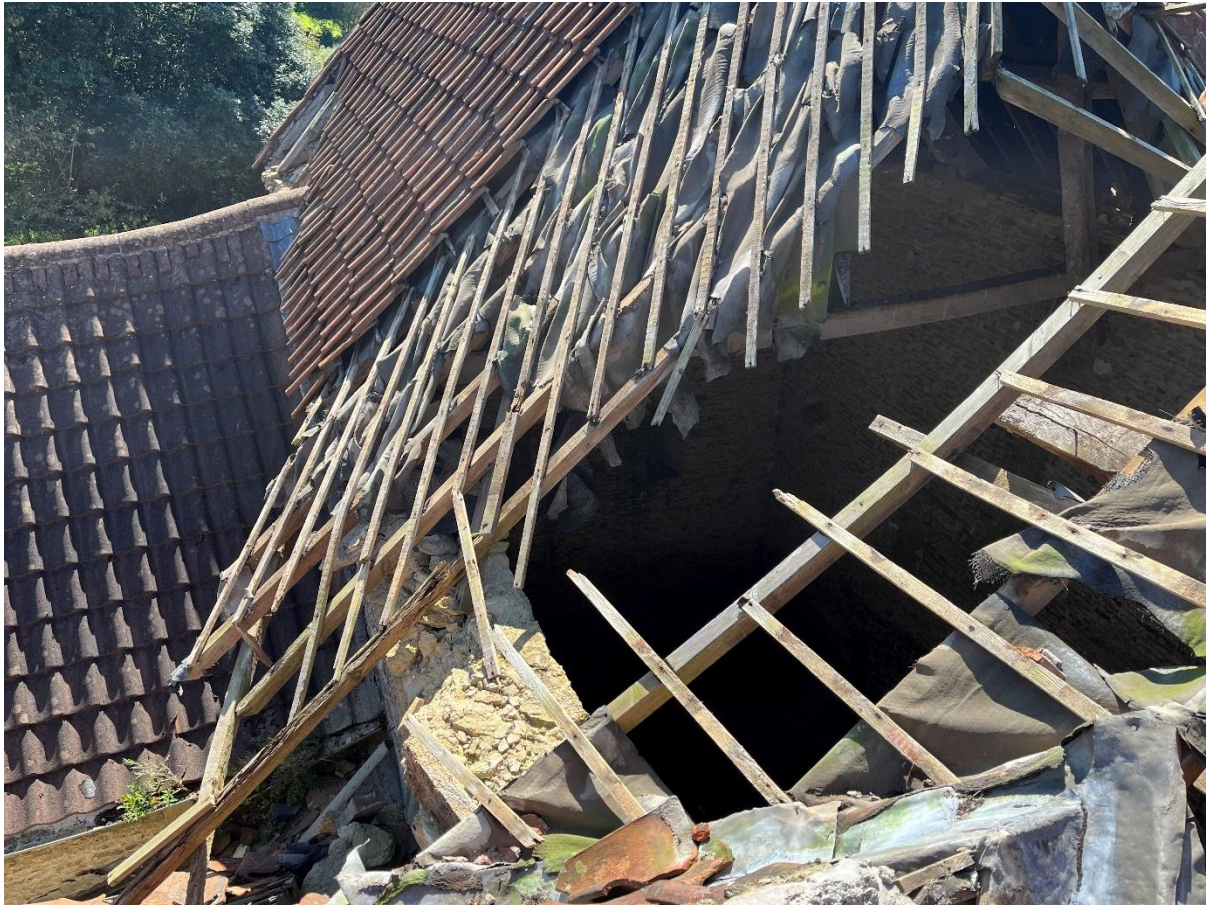
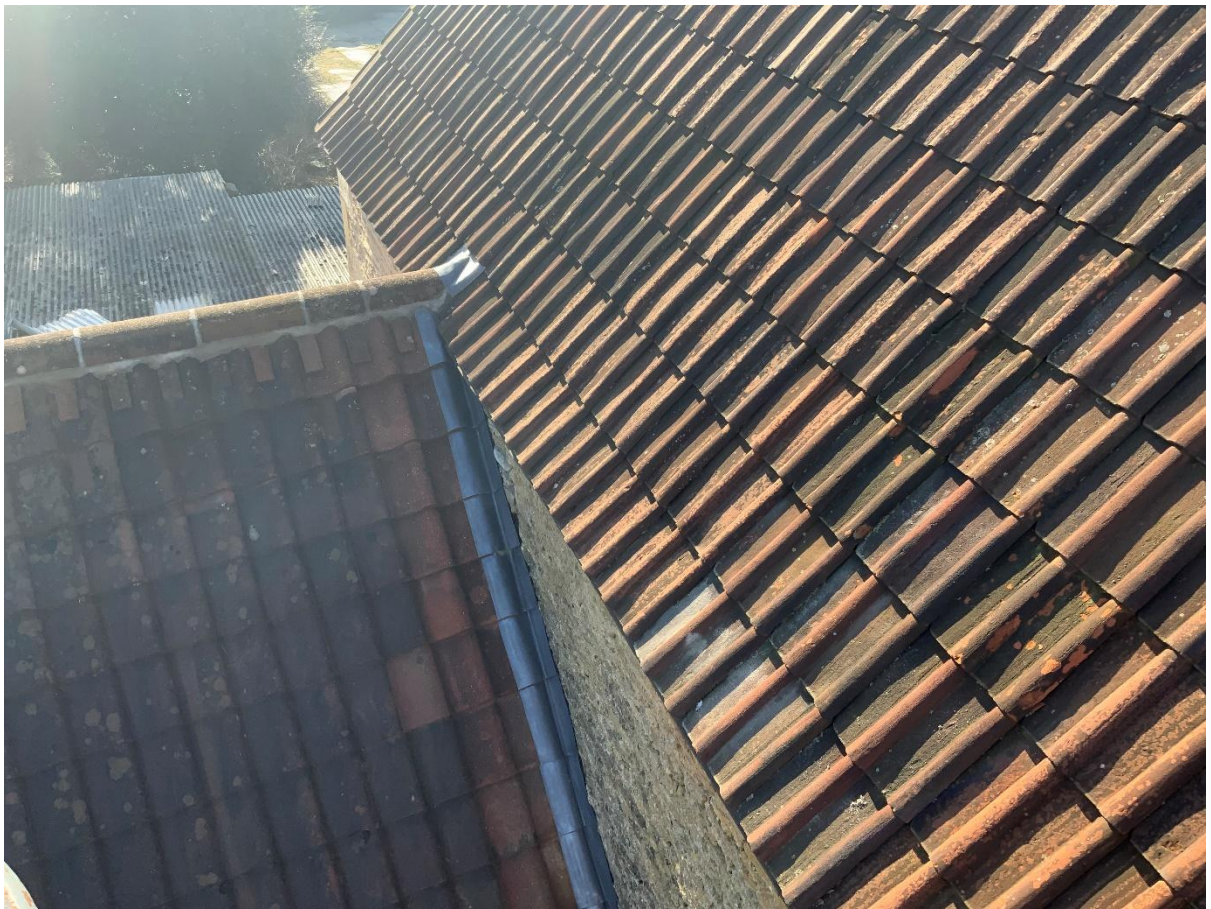
The tiles now in situ on the old barn are all clay double romans. Some are sound ones which we took off and others were bought second hand from a reclamation dealer and matched, as far as possible, to those we already had. The purchased tiles are, at the moment, slightly darker than the originals which we put back on due to ingrained pollution which we were assured would wash down overtime and which appears to be gradually doing so. We power-hosed one before buying the batch and it was considerably lighter after the hosing.

Photographs P10 and P11 taken today from the cherry-picker show close ups of the tiles on the roof including the clay ridge tiles. I hope the composition of the tiles is clear from the photographs – but if there is doubt, please visit again and the tiles can be viewed close up along the length of the barn using the cherry-picker.
