# Drainage Report

## Site: ROYAL MAIL, BRUNEL ROAD, SALISBURY

## Section 5

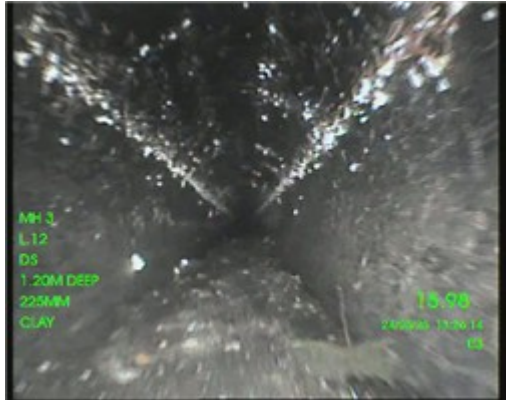
| Position | Code | Description | CD | Pic | Video Ref | |
|---|---|---|---|---|---|--|
| 15.98m | DER | Settled deposits coarse 15% | | 4_2 | 0:00:29 | |

| Pos | Video Ref | Code | Description | Image |
|---|---|---|---|---|
| 15.98m | 0:00:29 | DER | Settled deposits coarse: 15%<br>Cross sectional area loss -<br>Severity 3 | Image Provided - Ref: 4_2<br> |

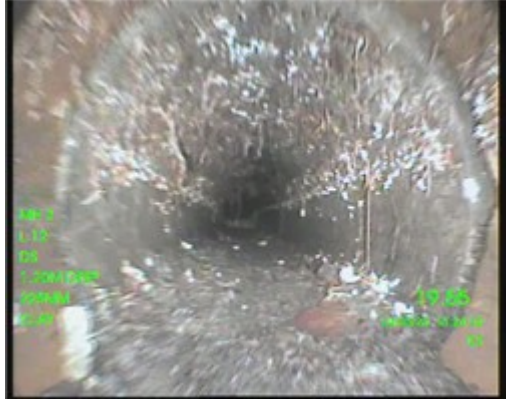
| Position | Code | Description | CD | Pic | Video Ref | |
|---|---|---|---|---|---|--|
| 19.55m | DER | Settled deposits coarse 30% | | 4_3 | 0:00:04 | |

| Pos | Video Ref | Code | Description | Image |
|---|---|---|---|---|
| 19.55m | 0:00:04 | DER | Settled deposits coarse: 30%<br>Cross sectional area loss -<br>Severity 3 | Image Provided - Ref: 4_3<br> |

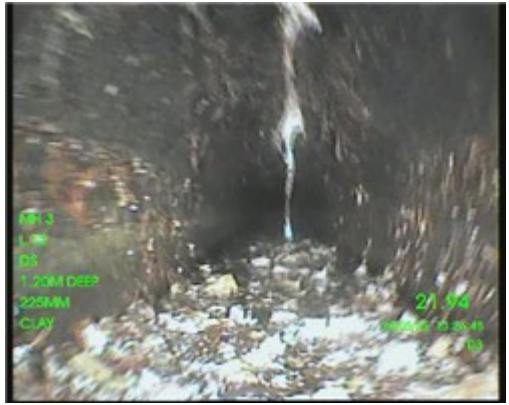
| Position | Code | Description | CD | Pic | Video Ref | |
|---|---|---|---|---|---|--|
| 21.94m | DER | Settled deposits coarse 40% | | 4_4 | 0:00:20 | |

| Pos | Video Ref | Code | Description | Image |
|---|---|---|---|---|
| 21.94m | 0:00:20 | DER | Settled deposits coarse: 40%<br>Cross sectional area loss -<br>Severity 3 | <p>Image Provided - Ref: 4_4</p> |
