## **STRUCTURAL APPRAISAL REPORT**

### **The Suitability of an Existing Agricultural Building for Conversion to a Domestic Dwelling**

**Oaksey Court,  
Oaksey, Wiltshire.**

Project Ref: 2252

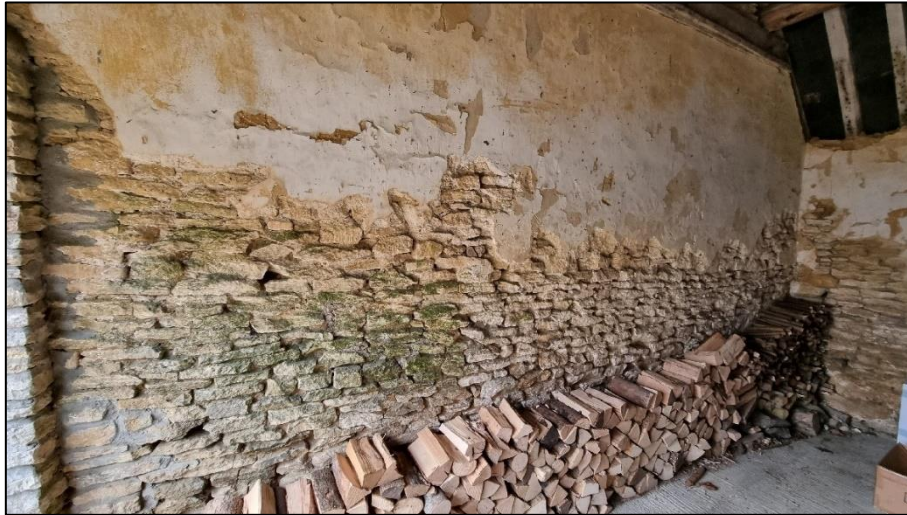
- 4.1. The internal face of the west gable wall requires re-pointing. Refer to photograph 4 below.

*Photograph 4: Wall requires re-pointing*

- 6.1. The walls require re-pointing at various locations. Local re-building of the wall is required below the truss adjacent to the external window,
- 6.2. The trusses will require strengthening with steel plates or angles bolted either side of the rafter members or re-newing incorporating horizontal tie members at eaves level.
- 6.3. The purlins require a suitable bracket to be fabricated to provide a connection back to the truss.
- 6.4. The internal and external walls can be tied together using a suitable crack repair technique. Refer to appendix C for a typical specification.
- 6.5. The rotten timber lintels need replacing, ideally with new concrete lintels.

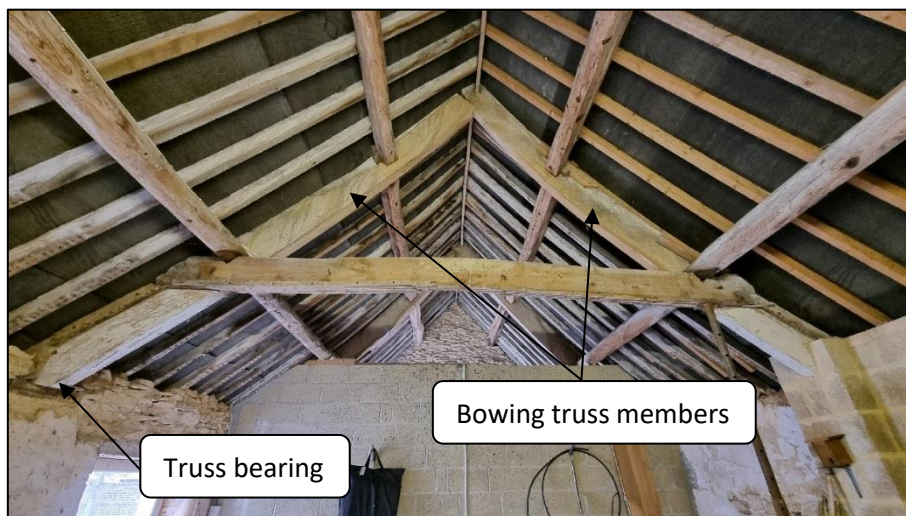
- 4.2. The bearing of one truss has been compromised due to movement of the front & rear walls. The top of the wall appears to have been pushed outwards by the roof. The rafter members of the truss bows. The lower purlin has moved off its bearing at the truss. New rafters and packing to the purlins has been undertaken on the rear section of the roof. Refer to photograph 5 below.

*Photograph 5: Movement to the truss*

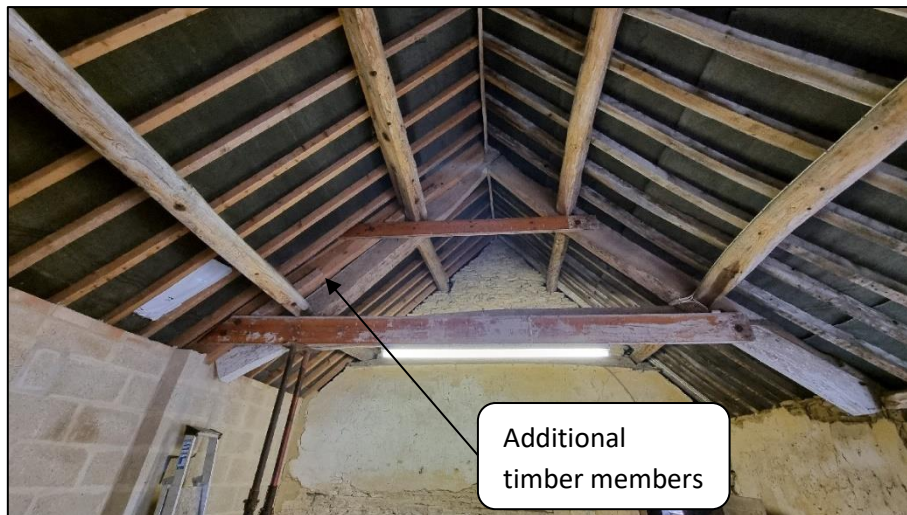
- 4.3. The end truss to the main building has been strengthened with additional timber members and is supported with acro props. New rafters and packing to the purlins has been undertaken on the rear section of the roof. Refer to photograph 6 below.

*Photograph 6: Movement to the truss*

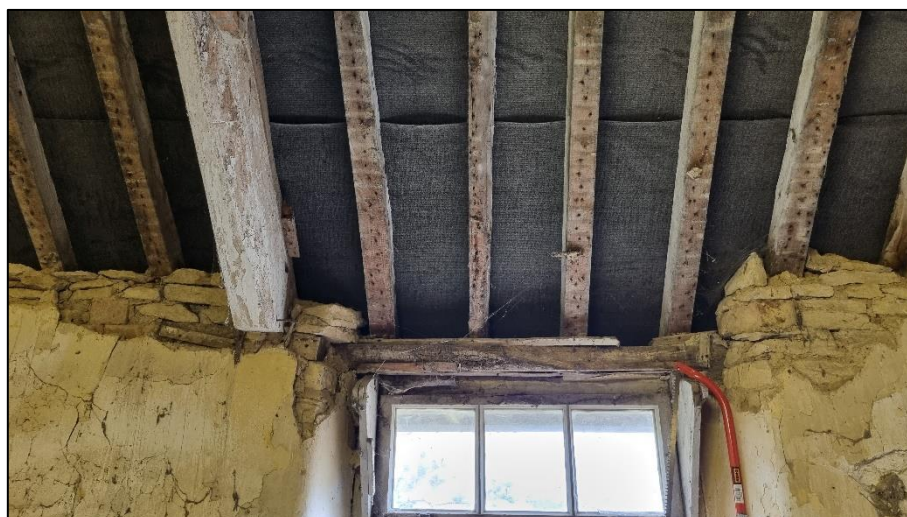
- 4.4. The end truss bears onto the front wall adjacent to a window. The lintel to the window is rotten. The masonry below the truss has moved, compromising the truss bearing. Refer to photograph 7 below.

*Photograph 7: Deterioration on timber lintel and masonry wall*

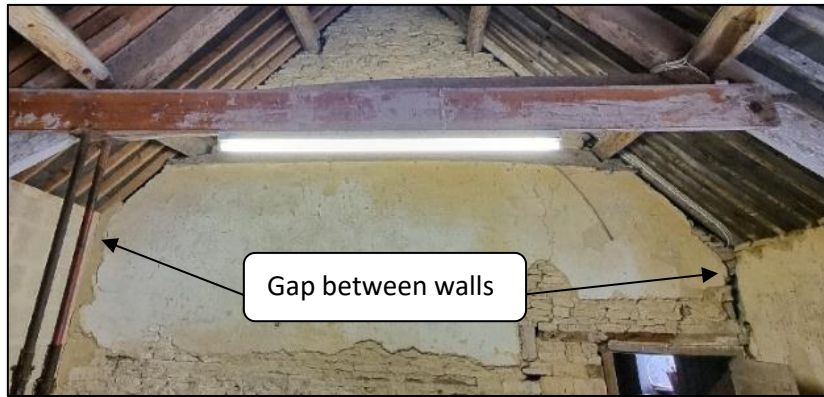
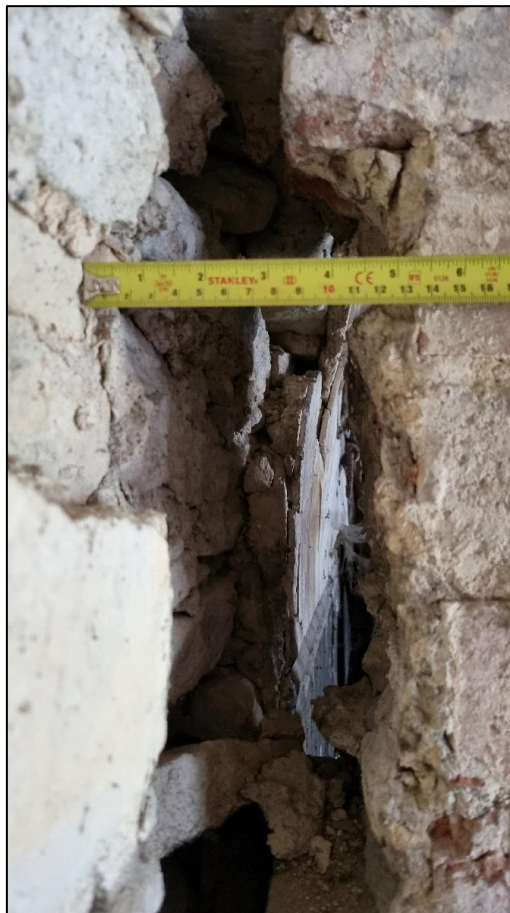
- 4.5. Gaps were observed between the internal wall and the front and rear walls. The gap with the rear wall has been cemented. Refer to photograph 8 and 9 below.

*Photograph 8: Gaps between the internal and front & rear walls*

*Photograph 9: Gap between the internal and front & rear walls*

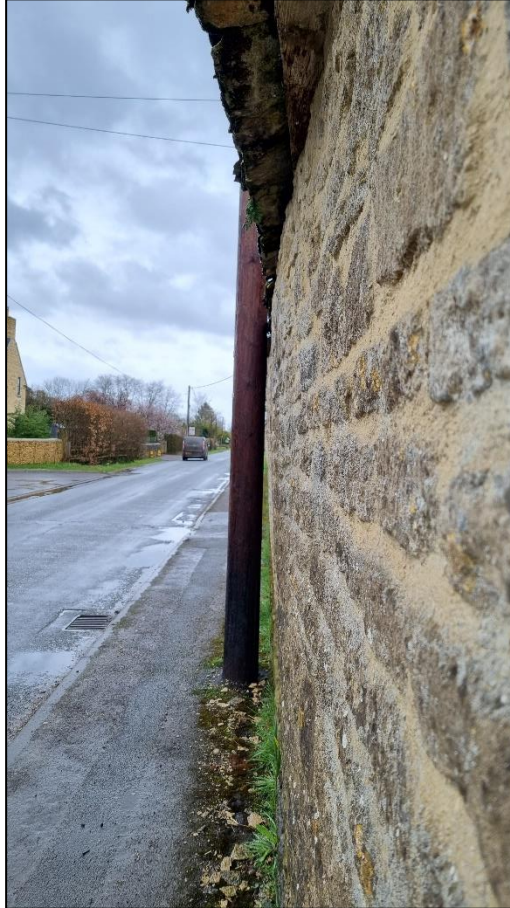
4.6. The front and rear walls lean outwards. Refer to photograph 10 below.

Photograph 10: Lean to rear wall

- 5.1. Overall, the external walls are in a structurally satisfactory condition. The re-pointing will maintain the structural integrity of the walls. The lean to the front and rear walls is not structurally excessive. The conversion works will provide stability to the walls.
- 5.2. The ground floor slab will need to be designed to accommodate the depth of the existing foundations should they be found to be of a shallow depth.
- 5.3. The existing timber roof structure will require strengthening or re-newing, to allow removal of the horizontal tie member. The strengthening will negate any further roof spread. The purlin to truss connection will need to be enhanced where the purlin support has been reduced.
- 5.4. The internal walls will require tying the external walls to maintain the stability of the building.
