## Heritage and Design and Access Statement - fire damage

St Boniface House, Warminster School  
Buxted, Uckfield, East Sussex  
TN22 4AY

Date: 1<sup>st</sup> December 2025

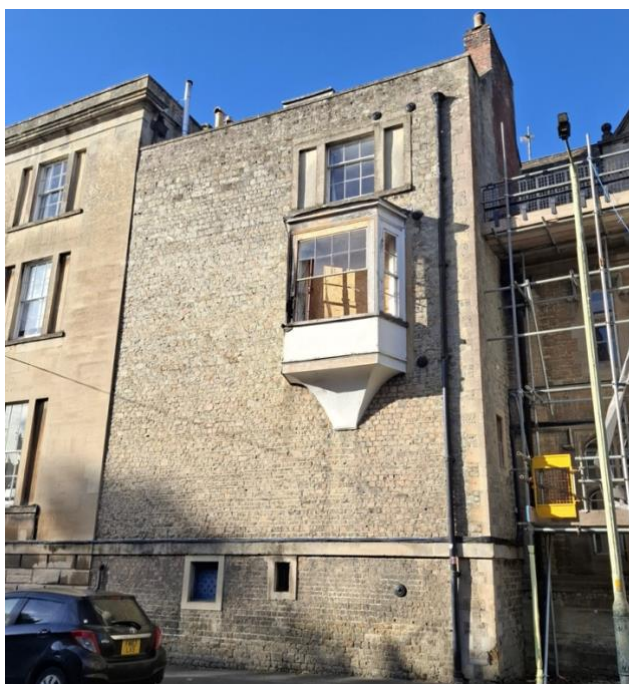
This heritage statement has been prepared in support of an application for Listed Building Consent, for repairs to the oriel window following fire damage at St Boniface House, Warminster School, (photos i & ii).

Photo (i) – elevation with oriel window

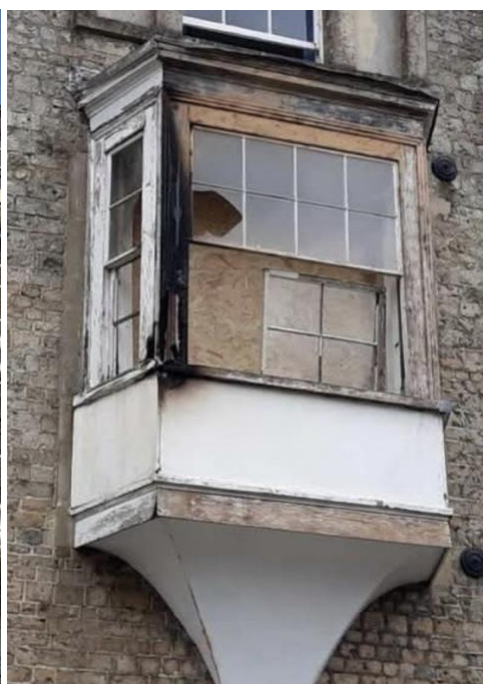
Photo (ii) – close up of oriel window

The oriel window would appear to date from 1796 when the building was constructed. The double hung sashes appear to be original with the original box frames and timber mouldings. However, the central timber panel appears to have been replaced with a plain panel.

It is understood that the outside of the building was being redecorated and the paint was being carefully burnt off. Unfortunately a fire occurred, resulting in the damage to the window and window surround.

- Replacement of the lower central sash with a new hardwood sash to match the original in every respect and as detailed in the attached drawing, including replacement of damaged glazing with 4mm clear plate glass.
- Repairs to upper central sash, unless it is found to be beyond repair and then it will be replaced with a hardwood sash to match the original, (see attached drawing).
- Repairs/replacement to lower right hand side sash, (when viewing from inside the property).
- Renewal of right hand side box frame to match the original.
- Replacement of render beneath sash windows with new timber laths and a hot lime render.
- Replacement of central and right hand side internal timber panels beneath window to match the original left hand side panel, (photo iii).
- Replacement of the lead flat roof coverings, (code 6 lead).

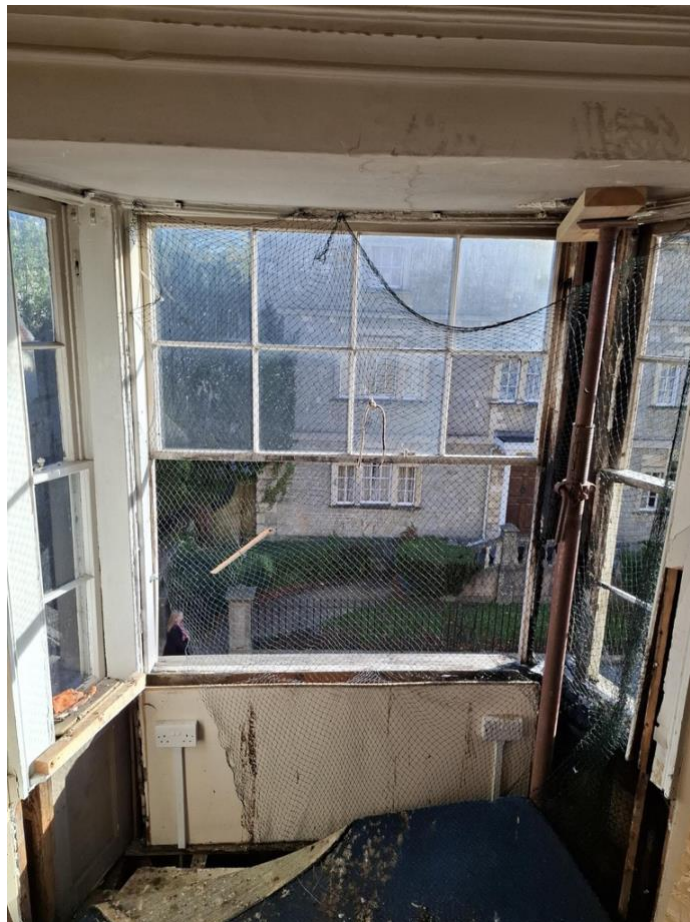
Photo (iii) – damage from fire internally
