**Full Tree Condition Report**  
**All Saints Church, Burbage.**

**Client Name:** All Saints Church Burbage

**Survey Address:** All Saints  
17 Eastcourt  
Burbage  
SN8 3AG

**Date:** 15/09/2025

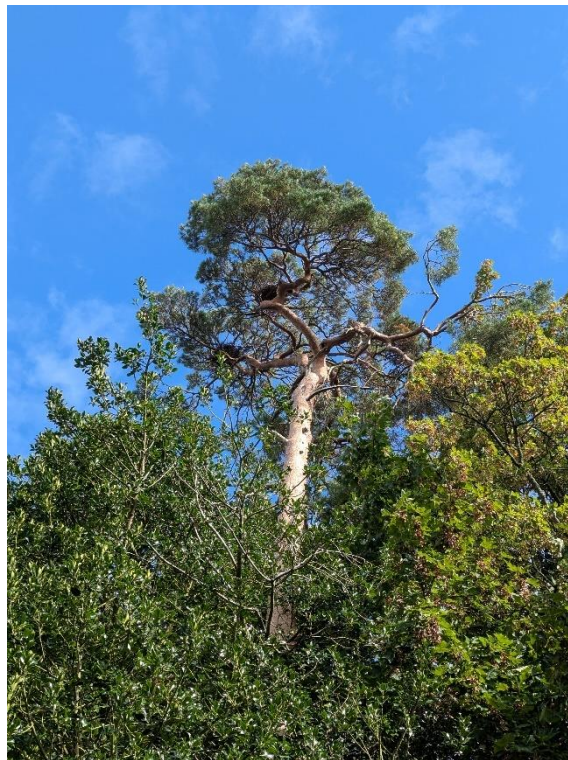
Photograph of T08.

T08 – Scots pine (*Pinus sylvestris*). Located in the north-west corner of the church grounds, near the entrance to The Old Vicarage. This tree was observed to have a slender stem diameter in relation to its height. While this is not unusual for the species, especially given its location among other trees, it is a point worth noting. Should the surrounding area be opened up, increasing the tree's exposure to the elements, it may become more vulnerable to windthrow. The tree also exhibits stem wounds resulting from historical limb failure, which may lead to structural weaknesses and provide potential entry points for pests and diseases. Given its proximity to the access road for The Old Vicarage, it is recommended that dead wood be removed.

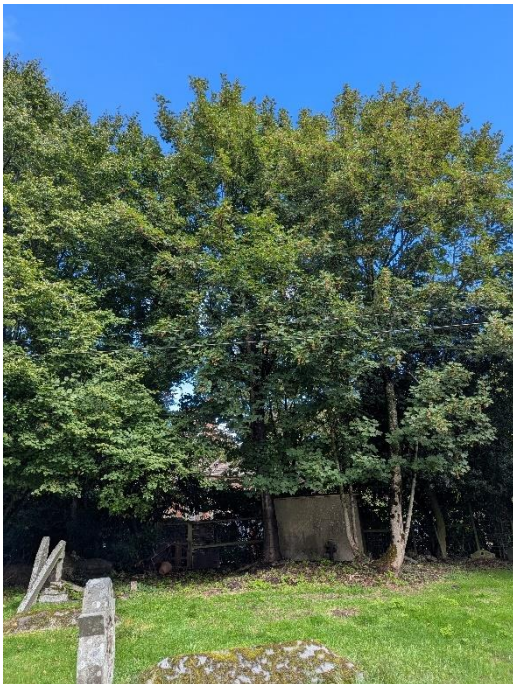
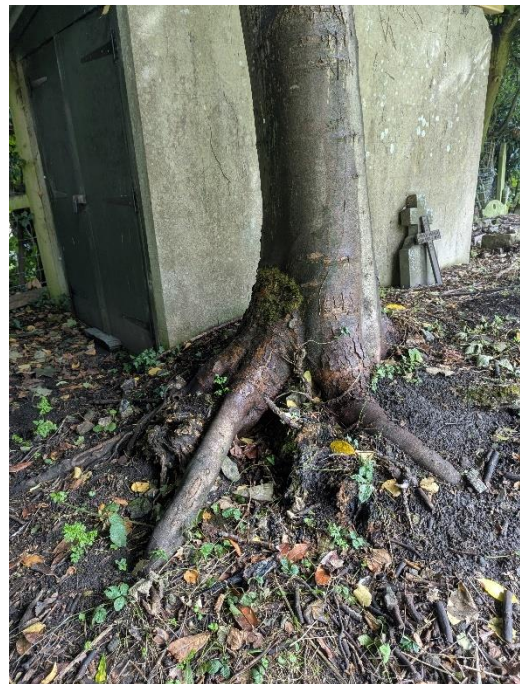
T17 – Sycamore (*Acer pseudoplatanus*). Located in the northern area of the church grounds. This tree is in good condition; however, exposed surface roots were noted on the western side of the stem, likely due to a reduction in soil levels. This exposure may lead to desiccation of the roots and a potential decrease in structural stability. To mitigate this, it is recommended that a thin layer of topsoil be applied around the exposed roots.

Photographs of T17. The left photograph is of the tree (centre). The right photograph is of the exposed roots.

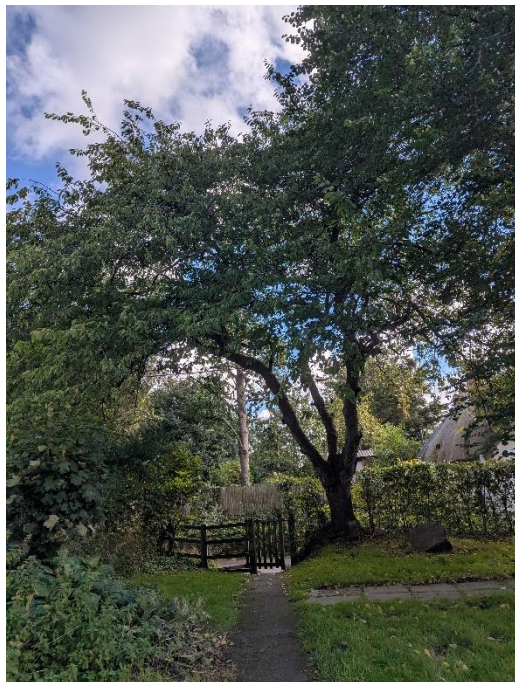
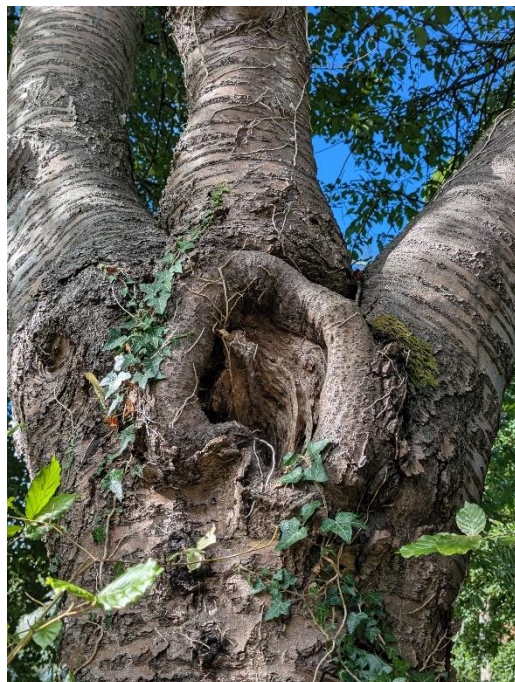
T25 – Wild cherry (*Prunus avium*). Located at the eastern pedestrian entrance to the church grounds, this tree is in good health; however, a large cavity was observed below the point of stem trifurcation. This cavity presents a potential structural weakness in the stem and may increase the risk of failure. Currently, there is good occlusion around the wound with minimal significant decay, but it is recommended that the cavity be re-inspected during the next scheduled inspection to monitor for any further deterioration.

Photographs of T17. The left photograph is of the tree (centre). The right photograph is of the cavity below the stem union point.

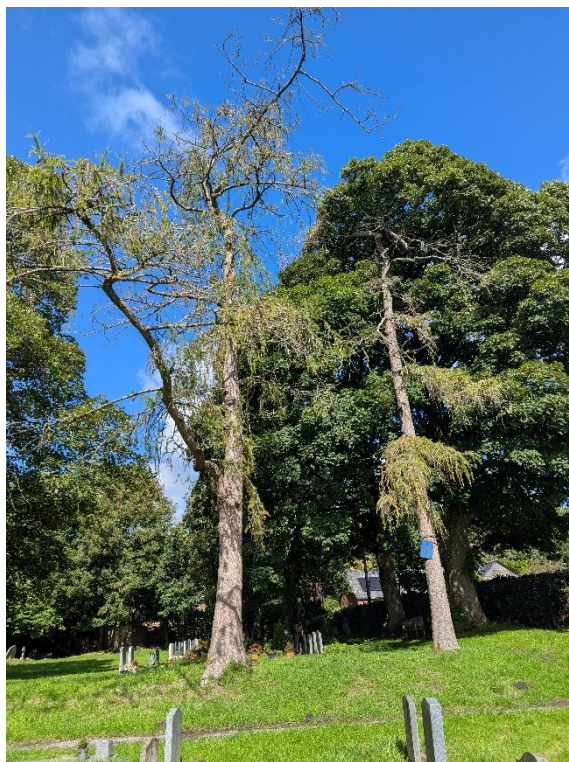
Photograph of T31 and T32.

T31 and T32 – European larch (*Larix decidua*). Located near the pedestrian footpath on the eastern side of the church grounds. These two trees have undergone significant decline, exhibiting extensive dieback of the leaf canopy and minimal visible foliage. Both trees have deteriorated to a point where recovery is unlikely and are no longer considered viable for retention within their current setting. Presenting a risk from the dead wood falling onto the pathway. It is therefore recommended that both trees be removed. *Pinus spp* would be a good replacement species to plant in their place once they are removed if so desired.

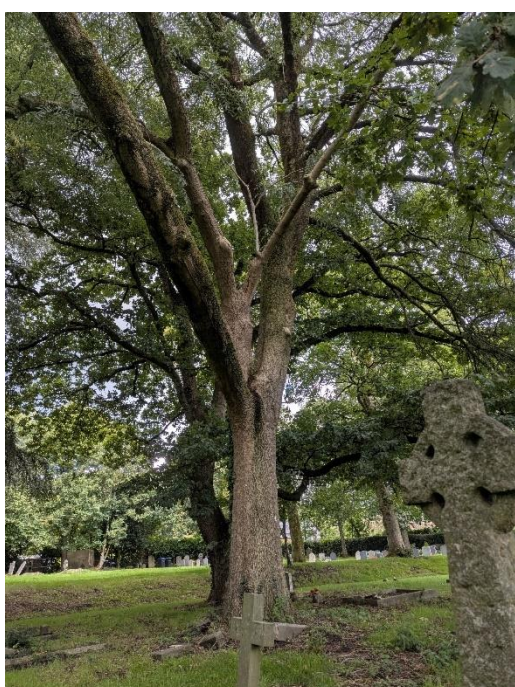
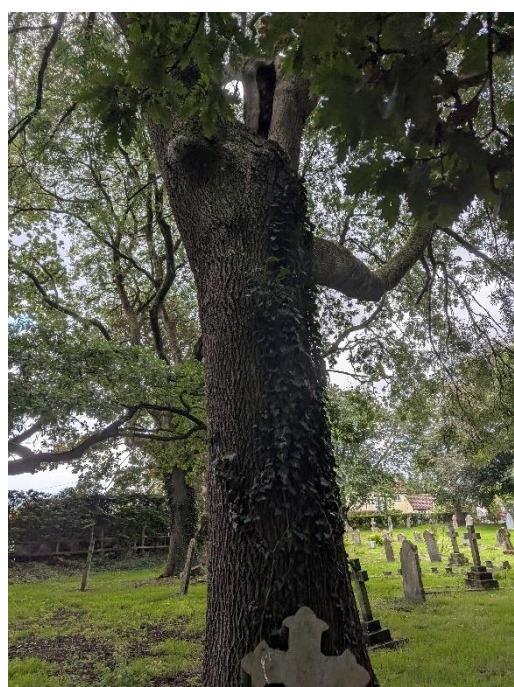
T40 – Common ash (*Fraxinus excelsior*). Located to the south of the main church building. This tree is exhibiting early signs of ash dieback, with some areas of dead wood present within the canopy. It is recommended that this dead wood be removed. Additionally, one limb displays visible splitting near its union with the main stem, making it susceptible to failure; removal of this limb is also advised. A significant cavity is present just above the stem union, which may represent a structural weakness. It is recommended that an aerial inspection be carried out to assess the condition and extent of the cavity.

Photographs of T40. The left photograph is of the tree, with the limb with cracks highlighted. The right photograph is of the northern side of the stem, with the cavity shown at the top of the photograph.

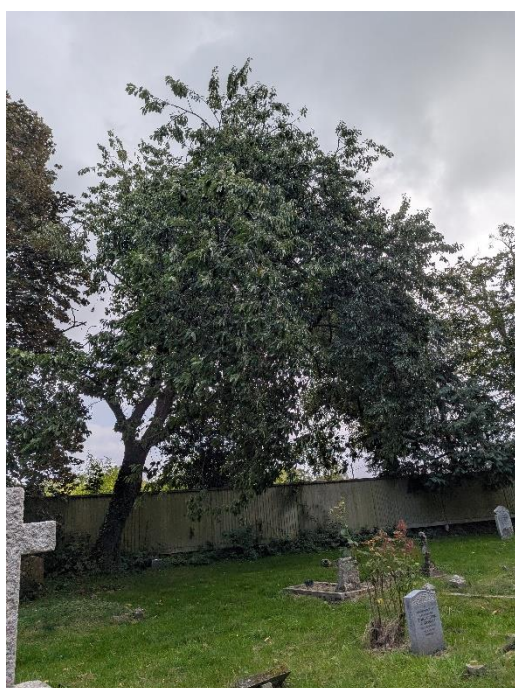
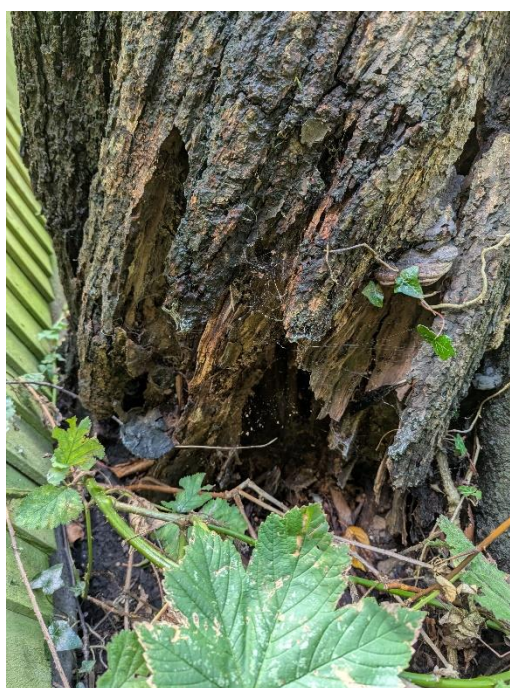
T44 – Wild cherry (*Prunus avium*). Located near the south-eastern corner of the church grounds. This tree displays multiple fruiting bodies of *Ganoderma australe* on the stem at the base, along with significant decay on the eastern side of the stem. Several sections of the canopy contain dead wood, indicating reduced vitality. Given the extent of decay at the base, which compromises structural integrity and increases the risk of stem failure, the tree is not considered suitable for long-term retention. It is recommended that the tree be felled and the area replanted with a replacement *Prunus* species.

Photographs of T44. The left photograph is of the tree. The right photograph is of the decay and fruiting bodies at the base of the tree.
