16585/DJSH/cmb

14<sup>th</sup> March 2018

**STRUCTURAL APPRAISAL OF BARN 4 – NEW FARM,  
ALDERTON, WILTSHIRE.**

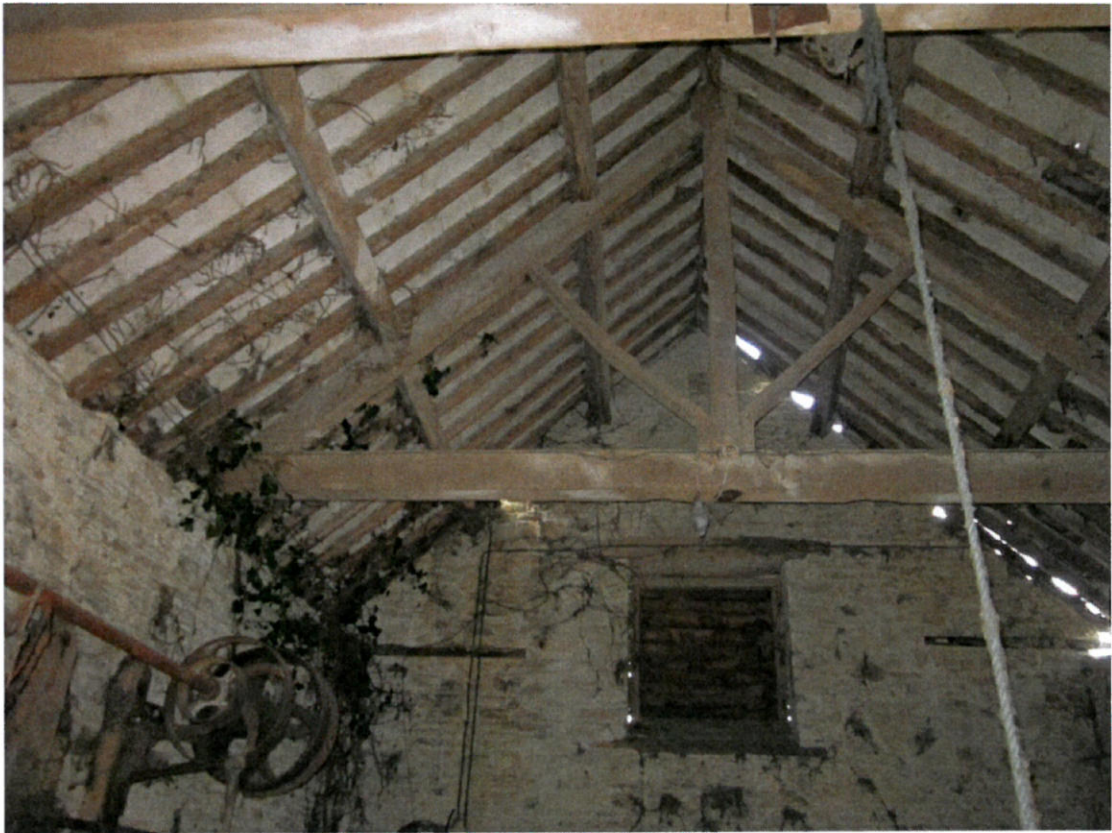
No: 5 Barn 4 - Roof Structure

The timber roof structure, rafters, purlins and trusses are all in a fair condition and adequately supported. There is some localised rot in areas where the roof tiles are missing. There is no underslating felt.
