4<sup>th</sup> September 2018

Our Ref: E987-01

enims Ltd has been commissioned to undertake a preliminary bat roost assessment of the summer house, which stands within the garden of Pound Cottage, Devizes, SN10 5SR (UK Grid Ref: ST 96715 56760), to establish the potential of this structure supporting roosting bats and in order to support a planning application for a single detached annex building within the same footprint as the current wooden structure.

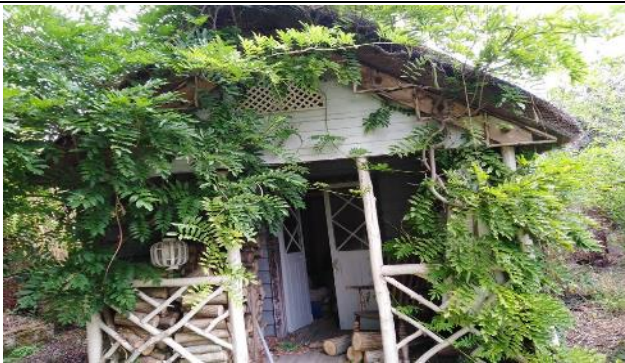
**Photograph 1.** View of the summer house.

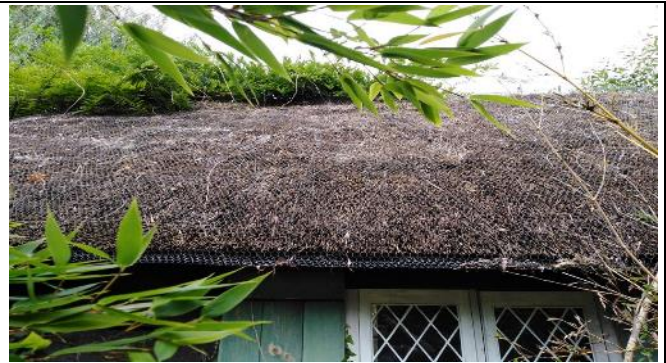
It is considered that the summer house is generally in a good condition. The chicken wire covering the thatch is also in good repair and limits access for bats. No gaps were observed in the wooden cladding or the eaves and thick cobwebs inside the structure indicated that the interior had not been recently disturbed.

**Photograph 2.** View of thatched roof completely covered in chicken wire.

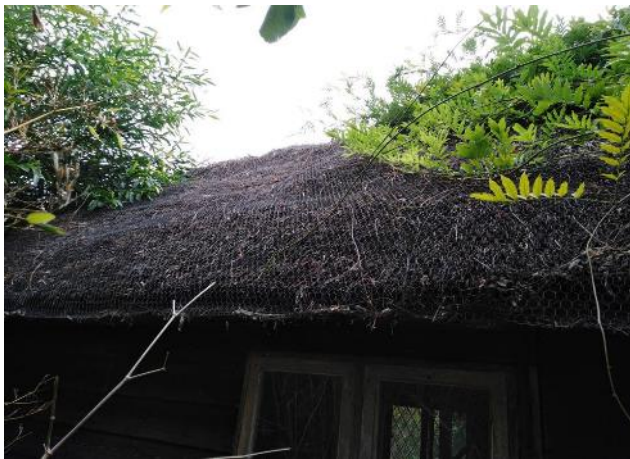
**Photograph 3.** View of thatched roof completely covered in chicken wire.

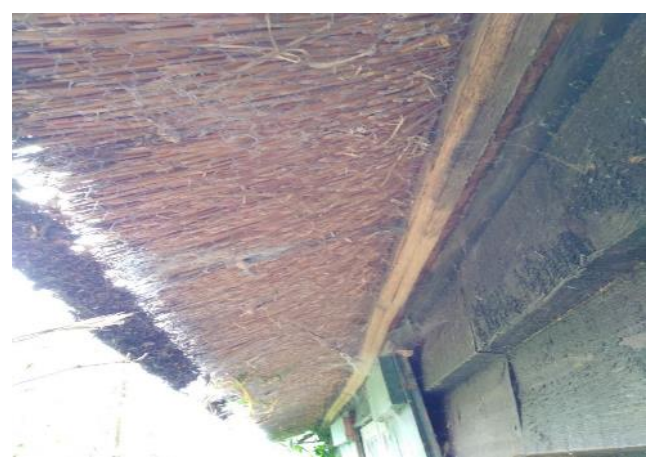
**Photograph 4.** View of underside of eaves and thatched roof.

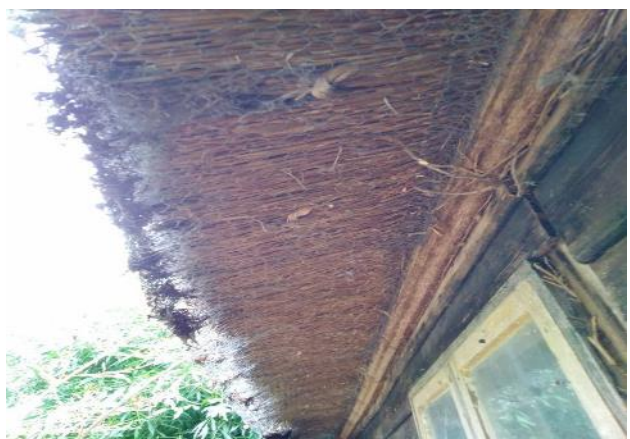
**Photograph 5.** Another view of the underside of the eaves and thatched roof.

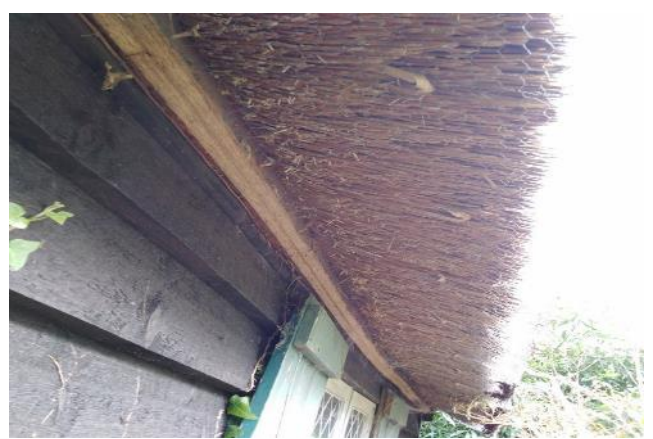
**Photograph 6.** Further views of the underside of the eaves and thatched roof.

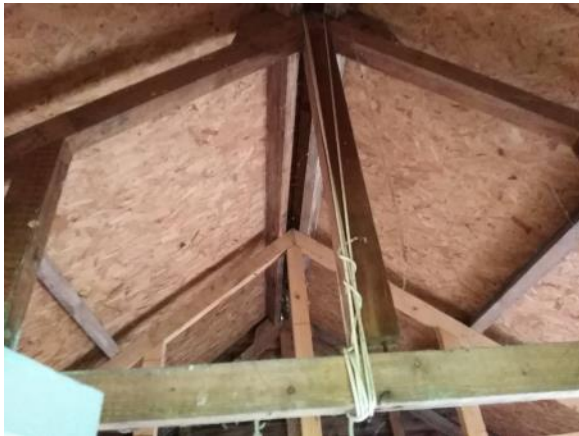
**Photograph 7.** View of the well-sealed internal building.

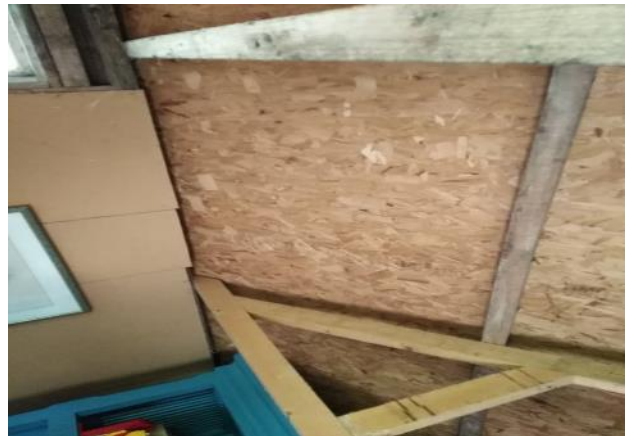
Internally the boards were in good condition, close fitting with no gaps. Any gaps in the exterior cladding were also inspected and no evidence of bats being present or potential roosting sites were found.

**Photograph 8.** View of plasterboards in good condition offering no gaps to the exterior of the building.
