**20251209 - Photos and Specification for Tree Works to**  
**Conservation Area within Avebury Village**

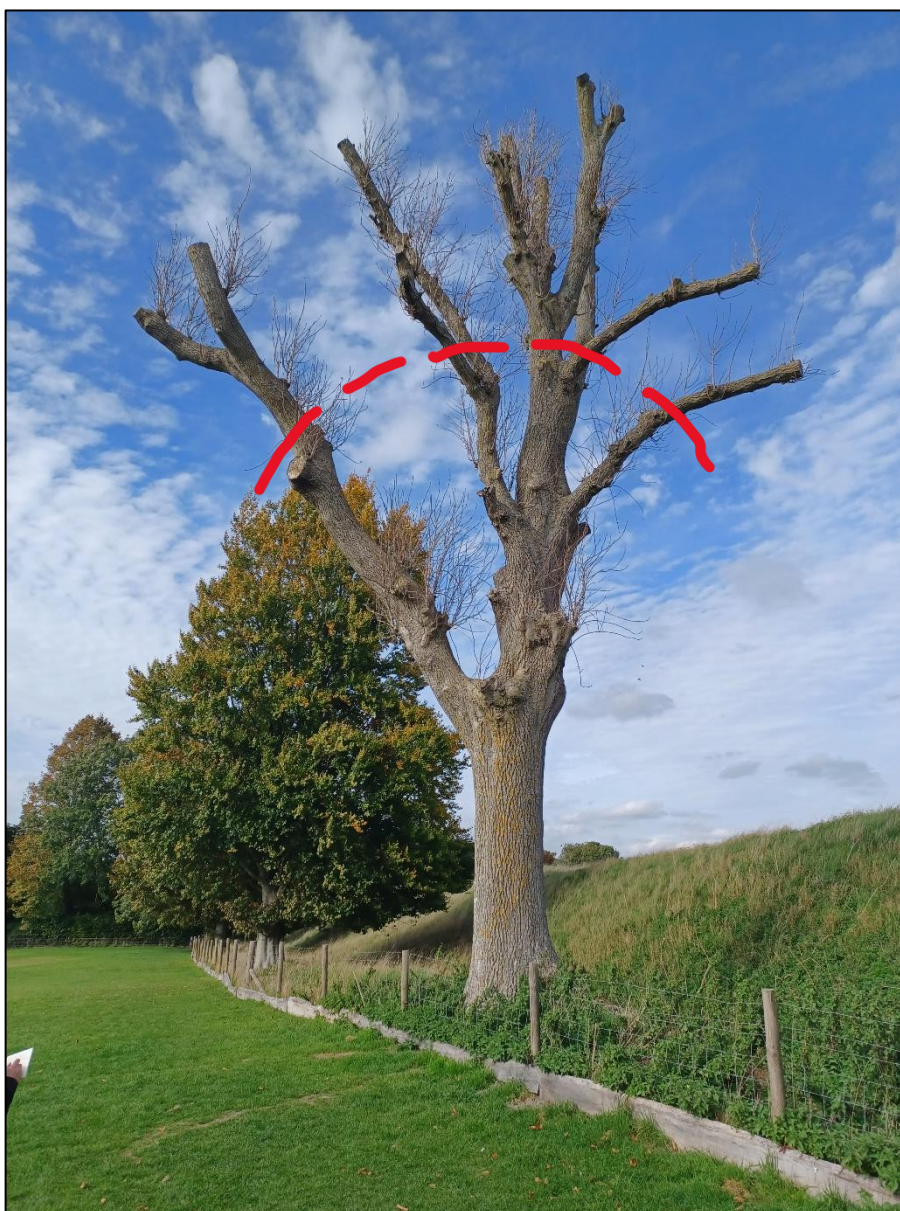
**i. Southwest Sector of Avebury Henge / boundary with Sports Field**

**Description:** Previously reduced Ash tree continuing to decline. Tree is not dead (Sept 2025) and there is still some potential for viable regrowth but also some high-level deadwood.

**Proposals:** Remove dead/dying limbs and pollard tree back to good growth points as indicated and monitor to see if this tree recovers as a pollard.

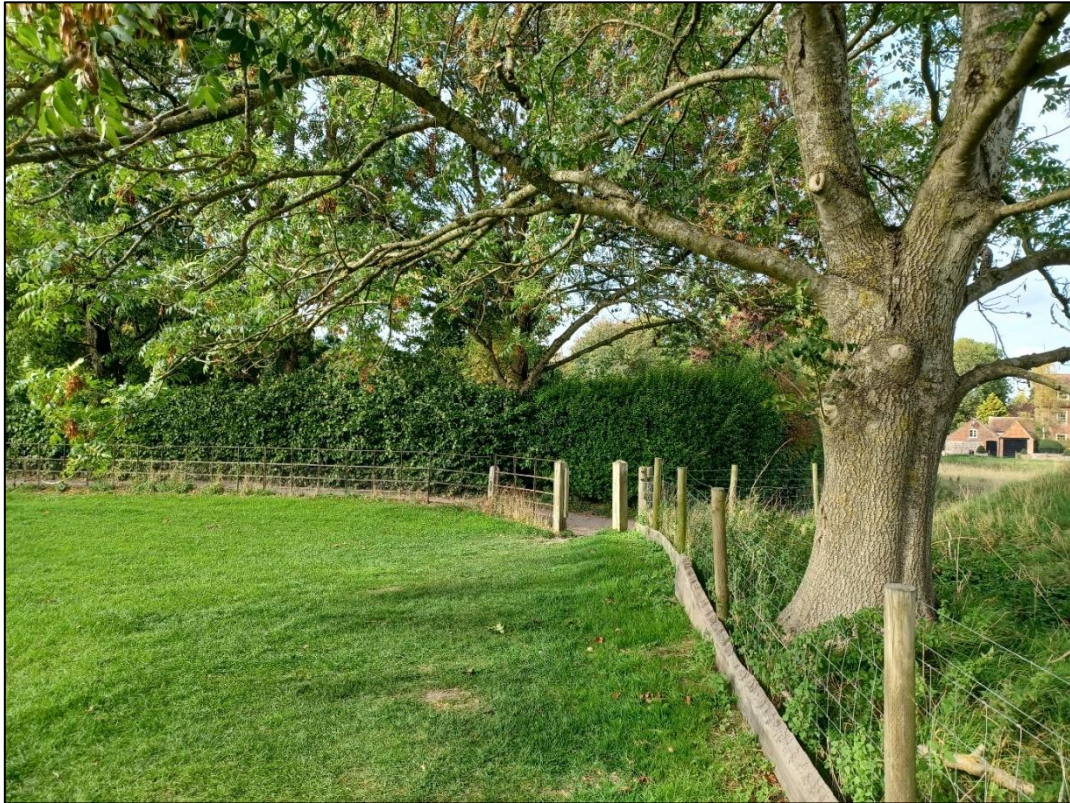
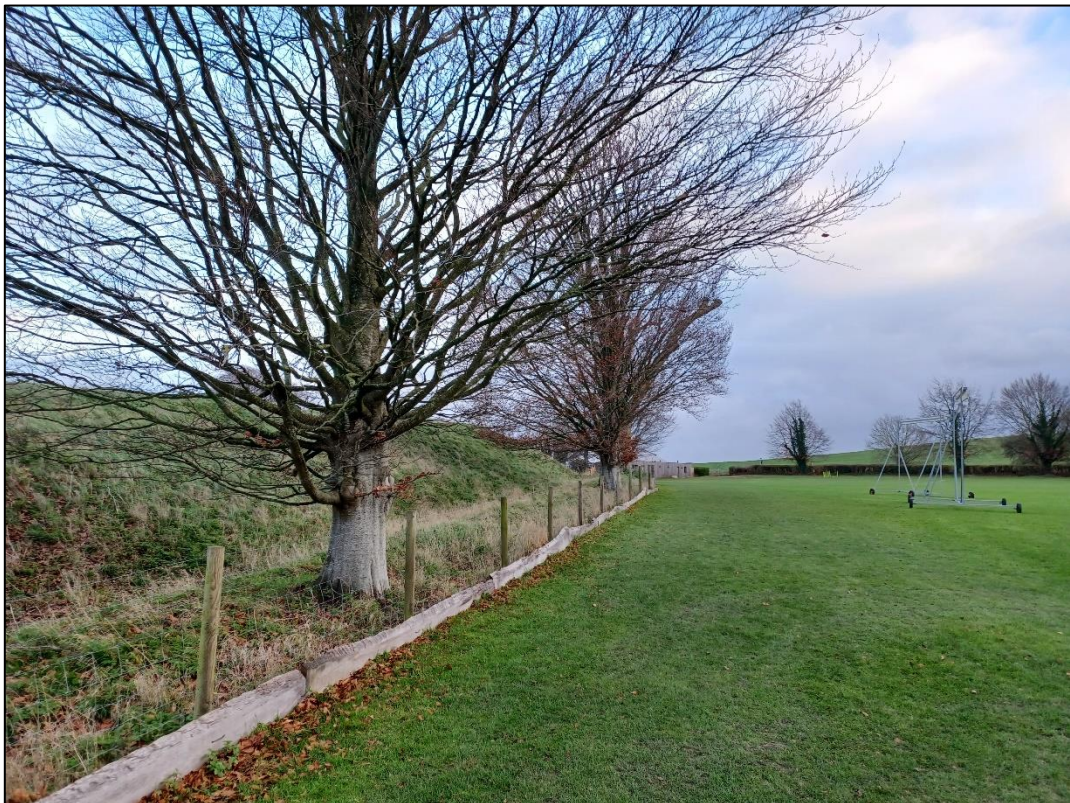
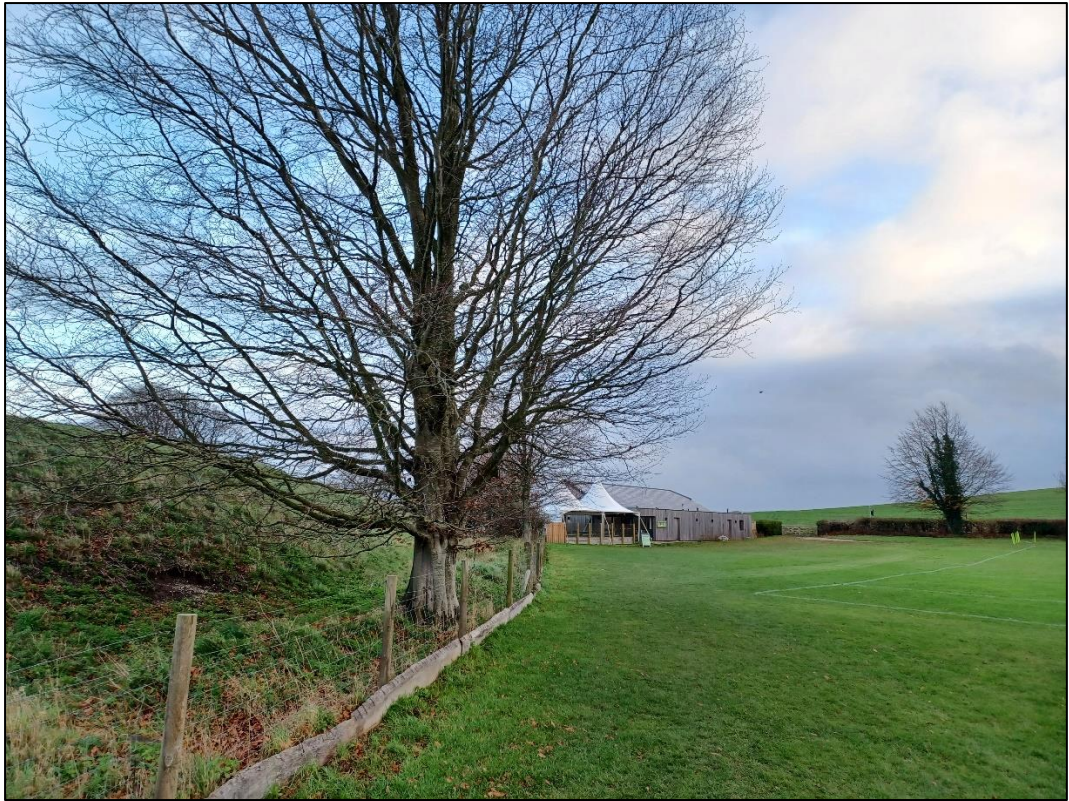
ii. **Southwest Sector of Avebury Henge / boundary with Sports Field**

**Description:** Boundary trees (1x Ash and 2x Beech)

**Proposal:** Light crown lifting to remove lowest branch(es) to allow sports field mower to pass safely underneath.

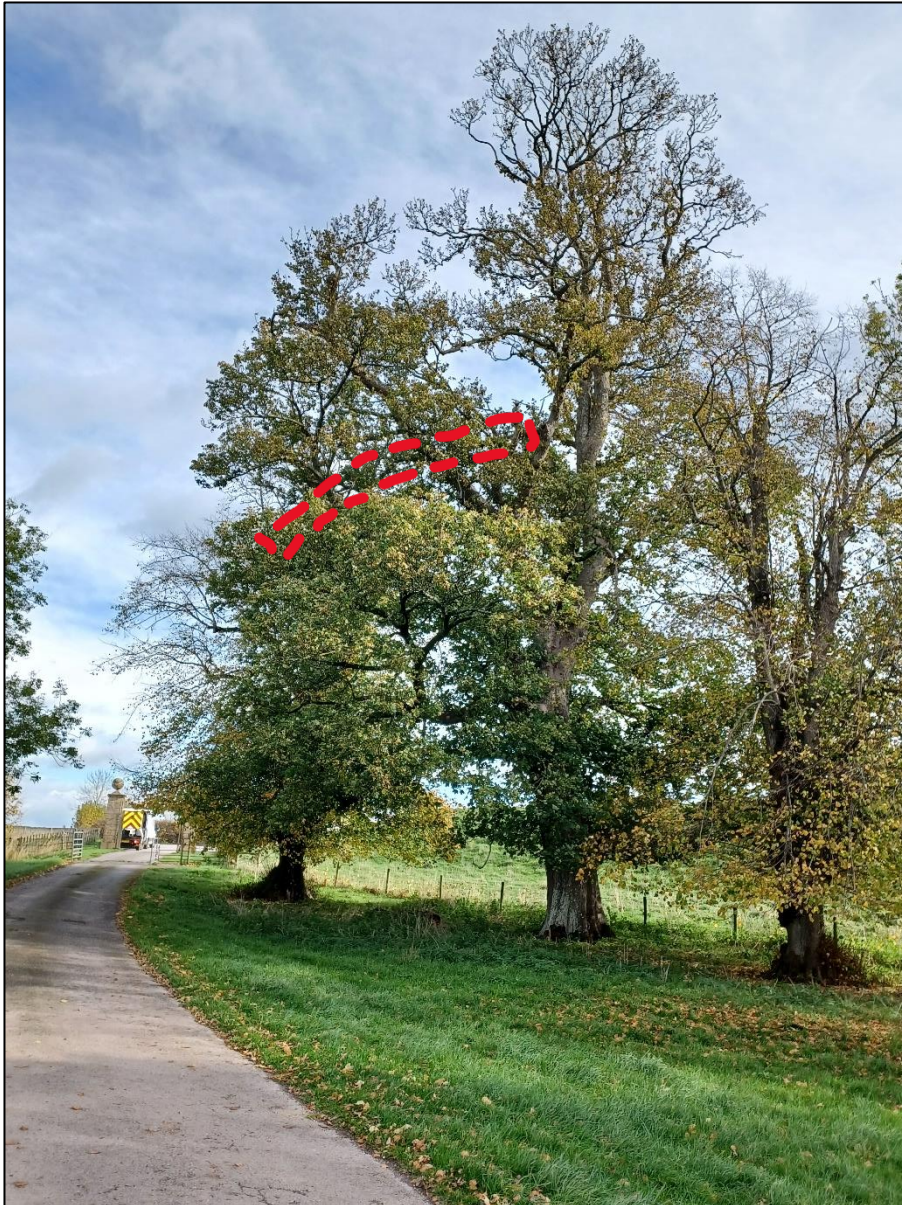
iii. **Manor Parkland, Avebury**

**Description:** Mature sycamore with single crossing/dipping limb within the crown that is now resting on adjoining branch and presents a hazard to the Manor Drive if it failed.

**Proposal:** Remove crossing limb within crown - outlined in red but not really visible in this photograph. This removal will not be apparent and not visible when the tree is back in leaf.

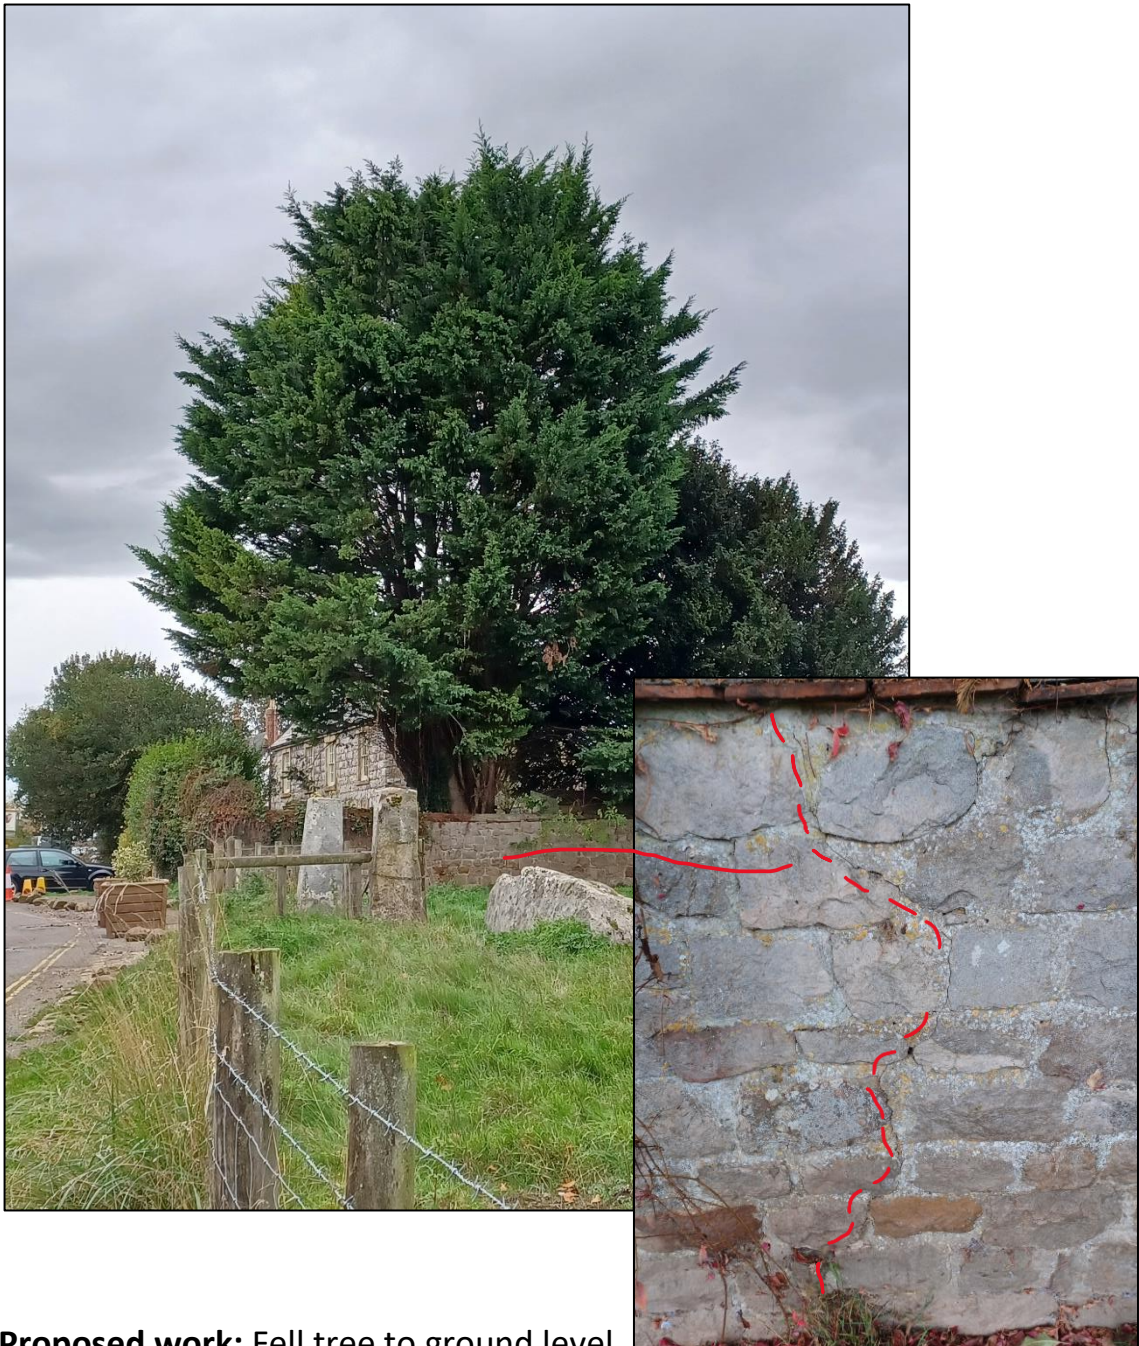
iv. **Silbury House - Avebury**

**Description:** Overgrown multi-stemmed Leylandii (or Lawsons Cypress *Cupressus sp.*) overshadowing the garden and impacting the adjoining Yew tree. Multi-stemmed base and expanding root plate starting to impact the adjoining sarsen stone wall.

**Proposed work:** Fell tree to ground level.

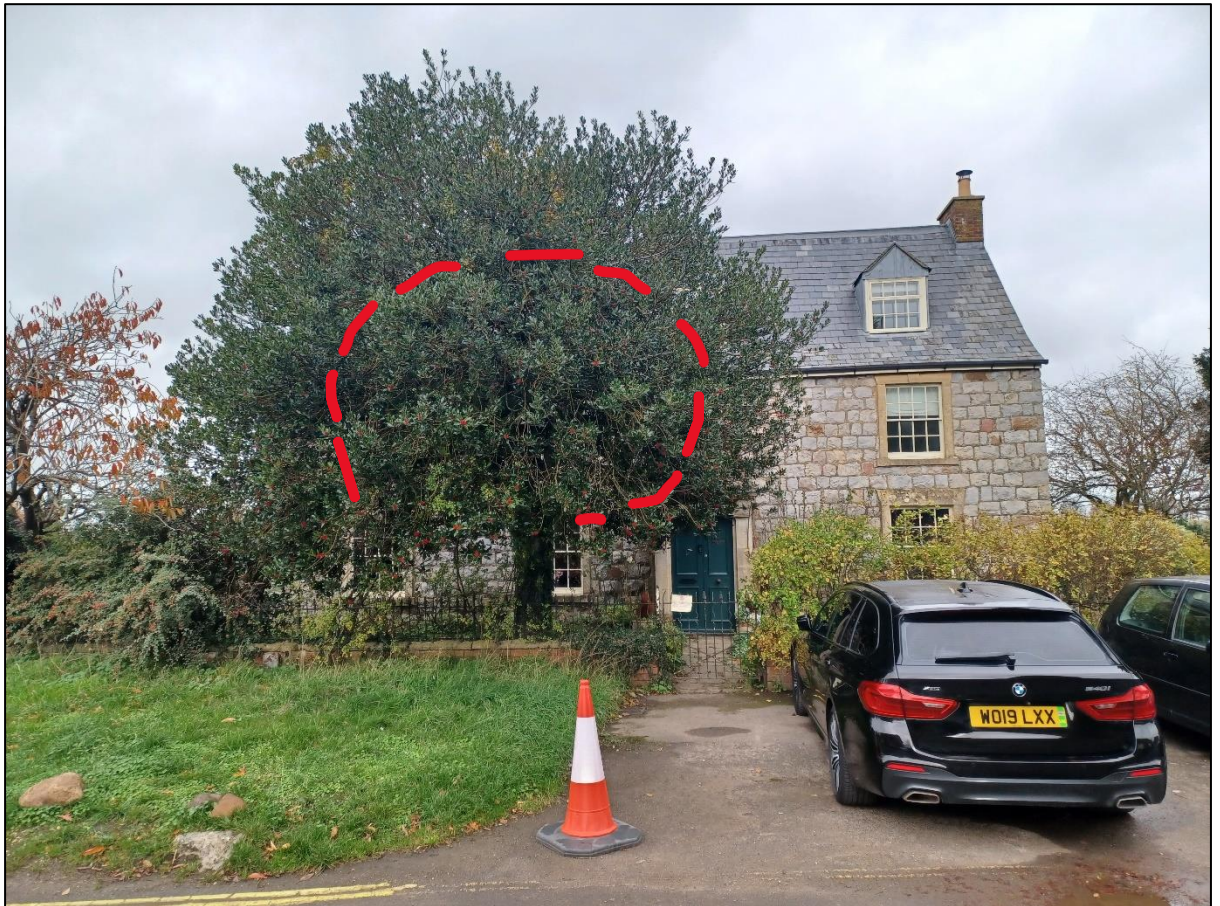
**v. Silbury House, Avebury**

**Description:** Ornamental Holly – Growing very large and blocking light to front of property.

**Proposed work:** Reduce crown by 30-40%.

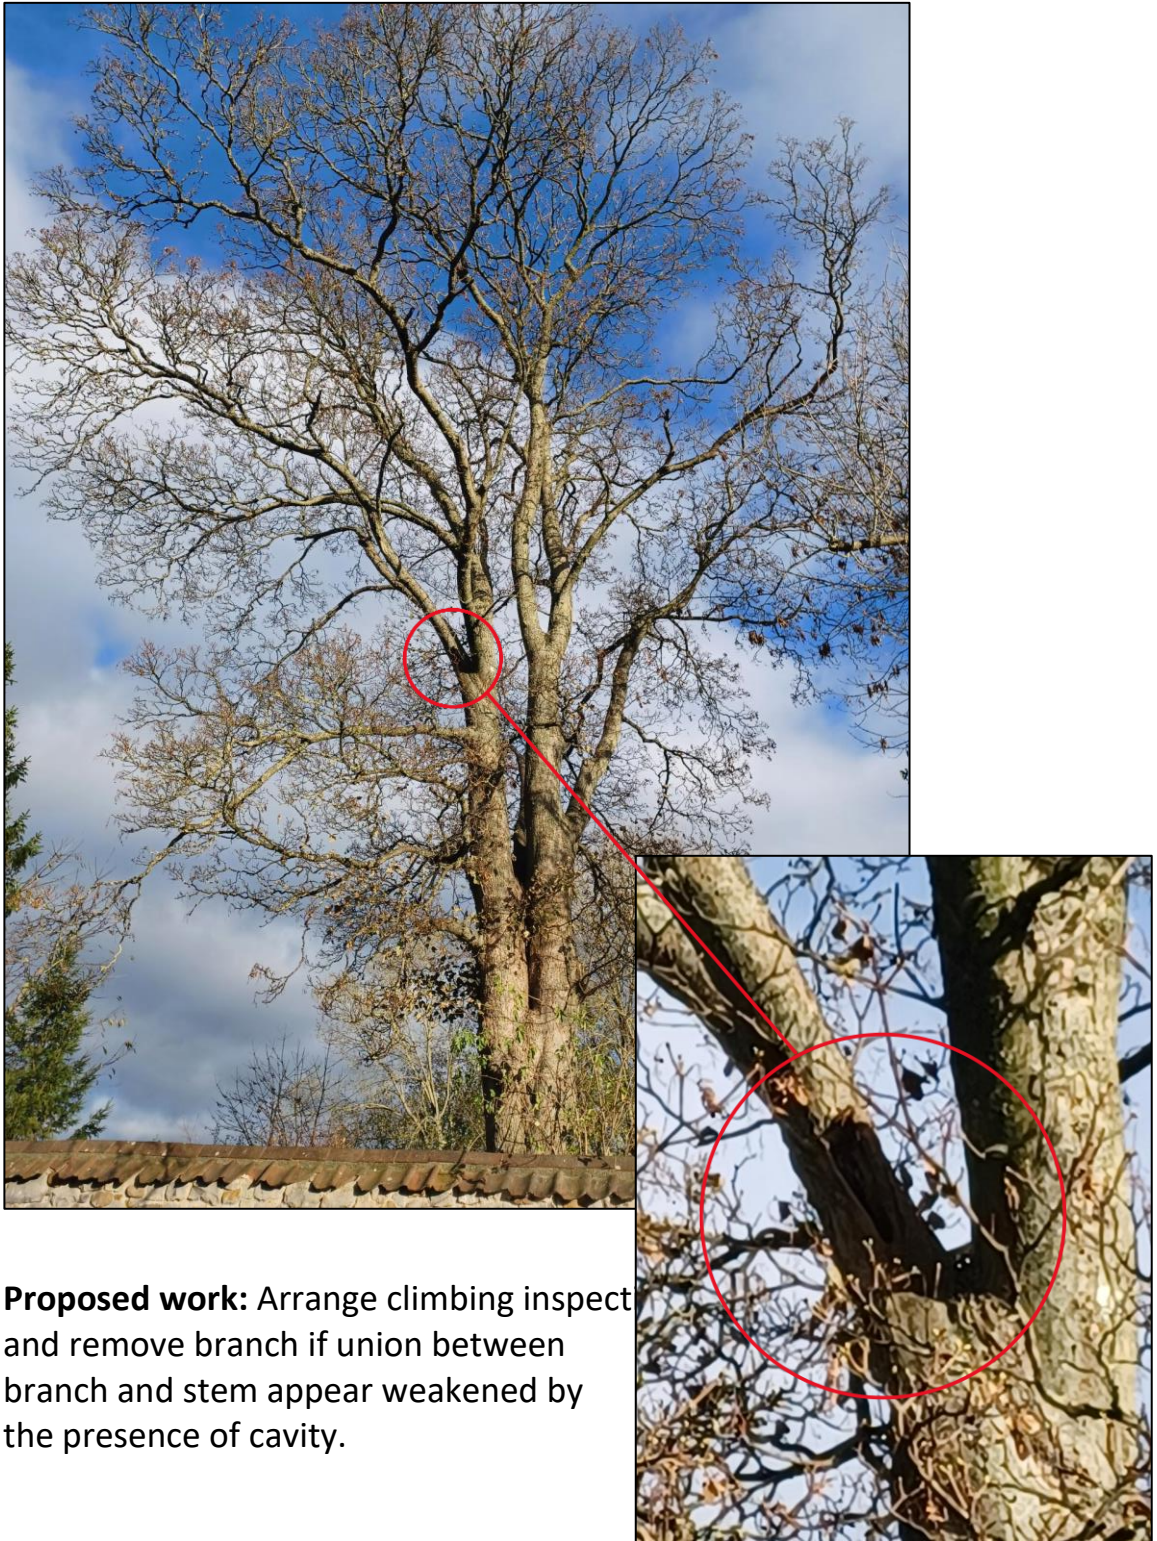
vi. **The Lodge, Avebury**

**Description:** Mature sycamore tree. One cavity defect identified to branch over the High Street carpark. Poor union with main stem.

**Proposed work:** Arrange climbing inspect and remove branch if union between branch and stem appear weakened by the presence of cavity.

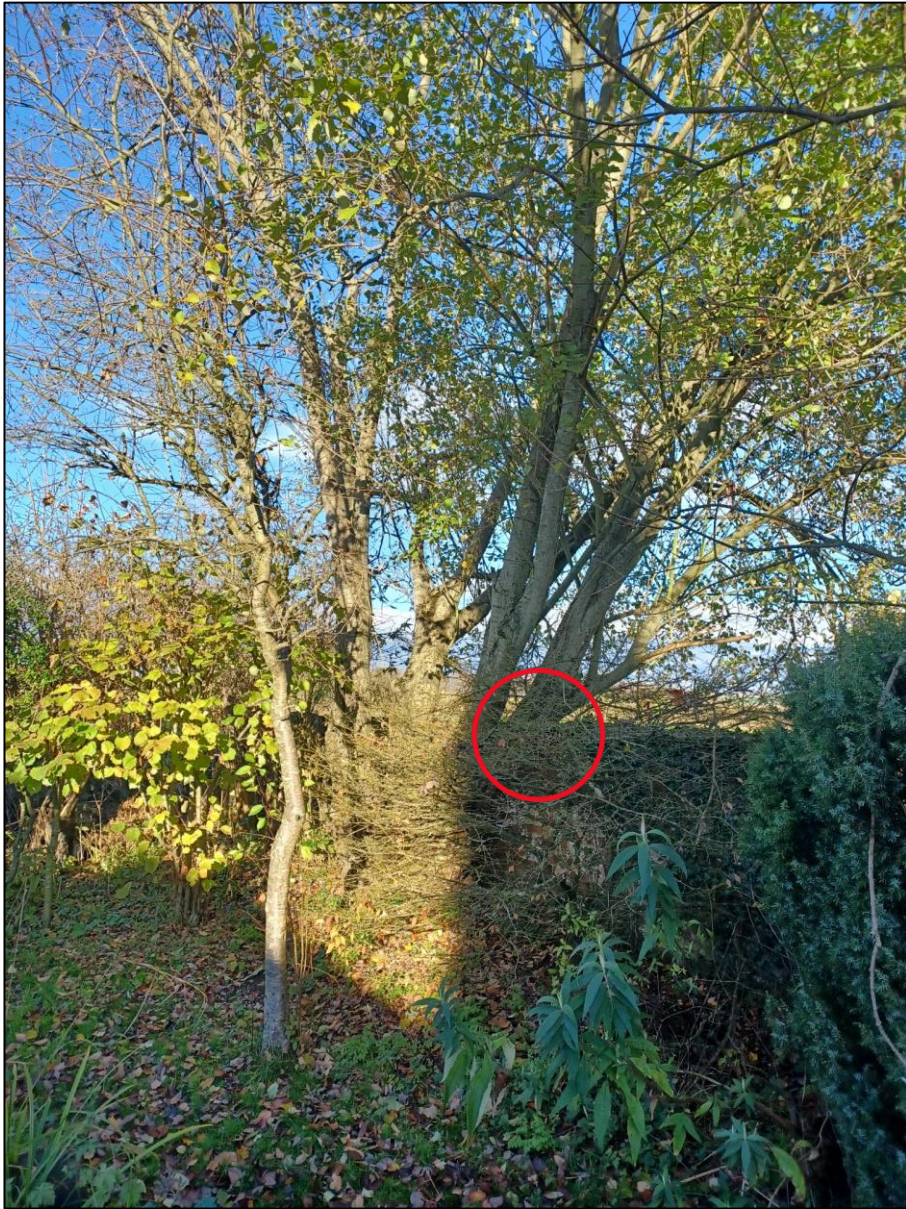
**vii. The Lodge, Avebury**

**Description:** Overgrown Goat Willow (*Salix sp.*) leaning/pushing against existing brick wall.

**Proposed work:** Remove leaning stem only that is against wall (red circle).

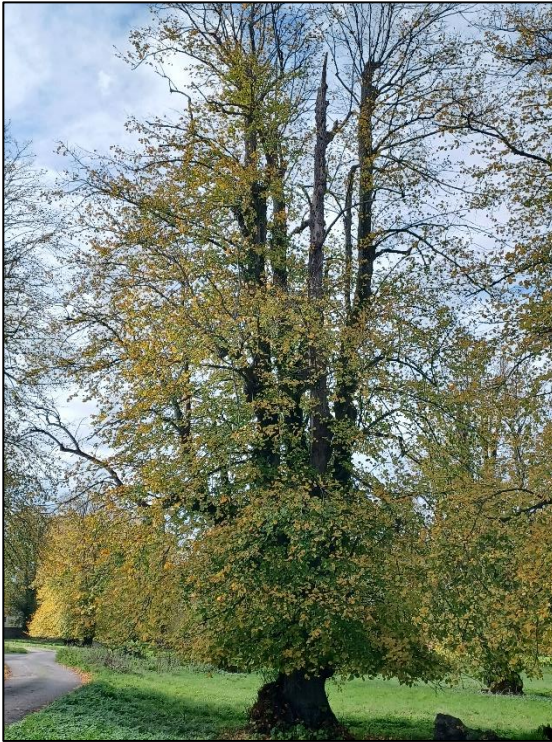
1. Lime  
tree – tag 4941

Description: Deadwood to Lime trees adjacent to temporary car park.

**Proposed work:** Remove dead wood to 4 x Lime trees

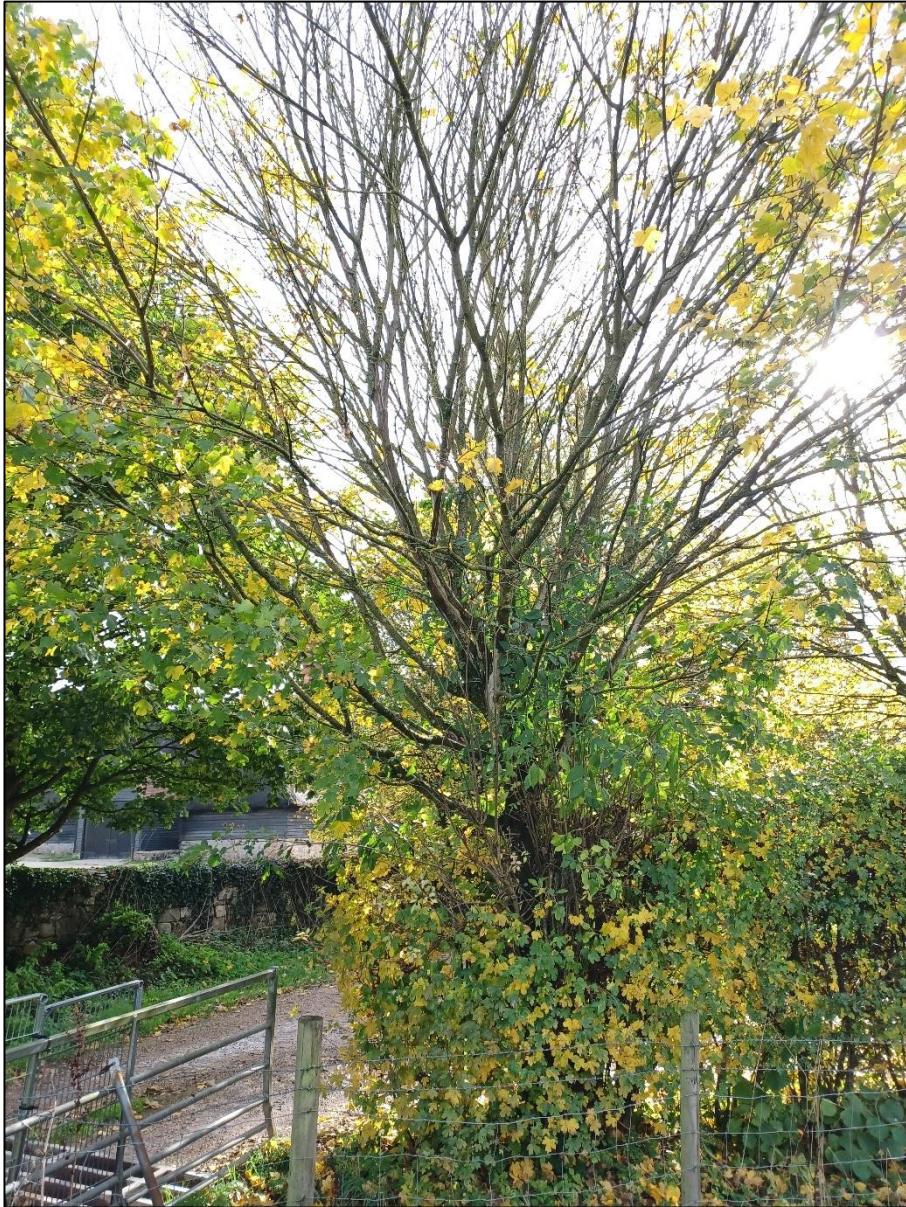
**ix. NT Staff Car Park - Avebury**

**Description:** Dying crown to field maple following squirrel damage.

**Proposed work:** Pollard tree to allow recovery.
