## **Off Mains Drainage Survey Report Prepared For:**

Tuppney Cottage, 25 Cholderton, Salisbury, SP4 0DL

**Date of Survey:** 30/10/2025

## Drainage Survey Standard Report:

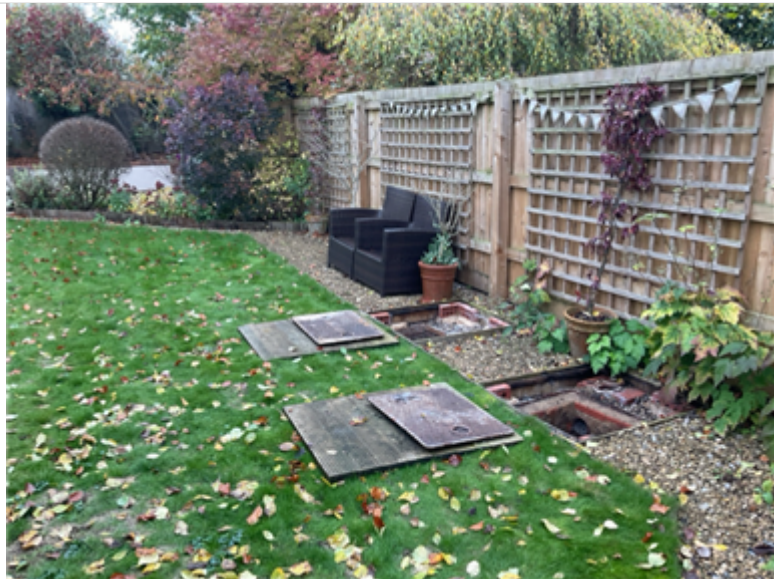
| <b>Is the existing discharge functioning correctly?</b> | No<br>Failed soakaway causing the tank to surcharge and the upstream drainage to back up. |

Photograph of the general area of the tank:

The system has a failed soakaway causing the tank to surcharge, this is non-compliant with the general binding rules for small sewage discharges.

Excavate and install a new 6 person WTE Vortex sewage treatment plant (STP) with integral pumped outlet, to be located downstream of the existing septic tank as close to the right boundary fence as practicable.

Empty, backfill, cap off and decommission the existing septic tank and MH3.

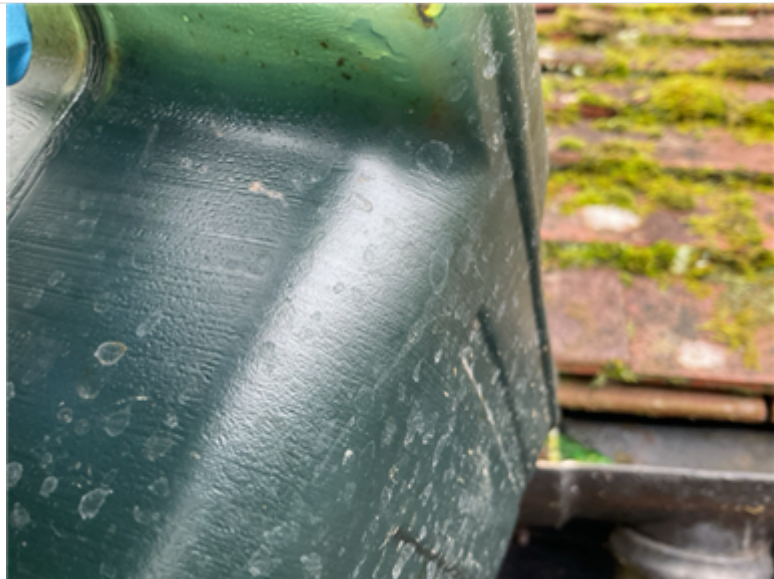
No

**Photograph of dye test undertaken**

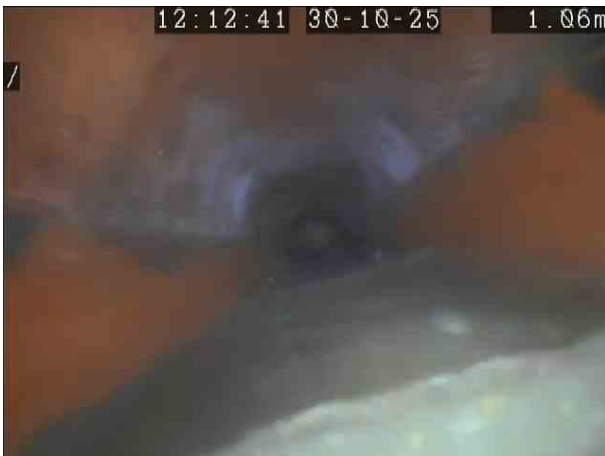
49e01016-535a-4699-b7ac-83271a2b2ab3.png, 00:00:41,  
1.06 m  
Water level, 15% of the vertical dimension

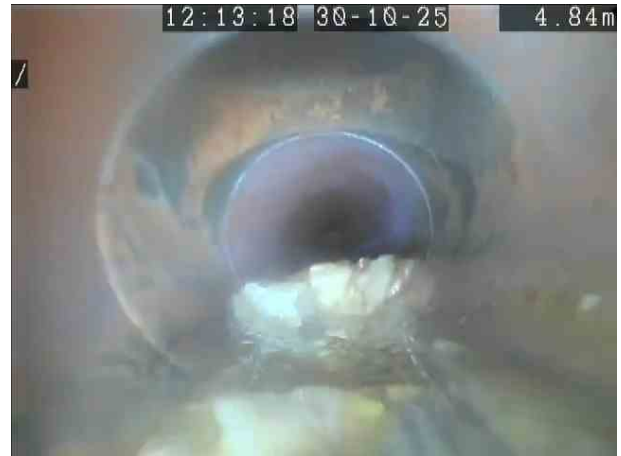
| Scale: 1:67 | Position [m] | Code | Observation | MPEG | Photo | Grade |
|---|---|---|---|---|---|---|
| | 4.84 | DEG | Attached deposits, grease from 5 o'clock to 7 o'clock, 10% cross-sectional area loss | 00:01:19 | | 3 |

59199569-7f25-43fa-bdfa-235cc5e65efc.png, 00:01:19,  
4.84 m  
Attached deposits, grease from 5 o'clock to 7 o'clock, 10%

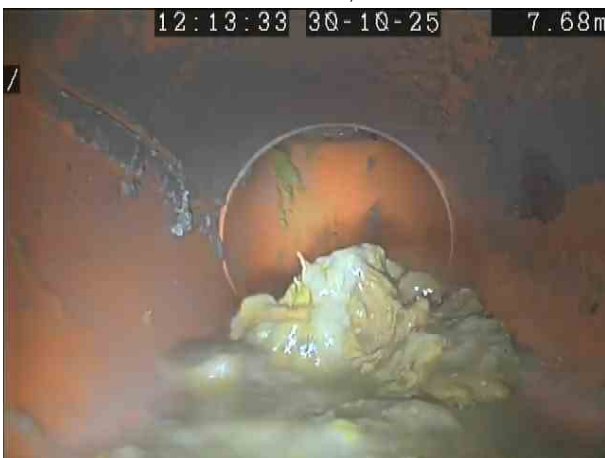
| Scale: 1:67 | Position [m] | Code | Observation | MPEG | Photo | Grade |
|---|---|---|---|---|---|---|
| | 7.68 | DEG | Attached deposits, grease from 5 o'clock to 7 o'clock, 15% cross-sectional area loss | 00:01:34 | | 3 |

a9c59574-7c2b-472e-8a7d-523843b1fb4d.png, 00:01:34,  
7.68 m  
Attached deposits, grease from 5 o'clock to 7 o'clock, 15%

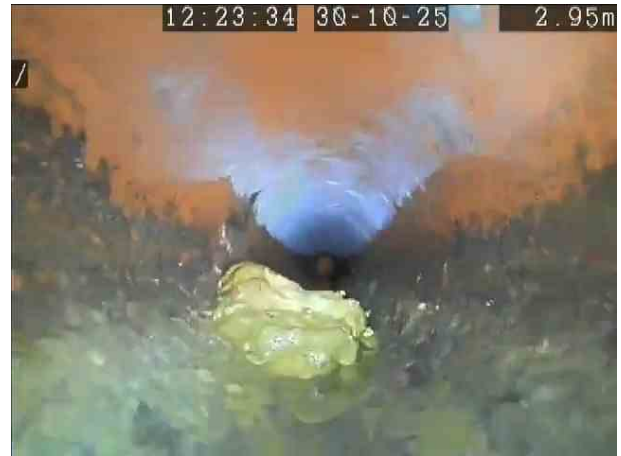
| Item No. | PLR | Grade | Description |
|---|---|---|---|
| 3 | U/SX | 3 | Attached deposits, grease from 5 o'clock to 7 o'clock, 5% cross-sectional area loss |

5c243ea2-1912-4433-8fbd-e34634534764.png, 00:00:15,  
2.95 m  
Attached deposits, grease from 5 o'clock to 7 o'clock, 5%

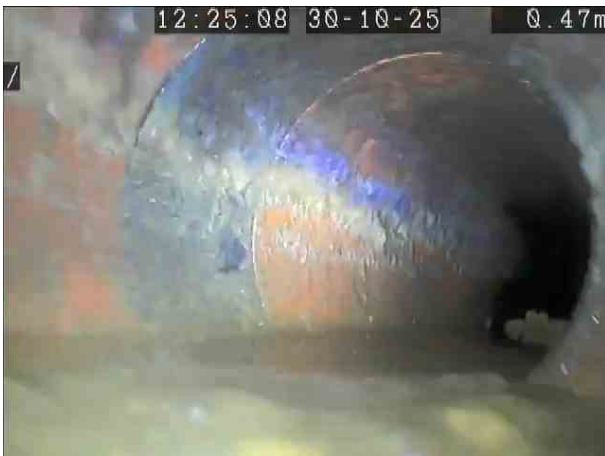
5a3a6218-ea7d-47a9-8565-31facc8db93a.png, 00:00:12,  
0.47 m  
Water level, 10% of the vertical dimension

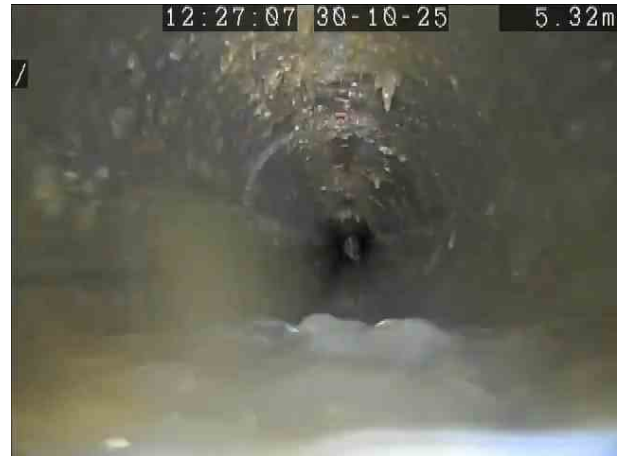
4541a076-da50-469d-ad11-c6a6ec86e41b.png, 00:00:19,  
5.32 m  
Water level, 5% of the vertical dimension

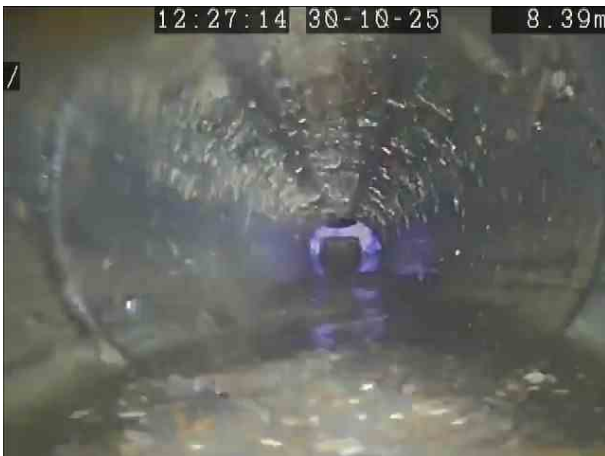
b17f079f-17da-4e3a-bfd1-0122a7252581.png, 00:00:27,  
8.39 m  
Water level, 20% of the vertical dimension

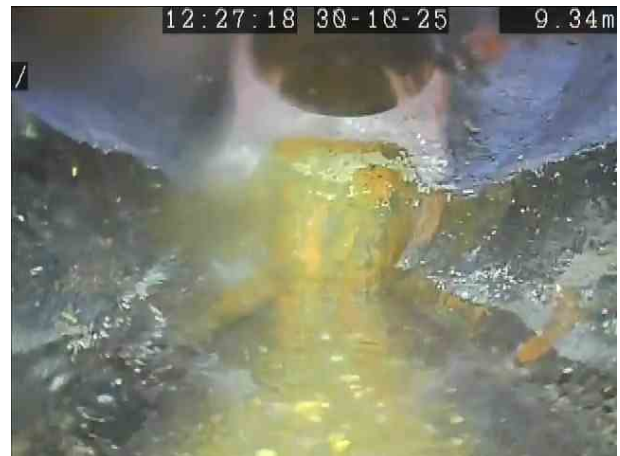
678ad3a0-3468-4057-adc5-0687f685243c.png, 00:00:30,  
9.34 m  
General remark, AT MH INTERCEPTOR

Excavate and expose the upstream drainage and install a new insulation chamber (IC), remove MH3 with interceptor trap.
