# **Window Condition Survey Report Yeomans Easton Royal SN9 5LZ**

**12 DECEMBER 2025**

**Heritage Window Consultancy Ltd**

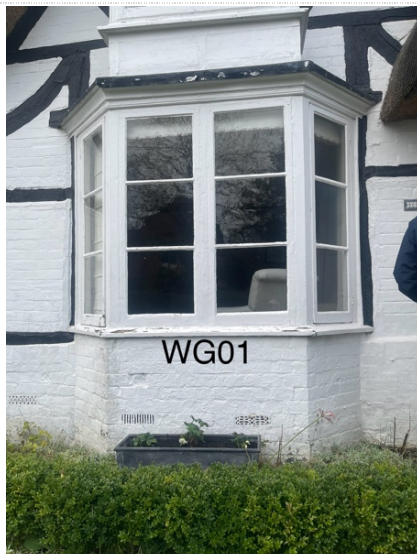
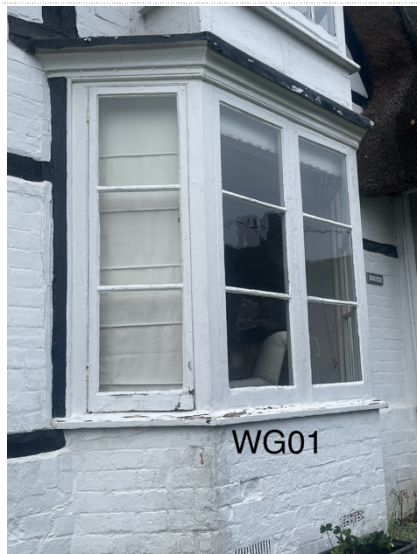
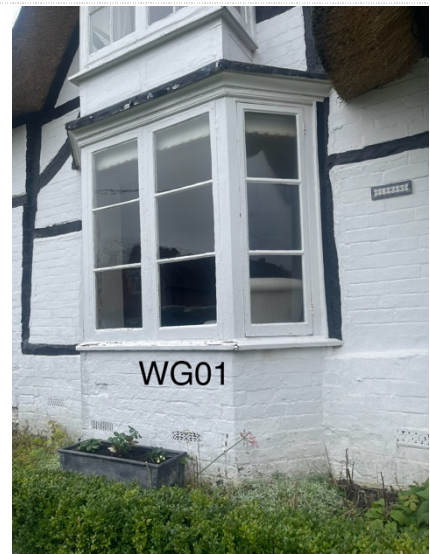
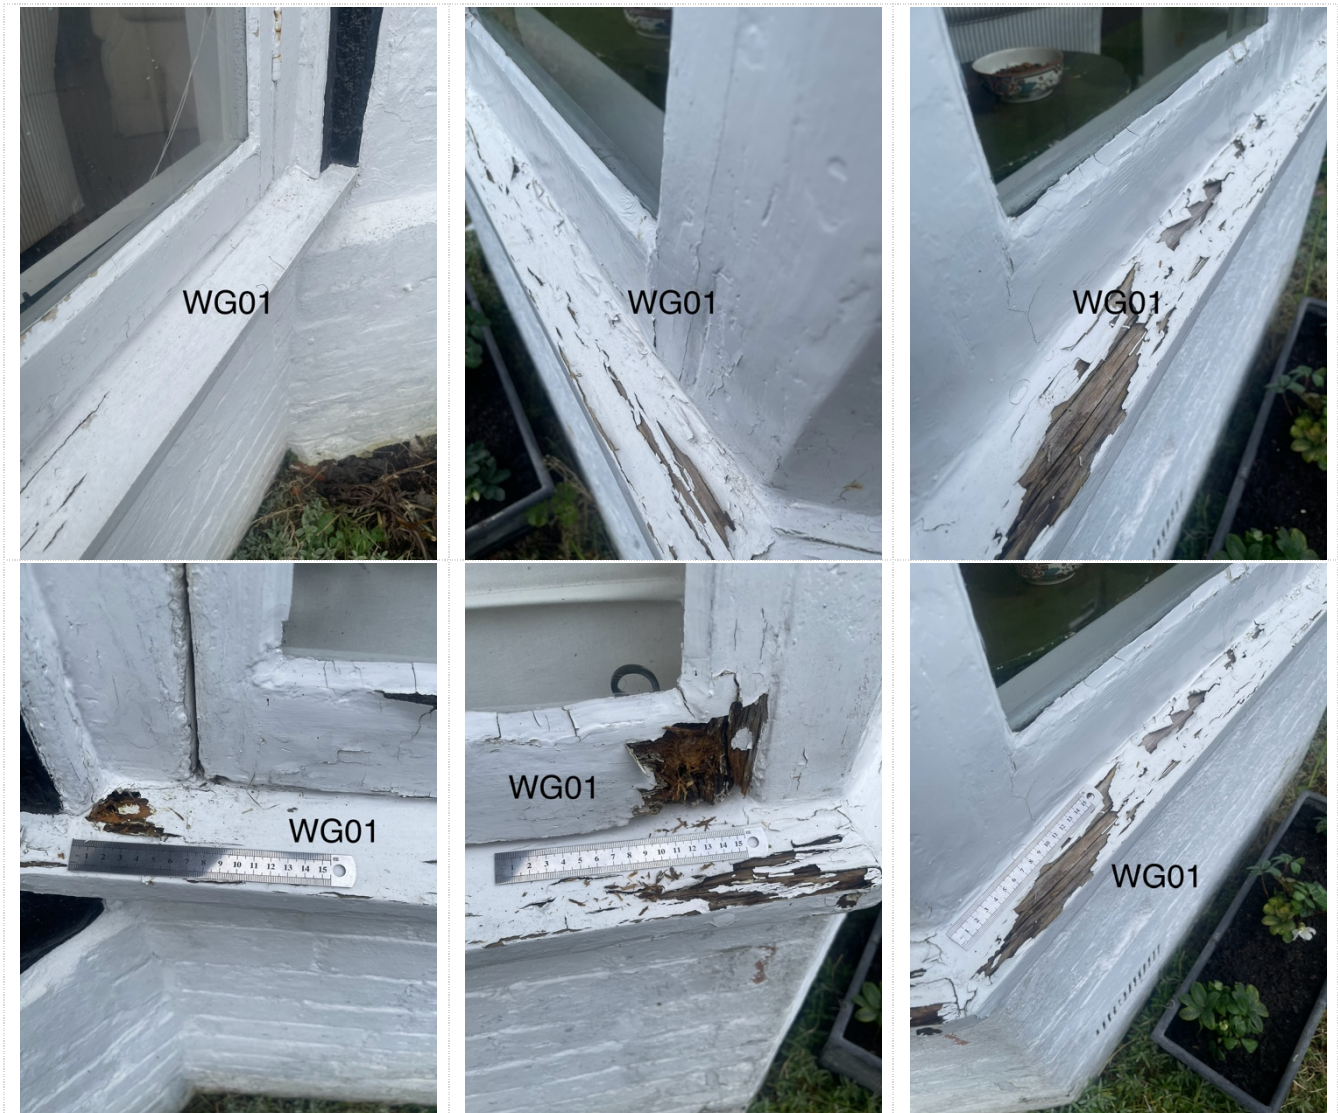
### WG01 – Ground Floor East Elevation

C20 canted bay window comprising four casement sections, each with three panes and 20mm chamfered glazing bars. Single glazed, predominantly with crown glass. The left- and right-hand casements are opening sections on side hinges with modern window furniture; the two central sections are fixed.

There is extensive timber deterioration in both the opening casement sashes and the fixed sections, primarily affecting the bottom rails and stiles. Areas of rot are clearly visible, and there is extensive use of filler in these locations. The glazing bars are also heavily filled.

There is further deterioration within the frame, with rot clearly visible in the cill sections. The mullions and side jambs are also heavily filled.

Any attempt to restore either the casement sashes or the bay window frame would result in very little original timber remaining once all rotten timber and filler are removed.

It is therefore not a practical or viable option to carry out restoration work.

Due to the poor condition of both the casement sashes and the bay window frames, it is recommended that each window is replaced with a hardwood timber replica.

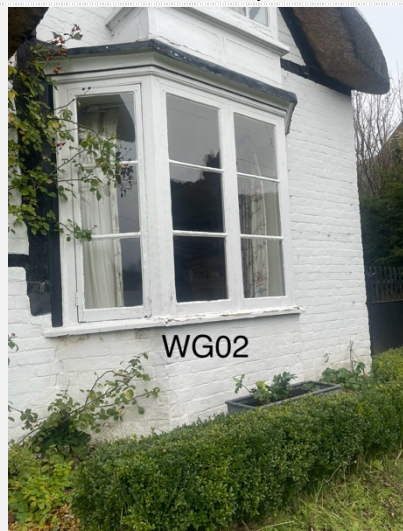
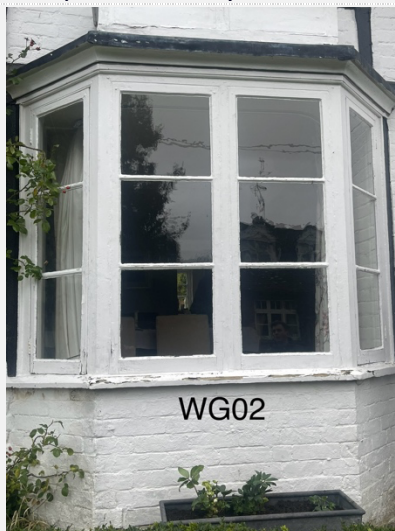
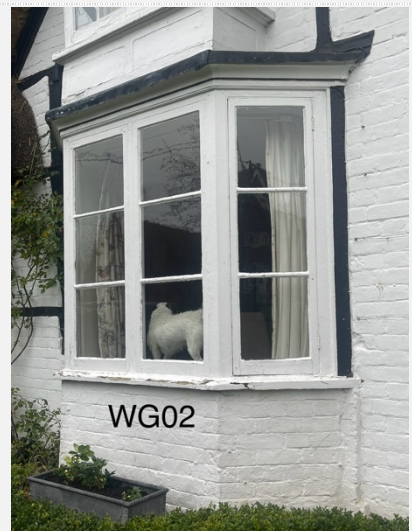
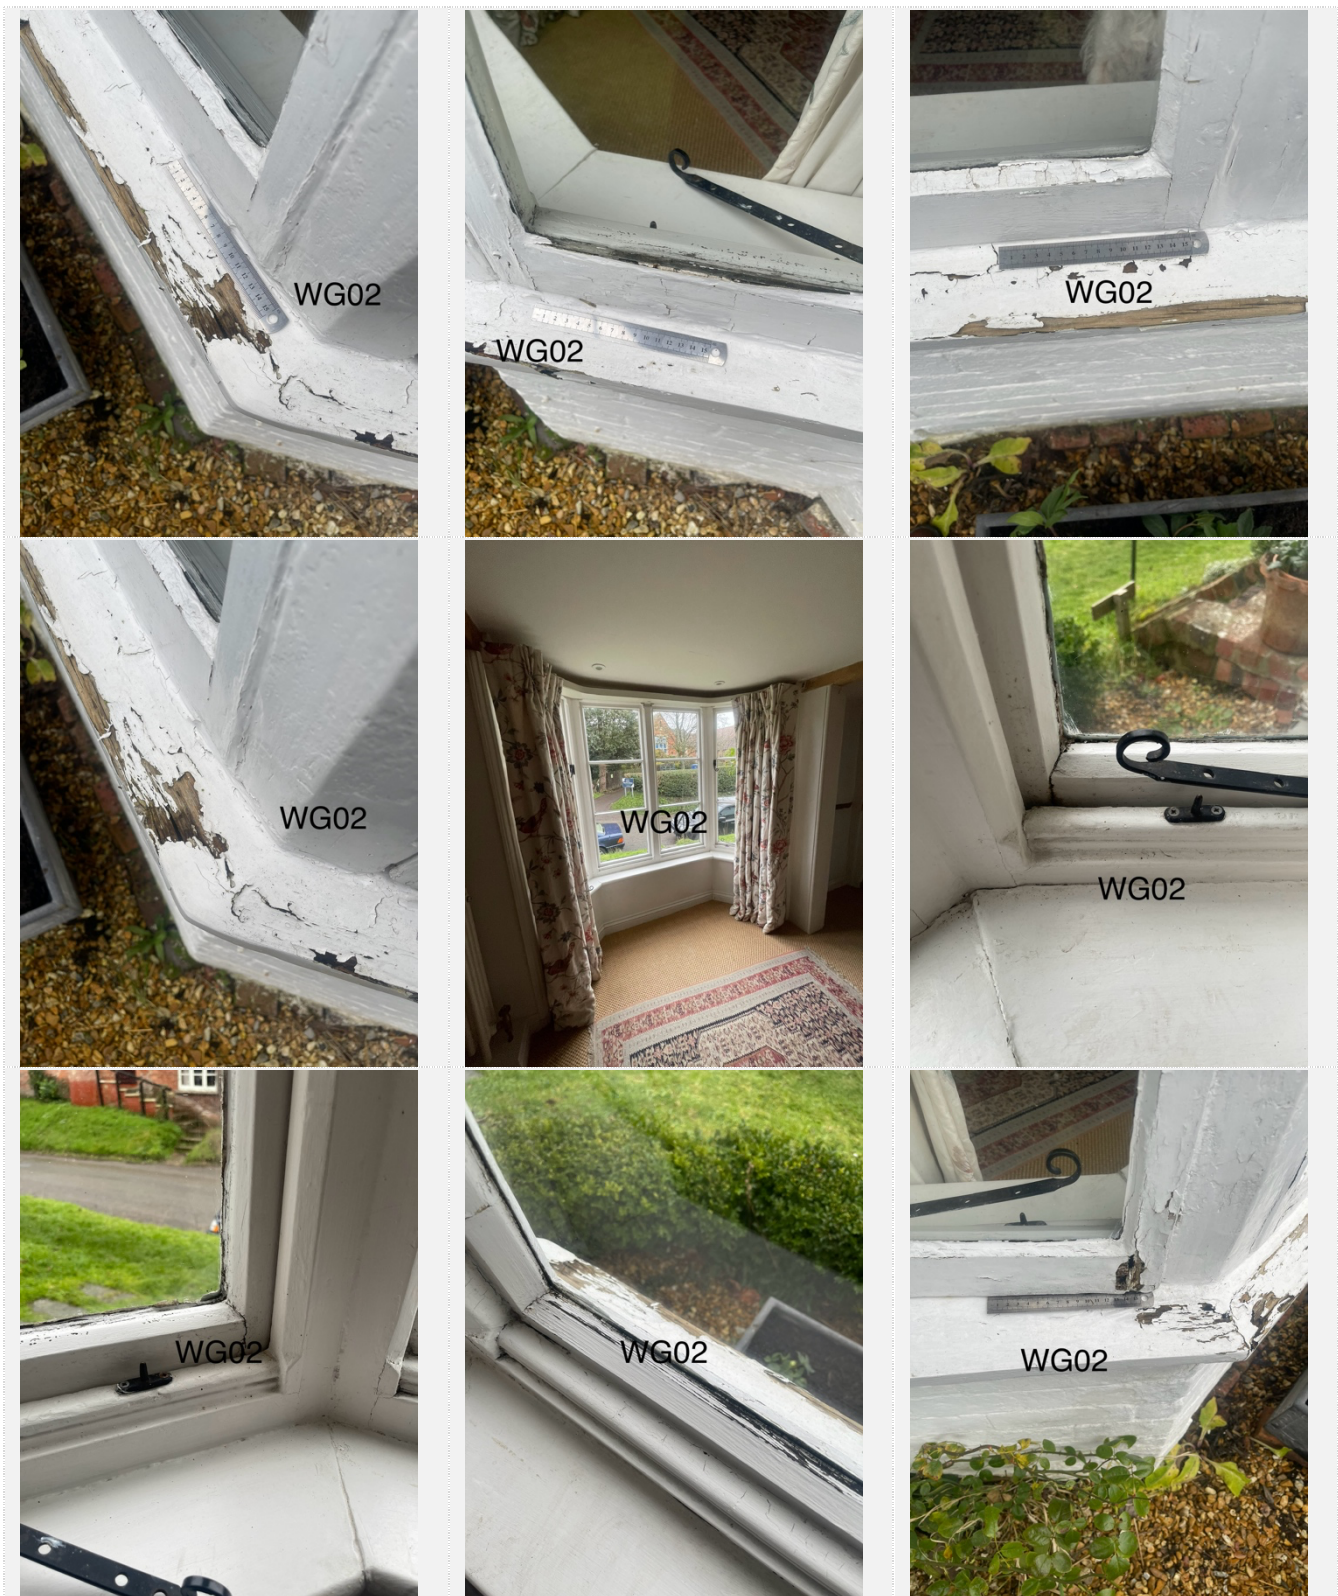
## WG02 – Ground Floor East Elevation

C20 canted bay window comprising four casement sections, each with three panes and 20mm chamfered glazing bars. Single glazed, predominantly with crown glass. The left- and right-hand casements are opening sections on side hinges with modern window furniture; the two central sections are fixed.

There is extensive timber deterioration in both the opening casement sashes and the fixed sections, primarily affecting the bottom rails and stiles. Areas of rot are clearly visible, and there is extensive use of filler in these locations. The glazing bars are also heavily filled.

There is further deterioration within the frame, with rot clearly visible in the cill sections. The mullions and side jambs are also heavily filled.

Any attempt to restore either the casement sashes or the bay window frame would result in very little original timber remaining once all rotten timber and filler are removed.

It is therefore not a practical or viable option to carry out restoration work.

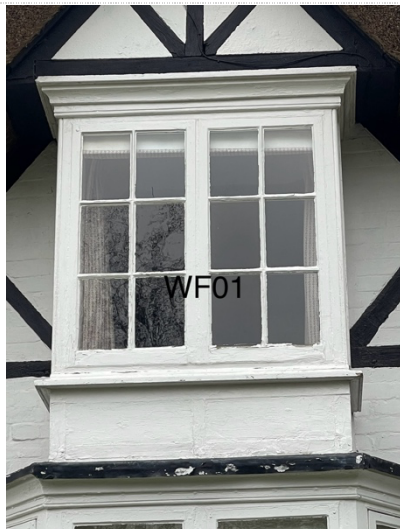
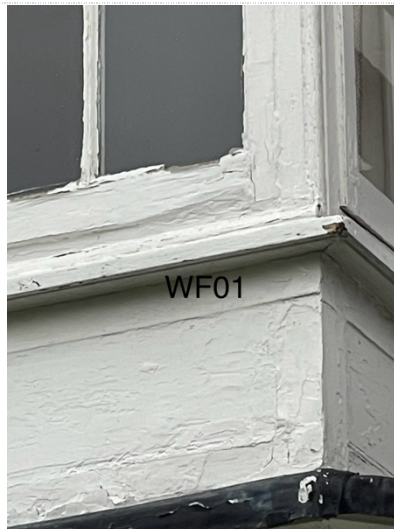
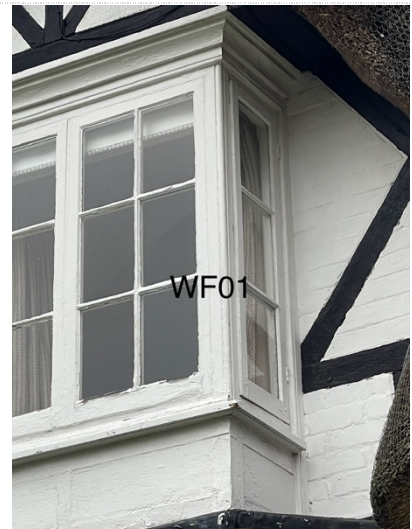
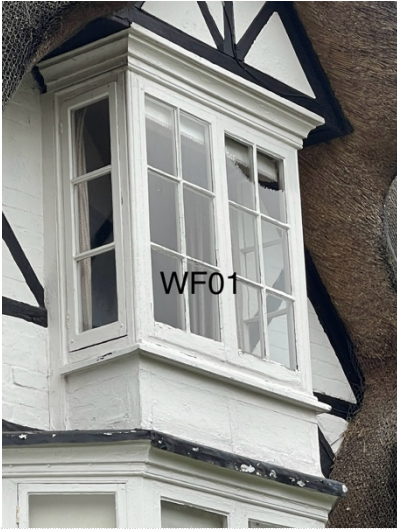
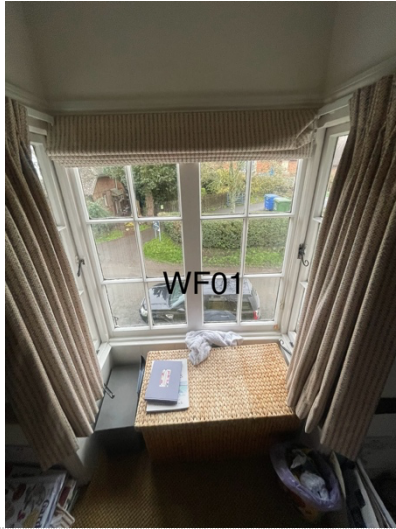
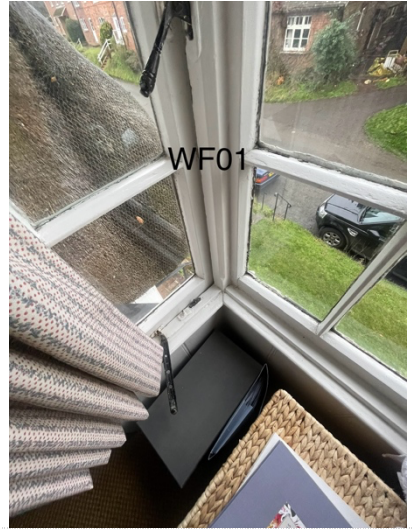
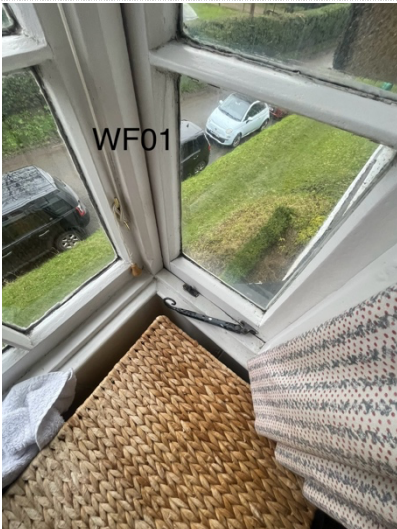
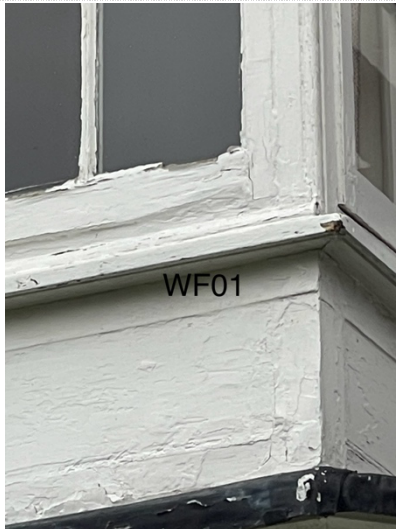
### WF01 – First Floor East Elevation

C20 boxed bay window comprising four casement sections. The left- and right-hand panels are side-hinged opening casements with modern window furniture; the two central panels are fixed shut. Single glazed, with a combination of crown glass and modern float glass across all sections.

There is extensive timber deterioration in both the opening casement sashes and the fixed sections, primarily affecting the bottom rails and stiles. Areas of rot are clearly visible, and there is extensive use of filler in these locations.

There is further deterioration within the frame, with rot clearly visible in the cill sections. The mullions and side jambs are also heavily filled.

Any attempt to restore either the casement sashes or the bay window frame would result in very little original timber remaining once all rotten timber and filler are removed.

It is therefore not a practical or viable option to carry out restoration work.

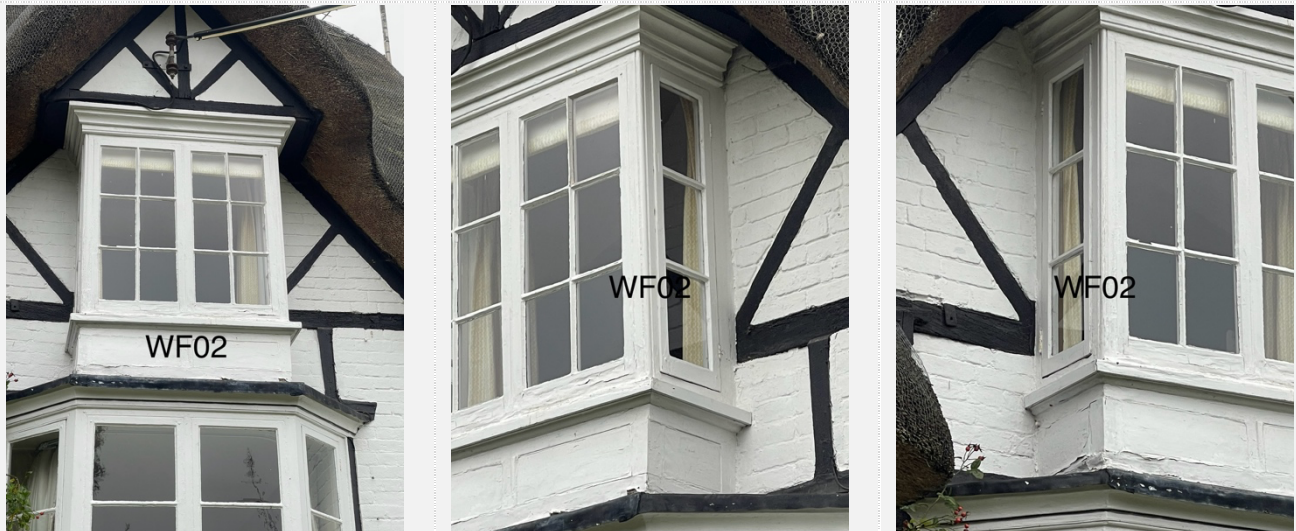
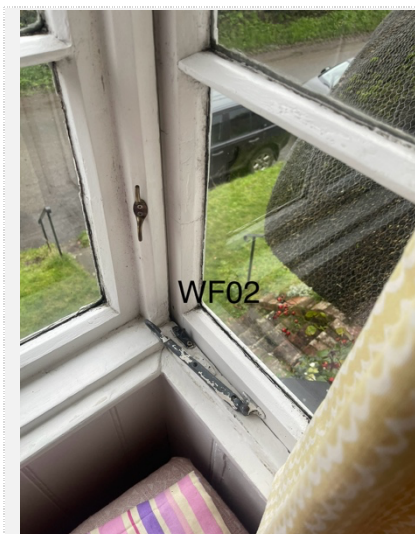
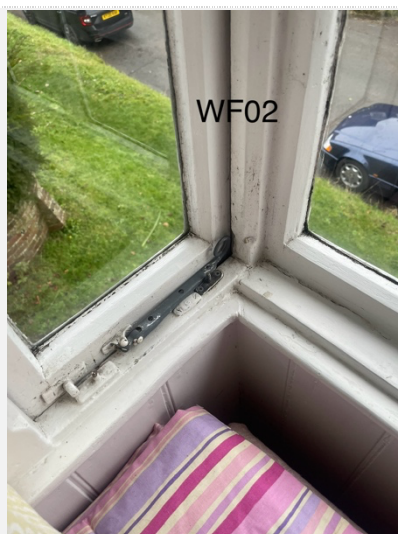
## WF02 – First Floor East Elevation

C20 boxed bay window comprising four casement sections. The left- and right-hand panels are side-hinged opening casements with modern window furniture; the two central panels are fixed shut. Single glazed, with a combination of crown glass and modern float glass across all sections.

There is extensive timber deterioration in both the opening casement sashes and the fixed sections, primarily affecting the bottom rails and stiles. Areas of rot are clearly visible, and there is extensive use of filler in these locations.

There is further deterioration within the frame, with rot clearly visible in the cill sections. The mullions and side jambs are also heavily filled.

Any attempt to restore either the casement sashes or the bay window frame would result in very little original timber remaining once all rotten timber and filler are removed.

It is therefore not a practical or viable option to carry out restoration work.
