# Arboricultural Consultancy for Prestige

| Insured | Mrs Karen Arnold | Address | Woods View, Lower Road, Devizes, Wiltshire, SN10 5UQ | | |
| Report Date | 22/08/2025 | | | | |

## for SMS (AVI, PRE)

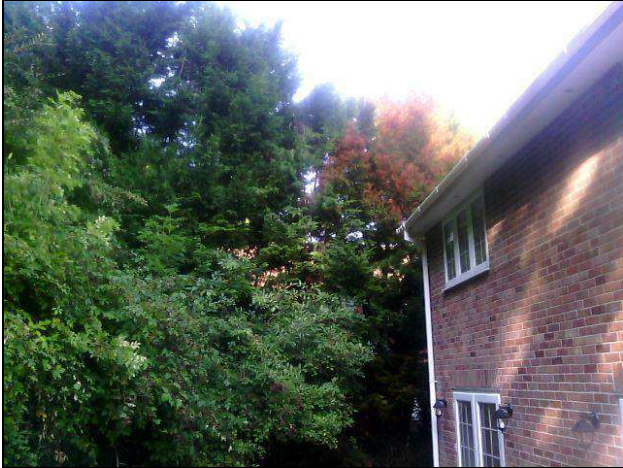
TG1 - Cypress

With due regards to species profile, size and proximity, TG1 (Cypress) is considered the dominant feature proximate to the focal area(s) of movement and accordingly, where vegetation is confirmed as being causal, we have identified it as the primary cause of the current subsidence damage.

| Tree No. | Species | Age Cat | Approx. Height (m) | Distance to Building (m) * | Ownership | Action | Requirement |
|---|---|---|---|---|---|---|---|
| TG1 | Cypress | 1 | 11 | 3 | E - Boundary Veg (ownership to be confirmed) | Remove | Remove section of group, close to ground level, to achieve 10m of clearance to the rear right corner of the property. Maintain retained section at, or below current dimensions by way of regular pruning. |

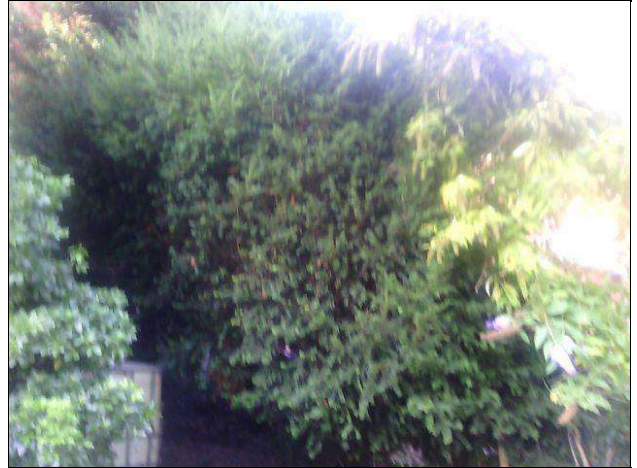
T1 - Yew

The mixed shrub group (SG1) and Yew (T1) cannot be discounted as contributing to the overall level of soil drying proximate to

the advised area of damage and are therefore also considered to be exerting a contributory influence, albeit in a limited / localised capacity when compared to TG1.

| Tree No. | Species | Age Cat | Approx. Height (m) | Distance to Building (m) * | Ownership | Action | Requirement |
|---|---|---|---|---|---|---|---|
| T1 | Yew | 1 | 3 | 3 | E - Boundary Veg (ownership to be confirmed) | Remove | Remove close to ground level and treat stump to inhibit regrowth. |

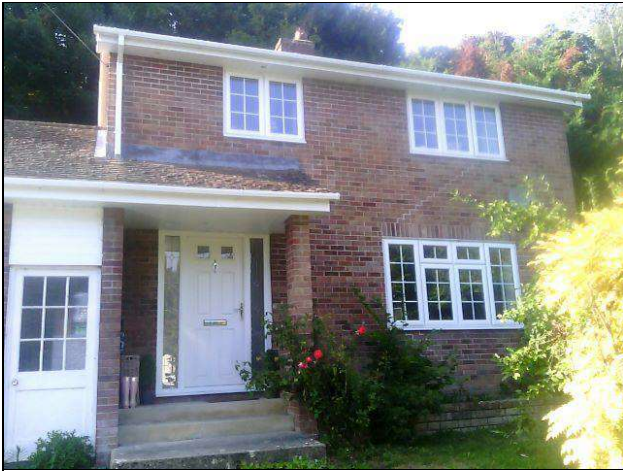
General site (front) showing TG1 to the right and W1 to the rear

| Tree No. | Species | Age Cat | Approx. Height (m) | Distance to Building (m) * | Ownership | Action | Requirement |
|---|---|---|---|---|---|---|---|
| W1 | : (woodland) comprised of broadly Acer, Ash, Birch, Hazel and Oak | 3 | 15 | 17 | D - Unknown | Action to avoid future risk | Maintain those trees within recognised influencing distance of the property (based on species, size and proximity) at, or below current dimensions by way of regular pruning so as to effectively mitigate subsidence risk. Any pruning undertaken should be in accordance with BRE IP7/06 and repeated on a 3-year (max) basis to be deemed as effective. Coppicing, pollarding and targeted / selective removal, followed by replacement planting with lower water demand species may also be deemed as appropriate. |

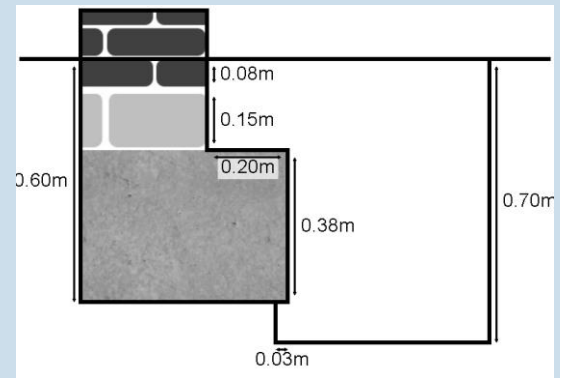
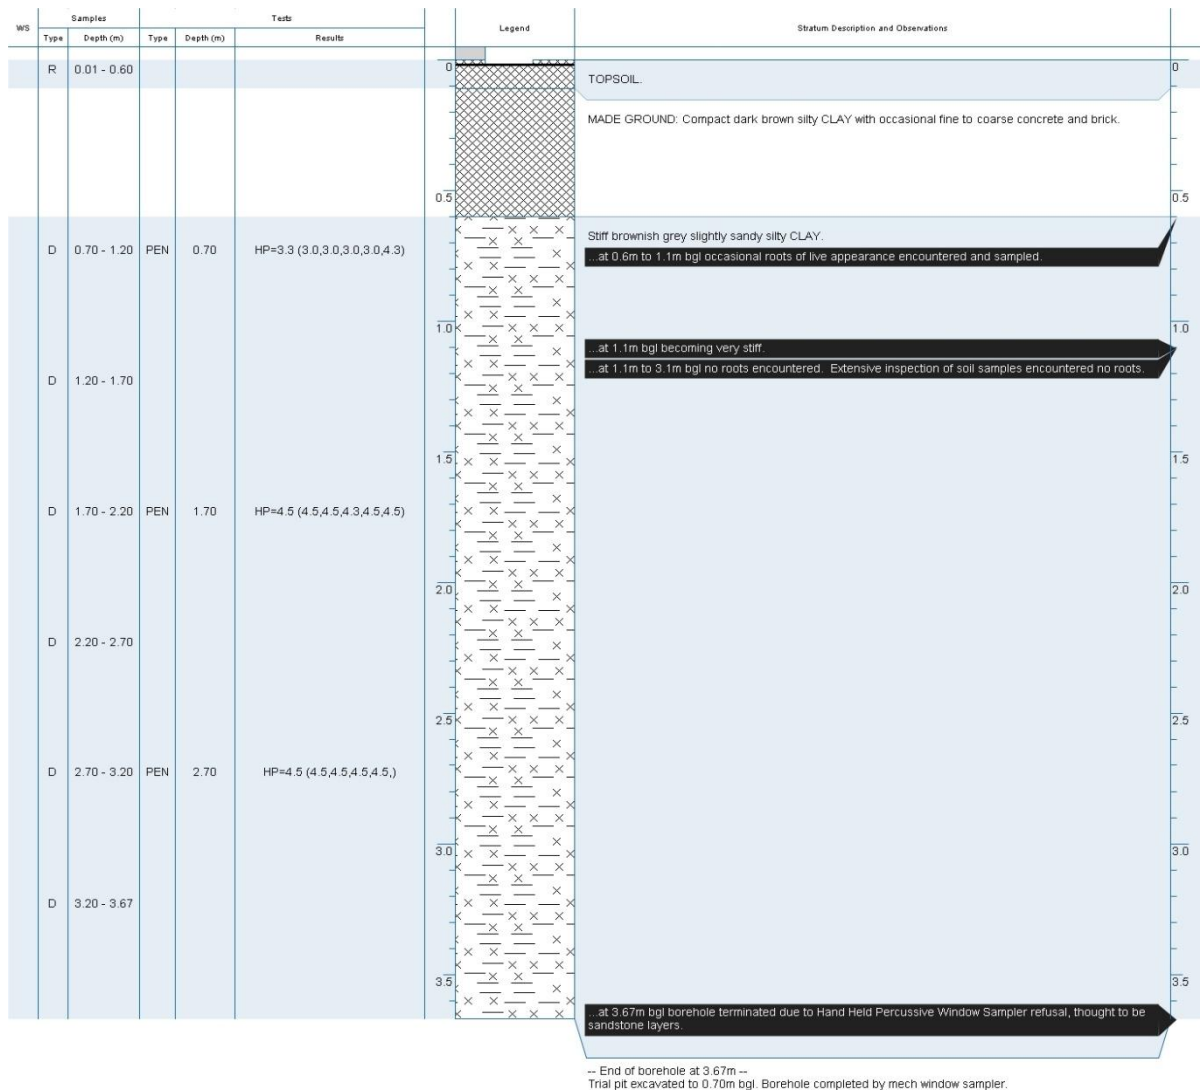
## TP/BH1 Foundation Detail and Borehole Log

House foundation comprised of brickwork to 80mm bgl, bearing onto blockwork to 230mm bgl, bearing on concrete to 610mm bgl, with a total projection of 200mm from the elevation. Underside of foundation (USF) was exposed to 30mm back from the face of the foundation and probed 220mm back from the face of the foundation.

At 3.67m bgl borehole terminated due to Hand Held Percussive Window Sampler refusal, thought to be sandstone layers in TP/BH1.

At 1.1m bgl becoming very stiff in TP/BH1.

At 0.6m to 1.1m bgl occasional roots of live appearance encountered and sampled in TP/BH1.

At 1.1m to 3.1m bgl no roots encountered. Extensive inspection of soil samples encountered no roots in TP/BH1.

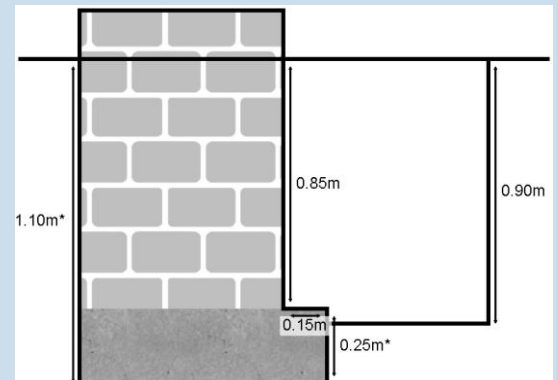
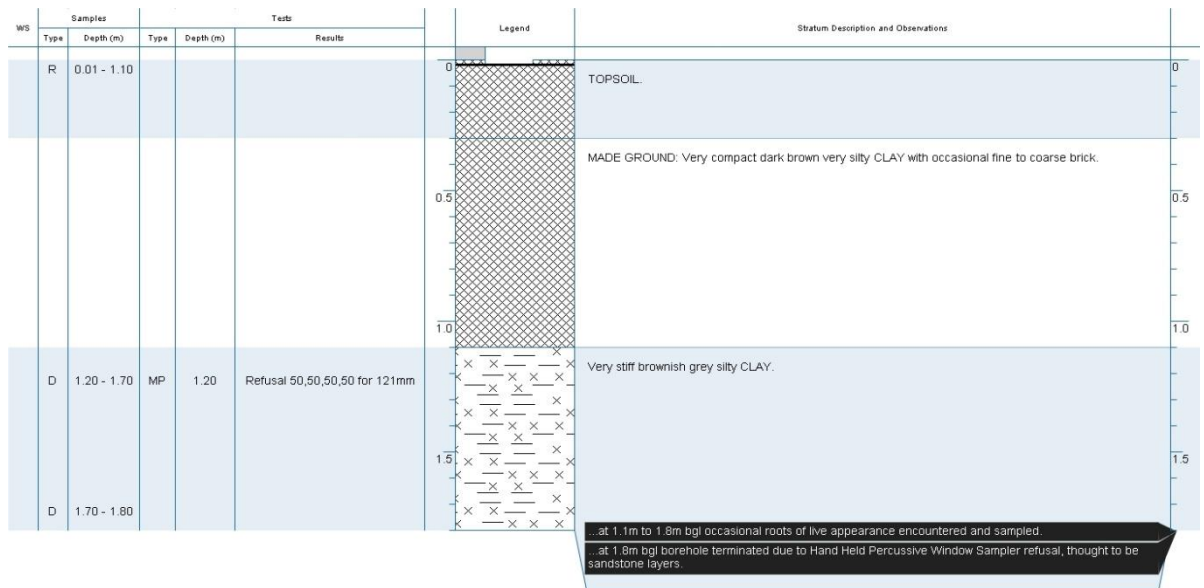
## TP/BH2 Foundation Detail and Borehole Log

House foundation comprised of blockwork wall to 850mm bgl, bearing on concrete to 1.1mm bgl, with a total projection of 150mm from the elevation. Underside of foundation (USF) was exposed to 0mm back from the face of the foundation and probed 175mm back from the face of the foundation.

At 1.8m bgl borehole terminated due to Hand Held Percussive Window Sampler refusal, thought to be sandstone layers in TP/BH2.

At 1.1m to 1.8m bgl occasional roots of live appearance encountered and sampled in TP/BH2.
