# Tree Pruning Specification

For a single beech tree near The Old Timber Yard

Instructed by the residents of  
No. 8 & 9 The Old Timber Yard  
Maiden Bradley  
BA12 7FE

Inspected and Prepared by Nick Baxter BSc(Hons) MArborA  
18<sup>th</sup> December 2025

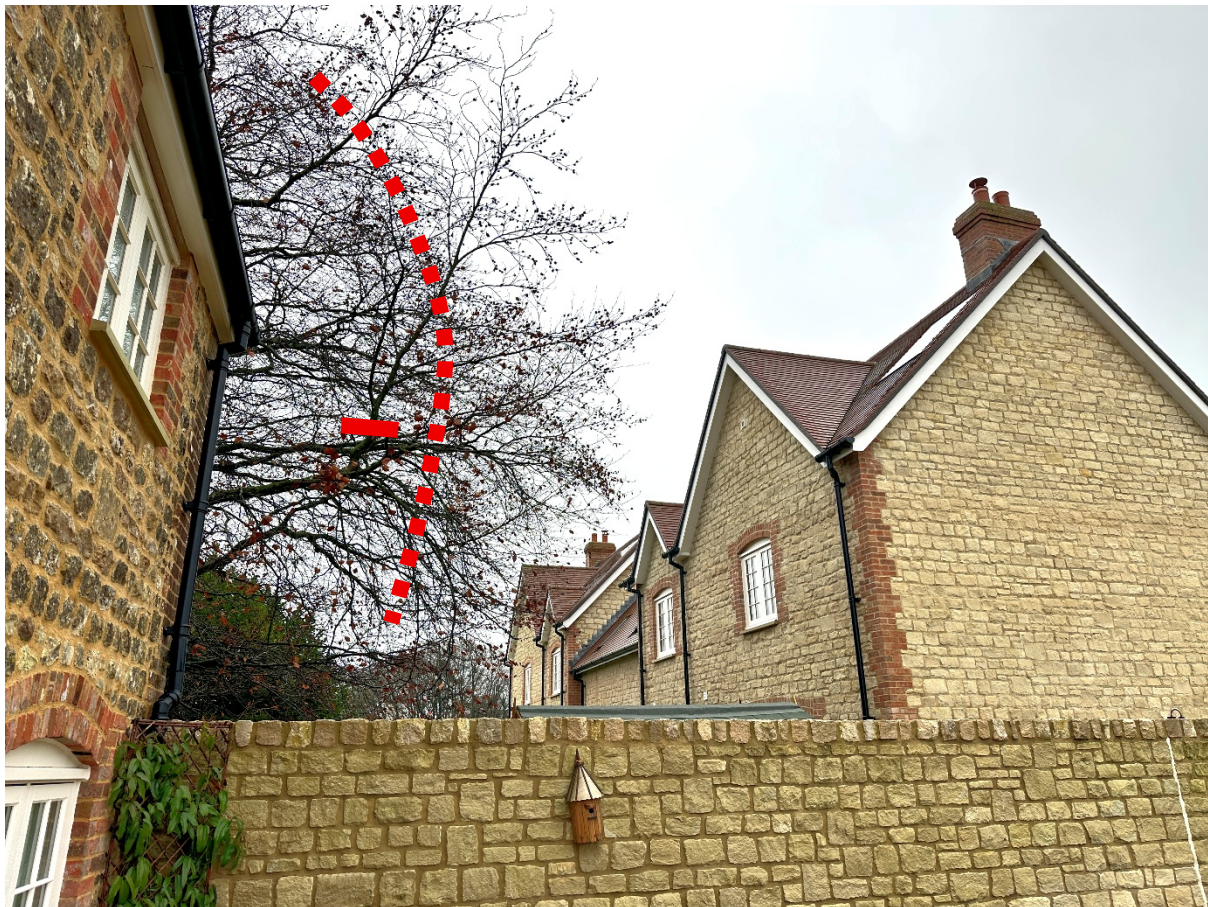
This tree is located in a neighbouring garden but overhangs the boundary wall into the garden of Cherry Tree Cottage and over the roof of Holly Cottage. A large secondary stem extends from a main union at 3m and a large limb extends north towards Holly Cottage, also from 3m. Past pruning is evident away from Holly Cottage but the surrounding foliage has now re-grown in close-proximity to the roof at the front and touches the roof to the rear. If left, there are increased chances of damage to the roof tiles from the adjacent branches in windy conditions. The whole canopy is full of buds which is a sign of high vitality.

**Figure 1:** Pruning illustration. Photo taken from Holly Cottage facing south towards Cherry Tree Cottage.

*“Reduce the tips of the western side by 1.5-2.5m (see Figure 1) and crown lift to 3m by pruning to the nearest branch junction over the boundary to provide a more substantial clearance from Cherry Tree Cottage and facilitate more light. Remove the tall upward shoot back to the scaffold branch on the north-western side at 4.5m (see Figure 1 & 2). Reduce the northern side of the crown (over Holly Cottage) by 2.5-3.5m to provide sufficient clearance from the roof of Holly Cottage (see Figure 2).”*

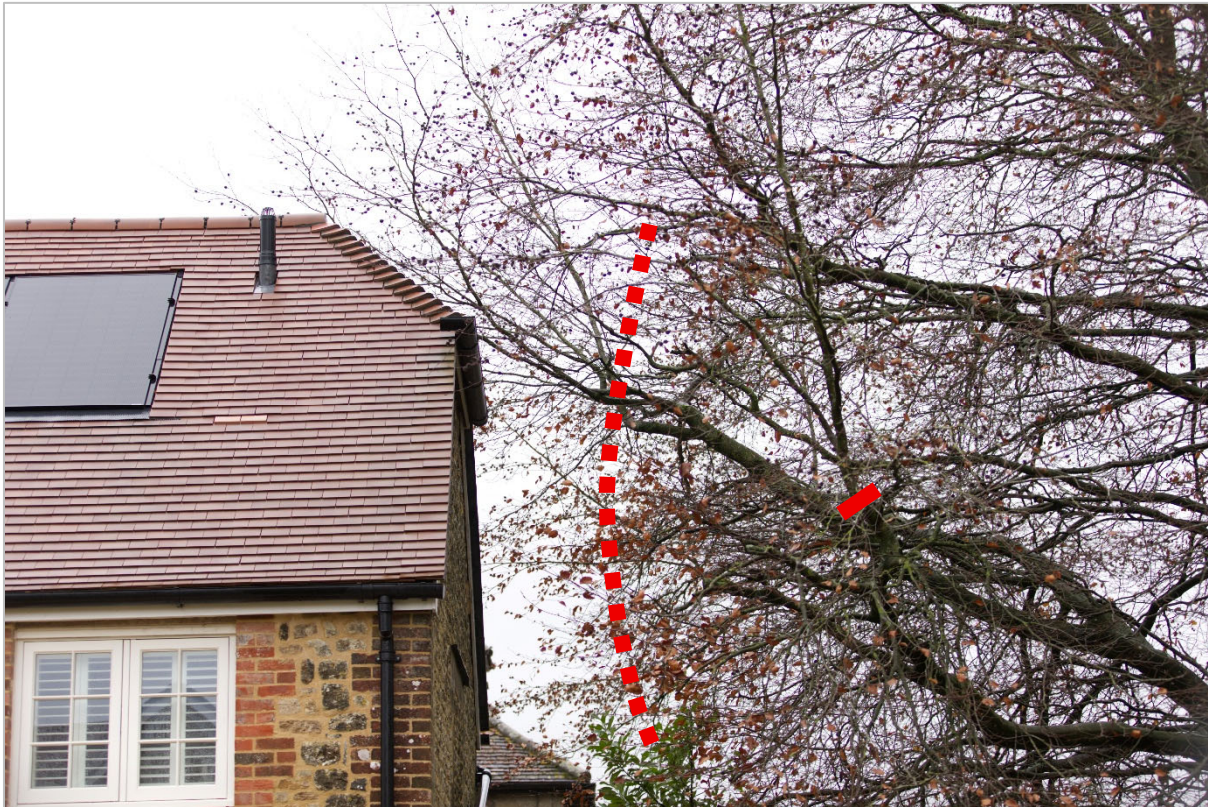
Figure 2: Pruning illustration. Photo taken from Cherry Tree Cottage facing east towards Holly Cottage,
