# Latchets, Malmesbury

## Structural Report

Project Reference: 2022-221

Document Reference: SR-01-005

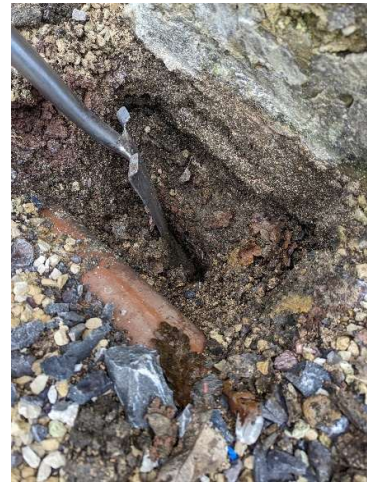
Figure 3: Photo of widened wall footing at trial pit location

The trial hole was dug to reveal that the wall simply appeared to thicken and was not formed on a concrete footing. This is to be expected of a building of this age. The footing was measured to be 250mm below external ground level and protruding 100mm from the wall above. The exact depth of the footing could not be determined on site as the hole could not be dug much further. The exposed footing showed a depth of 100mm but appeared to extend further below ground. Below is a summary sketch of the foundations found on site.

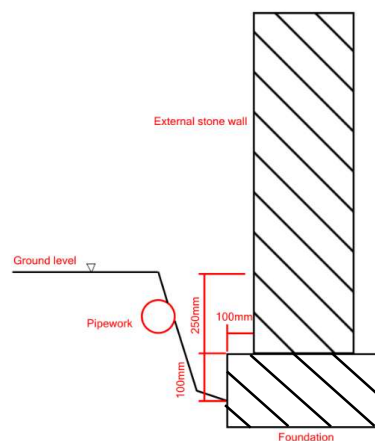
Figure 4: Sketch to illustrate foundation.

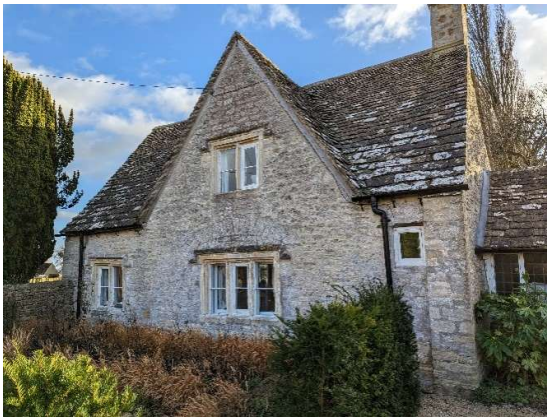
The external walls appeared to be in a relatively good condition. The structure formed of stone and what is assumed to be a cement-based mortar showed no obvious signs of cracking or bowing of the wall. Some areas of the wall looked as though they had been repaired with a concrete-based mortar which may have been where cracks had previously appeared. It was noted that the rear face of the property had areas of ivy growing up the wall. Although not an immediate danger to the structure, the ivy should be kept trimmed and not allowed to overgrow substantially. In some cases, ivy can penetrate the mortar within walls and begin to loosen brick or stonework.

*Figure 5: Photo of smaller front gable*

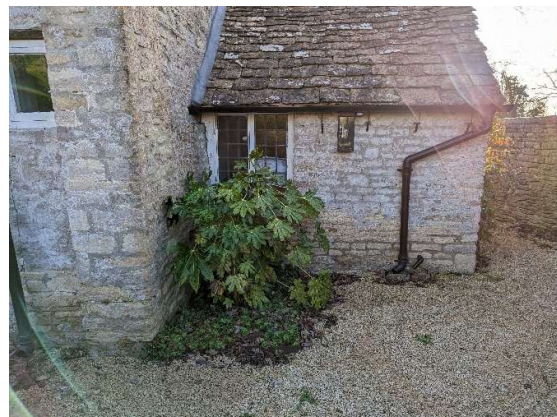
*Figure 6: Photo of single-story side structure*

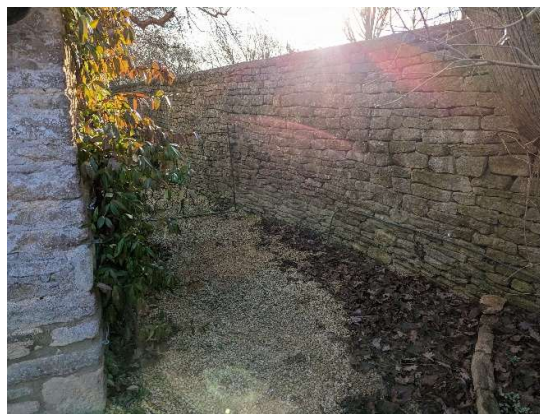
To one side of the property, a dry-stone wall was inspected. This wall separates the property from the neighbouring school and was roughly 2.2m high. At the time of the inspection, the wall appeared to be in a good condition with no obvious signs of deflection or cracking.

*Figure 7: Photo of boundary wall*

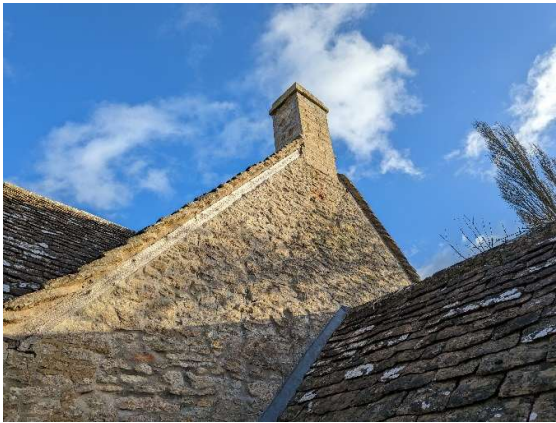
As previously stated, the roof comprises of multiple pitches which form the two side gables, as well as the smaller front and rear gables. The tiles all appeared to be in a good condition with no obvious signs of any that had fallen away or broken. Often in properties of this age, it is common to see slight deflections in the roof structure externally. However, the roof on this property showed no obvious signs of such and is considered to be in a good condition, with some areas showing signs of lichen. The roof structure was reconstructed within the 1970's which is likely the reasoning for its good condition.

*Figure 8: Photo of gable end*

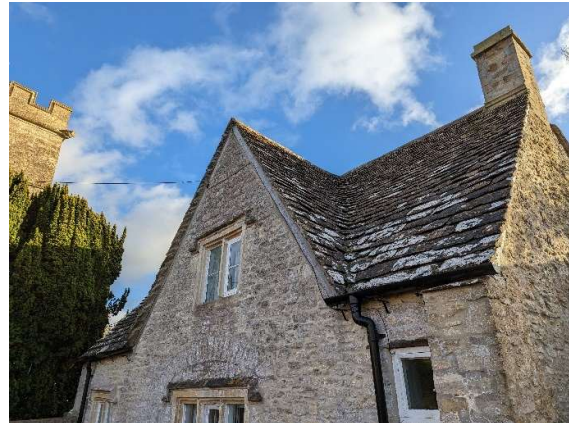
*Figure 9: Photo of front gable and roof structure*

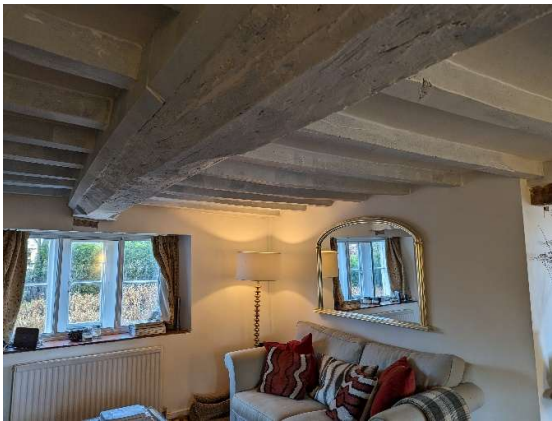
Figure 10: Photo of first floor joists and main timber beam

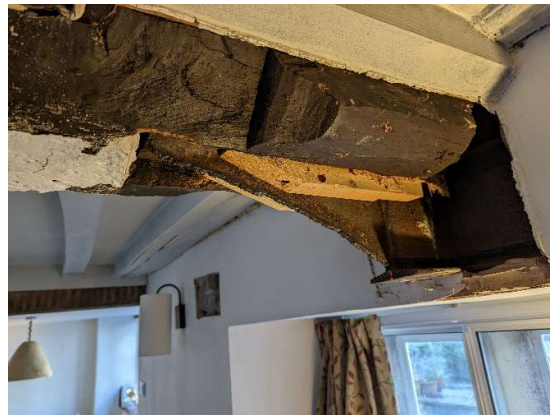
Figure 11: Photo of timber beam steel end connection

How this connection is working, was not clear on site and further opening up works would be needed to confirm the exact nature of the support. The oak timber beam was measured to be approximately 300mm wide and appeared to deflect slightly over its length but would not be deemed excessive. The other end of the oak beam, which sat upon the opposing window, had been opened up slightly, to reveal what looked like a concrete lintel.

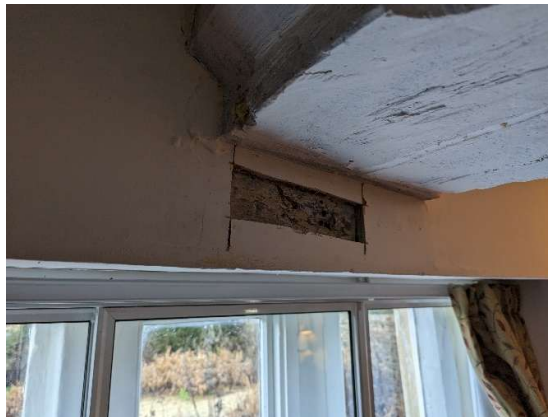
Figure 12: Photo of timber beam on concrete lintel

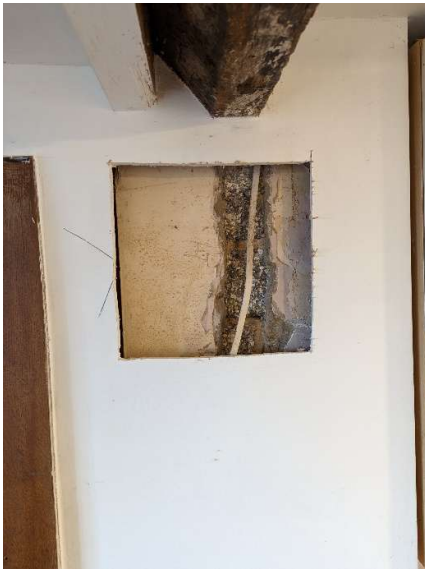
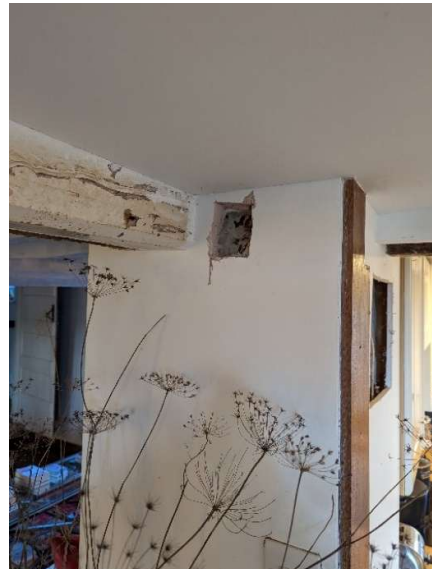
*Figure 13: Photo of kitchen partition wall*

*Figure 14: Photo of kitchen partition wall*

The main structural change at ground floor is to remove a part of the buttressing wall which separates the kitchen area from the living space. This wall supports the timber floor joist above, as well as the timber trimmer at the other end of the wall. To compensate for this, the wall, should it be taken down to a lower level, will need to be replaced with a structural beam. This may be in steel and clad in timber or a large timber beam may also work. It is recommended that this wall is not removed entirely. This is due to the fact that it is the only buttressing wall along the entire length of wall. Removing it completely may cause the external wall to bow and/or crack. An analysis can be done to confirm this. A post or frame may be designed to compensate for this.

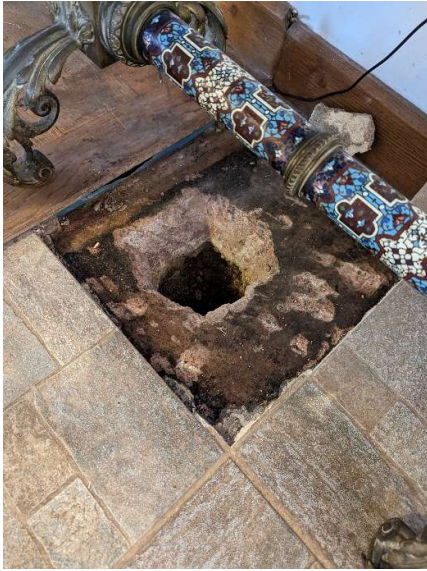
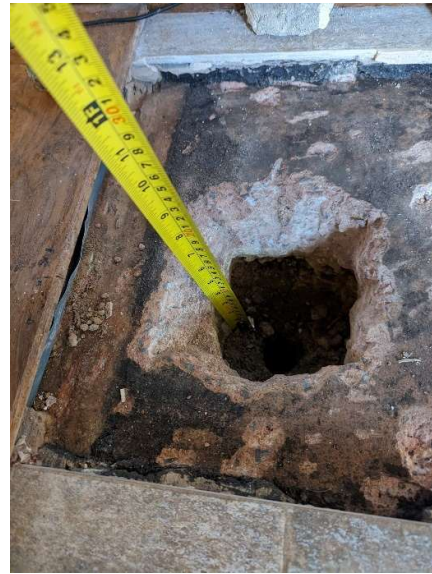
Within the dining room area, a section of the floor had been exposed to show that it was 120mm thick and formed with concrete. There appeared to be no signs of steel within the ground bearing slab. The ground beneath the slab could be seen and was 390mm deep and comprising a soft clayey material.

Figure 15: Photo of ground bearing slab

Figure 16: Photo of ground bearing slab

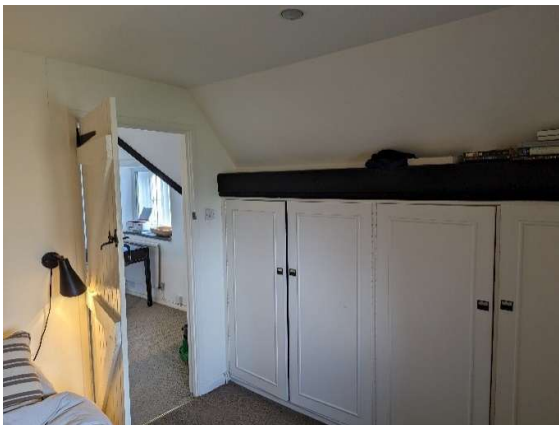
Figure 17: Photo of exposed purlin at first floor

These purlins form the main support of the roof structure as well as tying the rafters together. They appeared to be in a good condition with no signs of rot or excessive deflections.

At first floor, the timber stud walls may be removed and are not deemed to be part of the building structural stability. Exposed timber purlins which have been noted to be removed will need further intrusive inspections to assess if they are load bearing. If found to be only visual, then they may be removed without compromising the roofs structure. The new dormer window may be introduced onto the existing roof structure, providing this does not impact the existing ceiling joist layout. This will also require confirmation of the existing exposed purlins to confirm if they can be removed. New valley beams will be required to support the dormer walls.

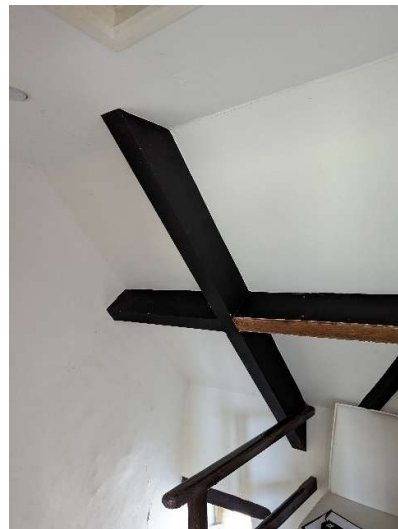
Figure 18: Photo of exposed purlin at first floor above staircase

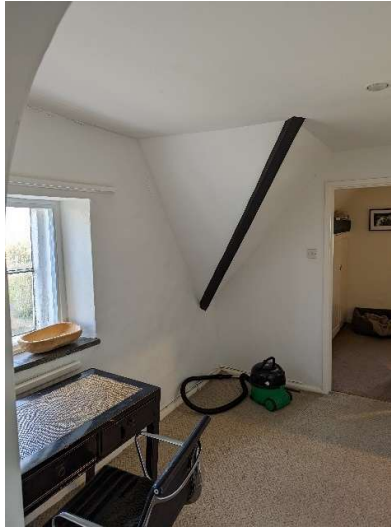
Valley beams which formed the front and rear gables were also exposed and measured to be 195mm by 75mm. Once again these appeared to be in a good condition.

*Figure 19: Photo of exposed valley beam*

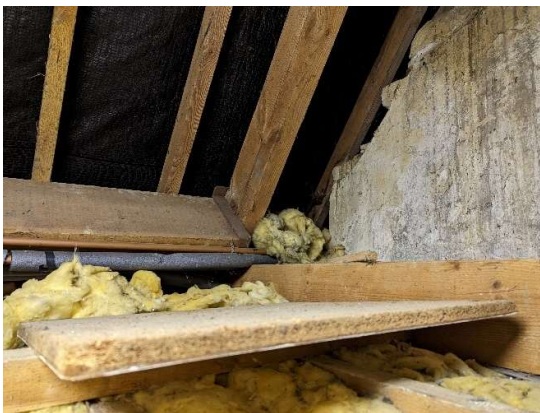
*Figure 20: Photo of principle truss and purlin within loft*

In general, the roof appeared to be constructed more recently than the structure below. The ceiling ties, rafters, principal trusses and purlins all appeared to be in a good condition and showed no signs of rot or obvious deflections. However, as stated previously only one end of the roof structure could be assessed as there was no access to the opposite end.

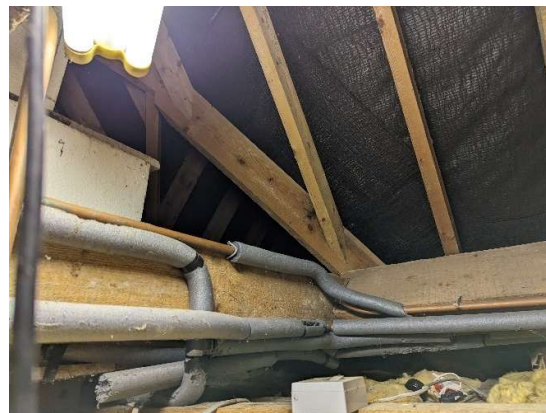
*Figure 21: Photo of principle truss, purlin and valley beam within loft*

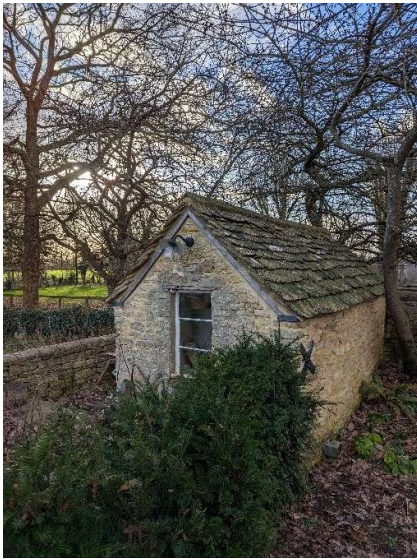
*Figure 22: Photo of small outbuilding*

The final proposed alteration is the outbuilding. The proposed alterations, structurally appear suitable and would likely be formed on a raft slab. However, to form gain any additional headroom within the structure, the roof would either need to be raised or the floor lowered. Lowering the floor, would not be recommended as doing so would require underpinning to the existing structure which may impact on the boundary wall which surrounds the structure.

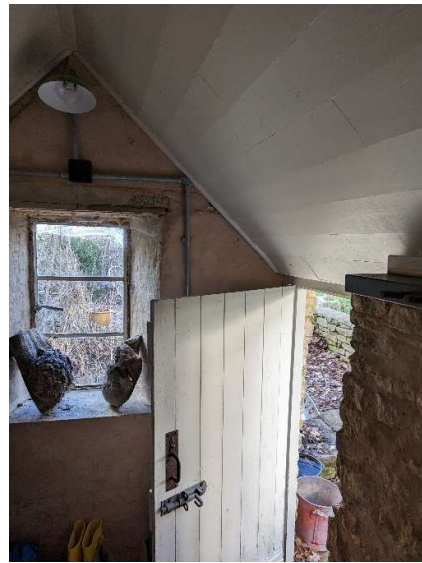
*Figure 23: Photo of internal area within small outbuilding*
