**Historic Building Impact Assessment  
Historic Door Restoration, Bourne Hill House  
Bourne Hill, Salisbury, Wiltshire**

November 2025  
Reference: 25984

**Historic Building Heritage Impact Assessment**

**Wiltshire County Council  
Country Hall,  
Bythesea Road,  
Trowbridge,  
BA14 8JQ**

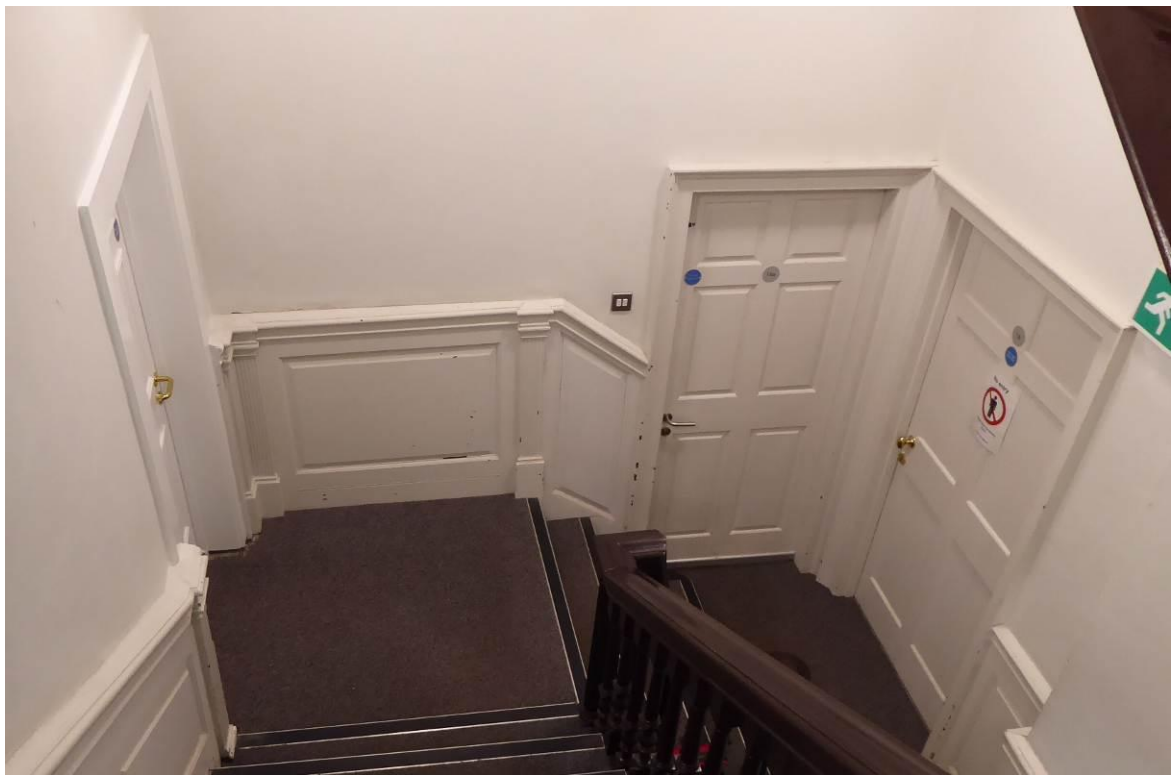
- 2.1.3 The subject of this assessment is a fire door, which is located inside the southwest wing of the historic part of the house on a landing between the lower and higher ground floors to one of the principal staircases and provides access into office N° 0/049.

Fig 2.1.3: Door position (changed door left)

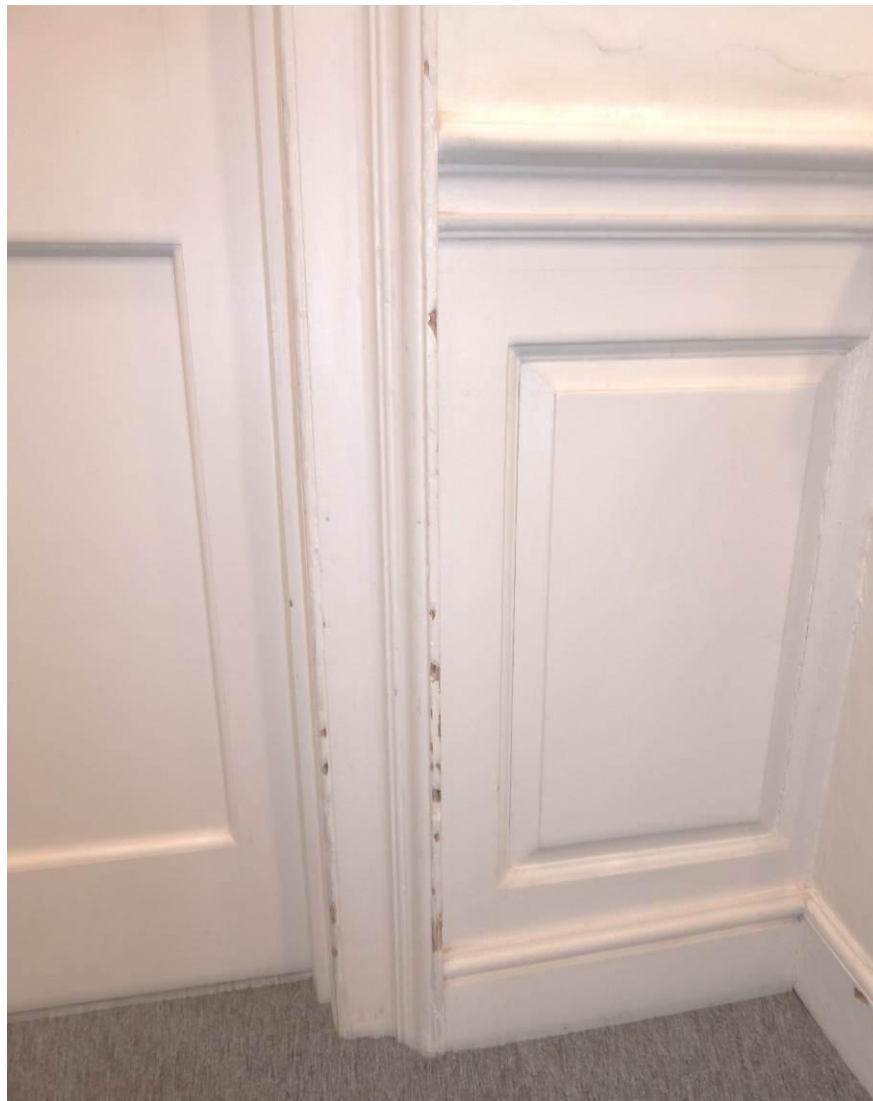
Fig 2.2.1: Timber panelling and typical door lining

- 2.2.1 The original door was a painted timber six panel door with raised and fielded panel hung with a door case lining with wide painted timber facings to the walls on both sides with projecting architraves of a late 18th or early 19th pattern. On either side

of the door opening there is painted timber dado panelling of a matching appearance and style.

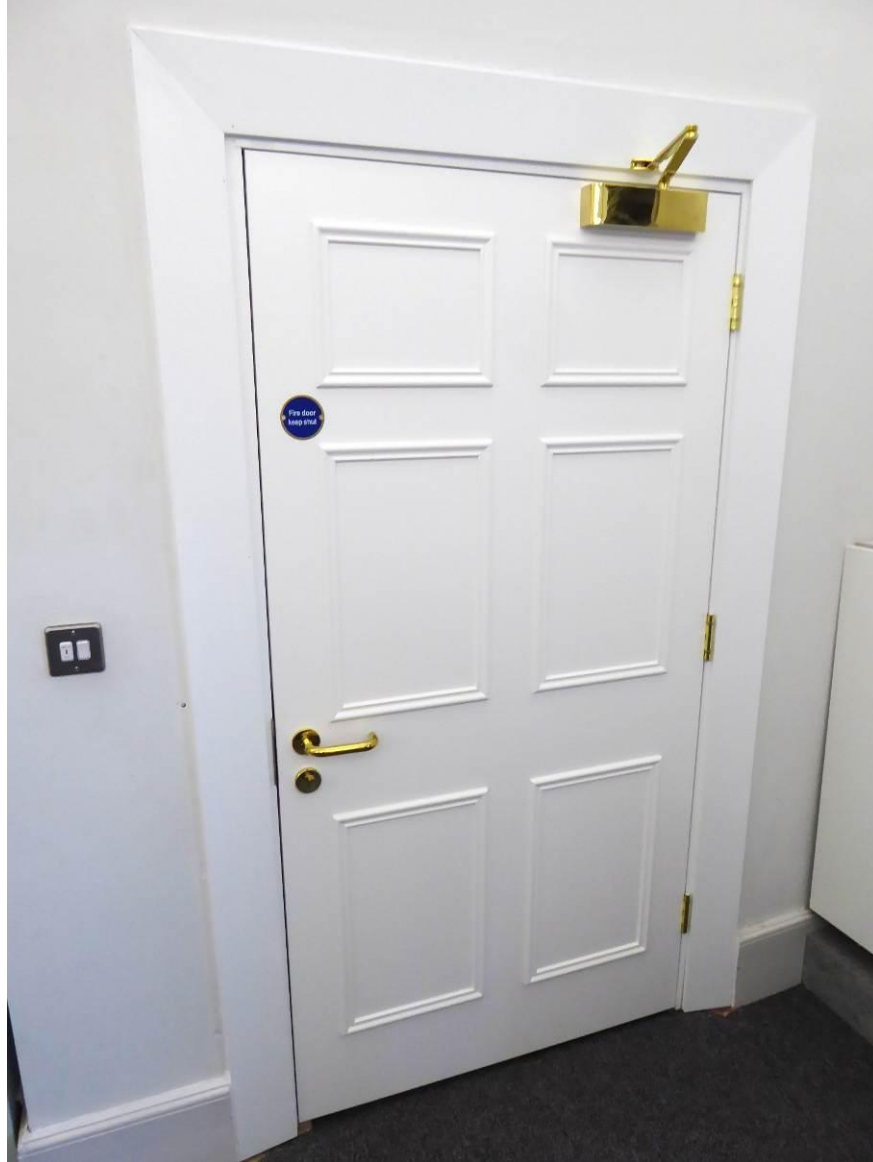
Fig 2.2.2: Unauthorised door

- 2.2.2 The door to this office was subject to unauthorised removal and disposal by a company as part of a fire safety works. This entailed removal of the door, the surroundings and the widening of the opening so as to be able to fit a standard blank fire door. This had nominal decorative beading applied to the external face in an attempt to simulate the panelling of the original door. The adapted opening was fitted with a plain white, apparently plastic, architrave type surround as, at

best, a token to replicate that which had been removed. The ironmongery that was fitted to this door is of a totally different colour, style and character of that to the existing doors. The result is an installation that has an appearance that does not relate to any other door installation in this locality and of a style is out of character that is alien to this historic building.

- 3.1.1 The proposal seeks to restore the unauthorised change with a replacement door of a traditional six-panelled timber door, as well as new door case and lining within an opening that will be adjusted in width to what it was originally. This replica is based on measurements of an adjacent similar door, together with its lining and architrave. The aim is to restore this opening to appearance and functionality as it was before this work altered.

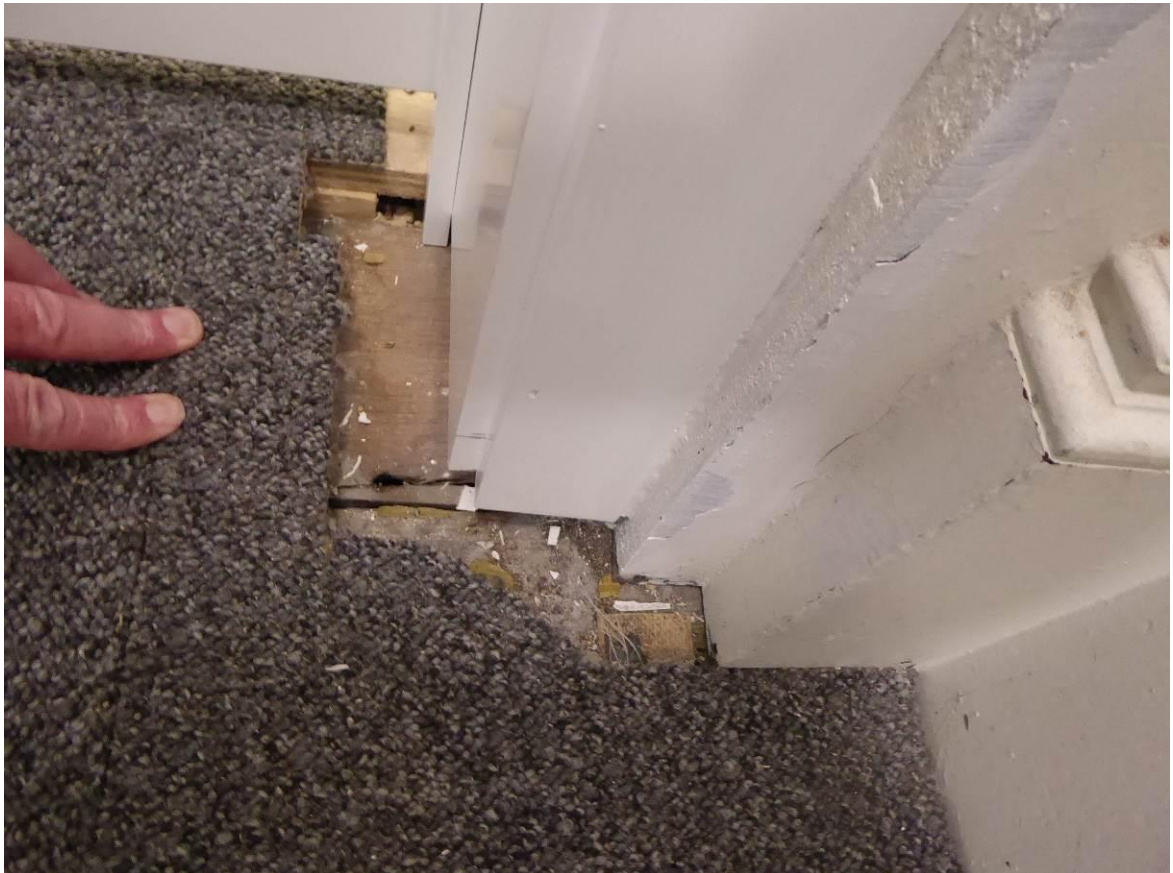
Fig 2.2.3: Widened door opening and lining change

- 2.2.3 On either side of the opening, where fitted carpet has been installed through it, the outline of the original door lining as well as its width can be seen. This clearly shows the widening of the opening that took place as the difference in the style of the original, compared to the replacement, door linings.

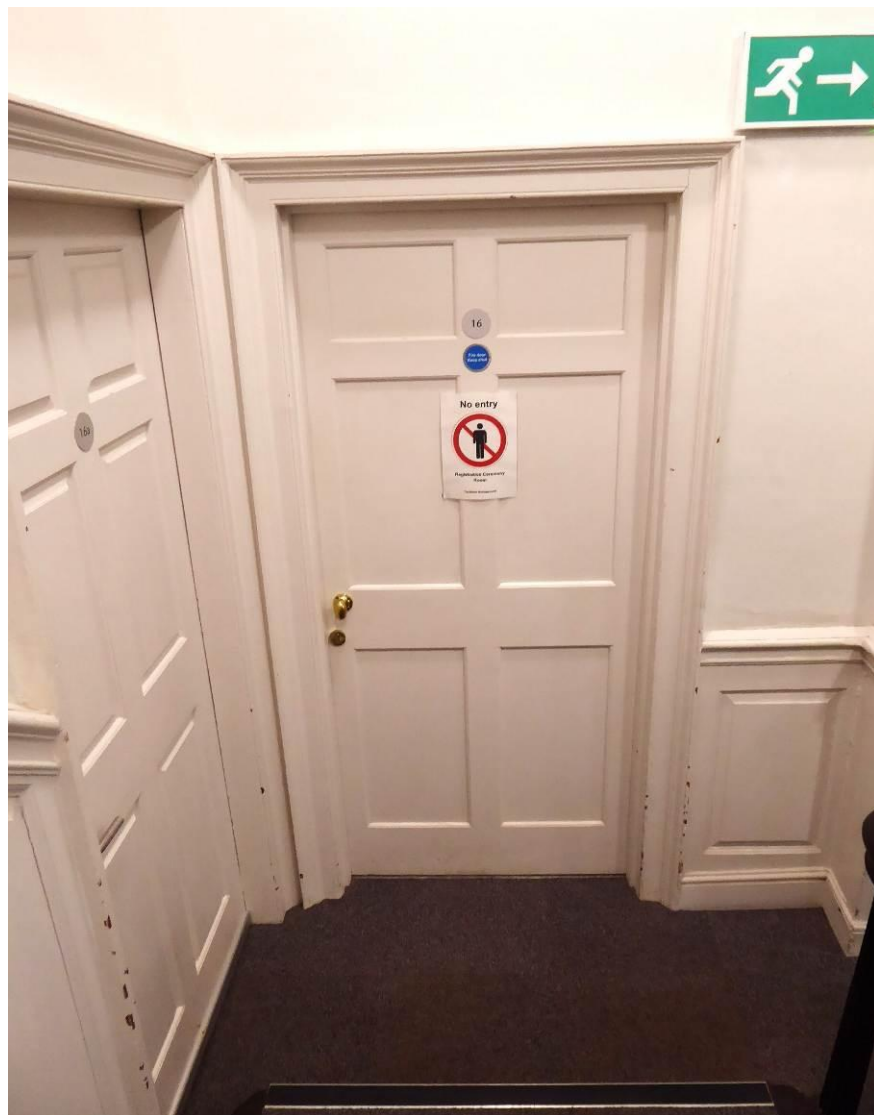
- 2.2.4 There are two other doors in the immediate vicinity that are traditional six-panelled timber units, where one has a more detailed panelling than the other, and both have the same form of linings and architraves to the openings. Both are classed as fire doors and painted white.

Fig 3.1.1: Adjacent fire doors and wall panelling

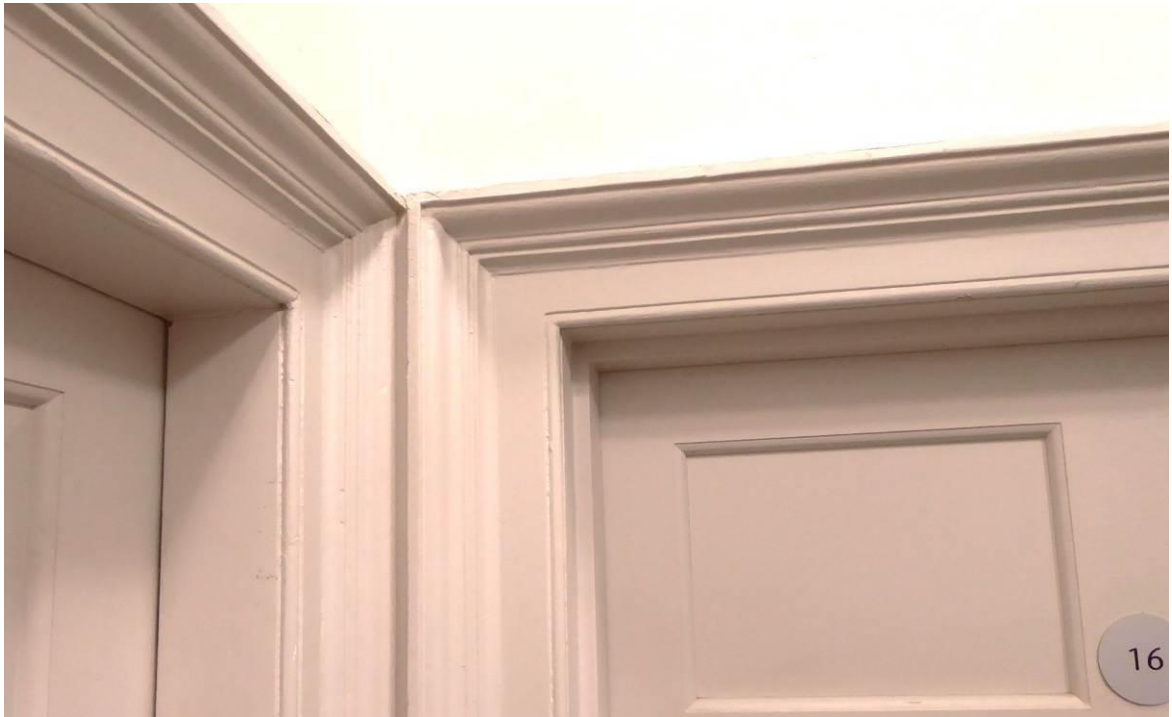
Fig 3.1.1: Original pattern door linings and architraves
