# **Tree Condition Report**

**Somerhill Care Home  
Little Somerford  
Nr Malmesbury SN15 5BH**

**Tim Pursey**  
**MICFor, M.Arbor.A., Dip.Arb.(RFS), Tech.Cert.(Arbor.A.)**  
**Chartered Arboriculturist**

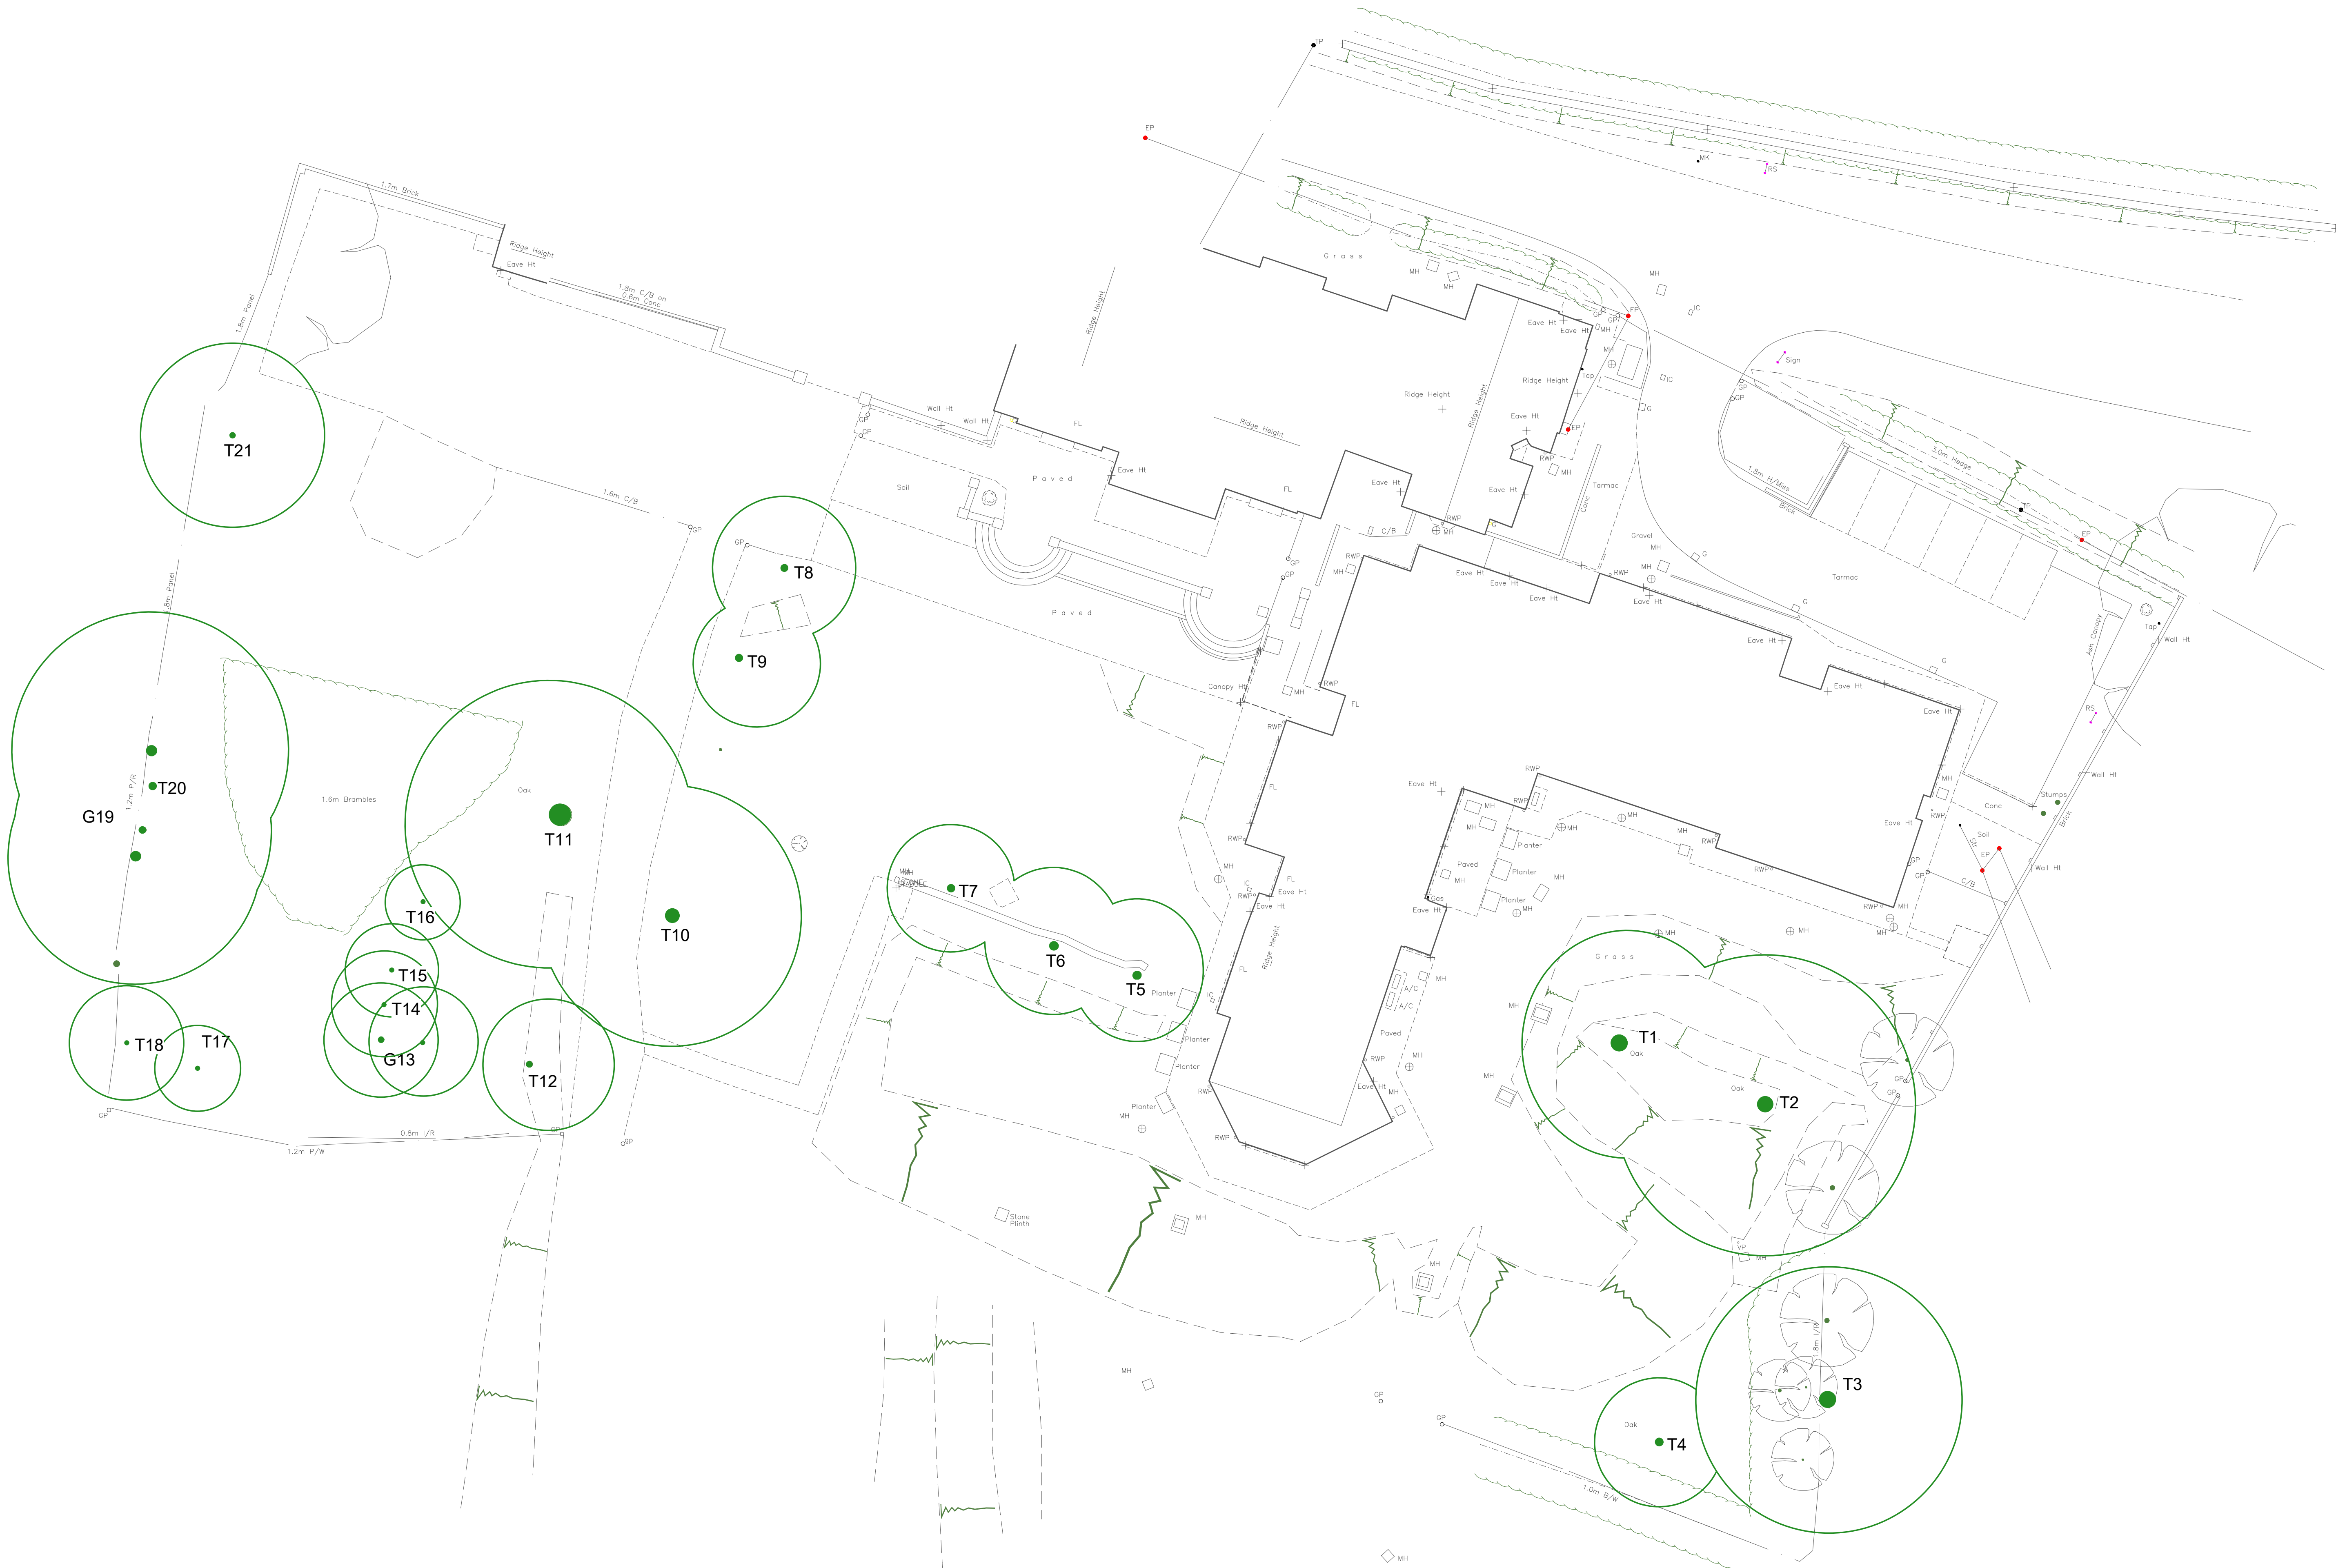
5.1 Trees inspected were not tagged or marked in any way. The positions of the trees concerned is indicated in the appended drawing TP 3237/2510. The site plan is drawn to scale and illustrates the positions of trees on site with sufficient accuracy for identification purposes only.
