## Manor House Barns, Rodbourne, Malmesbury SN16 0EX

### Visual Structural Inspection Report

Project Title: Manor House Barns, Rodbourne

Job no: 7000259 - Date: 27<sup>th</sup> March 2025

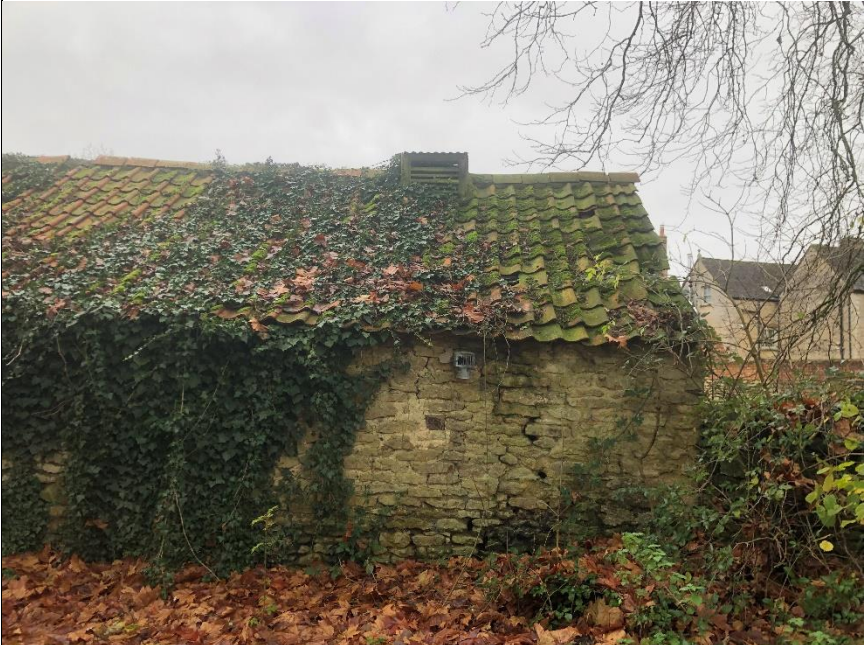
| Ref | Photograph |
|---|---|
| 1 | |

1. Single storey building with pitched clay tiled roof.
2. Significant vegetation (ivy including moss) growth to roof and walls (photo 2).
3. Simple cut roof construction comprising rounded rafters, midspan purlins and tie beams.
4. Lack of surface water disposal from roof. Water staining (discolouration) and washout of joint material to stonework. Some eroded joints appear like staggered and vertical cracks to wall (photo 1). Erosion of mortar joints to brickwork.
5. Face of some stone and brick has blown (spalled).

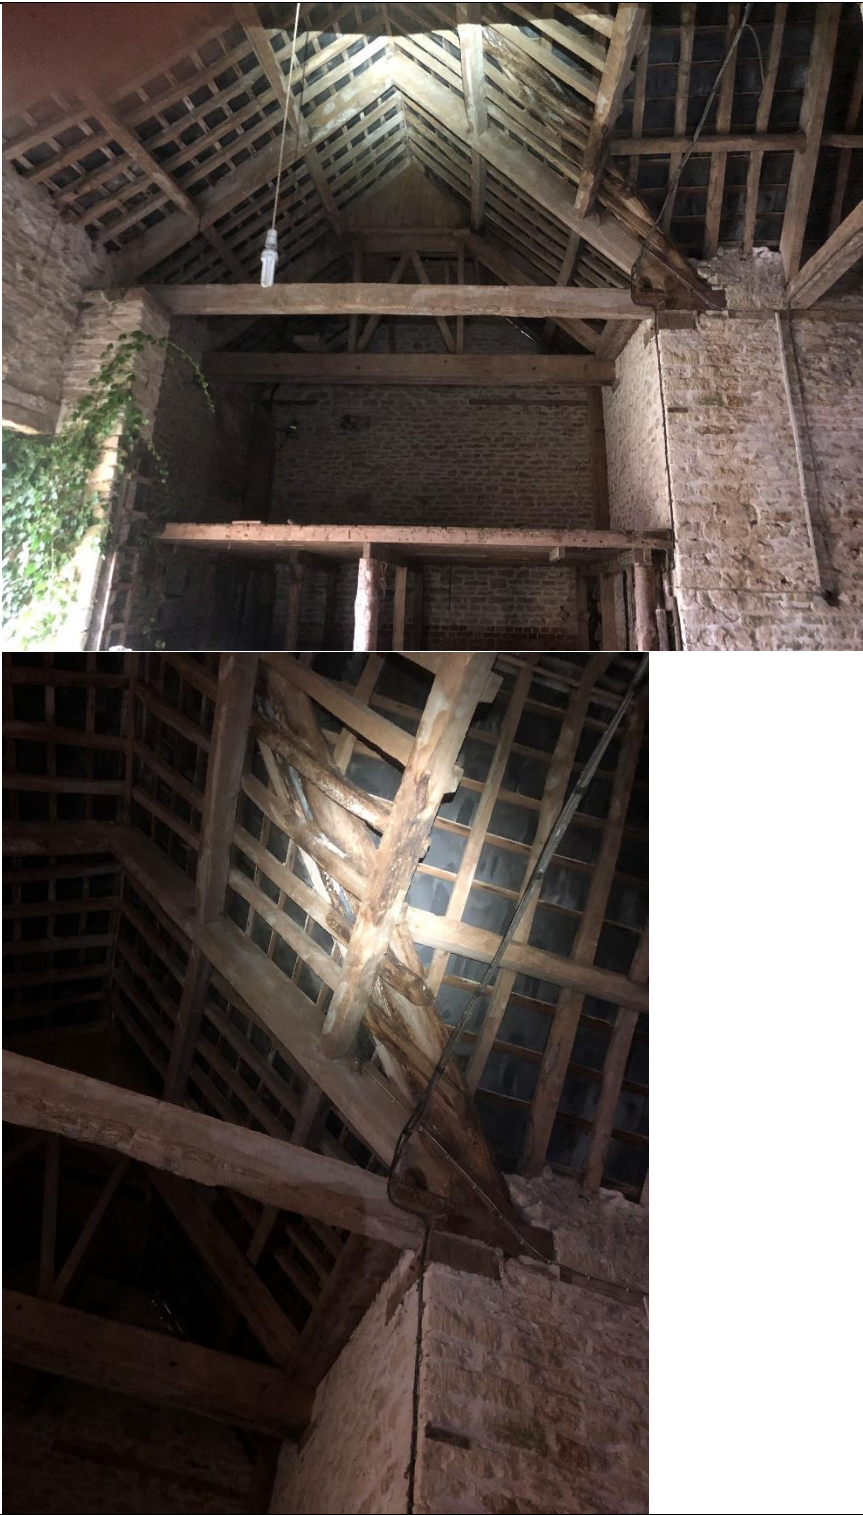
8

1. Double storey height pitched slate tiled roof with substantial stone walls, brick plinths, quoining and south gable.
2. Traditional timber roof comprising rafters, purlins at third span with principal rafter and tie beam A-frames (photo 8).

3. Roof structure generally in good condition. Visible water damage at roof intersection to south gable affecting valley boards, timber purlins and rafters (photo 8).

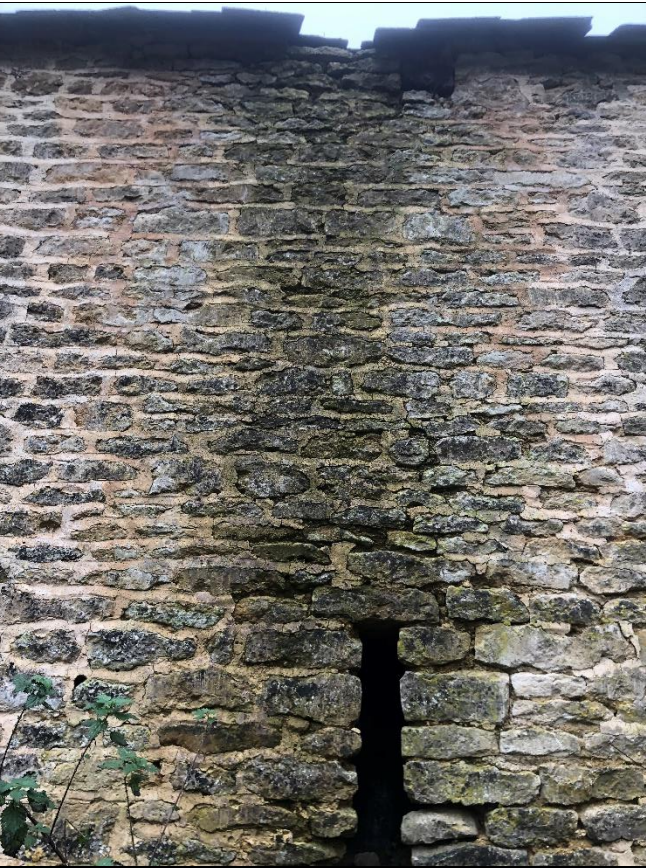
4. Slipped and missing slate tiles. Lack of positive rainwater drainage from roof.
5. Water staining and damage externally to walls (photo 9). Localised weathering and erosion of joint material between stonework and brickwork mortar. Evidence of repointing to stone and brick joints. Visible cracking, frost action and deterioration of pointing. Localised spalling of brickwork. Surface of walls damp where vegetation present

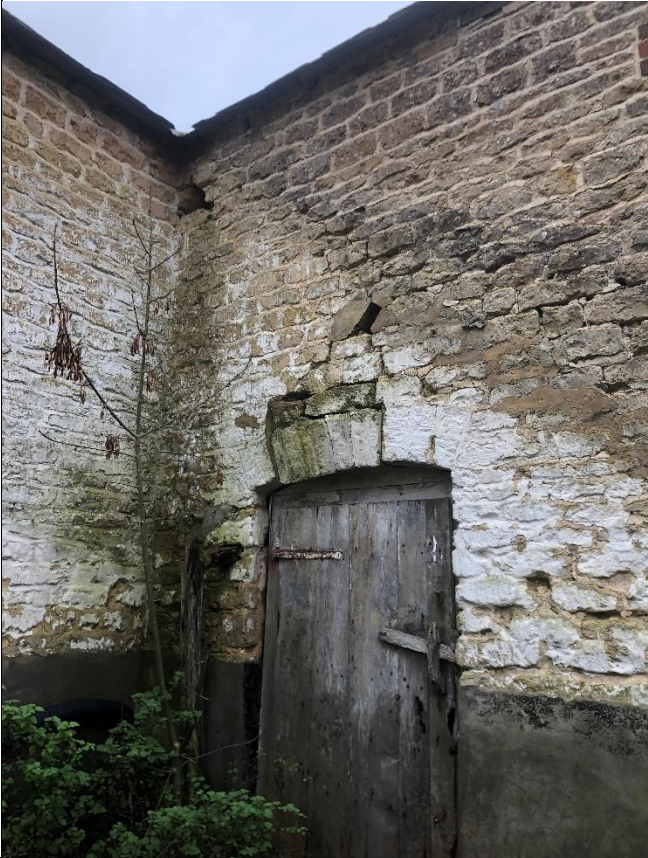
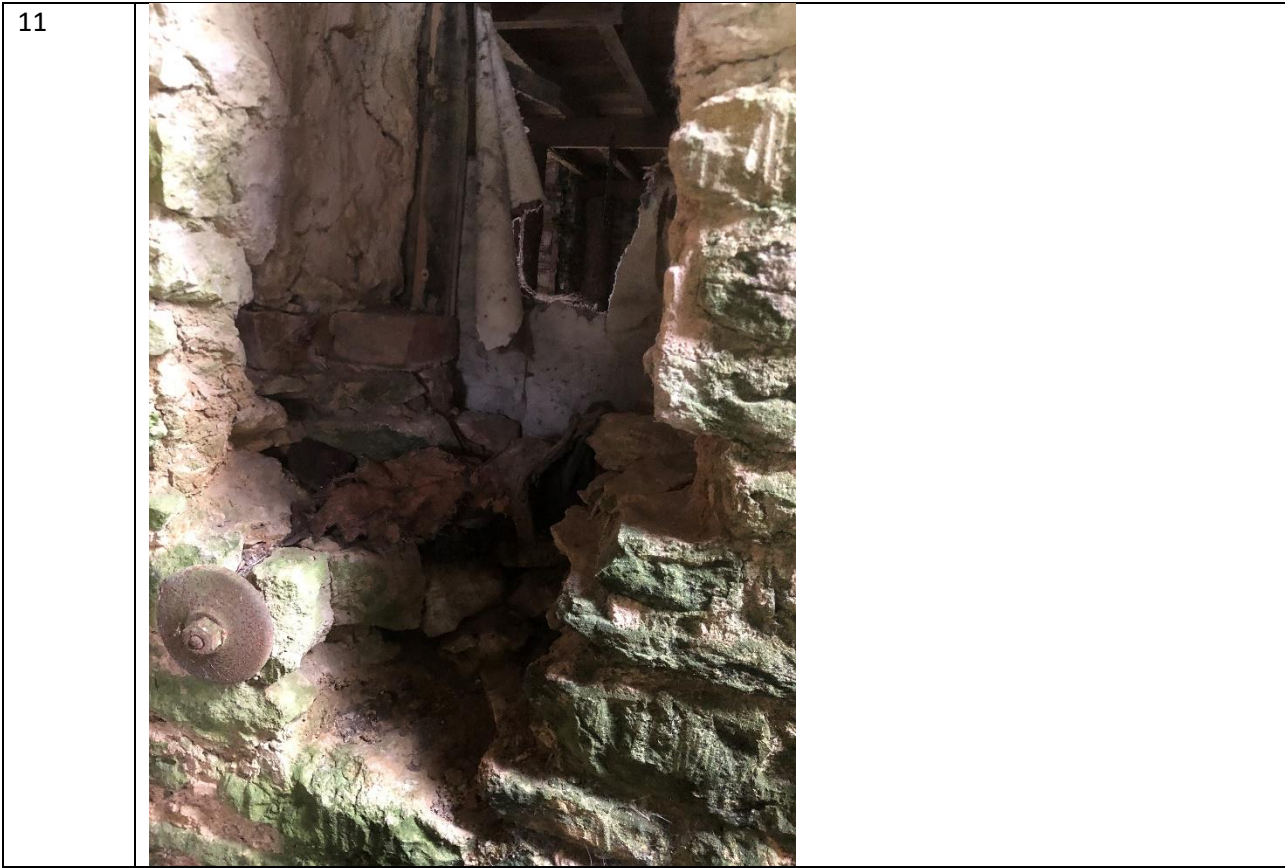
7. Localised failure of arched stonework with bulging of wall. Tie bar and pattress plate in area of wall damage (photos 10 and 11).
8. Evidence of water ingress and damage. Vegetation growing on or immediately adjacent to walls (photo 12).

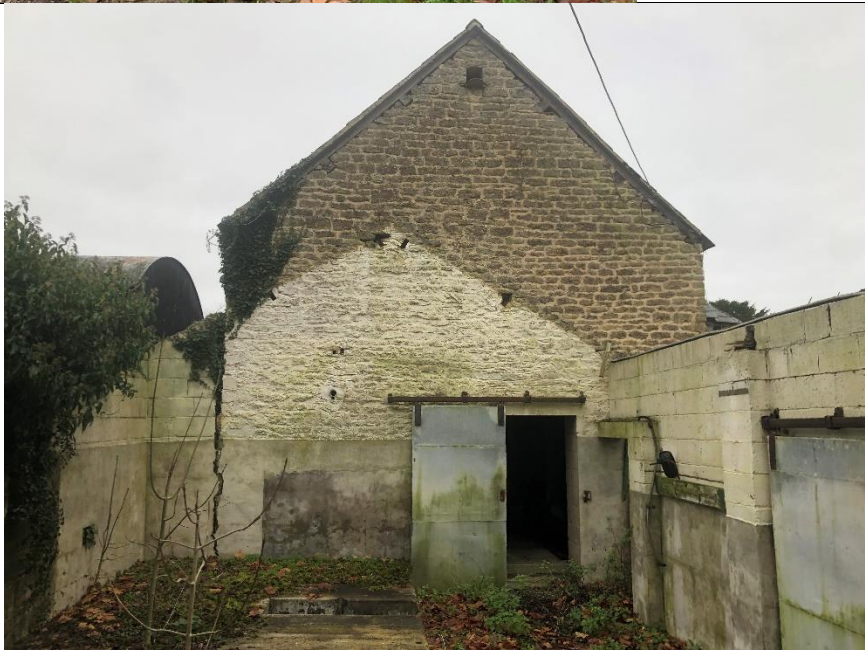
| 13 | | |

9. Northern link building to main barn: -
  - a. Roof missing.
  - b. Block wall construction, concrete slab with concrete plinths. Sand/cement render finish to half storey height of walls internally (photo 13 and 14).

- c. Large significant vertical slightly tapered crack between link block wall and barn stone gable wall, indicative of differential foundation movement/rotation of block wall (photo 13).

3. Generally, the pattern of cracking to the walls is not indicative of foundation movement. Where foundation movement has taken place cracking is present at the junction of the stonework and concrete block walls. The block walls having rotated away.

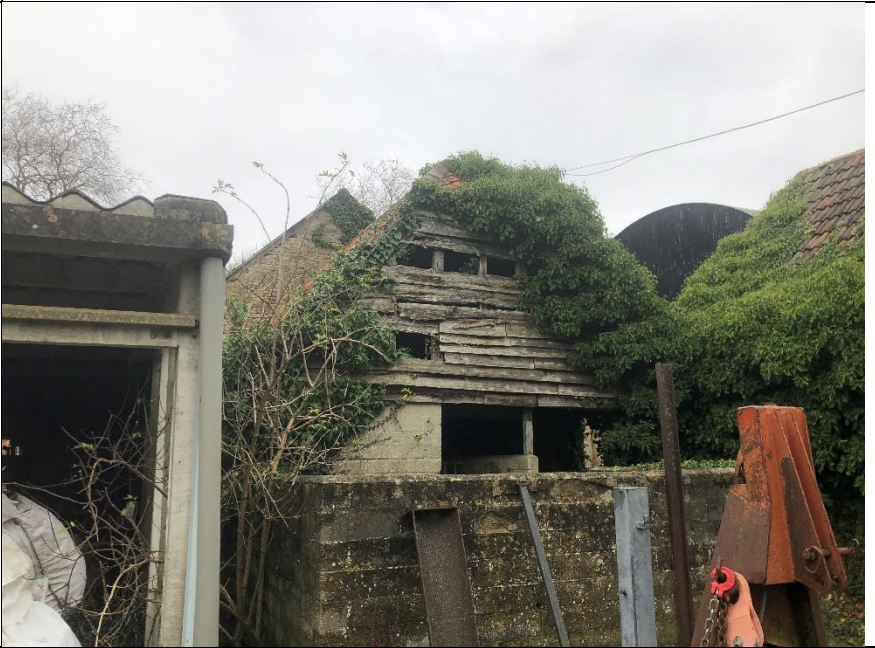
| 15 | | |

- f. Significant vegetation (Ivy) growth to roof and internally (photo 15). Rotten and missing timbers to gable.

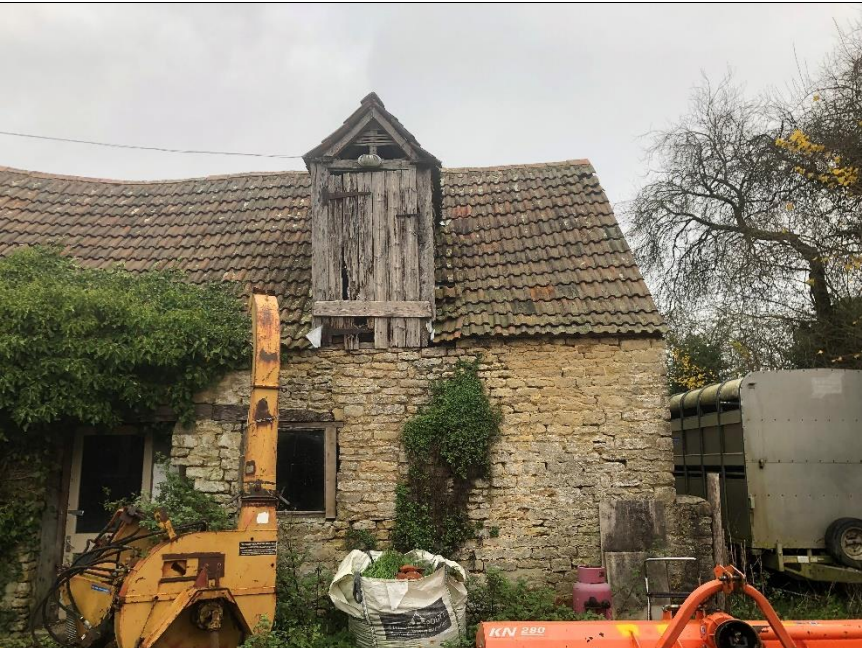
| 16 | | |

1. Two-storey building, first floor within roof space with pitched clay tiled roof. Timber door “dormer” for access to front/west elevation. Stone walls (photos 16 and 20). Polythene/tarpaulin sheeting fixed to underside of first floor, sagging underweight of trapped water (photo 23).

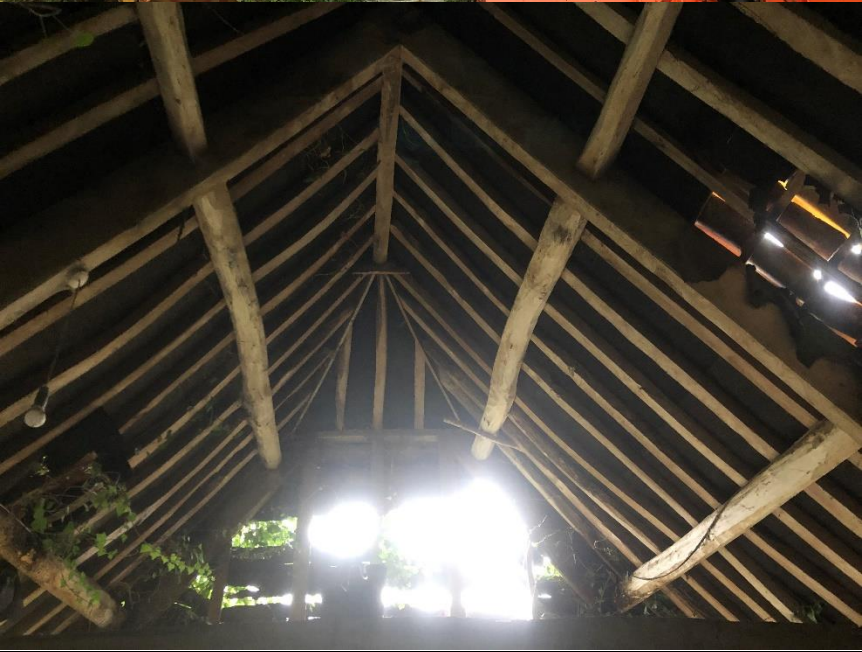
| 17 | | |

10. Southern open-ended adjoining building to main barn: -
  - a. Traditional timber roof comprising rafters, purlins at third span with principal rafter and tie beam A-frames (photo 17).

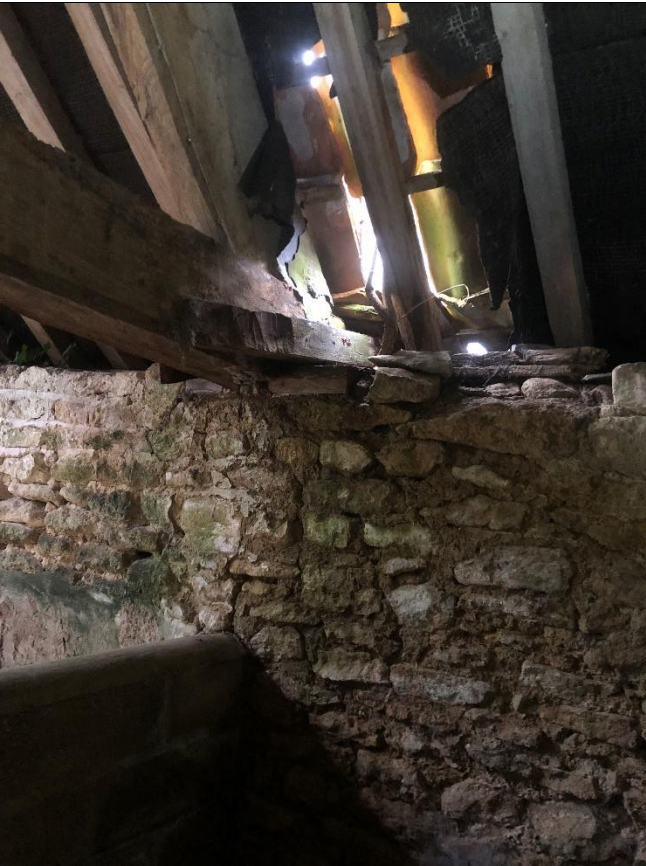
- b. Roof structure generally in good condition
  - c. Cracking to stone walls.
  - d. Missing tiles to roof. Water ingress and rotten roof timbers at head of wall and localised rafters. Water staining and erosion of stone jointing material (photo 18).

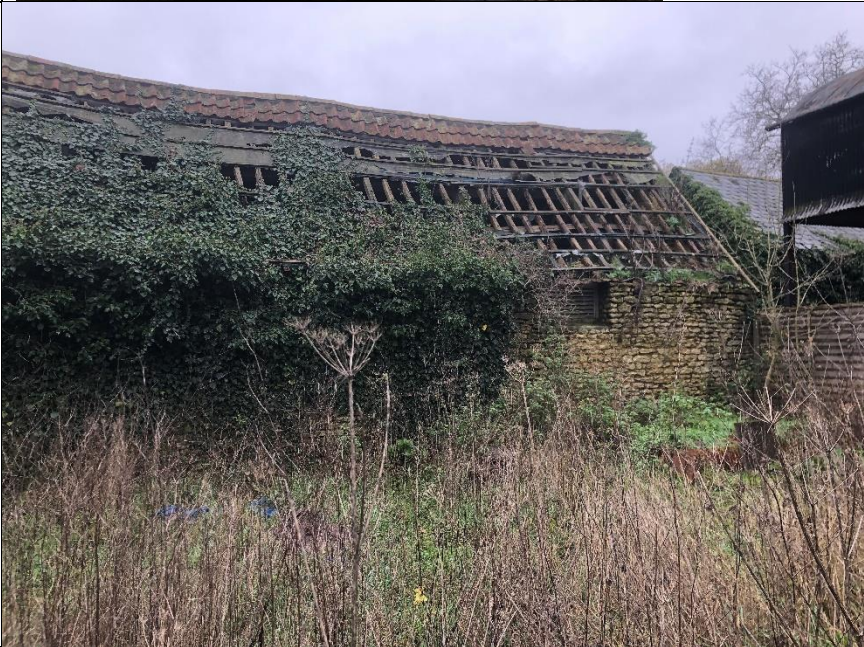
2. Roof tiles missing to rear/eastern elevation (photo 19).
3. Significant vegetation (Ivy including moss) growth to roof, penetrating internally and walls.

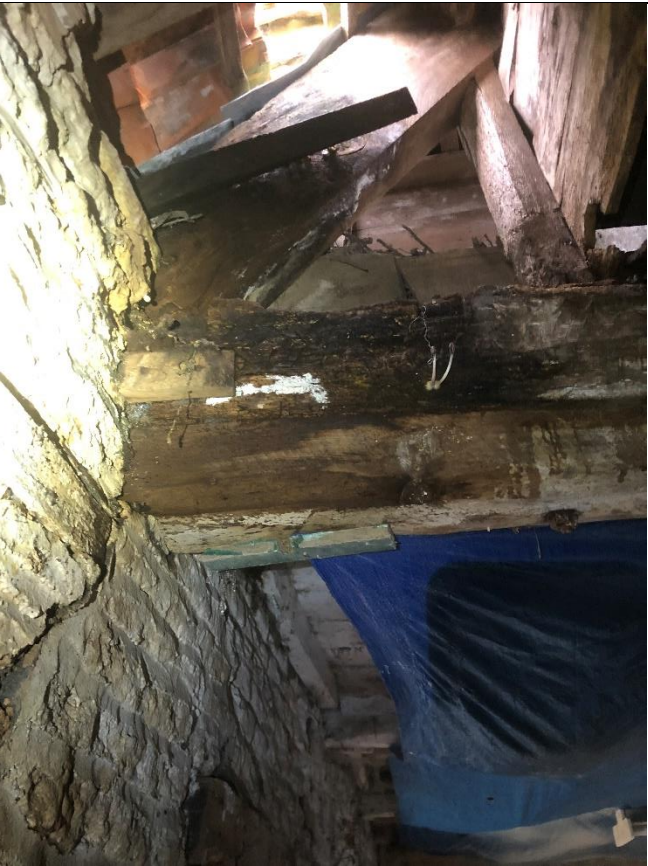
6. Water staining and erosion of joint material to stonework (photo 21). Staggered vertical crack to wall adjacent to junction with rear elevation (photo 22), laterally displaced cracking at location of tie/floor beam (photo 21).

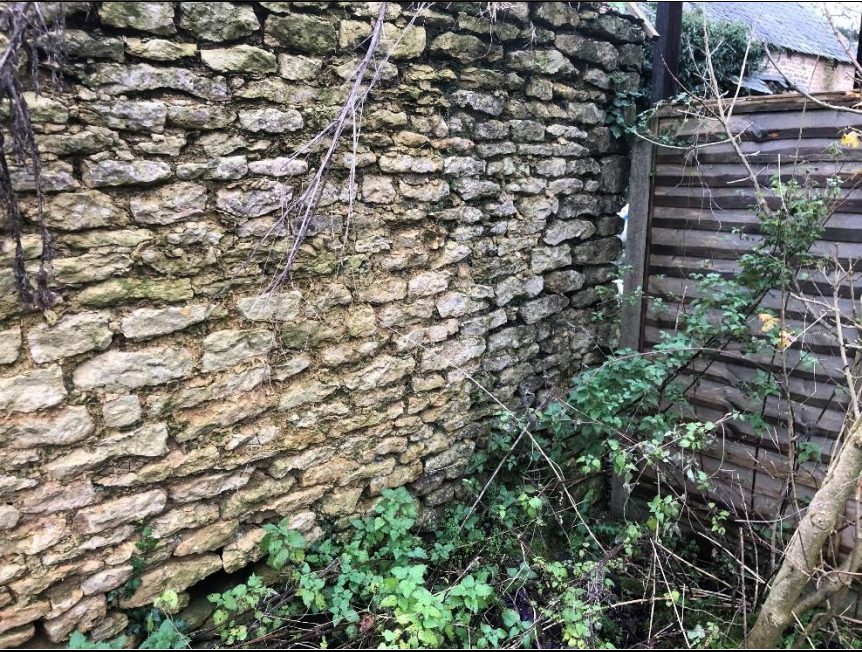
7. Weathering of masonry internally- stone fragments/debris on floor adjacent to wall.
8. Significant erosion of joint material to stonework externally, to some areas visible holes into wall core (photos 22 and 20). Cracking to stone. Visible repointing in areas. Localised collapse of stonework.

4. The significant cracking to the South Building, gable and rear walls is due to a lack of restraint and effect of movement of the failed roof structure.
