# Heritage Impact Assessment

Studley House Farm, Studley Lane, Calne,  
Wiltshire, SN11 9LL

**Structural Appraisal  
of  
Studley House Farm**

**Ref:  
W10176-GCA-RP-S-0001-S2-P01**

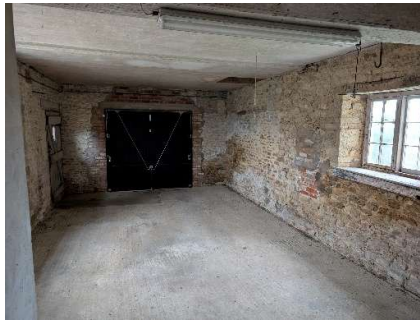
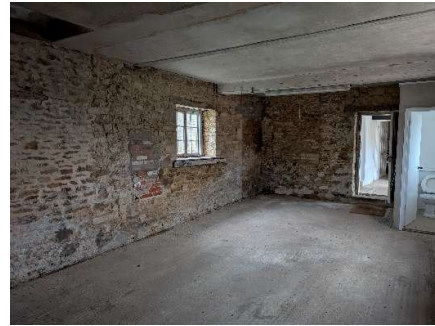
- 501 The garage walls are constructed from a mixture of differing stone types, predominantly fairly thin stones embedded into a fairly thick lime mortar. However, there is widespread evidence of inappropriate repointing undertaken over the years. This manifests as patches of cementitious mortar varying significantly in colour, ranging from very white-beige to sandy brown, a much redder cement colouring, and finally a grey cement.

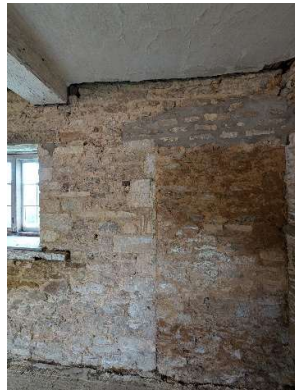
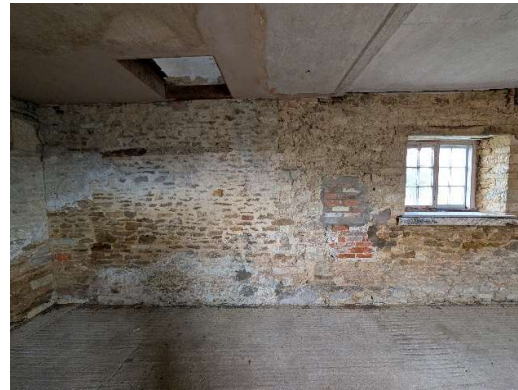
- 502 Vertical joints are clearly visible in the masonry where at least two previous openings (likely a window and a door) have been infilled. The stonework in these infills has not been "toothed" or lapped into the original masonry, creating a straight vertical joint between the old and new sections.

- 523 **Structural Stitching:** Install stainless steel helical bars (e.g., Helifix) at the vertical joints of the infilled openings (extend approx. 500mm L either side of crack) and along the corners (extend approx. 900mm L either side of the crack) to prevent separation.

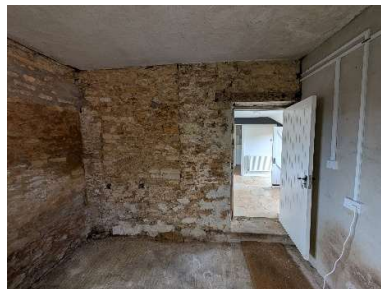
- 503 The most significant structural issue in this area is the stability of the West and East elevations. In the room above the garage, the ceiling is pulling away from the walls. This movement is occurring because the main Oak beams run East-West, which indicates the floor joists run North-South. Consequently, the joists run parallel to the leaning walls and provide no bearing

or lateral restraint. This lack of connection prevents the structure from acting as a rigid diaphragm box.

- 517 The primary concern regarding the East and West elevations is a loss of equilibrium caused by the decoupling of the walls from the floor diaphragm, exacerbated by foundation undermining from vermin activity.

- 522 **Lateral Restraint:** Install A2 stainless steel lateral restraint straps between the first floor and walls to tie the leaning West and East walls to the floor structure. This may require installing noggins between the existing joists, these are to be D30 oak.

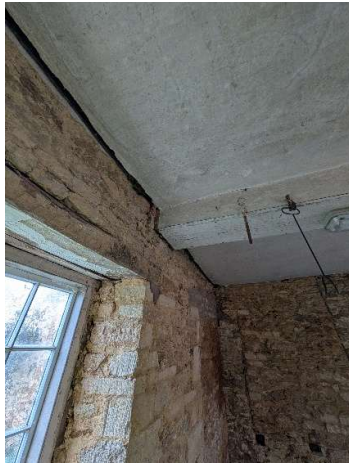
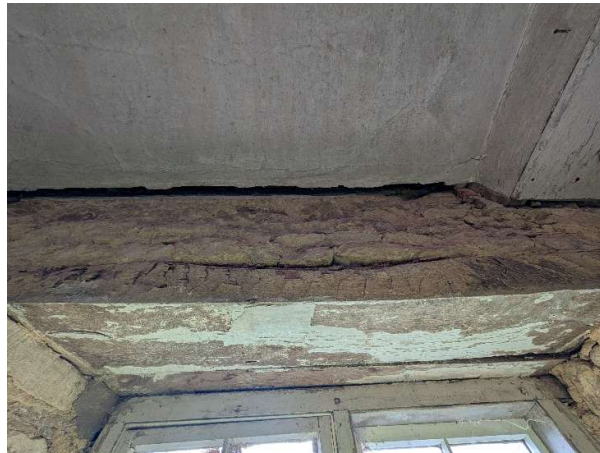
- 504 Above the garage door, a concrete lintel has been cast in-place; it is difficult to determine if this contains adequate reinforcement. The bearings on either side have been rebuilt in brickwork and cement mortar.

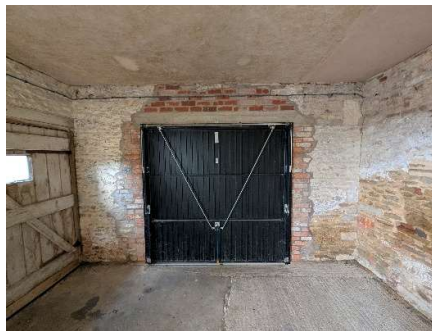
- 505 The brickwork used to infill areas on the East elevation and West elevation appears to have a rougher face (handmade), which is appropriate. However, the bricks used above the timber lintels and garage door are smooth-faced and much harder. This is an inappropriate material choice as it is denser and stronger than the surrounding stone, potentially causing differential movement.

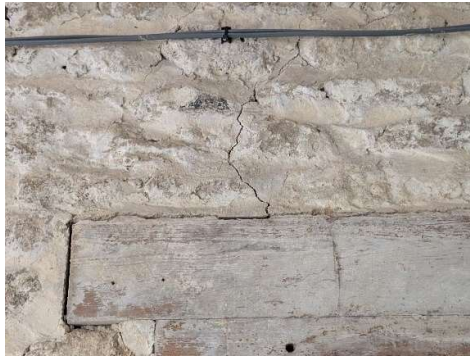
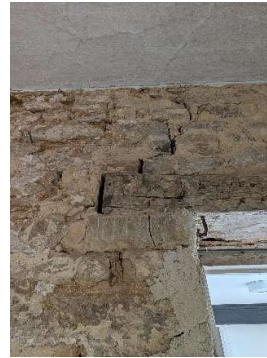
- 507 There are vertical cracks at the corners indicating they are not toothed in significantly enough.

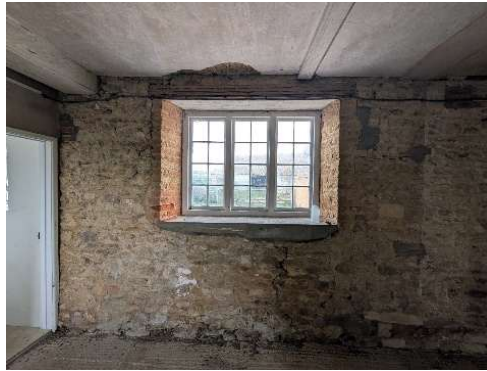
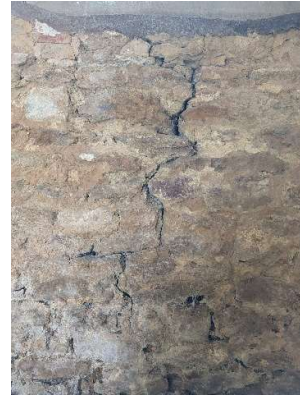
- 511 The brickwork surrounding the west window frame is delaminating due to moisture ingress and significant vertical cracks separating it from the stonework, most likely due to thermal and shrinkage movement. The junction between the frame and brick has been sealed with an inappropriate "polyfilla" foam, which traps moisture.

- 525 **Window Repairs:** Remove all cementitious render on window frames to reveal the underlying timber and the inappropriate polyfilla/foam. Window frame to be inspected by architect and a repair strategy developed with approval from the Conservation Officer. Ensure the window is sealed with traditional Oakum and Burnt Sand Mastic to match the original design intent.

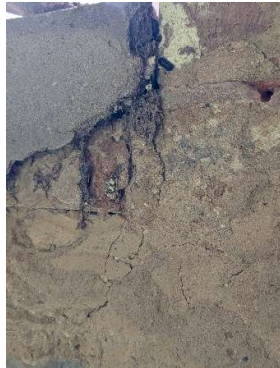
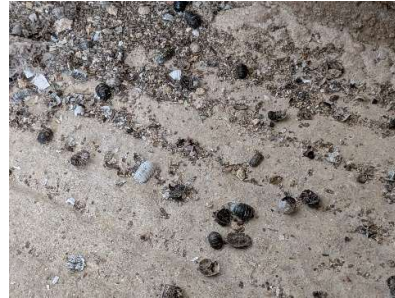
- 513 Externally, significant holes were observed in the ground immediately adjacent to the Eastern elevation. These appear to be active vermin holes (rat runs) exacerbated by soil washout. Crucially, these voids coincide directly with the section of the wall that is leaning outwards. This suggests that the shallow foundations in this location may have been undermined, reducing the ground bearing capacity and contributing to the rotational movement of the wall.

- 520 **Rat holes:** Investigations should be undertaken to confirm if the vermin activity is current, followed by humane pest control measures. Subsequently, a Ground Penetrating Radar (GPR) survey is recommended to map the extent of the tunnel system. If extensive voiding is confirmed, Geopolymer Soil Strengthening (resin injection) is proposed to fill deep fissures and voids, stabilising the foundations without the need for disruptive excavation. If voiding is not excessive, then move on to lateral restraint.

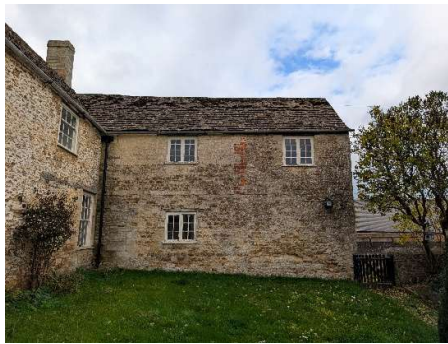
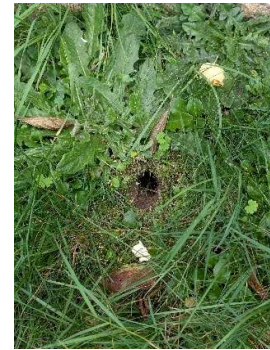
- 514 The stonework on the Eastern elevation at the northern end has deteriorated with stonework becoming friable and significant section loss in some of the individual stone blocks.

- 524 **Masonry Repairs:** Remove all inappropriate cementitious mortar, repoint these areas as well as the joints that have degraded with a flexible lime mortar NHL 2.

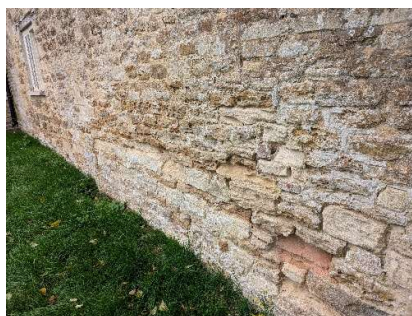
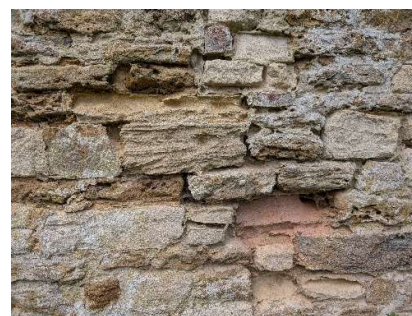
- 515 The timber lintel externally can be seen that it looks like it was originally rendered in cementitious mortar and that the bearings have suffered historically from wood worm, no visible frass was evident.

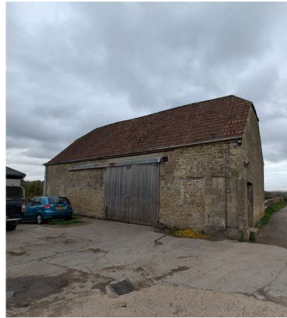
- 601 Barn 1 features an Oak truss structure supporting clay tiles. The trusses are substantial, especially when looking at the tie beams. Wind bracing is present, although members are missing on both the West and East sides, which compromises the longitudinal stability of the roof. The roof lacks a structural ridge beam, relying instead on a ridge board, and the rafters appear to be newer additions.

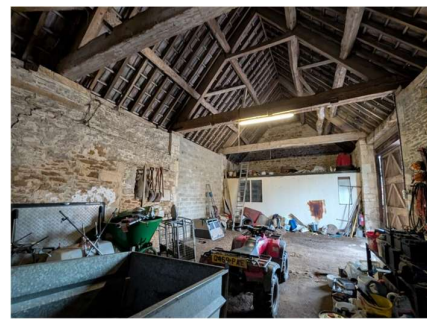
- 602 A series of cracks were noted, predominantly at the North-East corner. On the Eastern side, the top section of the wall appears dislodged, forming a "ledge" at the northern corner where it bulges outwards. This suggests an eccentricity in the loading is applying a horizontal "push" to the wall tops.

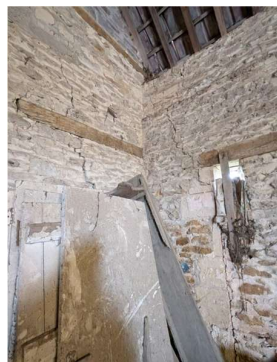
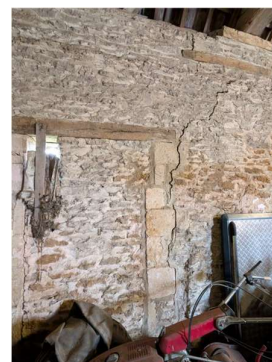
- 603 A large amount of the openings (e.g. doors, windows, etc) have been infilled, in some cases this has been done with stonework to match the existing walls, however in some instances these have been filled in with blockwork including what appears to be one of the previous

main barn doors. From the colouration, it can be seen that there a significant amount of masonry has been extensively repointed with cementitious mortar.

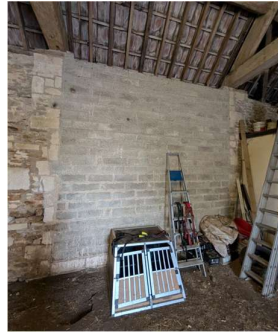
604 Furthermore, there appears to be no positive connection between the heavy trusses and the wall plate; the roof is relying primarily on friction to stay in place.

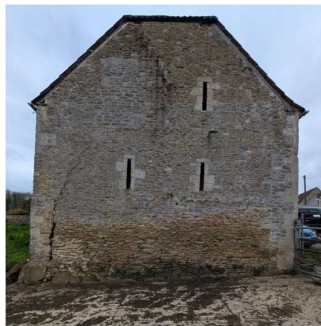
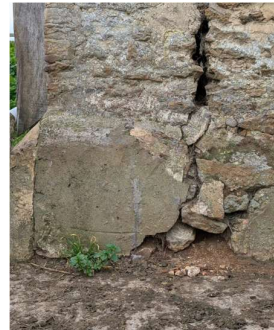
605 Externally, the crack in the northeast corner can be seen to have developed through the entire wall thickness. The crack is primarily vertical from ground level to chest height before beginning to shift in a diagonal manner. It is also noticeable that there isn't a defined set of quoins at this corner, as one would expect, especially when comparing to the other corners of this building. The northwest corner appears to have been repointed in cementitious mortar and has a larger quantity of dressed stones as the quoins.

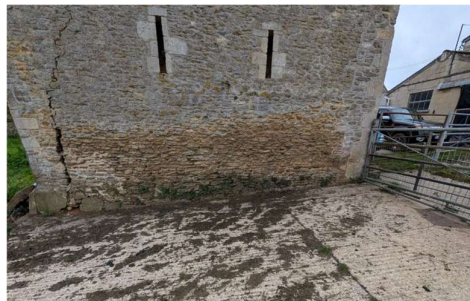
606 There is a downpipe that leads into a gully at the northeast corner, it could not be seen if this gully is blocked. It appears that the drainage pipe moves along the north elevation as evident by the manhole. Along this stretch of the north elevation, there is a significant amount of discoloration from base to chest height which would indicate high saturation and given the proximity of the drainage pipe would suggest a broken pipe. The over saturation of the soil could be causing ground movement, or the saturated stonework is subject to freeze thawing and this will cause horizontal movement leading to the crack pattern.

- 612 This movement is being actively exacerbated by likely drainage defects at the northeast corner, where soil saturation appears to be undermining the foundation or causing freeze-thaw damage.

- 614 **CCTV Survey:** A CCTV survey of the drainage system should be undertaken to determine if any of the pipes are broken and leaking.
- 615 **Wall Stabilization:** Install stainless steel helical bars (e.g., Helifix) at the vertical cracks (extend approx. 500mm L either side of crack) and along the corners (extend approx. 900mm L either side of the crack) to prevent separation.
- 616 **Roof Connections:** Install stainless steel cleats or mechanical fixings to positively tie the trusses to the wall plates.
- 617 **Masonry Repairs:** Remove all inappropriate cementitious mortar, repoint these areas as well as the joints that have degraded with a flexible lime mortar NHL 2.

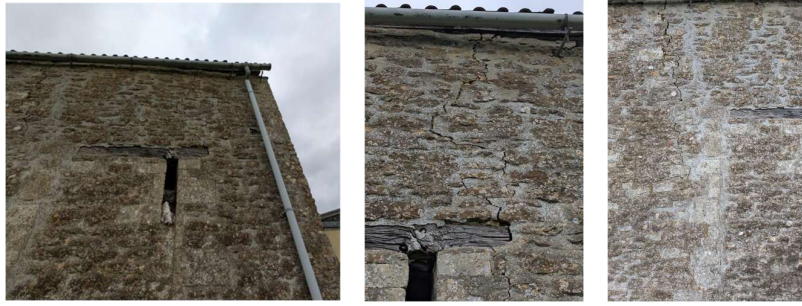
- 607 There are two additional vertical cracks in this corner, these are on either side of the infilled doorway.

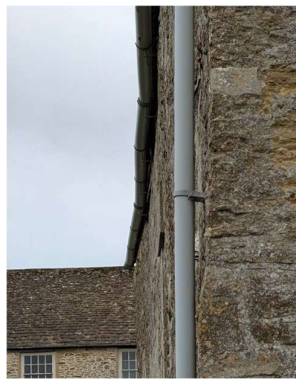
- 608 The gutter along the eastern elevation shows signs of movement, but as the gutter is intact this would indicate that the movement is historic.

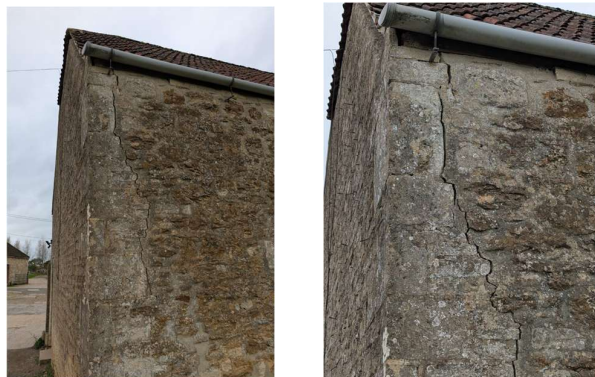
- 609 At the southeast corner of the building there is a vertical crack at the interface between the quoin and rubble stone wall. The crack is wider at the top which would indicate a slight lean to the top of the wall. This is expected given lack of head restraint.

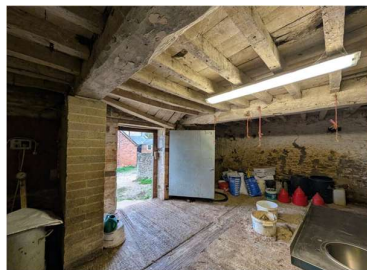
- 701 In the Plucking Barn, a ceiling joist has failed completely due to severe woodworm infestation, which is evident throughout the timber framing in this section.

- 710 This structural vulnerability is compounded by a severe, widespread woodworm infestation that has already resulted in the complete failure of a ceiling joist.

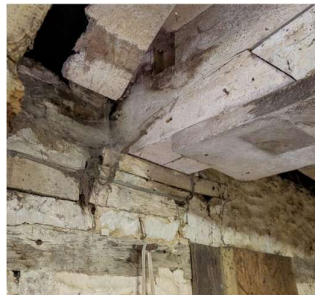
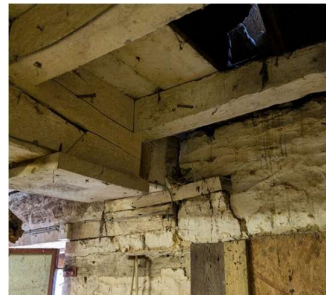
- 702 Of critical concern is the eastern truss bearing. The timber packing and stonework have disintegrated and pulled away, likely due to the deterioration of the timber bearing plate from moisture ingress. Nails in this section show signs of "rust jacking," which has further spalled the stonework.

- 712 **Immediate Propping:** Install Acrow props under the southern truss bearing immediately to prevent collapse.
- 713 **Masonry & Timber Reconstruction:** Carefully remove the unstable stonework at the bearing, replace the rotten timber bearing plate, and rebuild using lime mortar.
- 714 **Reset Gutter:** The gutter needs to be reset to work as intended and ensure rainwater is being transferred away from the wall face and to the gully.
- 715 **Masonry Repairs:** Remove all inappropriate cementitious mortar, repoint these areas as well as the joints that have degraded with a flexible lime mortar NHL 2.
- 716 **Drainage:** Reroute the terminating drainpipe into a proper gully away from the foundations to prevent further saturation of the ground.
- 717 **Access:** Create an access hatch to allow proper future inspection and maintenance of the roof void.

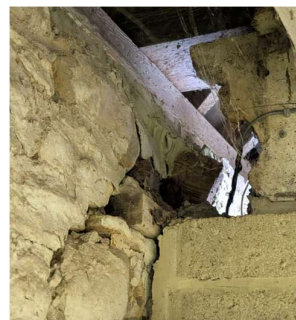
- 703 The southern appears to have previously failed and a pier was built to support the truss using blockwork.

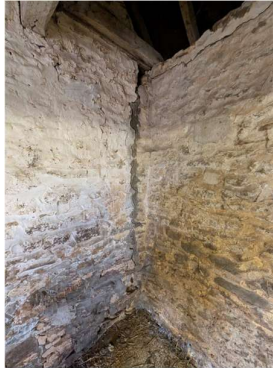
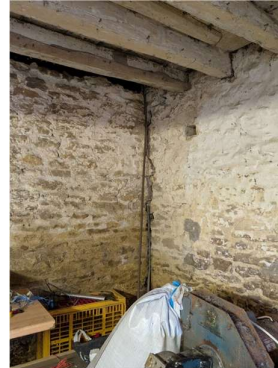
- 704 There is no access hatch to the roof void, which restricts maintenance capabilities. Signs of rot in the ceiling suggest the roof is no longer watertight.
- 705 There are vertical cracks at the internal corners of the building.

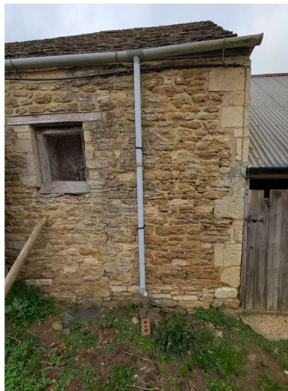
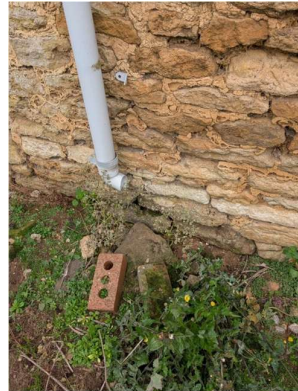
- 706 Externally, a drainpipe terminates effectively nowhere, discharging water directly into the foundation soil causing localized stone damage via erosion but also from the increased saturation of the stonework.

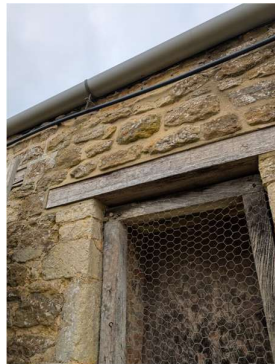
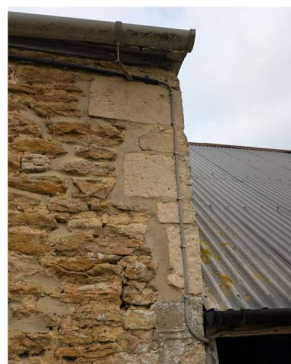
- 707 The lintel above the northern window on the East elevation appears to be a modern replacement (sharp cut edges), this coincides with the newer blockwork pier suggesting the previous lintel failed due to similar water ingress issues seen in the southern tie beam. Additionally, the stonework has been repointed with cementitious mortar.

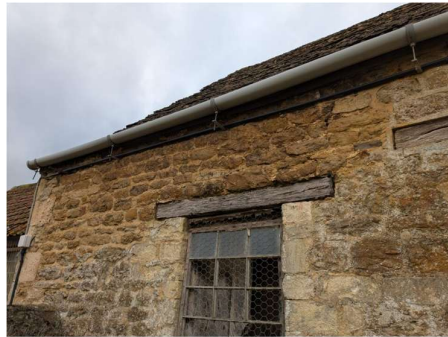
- 708 The stonework above the window on the east elevation at the southern end, which coincides with the failing southern tie beam bearing is greatly discoloured indicating significant water saturation.

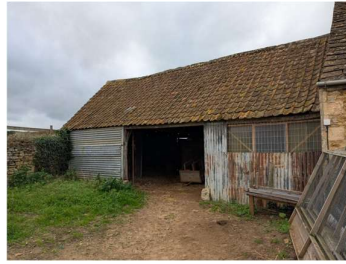
- 801 The Chicken Barn features oak framing with corrugated iron cladding. The jowl post on the southside of the opening has failed and is currently propped with an Acrow prop. The failure mechanism appears to be "Rust Jacking." Large iron nails or metal dowels were used for the connections instead of timber pegs. Once these oxidise, they exert an immense amount of pressure that has split the timber post along the grain. While the jowl post has failed, it has not caused a catastrophic collapse, suggesting the load has redistributed to adjacent timbers. The localised failure has caused some horizontal movement; this has resulted in the tea beam to shift off the eaves beam due to a lack of positive connection.

- 808 **Timber Repairs:** Reseat the tie beams onto the eaves beam. Fix mechanically, using A2 stainless steel angle cleats and A4 Stainless steel screws, to provide a positive connection between all tie beams to the eave's beams. Scarf a new top section of the jowl post, like for like, to match the existing post.
- 809 **Fixings Replacement:** Replace all corroded mild steel bolts and fixings with Minimum A2 Stainless Steel to resist the corrosive environment and prevent future rust jacking.
- 810 **Flaunching:** Flaunch the bottom of the jowl posts at the interface with the straddle post to ensure water run off at the base.
- 811 **Gutter:** Install a gutter, downpipe into a gully.
- 812 **Weather Sheltering:** Extend the corrugated sheet cladding on either side of the opening to act as a rain screen to reduce the saturation of the oak posts.

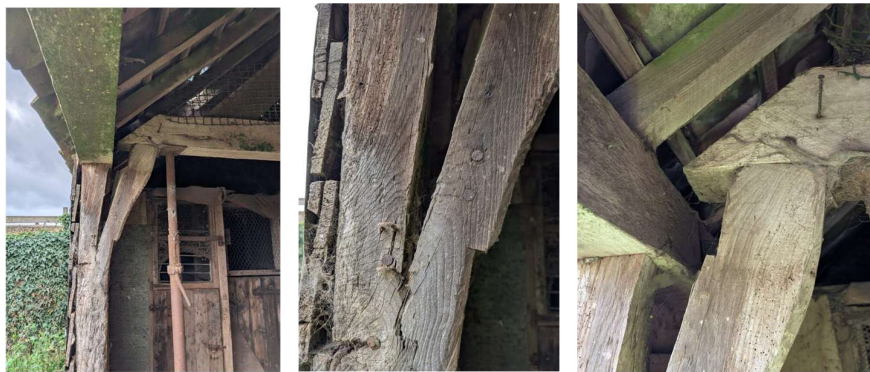
- 802 The roof structure is a modified Queen Post truss (with an additional central tie). For the purlins and eaves beam, a half-lap joint has been placed at mid-span. This is the worst possible location for this joint and will have led to excessive deflection but there doesn't seem to be any serious signs of these joints being overly stressed.

- 806 While the positioning of half-lap joints at mid-span represents an inherent historic design weakness, the immediate priority is addressing the active instability of the jowl post and the deterioration at the post bases caused by water ingress.
