## Window Restoration

Report Reference: Sash windows October 2025

Friarton  
Semley  
SP7 9AU

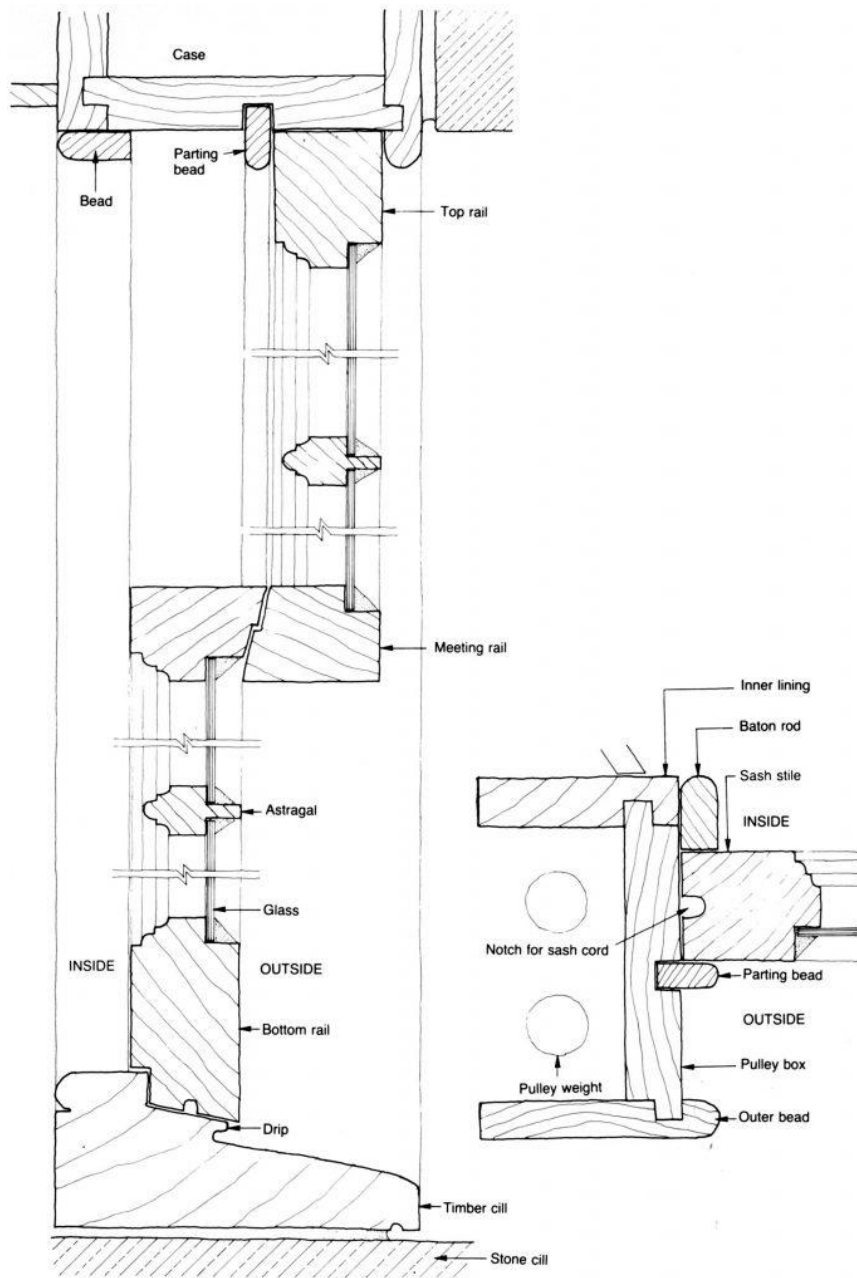
5. Detail of sash window

- The majority of sash frames are original timber, estimated to be over 50 years old. All boxes have been repaired some have multiple scarfing. The majority of casements have rot and deterioration of joints.
- Paintwork is flaking in several areas, exposing bare timber, particularly on upper sashes facing south.
- Signs of rot and minor decay can be seen in all wood work.
- Joints and putty around the glazing show general wear consistent with age.

- Most panes are original single-glazed, of historic interest.
- Putty deteriorating and in need of renewal in several locations.

The sash windows are of traditional timber construction and retain much of their original character. Unfortunately, I believe the windows are beyond repair. I would suggest remaking the sashes reusing original glass if possible and to remake the boxes using any of the original wood that is of a suitable condition.
