# CONDITION SURVEY OF WINDOWS

Friarton Semley

Listed Living

Kathryn Melhuish BA MA (Arch Cons) IHBC

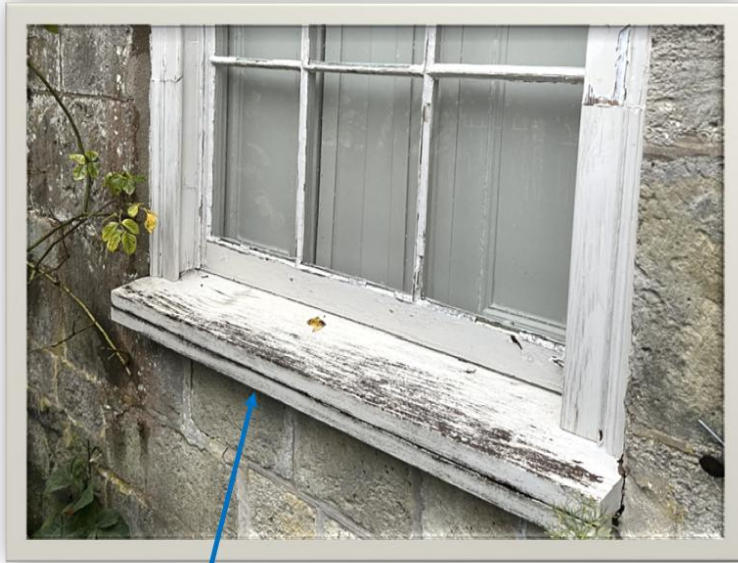
All Cils have been replaced with two pieces of softwood in an odd oversized design.

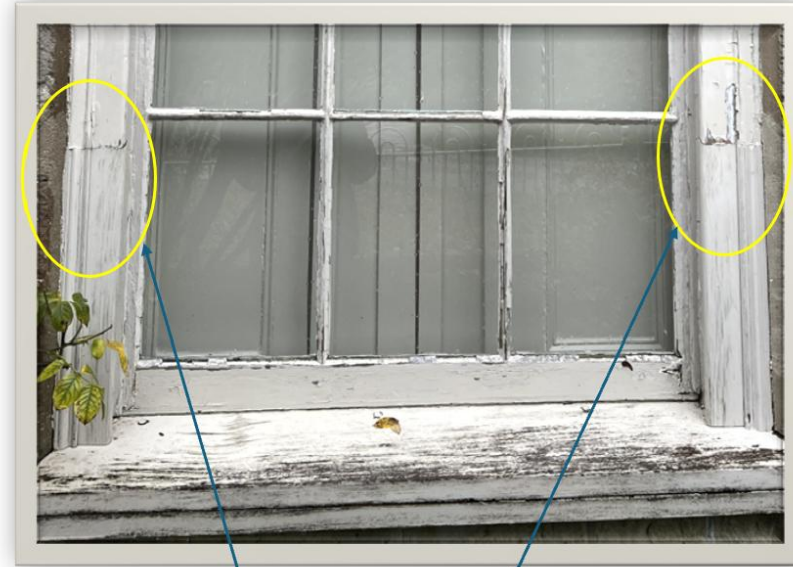
Bottom of Boxes on all windows have been scarfed in with poor quality soft wood timber

Cils/Boxes/Bottom Rail & Glazing Bars  
showing signs of decay

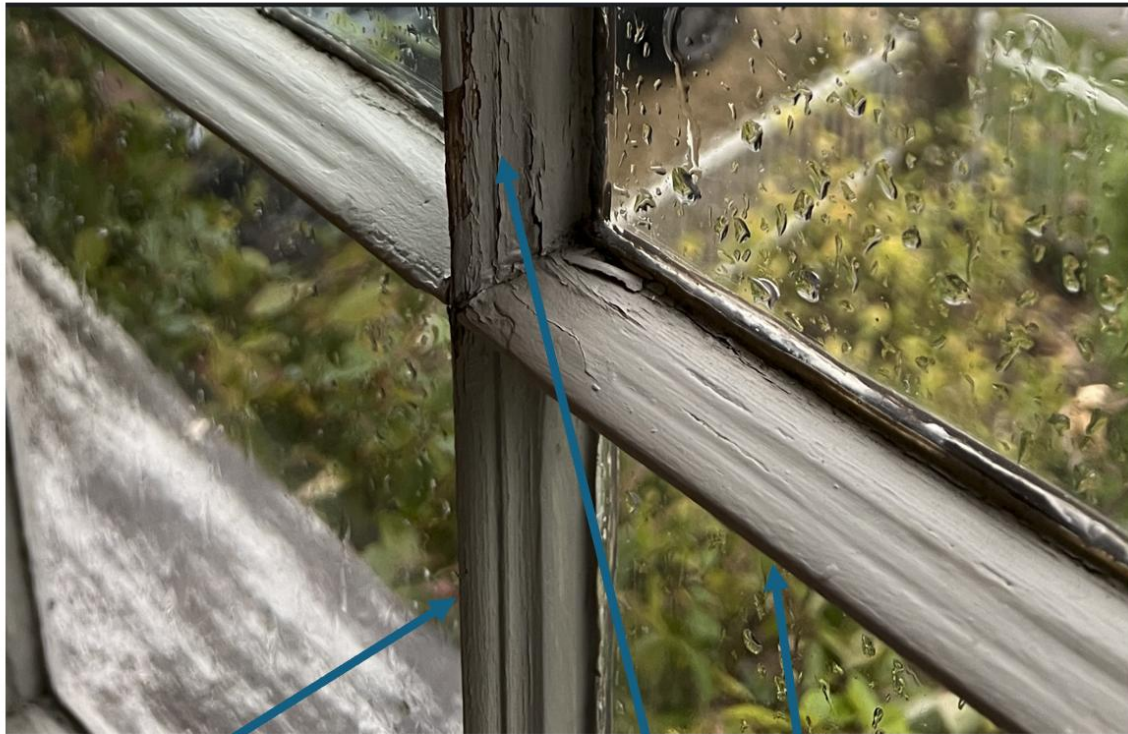
C20 glazing bars

Historic glazing bars

Glazing bars in windows have been replaced over time, evidence of C20 glazing bars

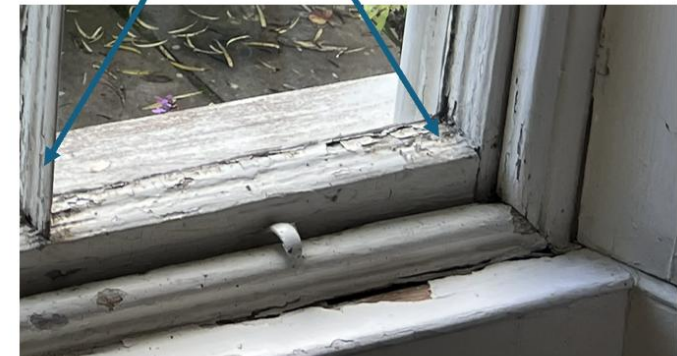
Internal rot to bottom rails & glazing bars

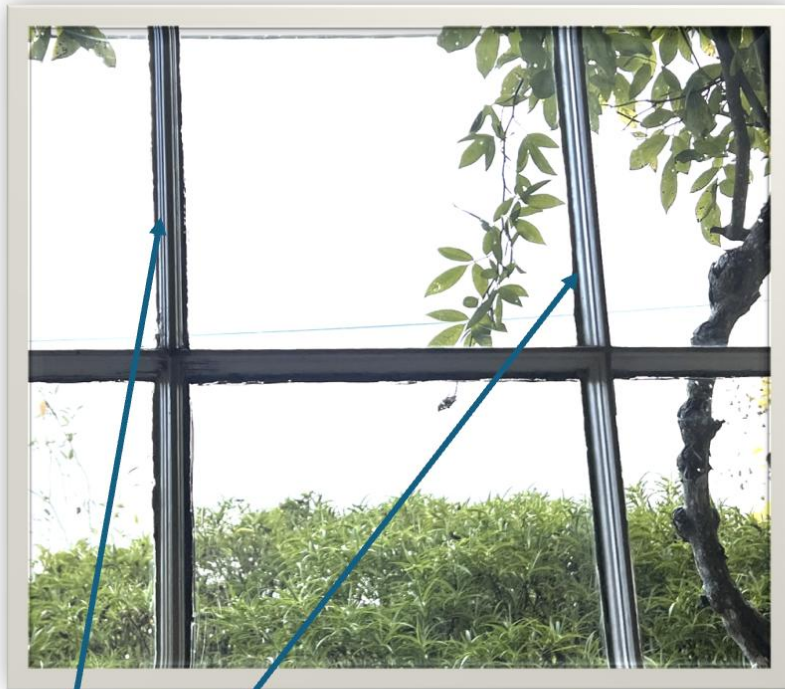
C20 glazing bars

Glazing bars in windows have been replaced over time, evidence of C20 glazing bars

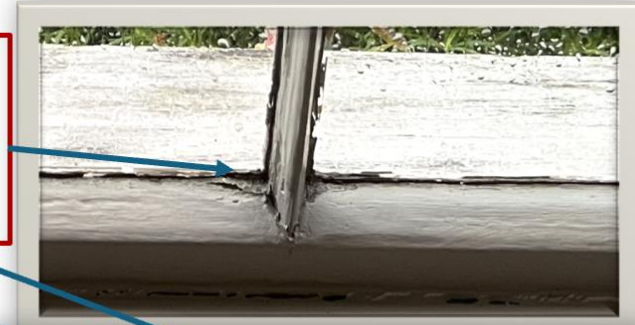
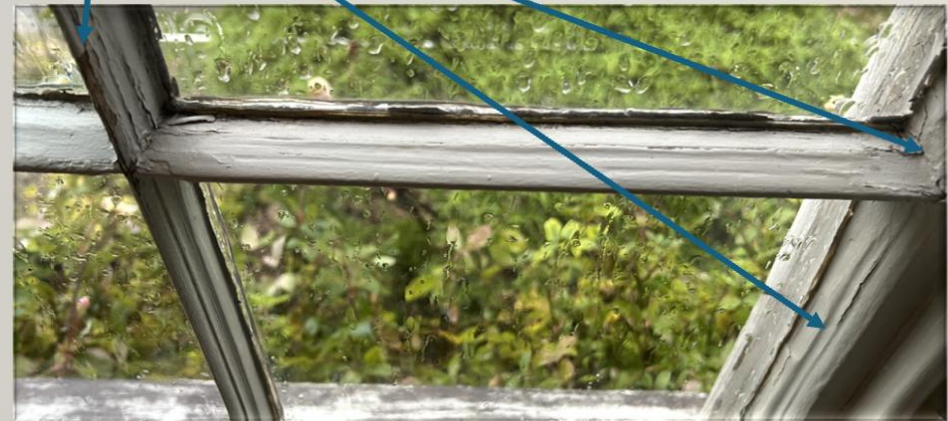
Internal rot to  
bottom rails &  
glazing bars  
painted over

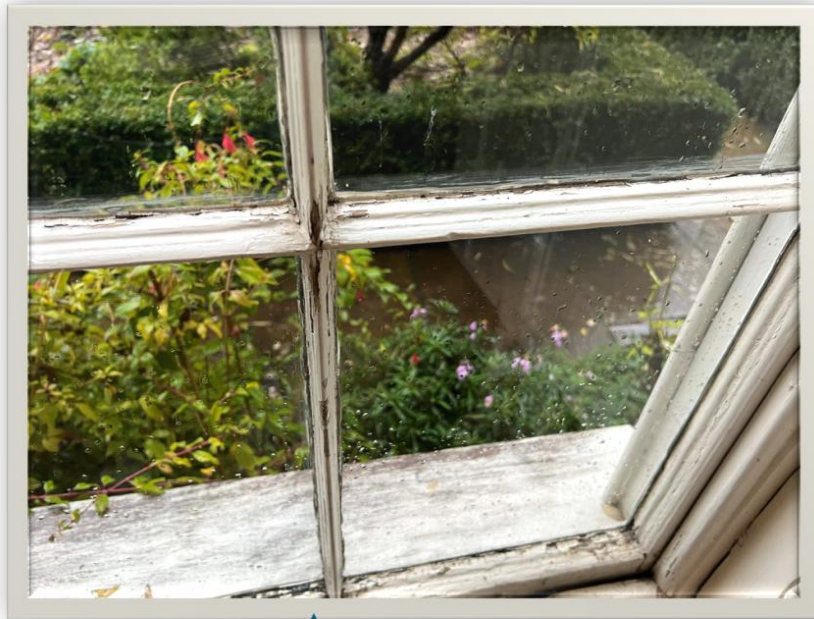
Internal rot to  
bottom rails &  
glazing bars

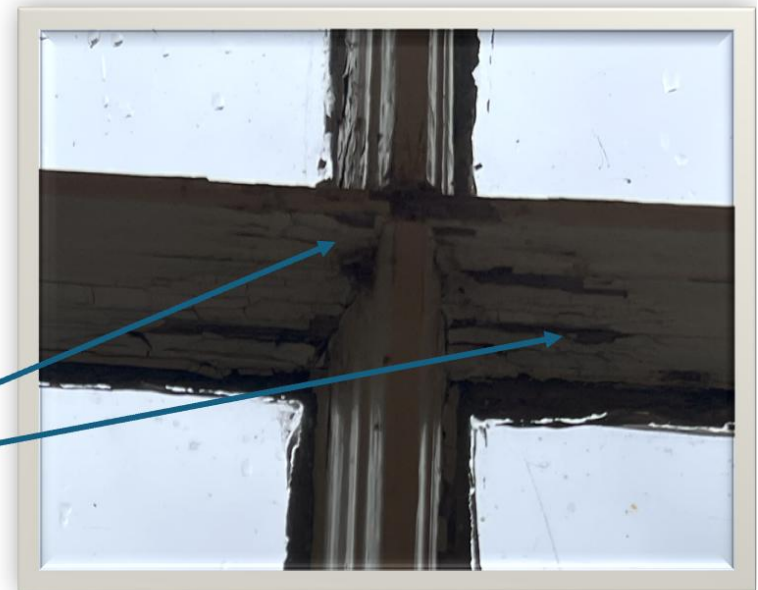
Internal rot to soft  
wood glazing bars

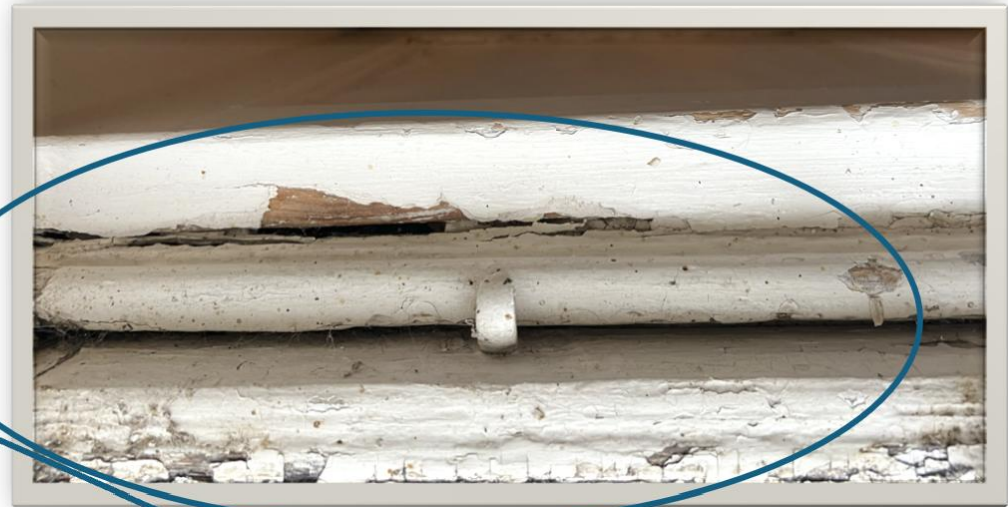
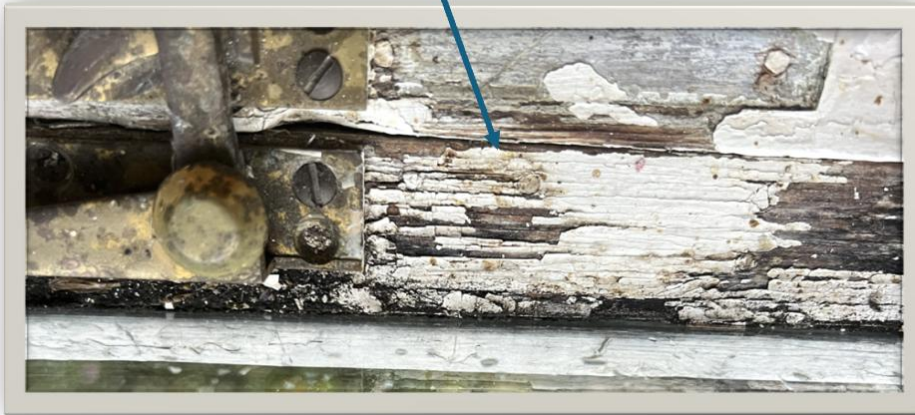
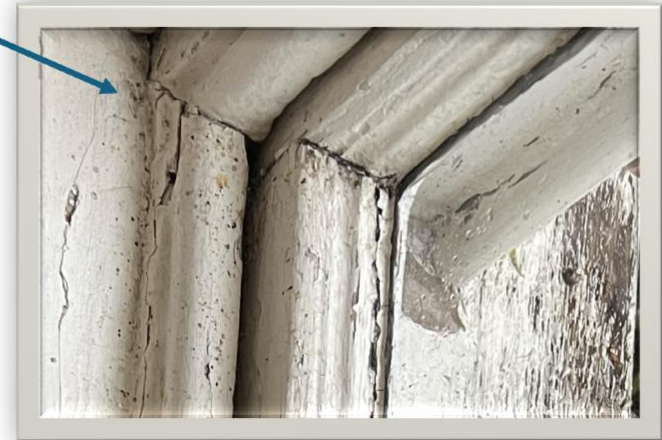
Internal rot

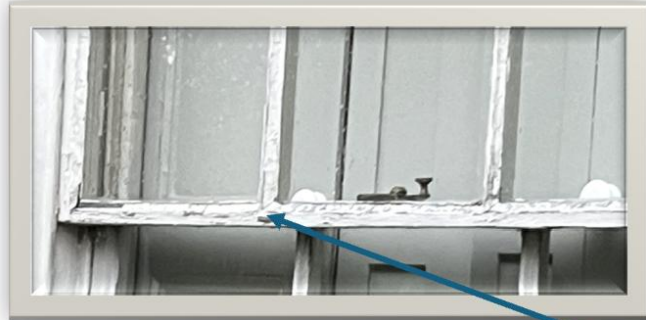
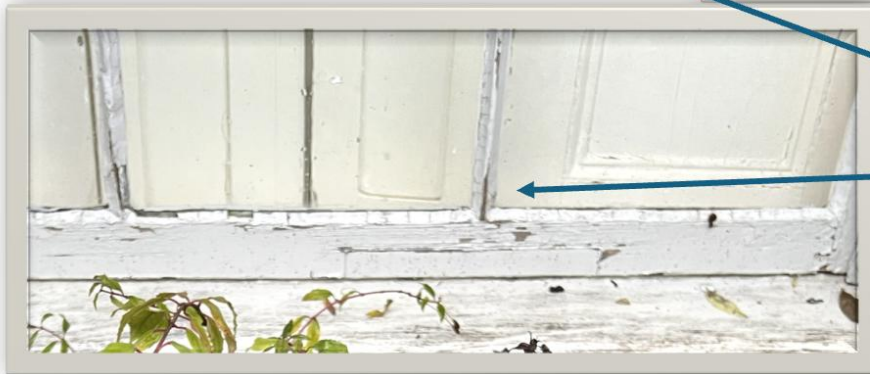
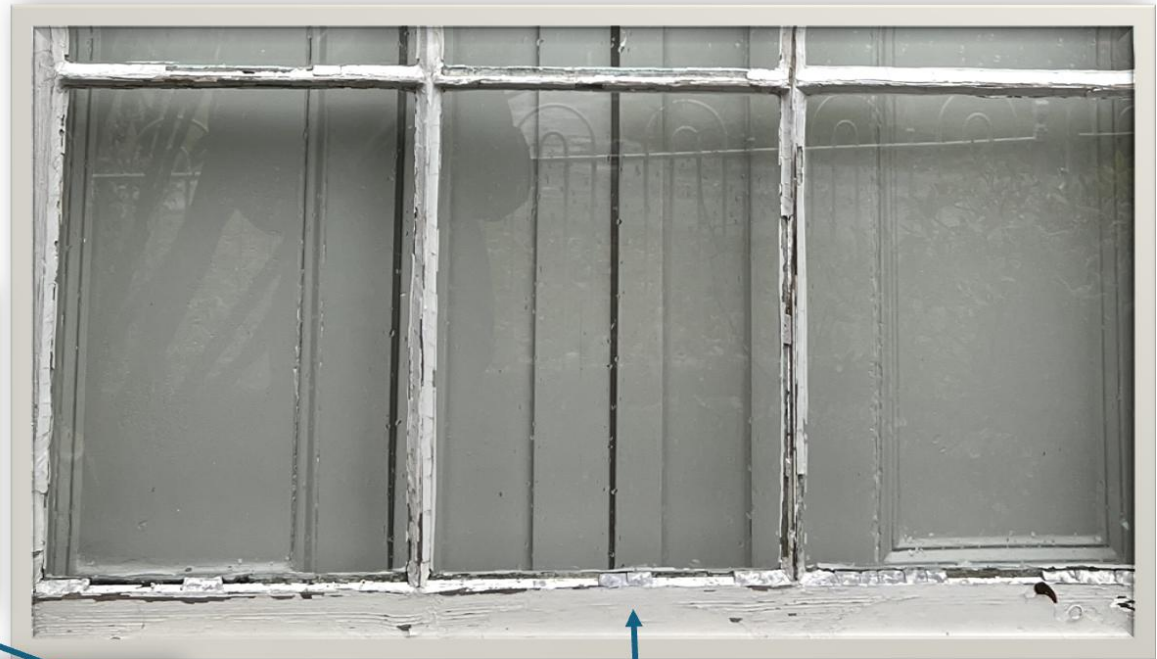
Glazing bars in windows have been replaced  
over time, evidence of C20 glazing bars

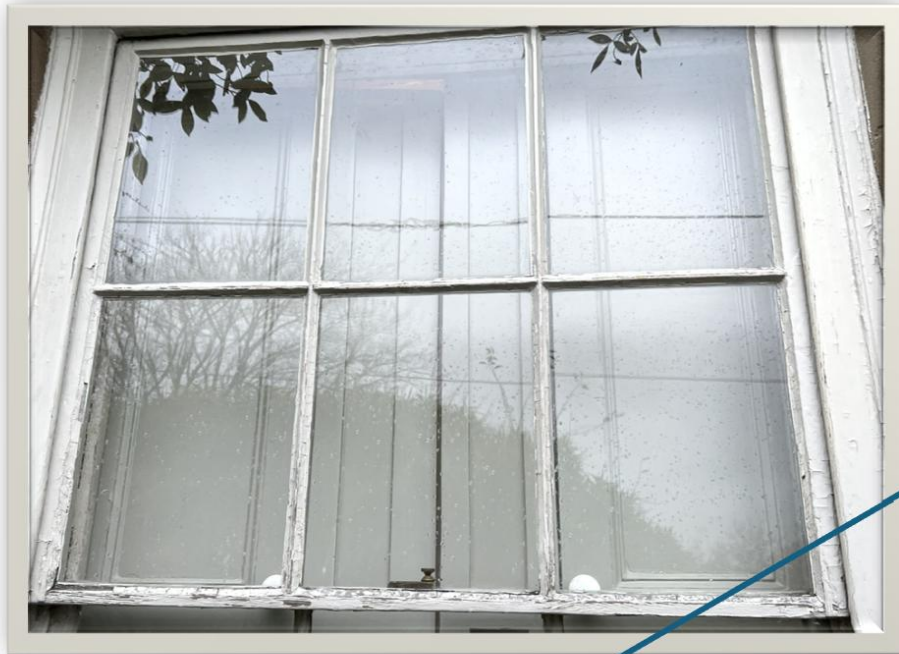
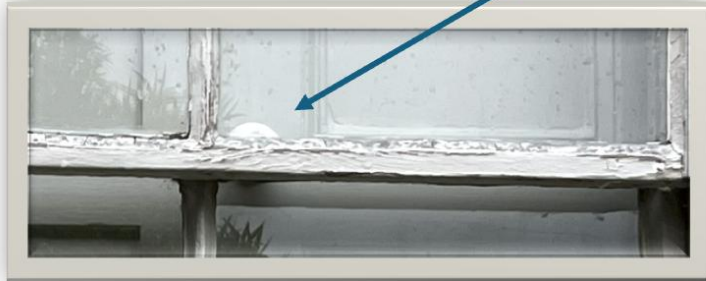
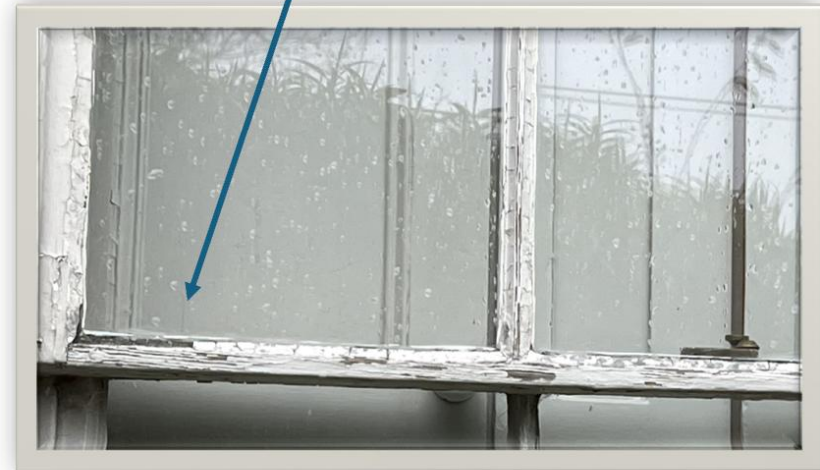
## Window W05GF Defects

Top sash has been replaced  
with softwood and is  
showing signs of decay

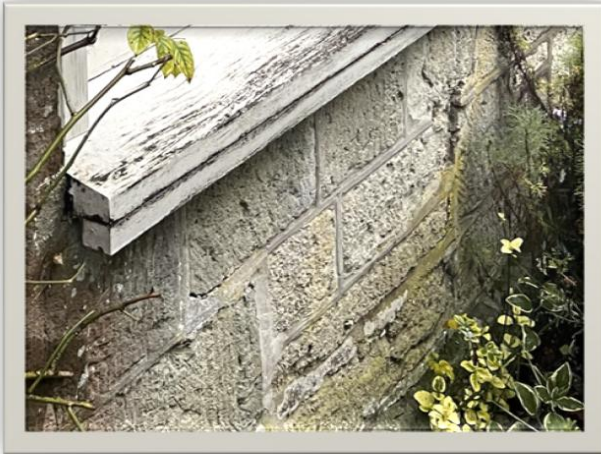
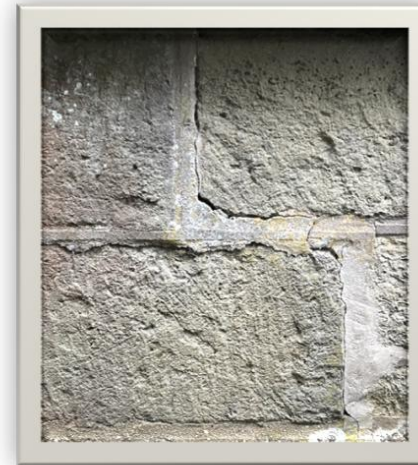
Cement pointing failing, cracks allowing water ingress

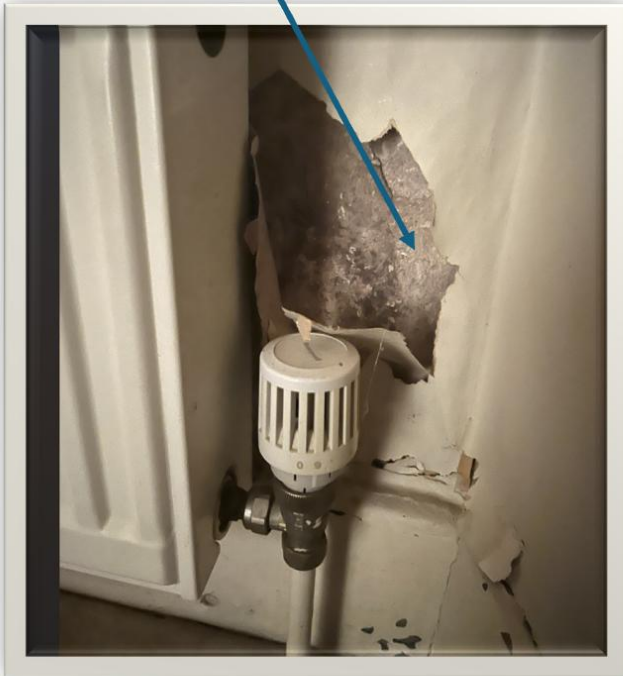
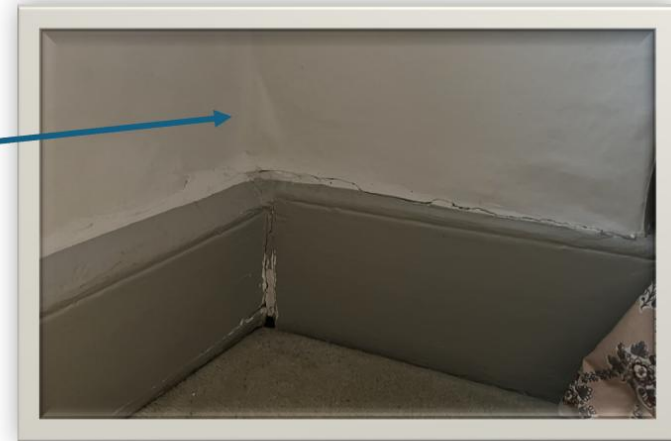
Plaster Failing due to moisture ingress

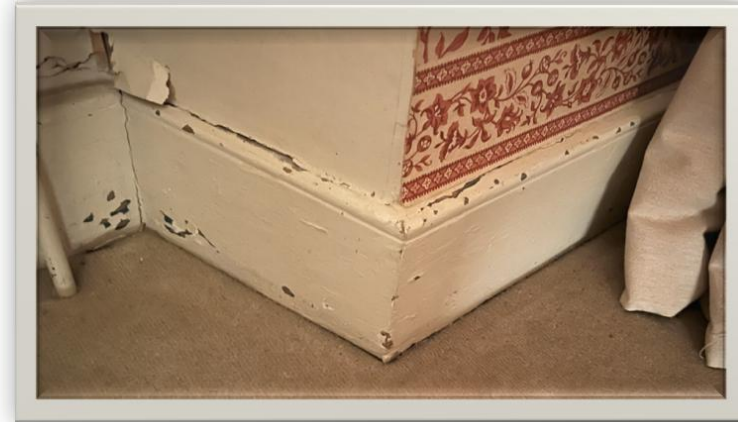
Timber Rotting due to moisture ingress

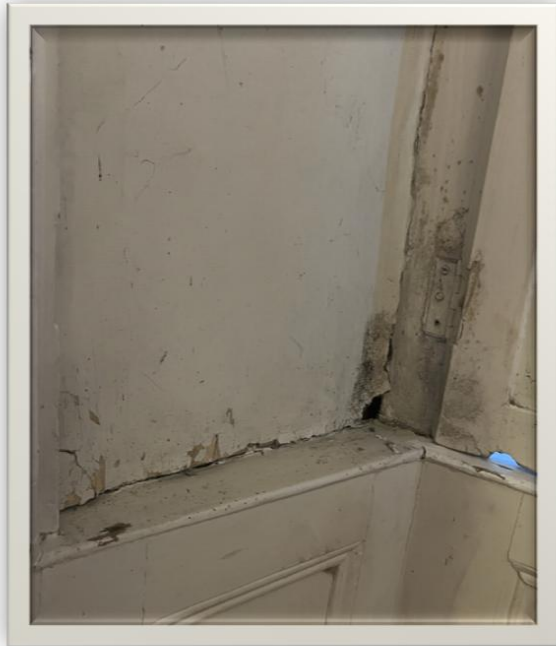
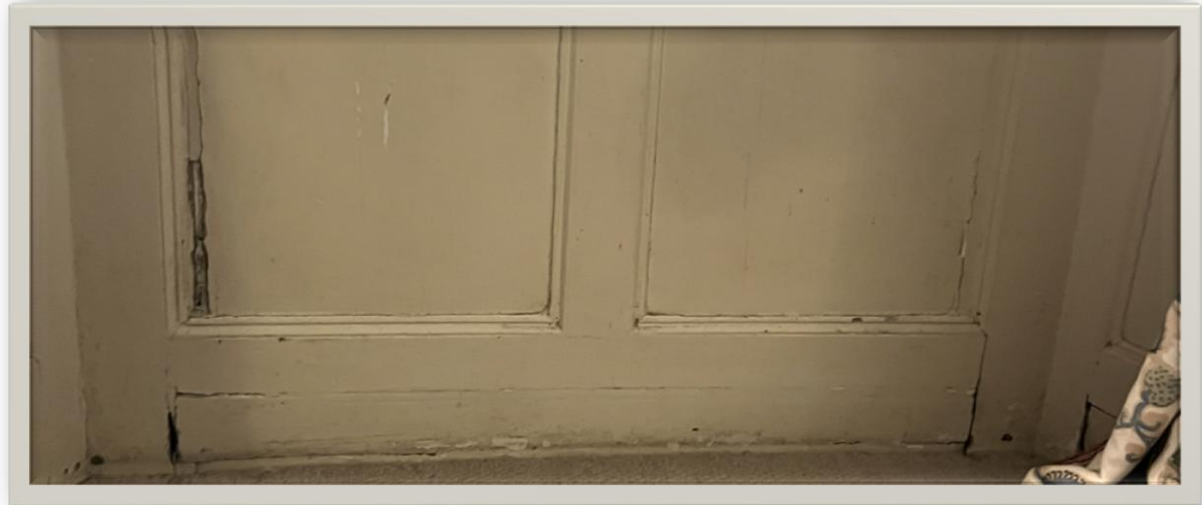
Historic Window joinery Failing due to  
moisture ingress
