# Outbuildings, Church Farm, Lower Seagry

## *Structural Appraisal*

| Issue Date: | 11 December 2023 |

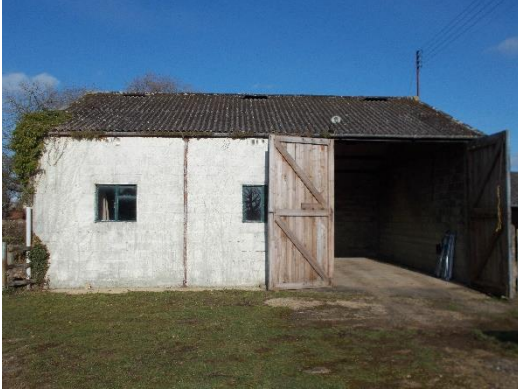
- 2.1.1 Building A has a duo-pitch roof, clad in (assumed) concrete corrugated sheeting. Externally the roof lines look to be reasonably true, suggesting that the roof structure is performing satisfactorily.

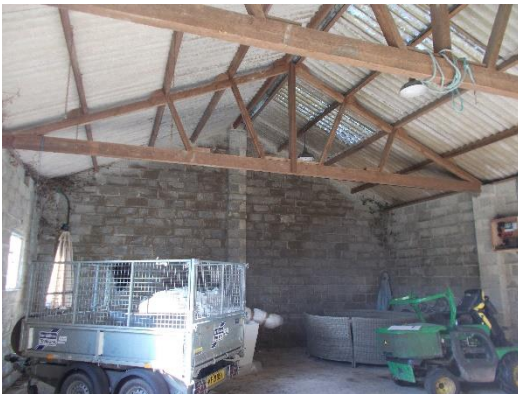
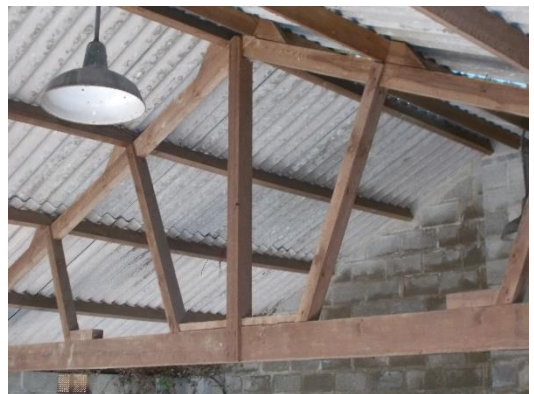
- 2.1.2 Internally the roof structure is seen to consist of three bays, formed by timber trusses spanning north-south, supporting timber purlins at approximately 1.1m centres. The trusses appear to be structurally sound, and performing satisfactorily. The purlin also appears to be sound, although a slight deflection is present.

- 5.1.5 Initial analysis of the timber roof trusses to Building A suggests that there is sufficient capacity for higher loading (ceilings, insulation) with only minor strengthening to the king post connections. The purlins will require slight strengthening for higher loading, but this can be carried out simply via fixing additional timber alongside the existing.

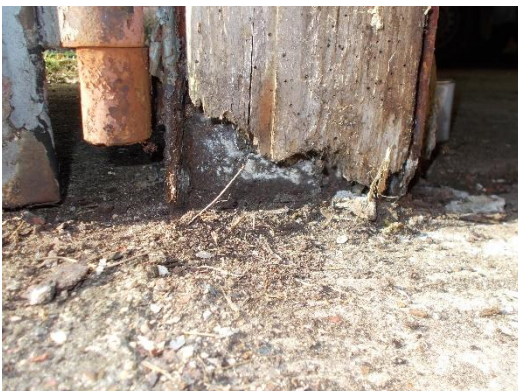
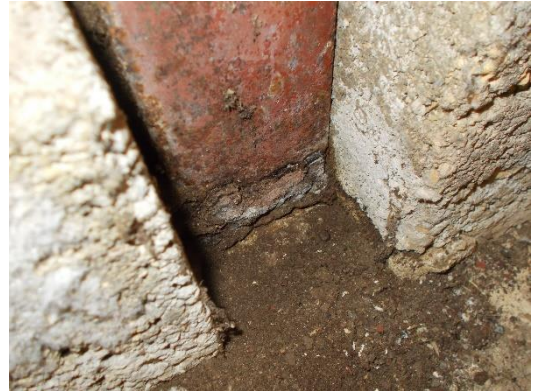
- 2.1.3 On the north elevation the trusses are supported on blockwork piers, formed as part of a 140mm thickness concrete blockwork wall. On the south elevation the trusses are supported on steel columns, 6" by 3". The columns appear to be performing satisfactorily; generally there is light corrosion evident on the visible steel faces, although more significant corrosion and delamination is evident at low level.

- 5.1.2 Minor structural defects are present in both buildings. The steel columns to Building A have sufficient corrosion at their bases to warrant remedial works, relatively simply carried out via steel plating. The minor cracking to the north elevation of Building B doesn't necessarily require remedial works, but consideration could be given to introducing movement joints if the building is to be converted to habitable use and the control of cracking becomes more desirable.

- 6.1.2 Minor structural defects are present, but these can be remediated relatively simply, via steel plating to the Building A steel column bases, and remedial works where minor blockwork cracking is evident.

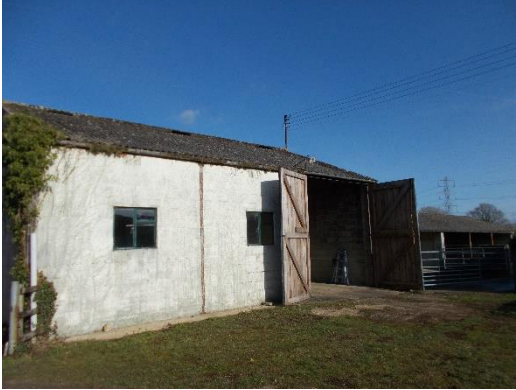
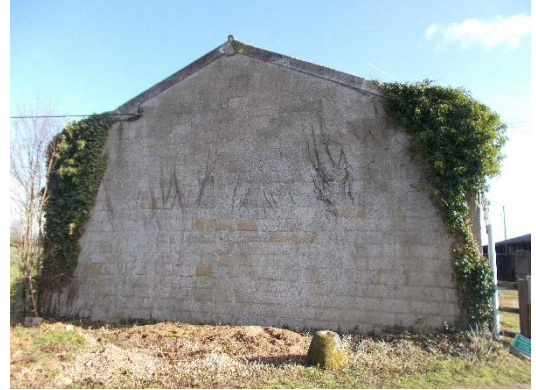
- 2.1.4 The gable ends are formed in 140mm concrete blockwork; on the south elevation 140mm blockwork is constructed as infill between the steel columns. The walls generally appear to be performing satisfactorily in that they appear to be plumb and free from significant cracking. This also suggests that the building is adequately founded.

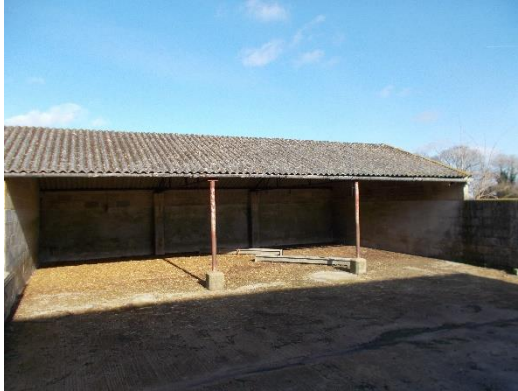
- 3.1.1 Building B has a duo-pitch roof, clad in (assumed) concrete corrugated sheeting. Externally the roof lines look to be true, suggesting that the roof structure is performing satisfactorily.

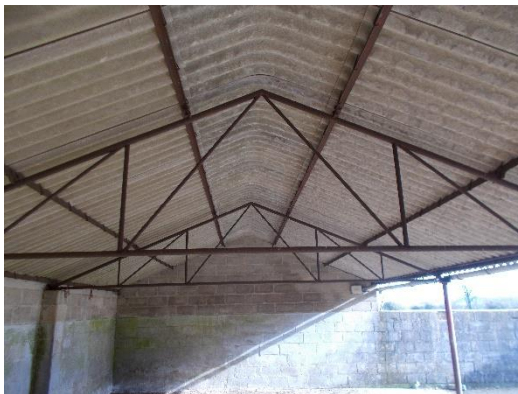
- 3.1.2 Internally the roof structure is seen to consist of six bays, formed by a central spine wall with two steel trusses either side. The steel trusses support two lines of purlin on each pitch and an additional row over the eaves line.

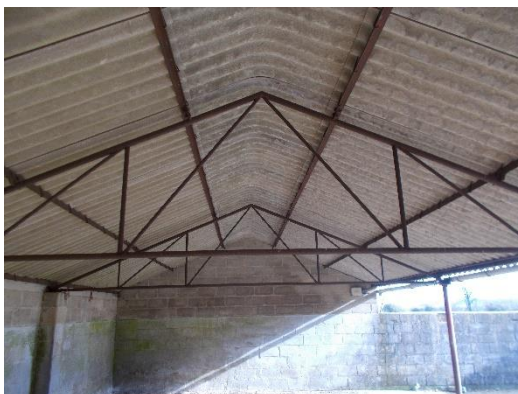
- 3.1.3 The steel trusses are formed with welded lightweight steel circular hollow sections; the trusses appear to be performing satisfactorily; although light corrosion is evident this does not appear to have developed excessively. Similarly, the steel purlins (angle sections) are lightly corroded; the sections are quite slender but appear to be performing satisfactorily, albeit with slight deflection evident.

- 5.1.6 Similarly, the purlins to Building B will require strengthening for higher loads, again by providing additional sections alongside the existing. The trusses to Building B appear to be adequate under existing loading; appraisal for higher loadings will be dependent on establishing steel thickness, but initial analysis suggests that the trusses are capable of carrying slightly higher loading if required without modification.

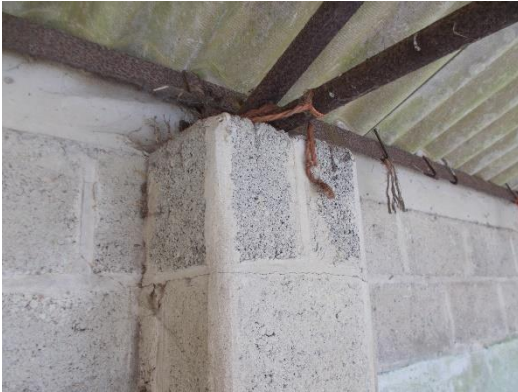
- 3.1.4 On the south elevation the trusses are supported on steel circular hollow section columns with concrete surrounds at the base. The columns appear to be sound, with only light corrosion, and the concrete base surrounds appear to be providing good protection to the vulnerable low level steelwork.
- 3.1.5 On the north elevation the trusses are supported on concrete blockwork piers to a 140mm thickness concrete blockwork elevation. The piers have a very slight cracking evident at the head; the reason for this is not immediately clear, but could be related to the very localised nature of the north elevation restraint at the truss positions.

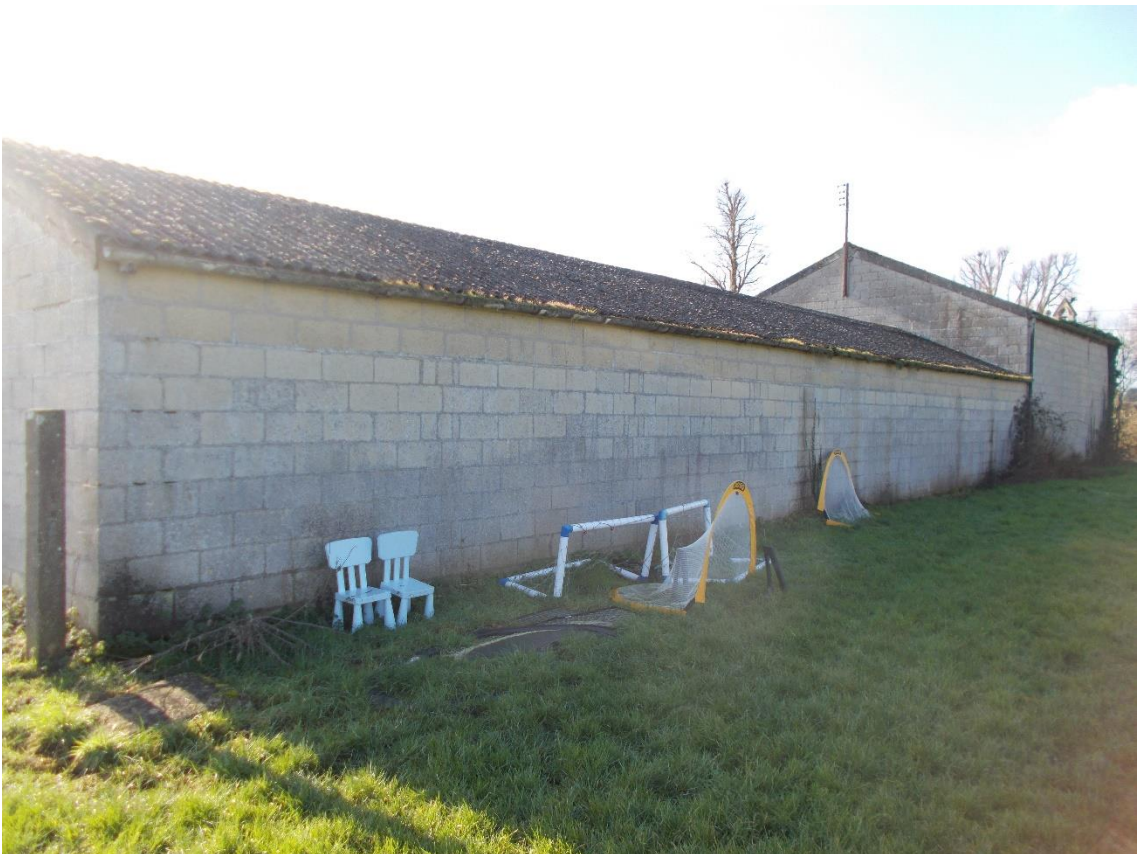
- 3.1.6 The north elevation itself has a very light cracking evident in places. It is assumed that in part this is due to the fact that the relatively long elevation has no joints over its length. It would normally be expected to provide joints at approximately 6m centres. The overall condition of the blockwork suggests that the building is well founded, with no significant cracking noted, and walls appear to be plumb.
