**SHOWELL FARM  
Showell  
Chippenham  
SN15 2NU**

**STRUCTURAL REPORT  
ON  
THE CART SHED**

3<sup>rd</sup> October 2025

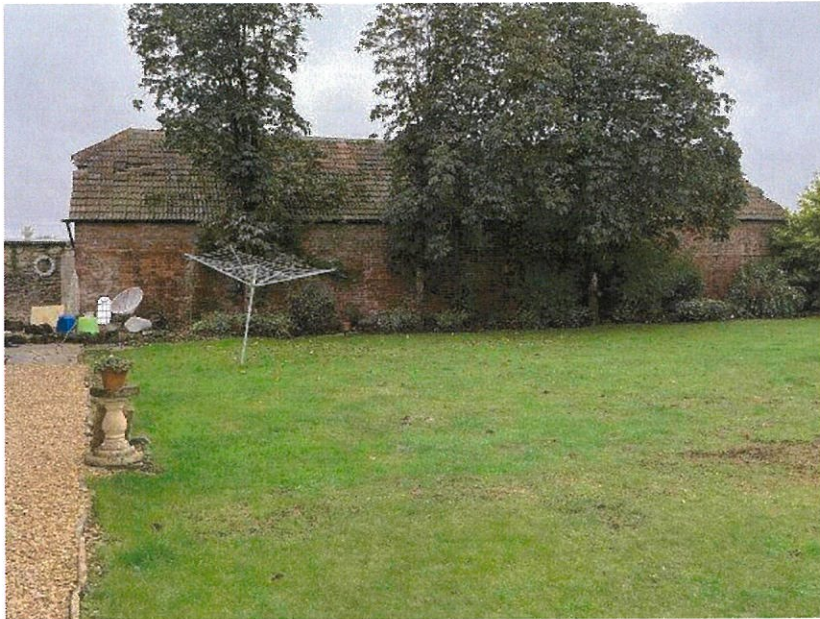
**1. North Elevation**

The north rear wall is 470mm overall thickness. It comprises half-brick thick external facing in lime mortar, fronting random rubble stonework. The brickwork has been built in traditional Flemish bond. It is unclear whether snapped headers have been used here or if full bricks have been bonded back into the stonework. There is a 210mm high stone plinth running the full length along the base of this wall. There is a series of high-level narrow vertical slit window openings along this wall. Some of these are finished with brick reveals.

There are a number of semi-mature trees and shrubs planted close to this wall.

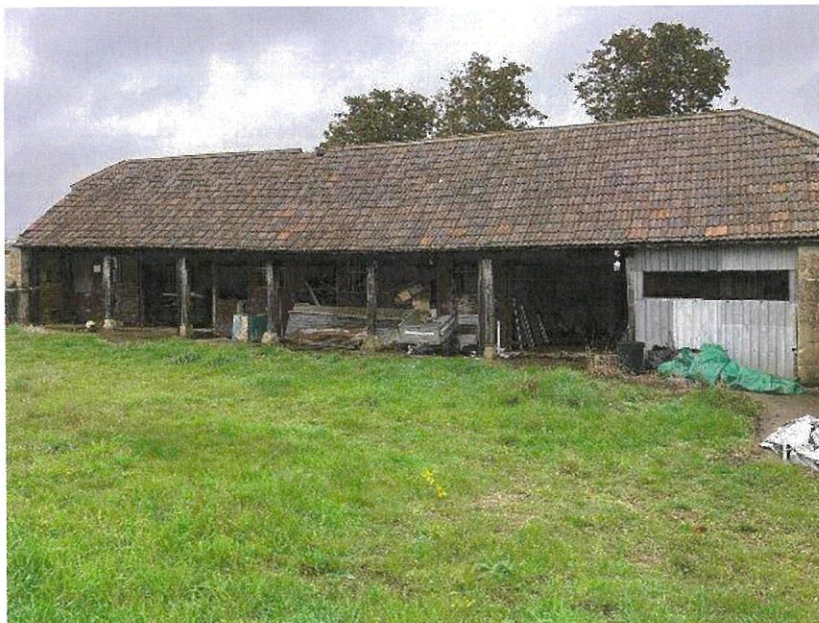
**2. South Elevation**

The south pitch appears in good condition with no significant sagging or undulations present. There are a few tiles missing from the south verge. There are also a couple of ridge tiles missing from the central part of the roof. There is guttering along this south elevation.

Apart from the ends of each gable, there is no masonry on the south elevation. The structure comprises 6Nr. oak posts set onto low-level staddle stones. These modestly weathered 160 x 160mm posts, incorporating flared heads, support a 205 x 175mm deep timber eaves beam. Some of the posts have been strengthened using supplementary timber set alongside. The eaves beam is scarf-jointed at the post positions. The western end of the eaves beam is partially decayed due to missing roof tiles. There are a couple of locations where the roof edge drops along this elevation. This is likely caused by the long-term but slow weathering at the base of the support posts. Overall, the timberwork appears satisfactory here.

Two of the timber posts along the south elevation would benefit from repairs to their lower ends, where they have been subjected to long-term moisture exposure and ingress through the end grain. This repair work could be incorporated into the overall enclosing of this elevation.

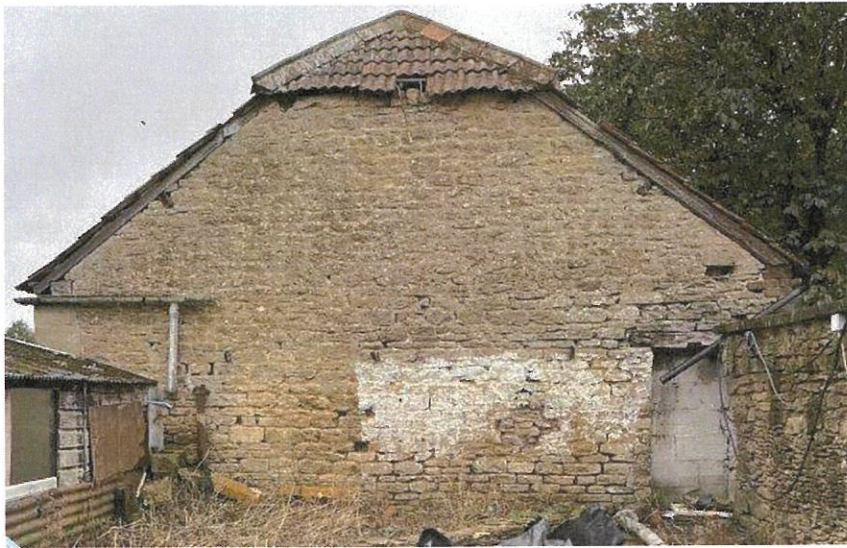
**3. East Elevation**

The east gable is a 450mm thick random rubble stone wall. Matching the opposing gable, there are ashlar quoins to finish its southern, front end. There are no windows present in this wall. There is evidence of a former doorway at the north corner which is now infilled with concrete blockwork. The timber lintel has been retained above the blockwork. Similarly, there are a few stones missing from this gable but overall, it appears to be flat, solid and in good condition.

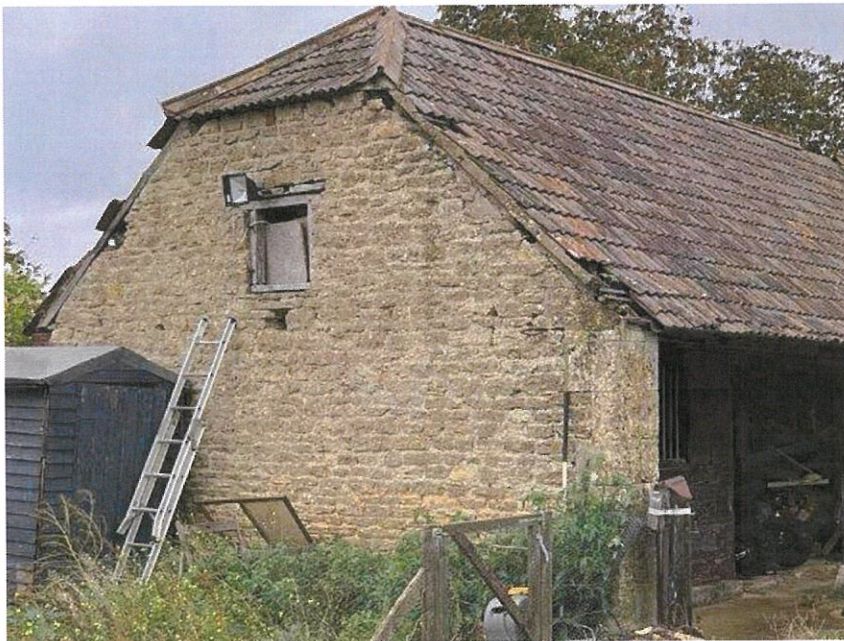
**4. West Elevation**

The west gable is a 460mm thick random rubble stone wall. The south end is finished with ashlar quoins. There is a single, high-level window opening in this wall, which is framed with sawn timber. There is a timber lintel above this window. There are a few stones missing from this gable, but overall it appears to be flat, solid and in good condition.

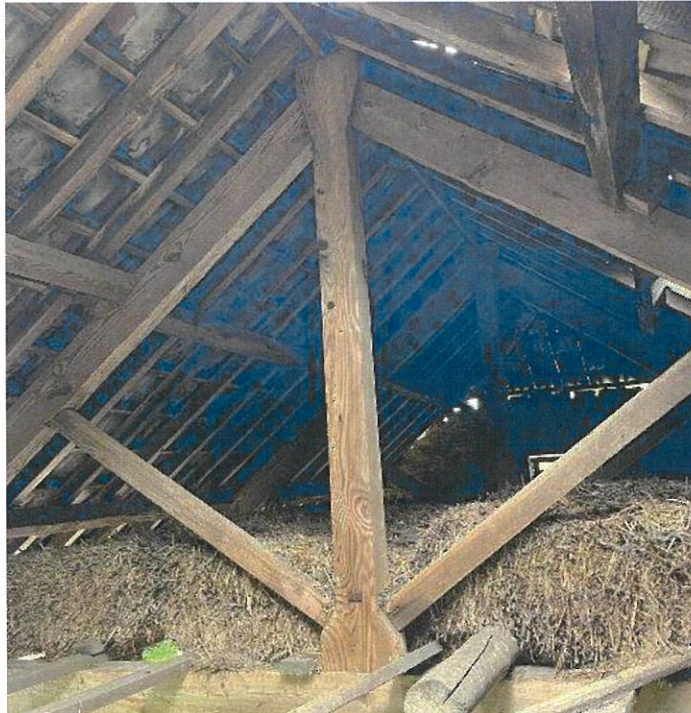
**5. Typical King Post Truss**

The primary roof structure comprises 6Nr. timber king post trusses aligned with the front posts. These consist of 225x150mm tie beams, 200x90mm principal rafters and 140x130mm king posts. The far end of the tie beams bear onto the north wall, with short timber spreaders used as seatings. At the front, they are housed into the top edge of the eaves beam. Overall, these trusses appear in excellent condition. Locally, Truss 3 has some decay due to missing roof tiles and Truss 4 is missing a rear strut.

The king post trusses are in generally excellent condition with only a few minor repairs necessary for their long-term retention. Similarly, only limited repairs are necessary for the secondary roof timbers.

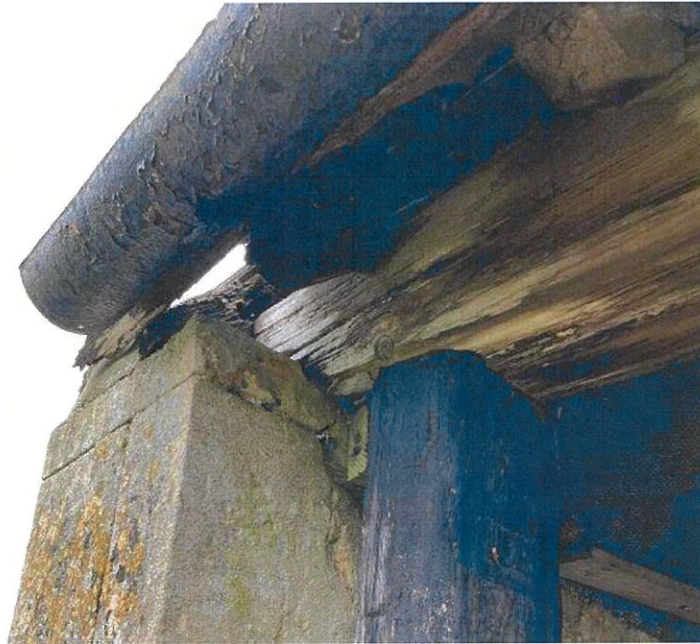
**9. Decay at West End of Eaves Beam**

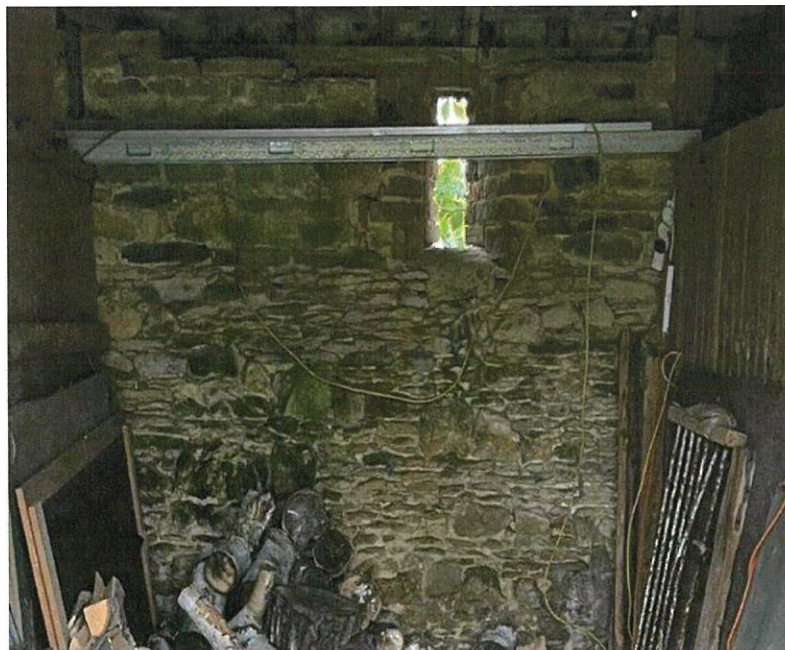
**10. Internal Face of North Wall**

At a couple of places along the north rear wall, the random rubble stonework appears to have two distinct patterns or styles. The lower two-thirds of the wall exhibit a blend of large and small stonework, set in modestly-sized mortar joints. The upper third portion consists almost exclusively of larger stones in much larger mortar joints. This may indicate represent either repair works or that the roof height was raised at some point.

Some areas of these walls have green algae growth present.

Overall, the inspected walls appear in good overall condition with no sign of significant movement, cracking or major structural defects.
